Inspection Photos

Operator: Chesapeake Operating LLC #16660

Location ID: 316037

Rio Blanco County, CO

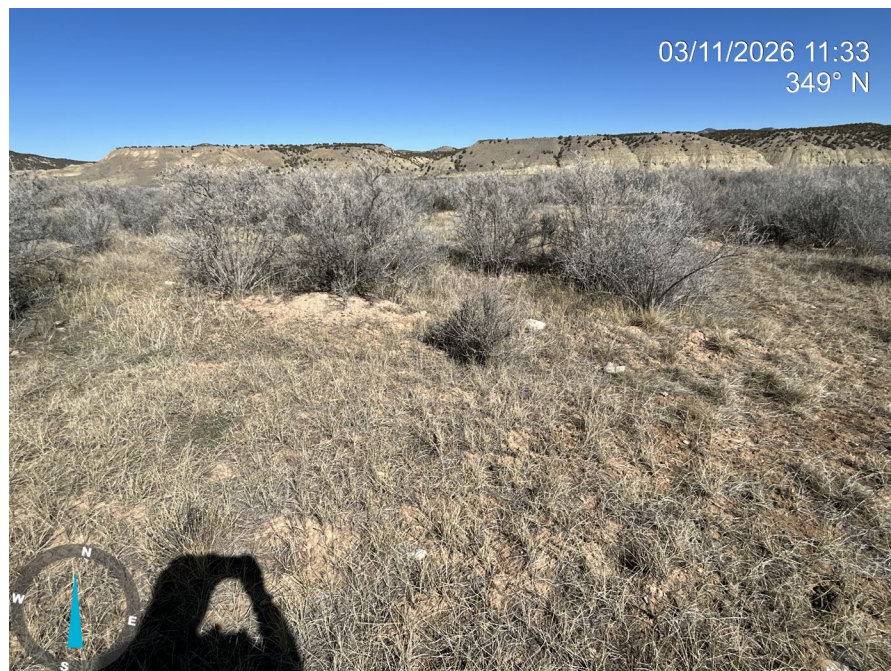
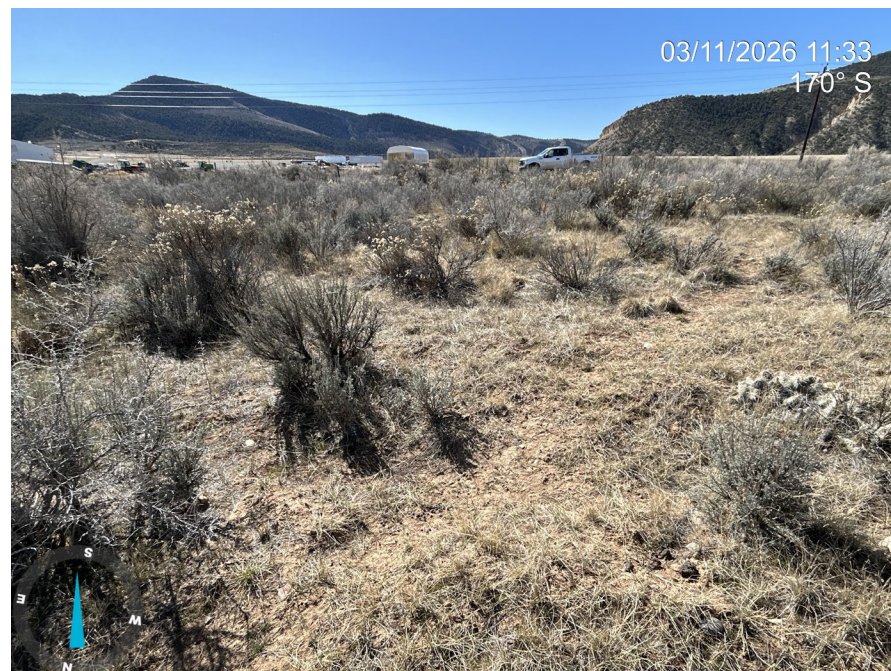
Photo 1: Photos showing an overview of the location looking north and south, respectively. Desirable, perennial and uniform vegetation with at least eighty (80) percent cover of a nearby reference area is present.

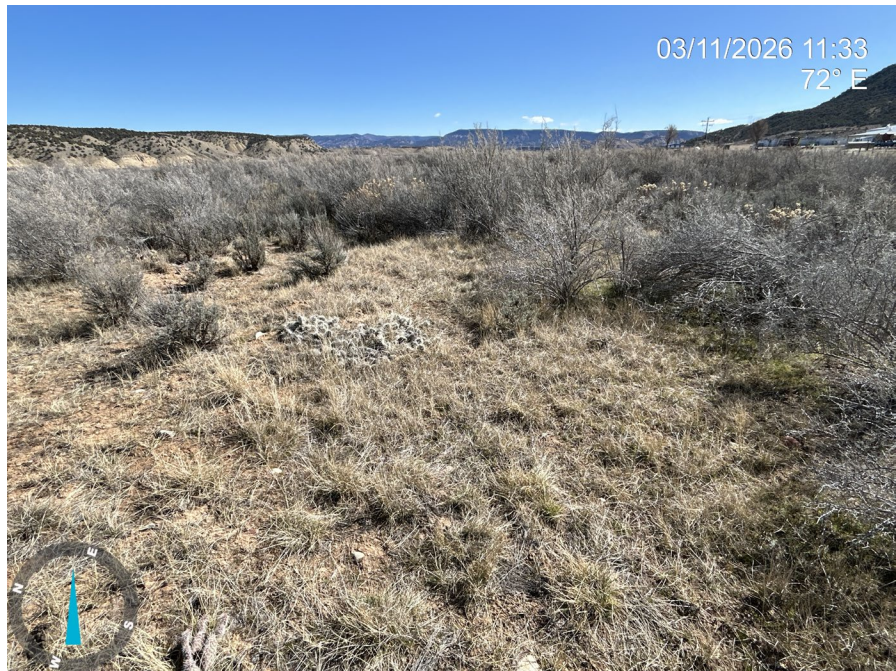
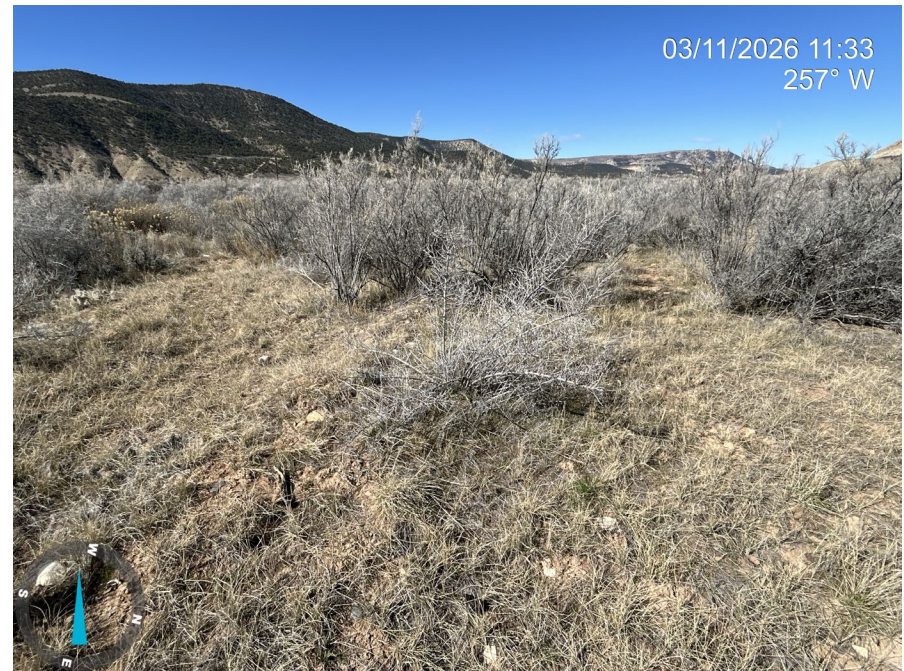
Photo 2: Photos showing an overview of the location looking east and west, respectively. Desirable, perennial and uniform vegetation with at least eighty (80) percent cover of a nearby reference area is present.

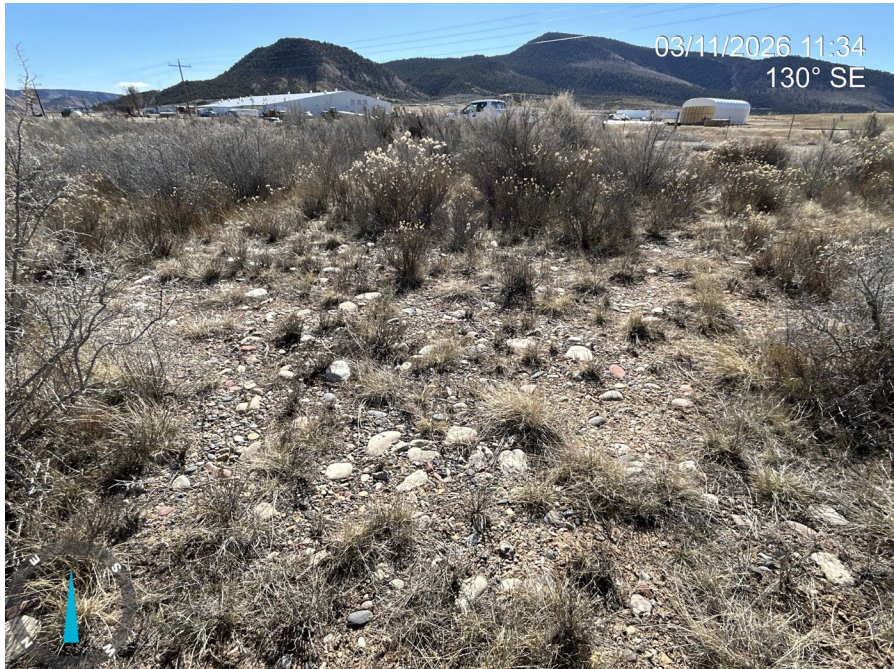
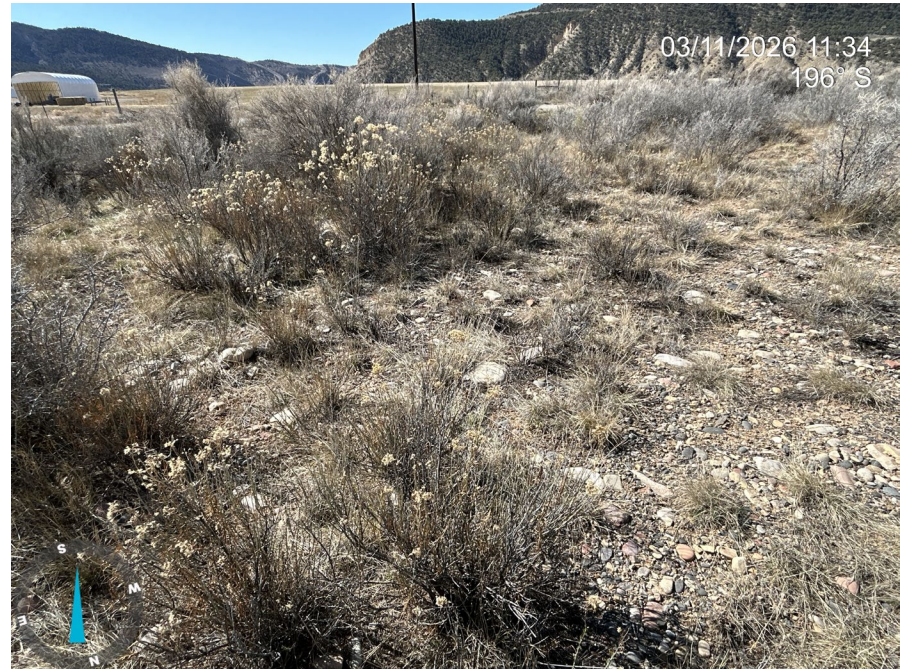
Photo 3: Photos showing that some gravel remains present at the entrance to the location. Perennial grasses and shrubs are present; mature vegetation has established.

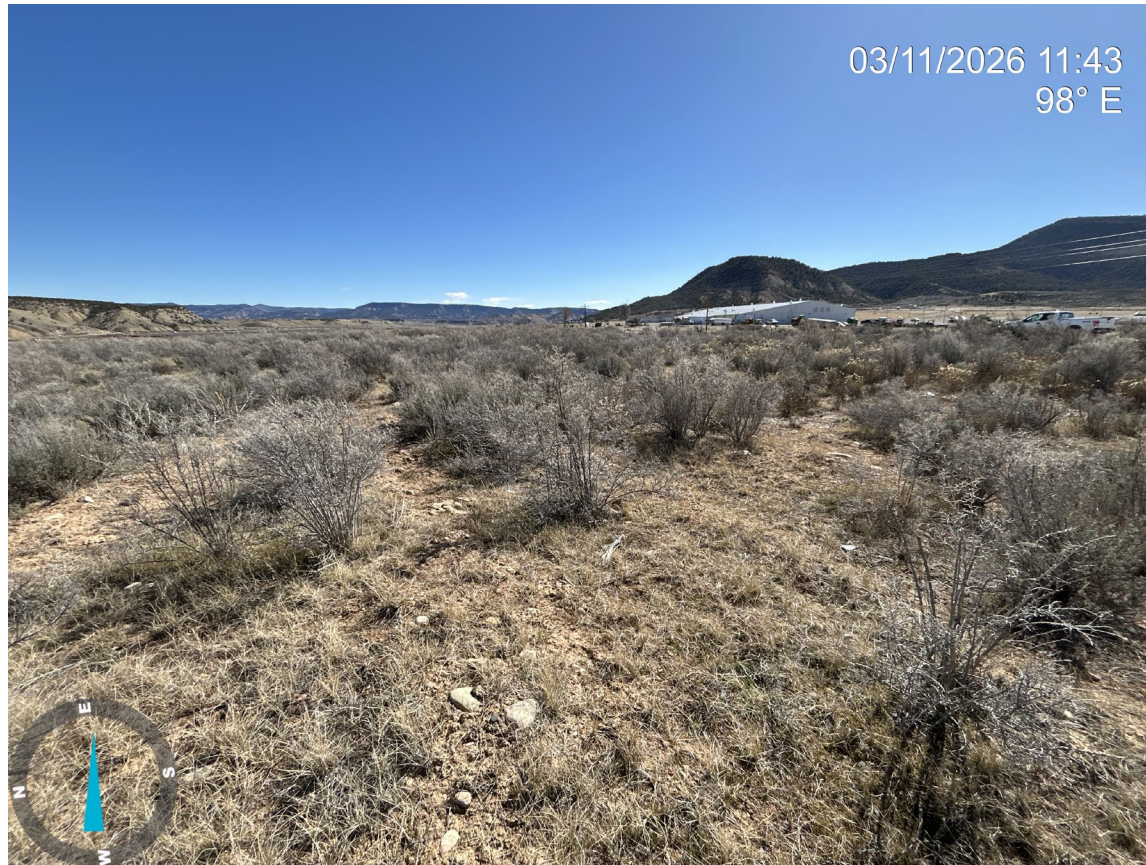
Photo 4: Photo showing an example of a nearby reference area, located directly west of the location. Vegetation composition and cover at the location is comparable to the reference area.
