# INSPECTION PHOTOS

Well: HILL RANCH 26-09V

API #: 05-071-07359

INSPECTION DOC #: 716302078

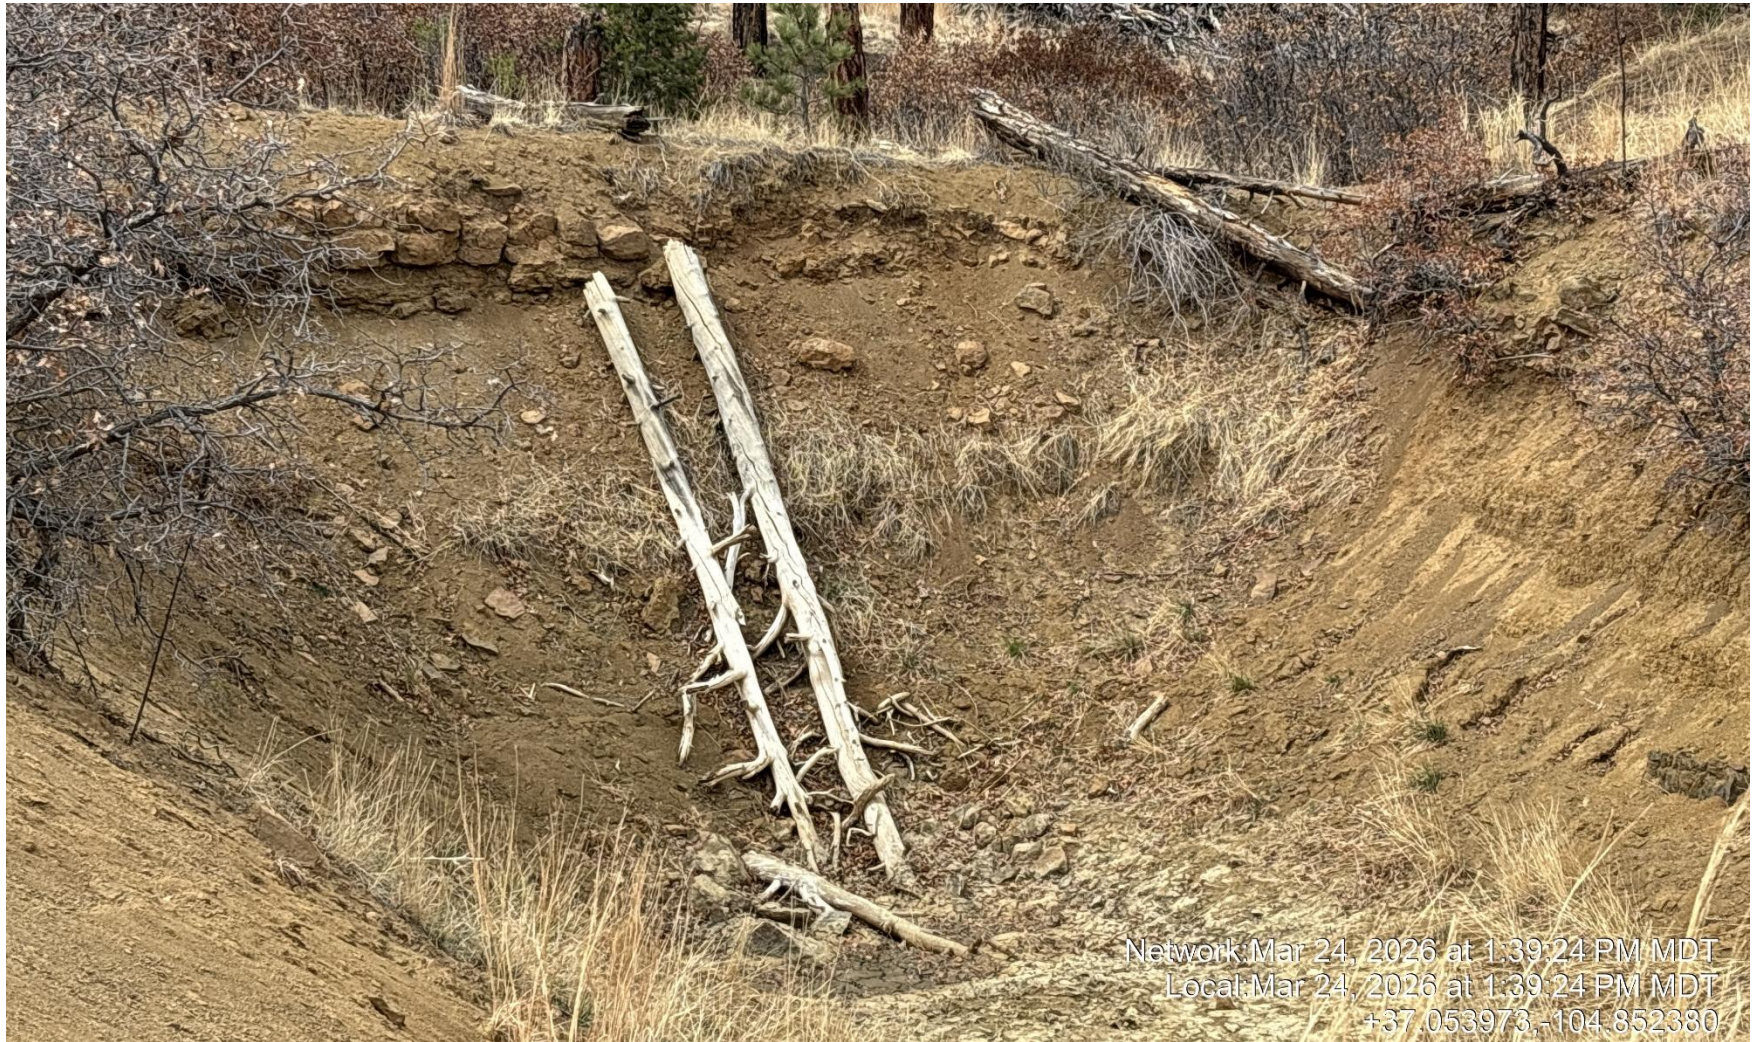
**PHOTO 5: OILY WASTE INSIDE PRIME MOVER ENGINE SKID. DRAIN OILY WASTE REPAIR ALL LEAKS AND REMOVE IMPACTED SOIL PER RULE 1002..(2).D & 1002.f.(2)B, Comply with general provisions of the oil and gas act for wildlife protection AND SB-181. CA DATE 3/25/2026 FOR OILY WASTE, 3/30/2026 TO REMOVE IMPACTED SOIL.**
