Inspection Photos

Operator: QB Energy Operating LLC #10844

Location ID: 323937

Inspection Doc: 719200947

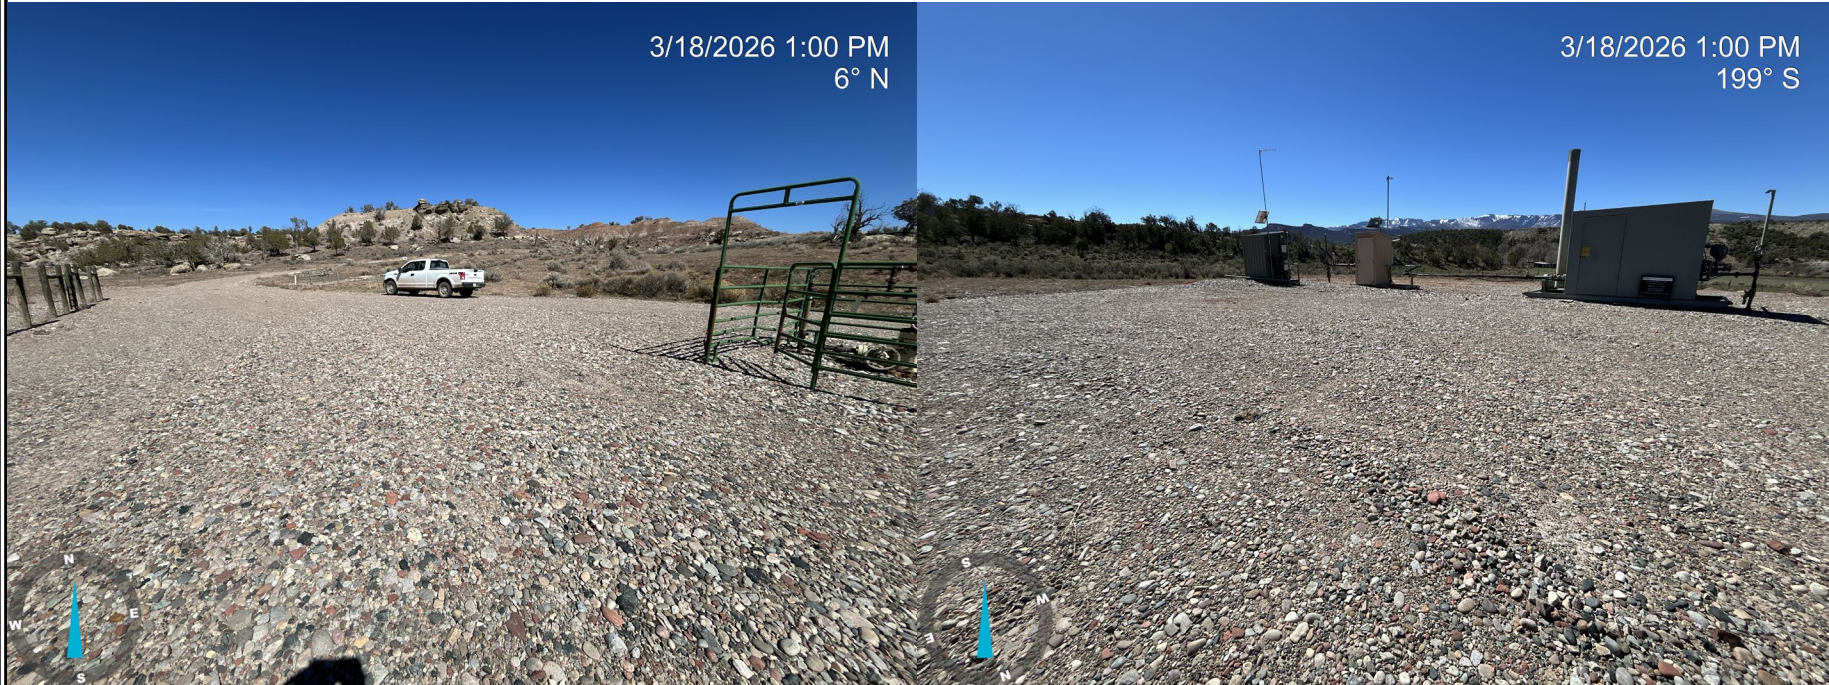
Photo 1: Photos showing an overview of the location looking north and south, respectively.

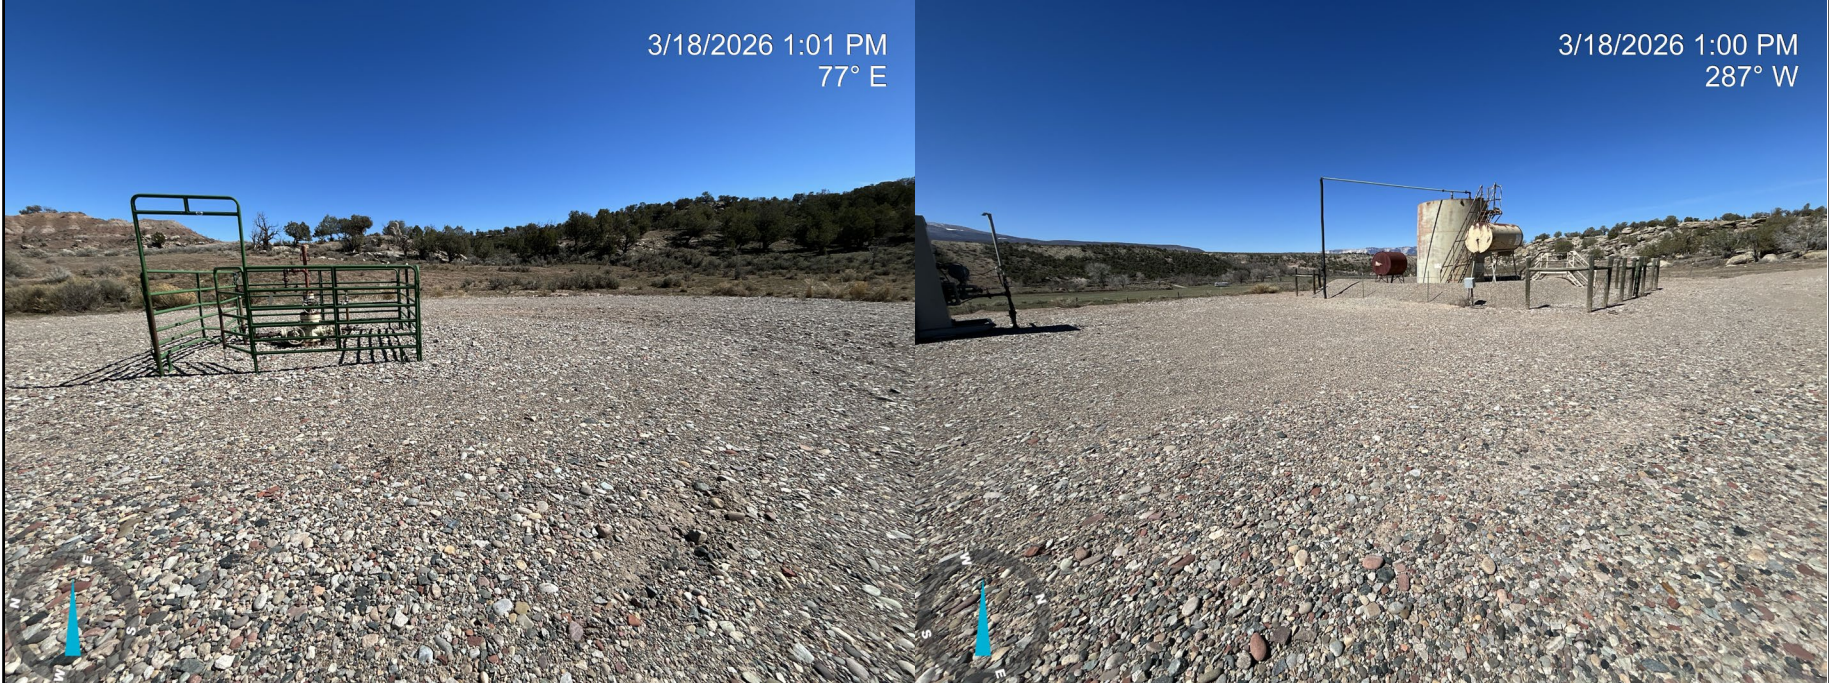
Photo 2: Photos showing an overview of the location looking east and west, respectively.

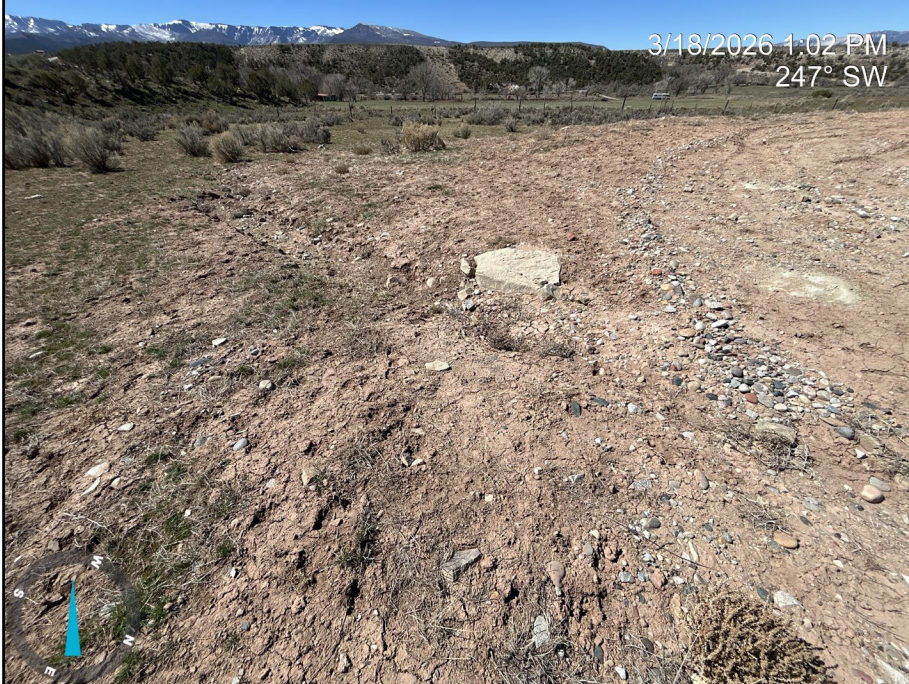
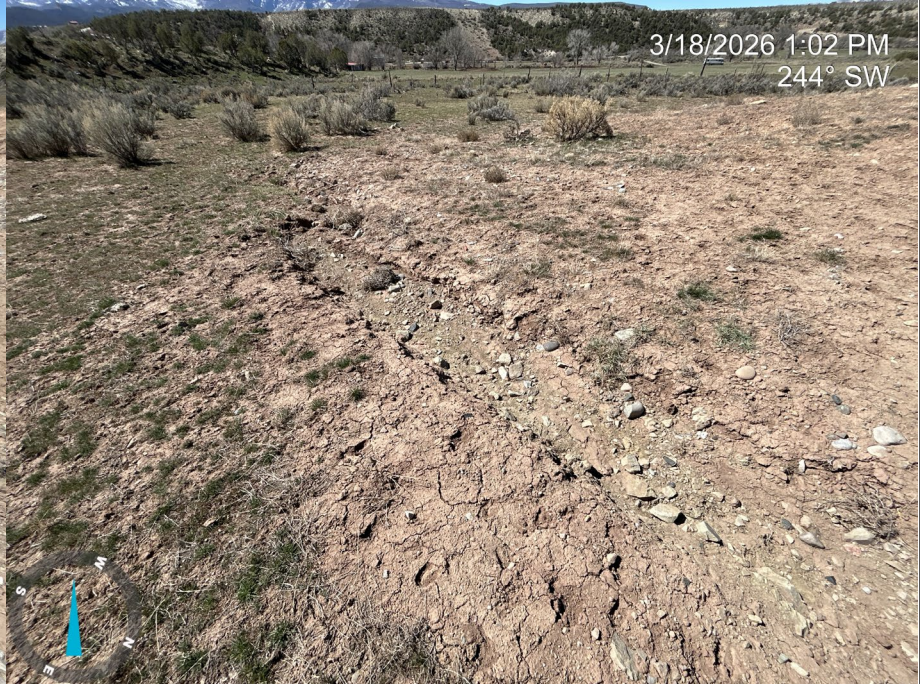
Photo 3: Photos showing erosion that is occurring on the eastern edge of the working pad surface; stormwater BMP's appear to be missing or insufficient. Comply with Rule 1002.f.

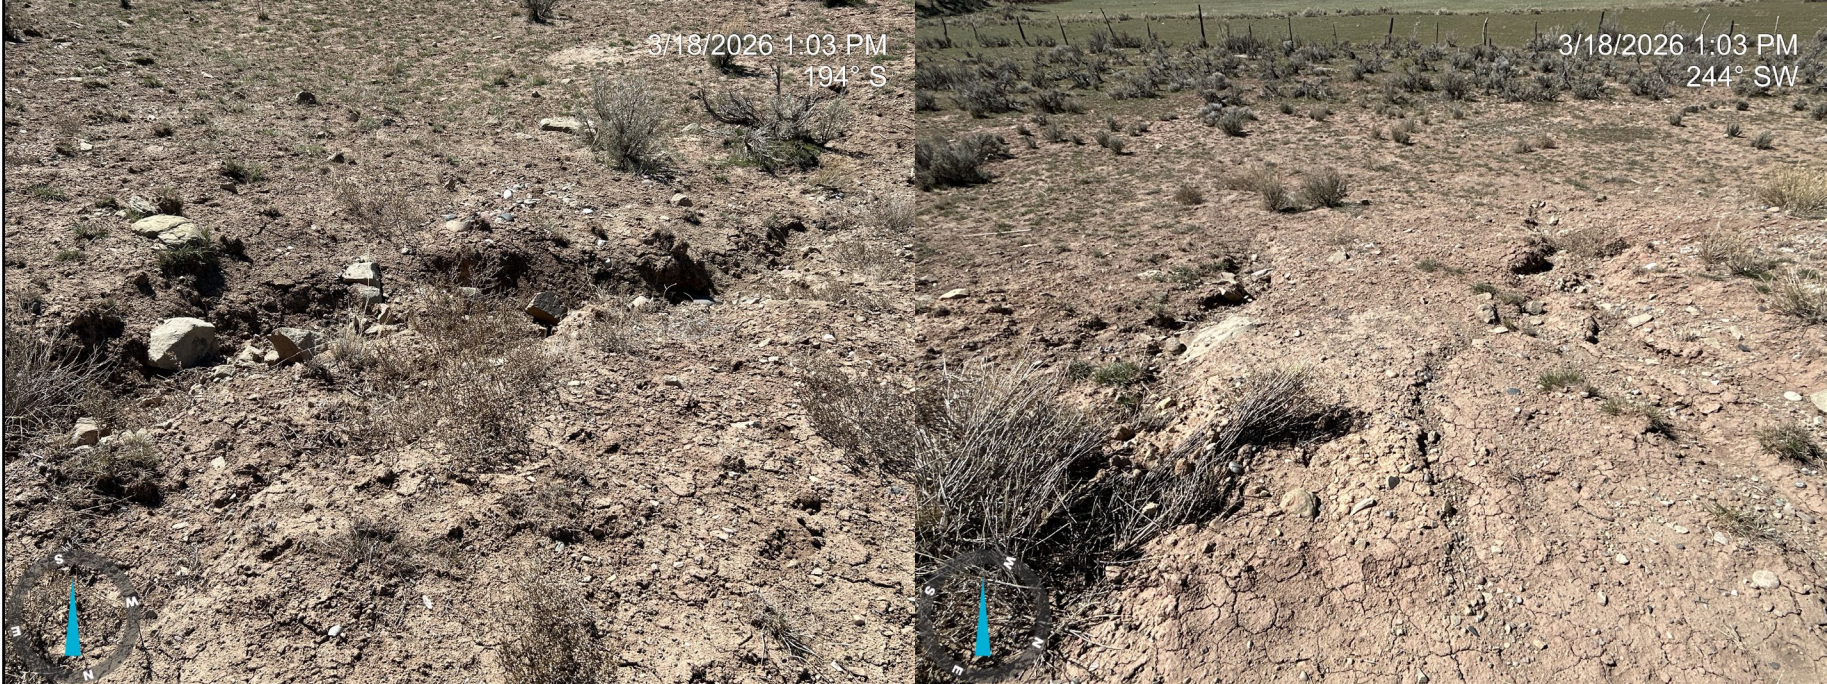
Photo 4: Photos showing examples of erosion that is occurring on the western edge of the working pad surface; stormwater BMP's appear to be missing or insufficient. Comply with Rule 1002.f.

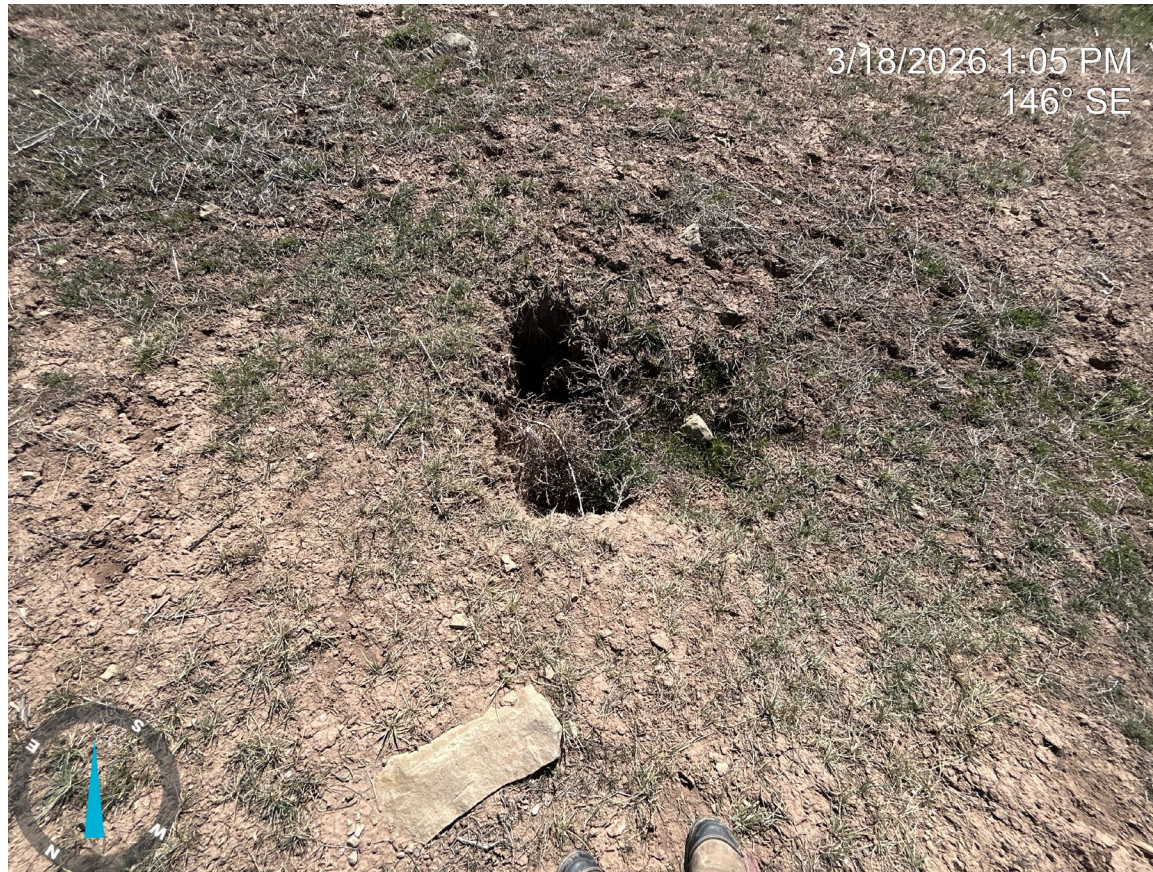
Photo 5: A small subsidence is occurring in the northeastern interim area. Maintenance is required.

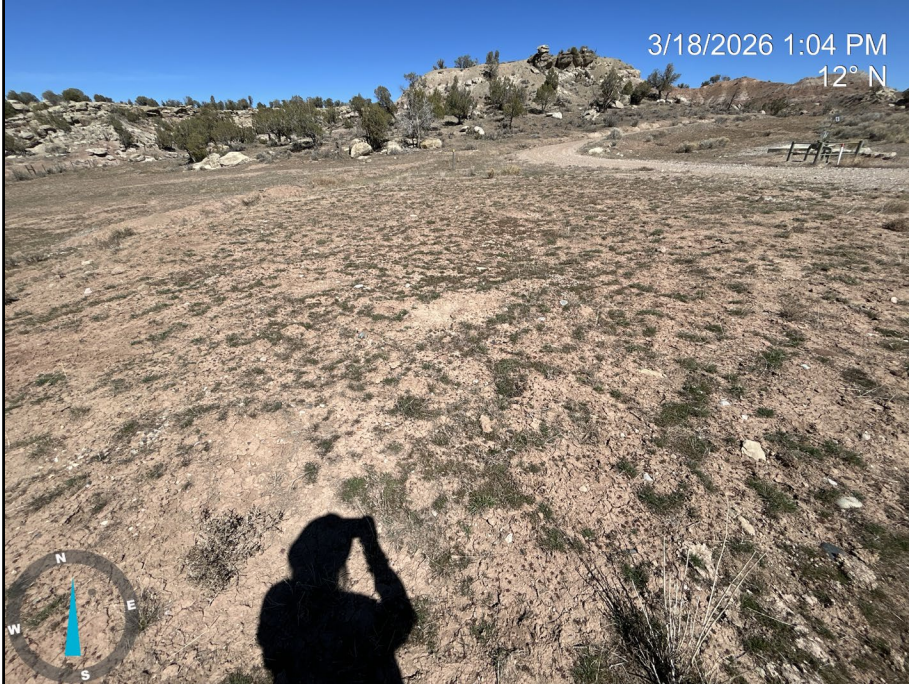
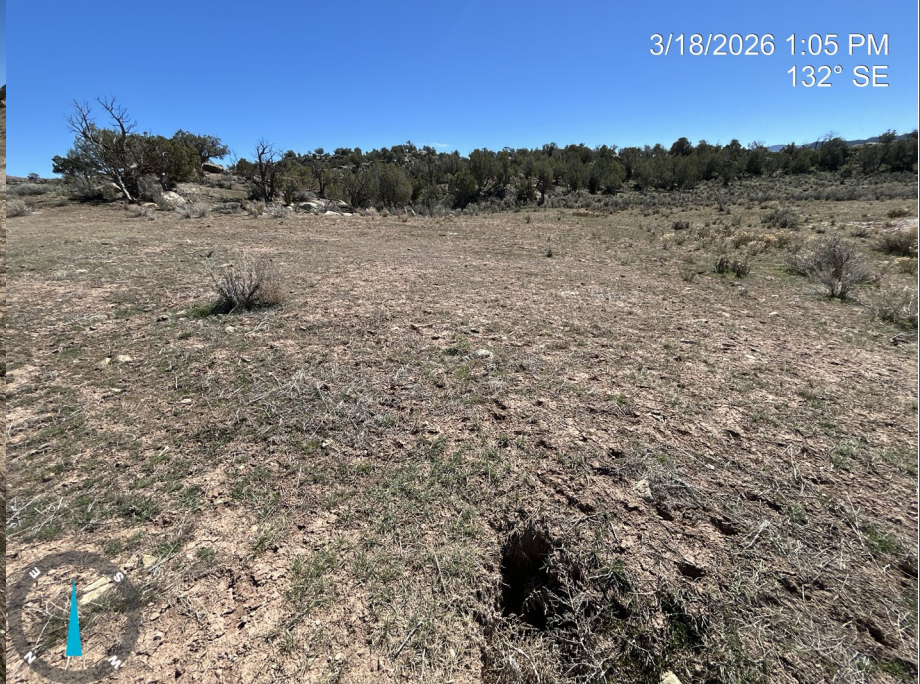
Photo 6: Photos showing examples of the northwestern and eastern interim areas, respectively. Interim areas are used by cattle; perennial grasses are present. Interim areas are progressing towards 1003 reclamation requirements.

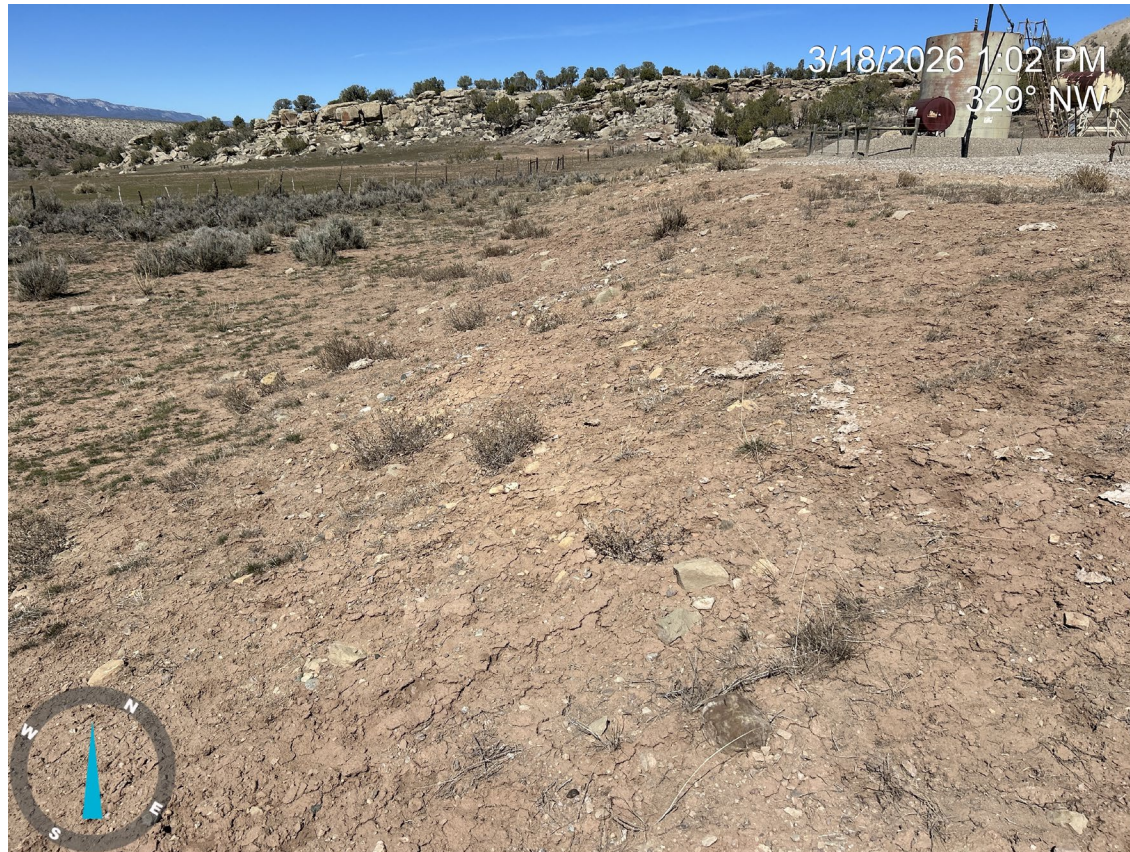
Photo 7: Fill slopes are predominantly bare in some areas, and erosion/rilling is occurring. Additional reclamation efforts may be required in the future to stabilize the slopes.
