# Inspection Photos

Operator: QB Energy Operating LLC #10844

Location ID: 334867

Inspection Doc: 719200953

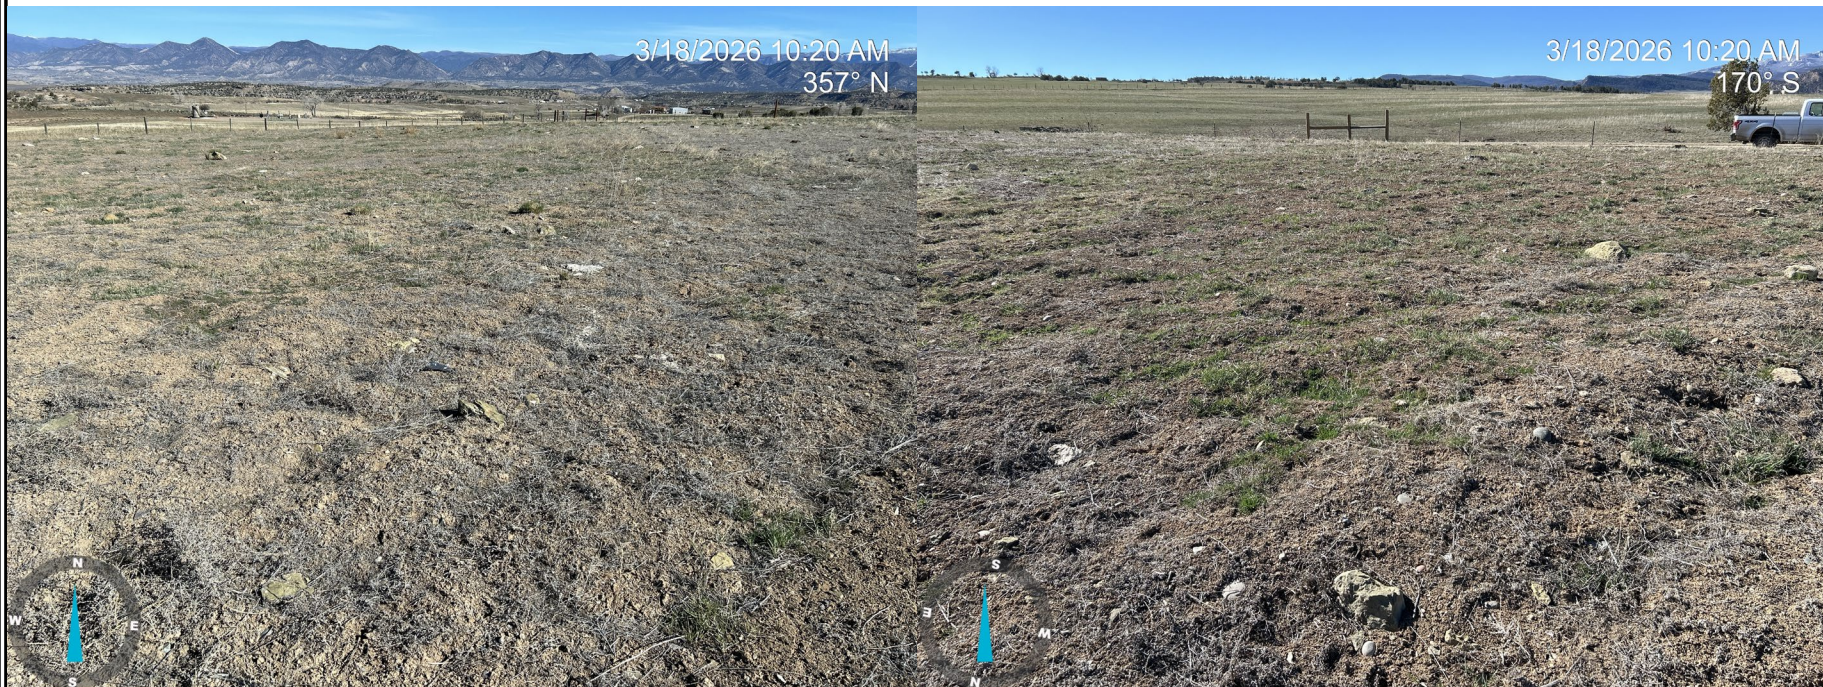
**Photo 1:** Photos showing an overview of the location looking north and south, respectively. Grey material is undesirable plant species such as kochia and prickly Russian thistle.

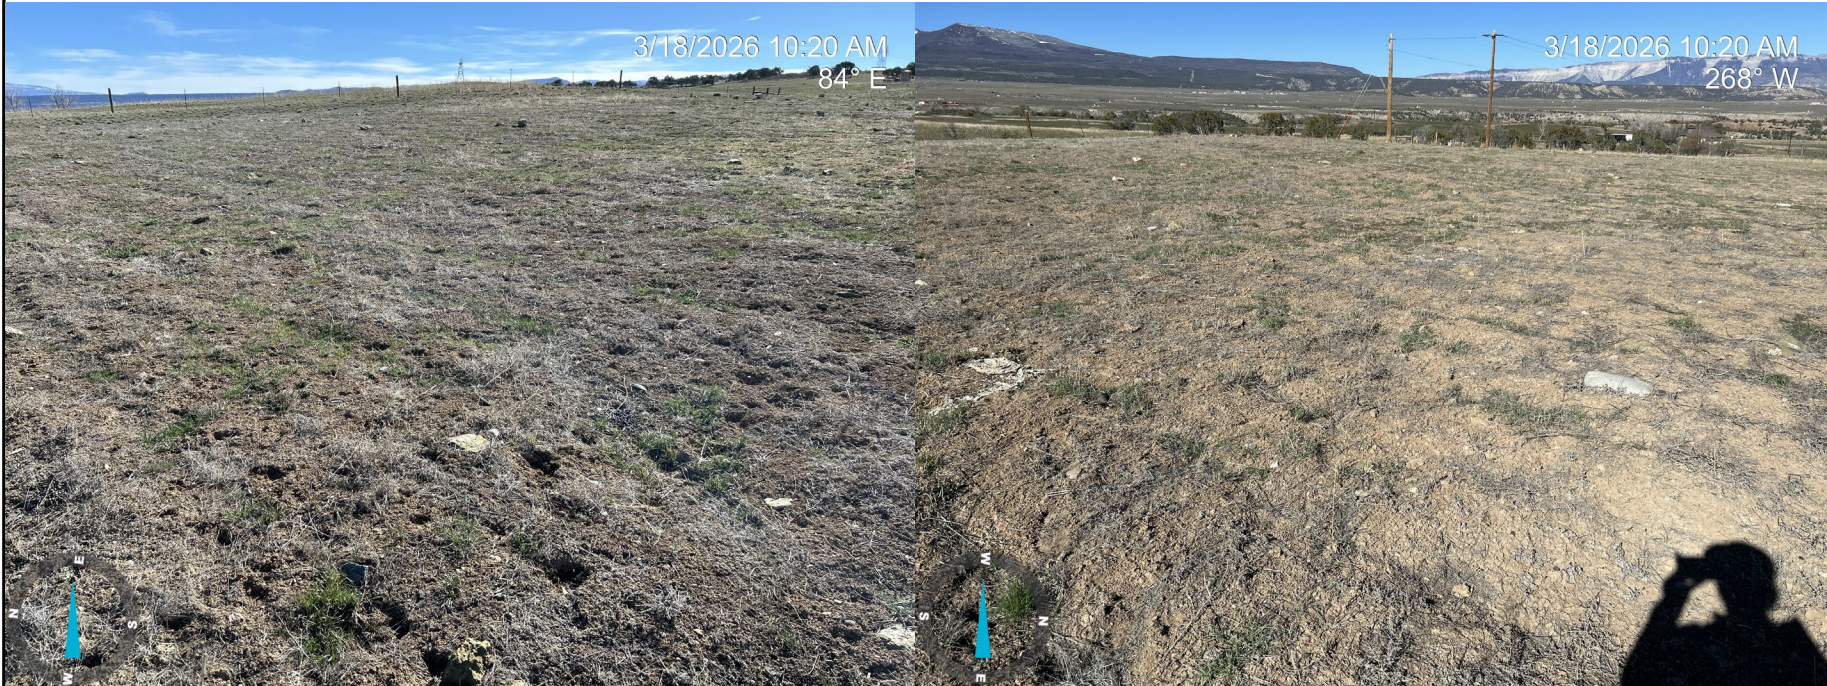
**Photo 2:** Photos showing an overview of the location looking east and west, respectively. Grey material is undesirable plant species such as kochia and prickly Russian thistle.

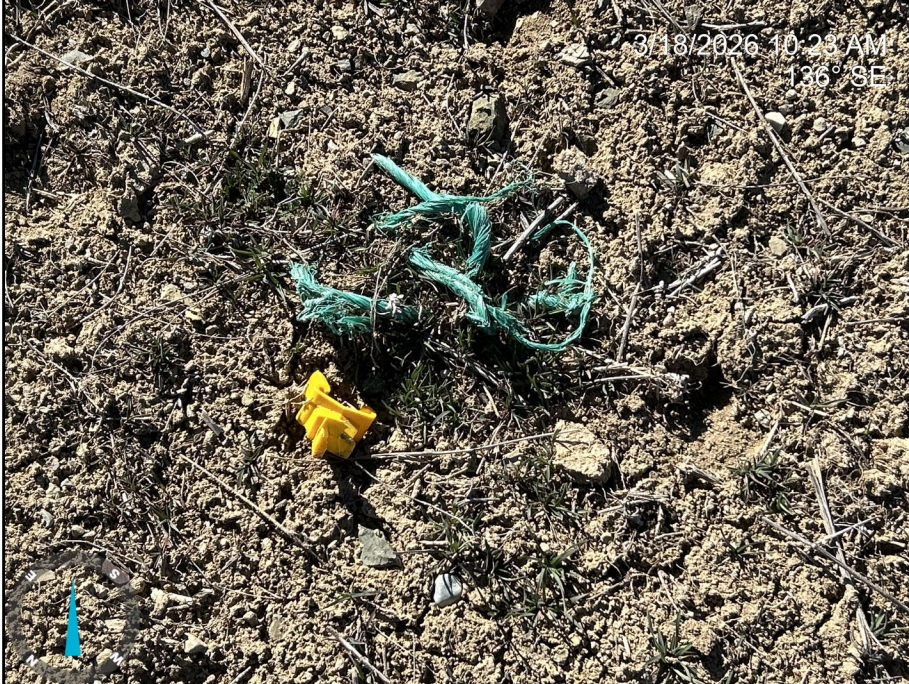
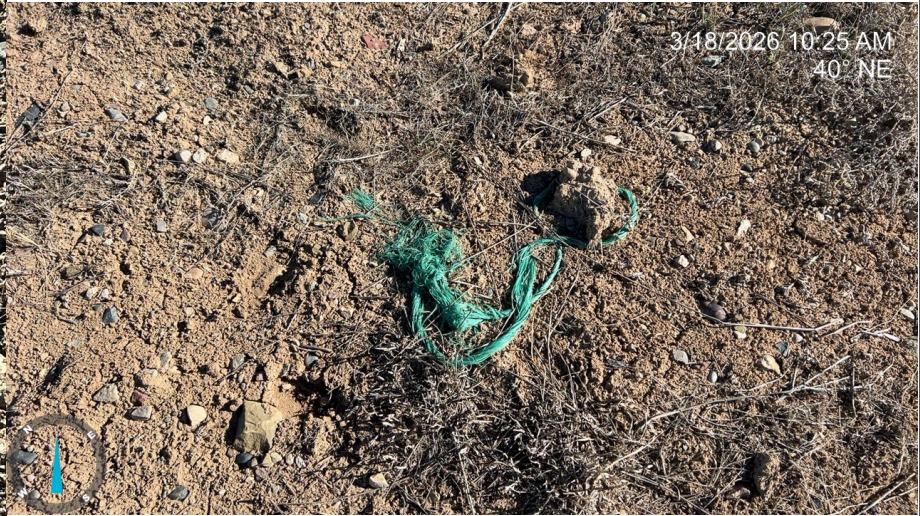
**Photo 3:** Photos showing examples of twine trash that is scattered throughout the location and requires removal.

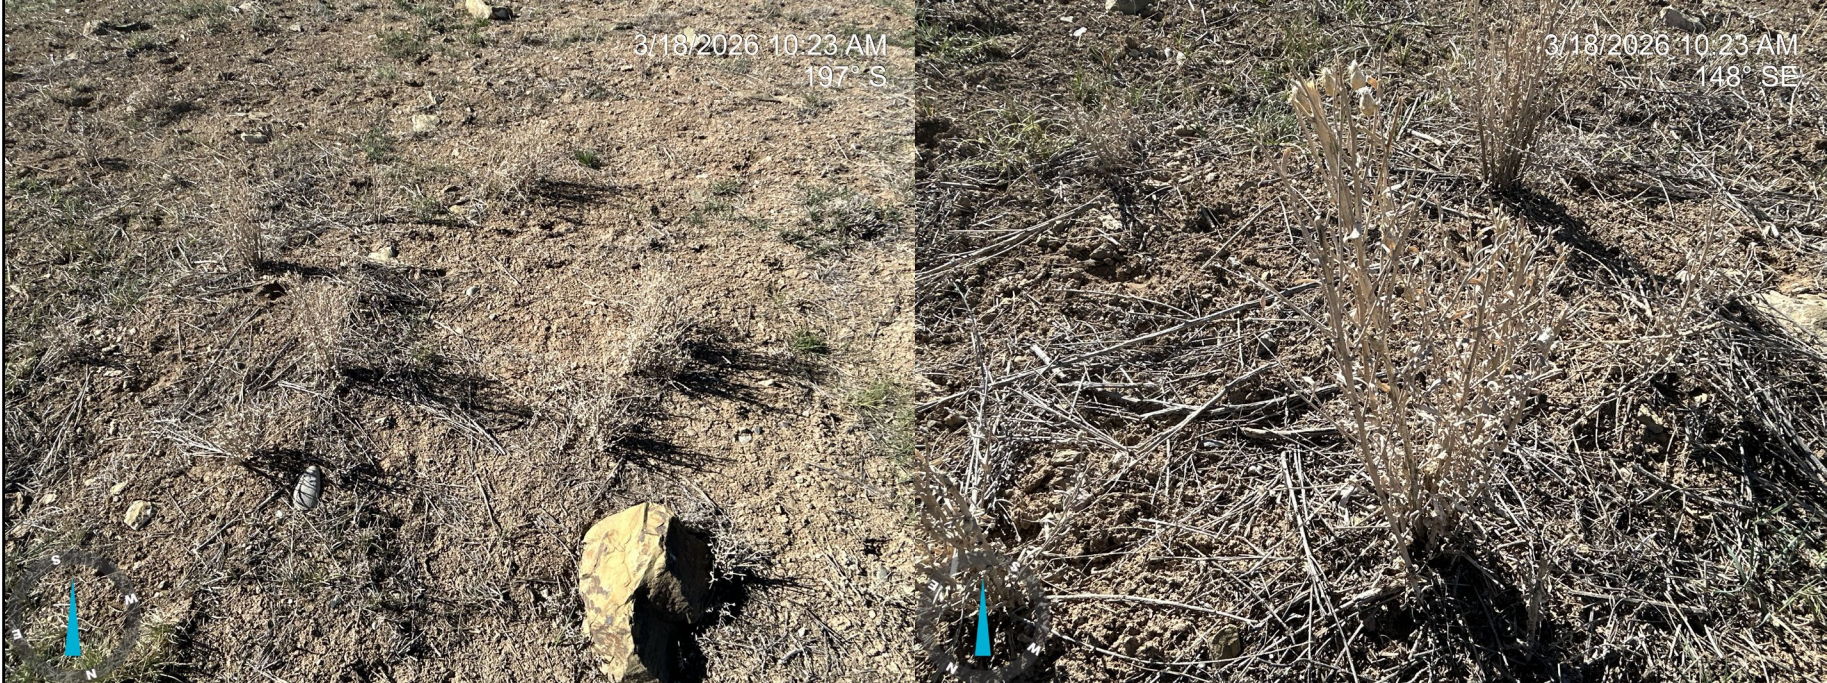
**Photo 4:** Photos showing a small patch of Russian knapweed, a List B noxious weed species, is present in the southeastern portion of the location. Weed control efforts are required.

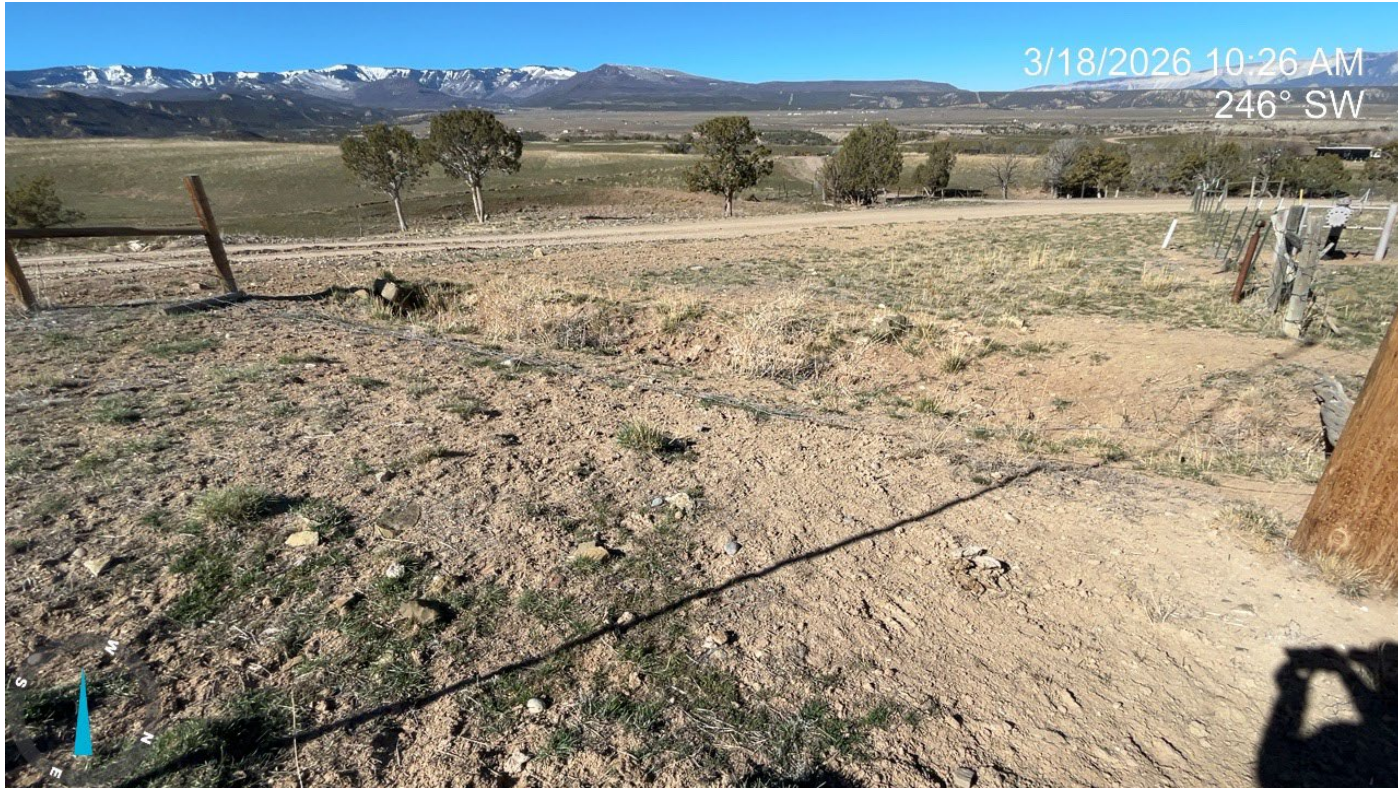
**Photo 5:** Downed fencing allowing cattle access and grazing activities at the location. It is recommended that grazing is not permitted while final reclamation is in process.

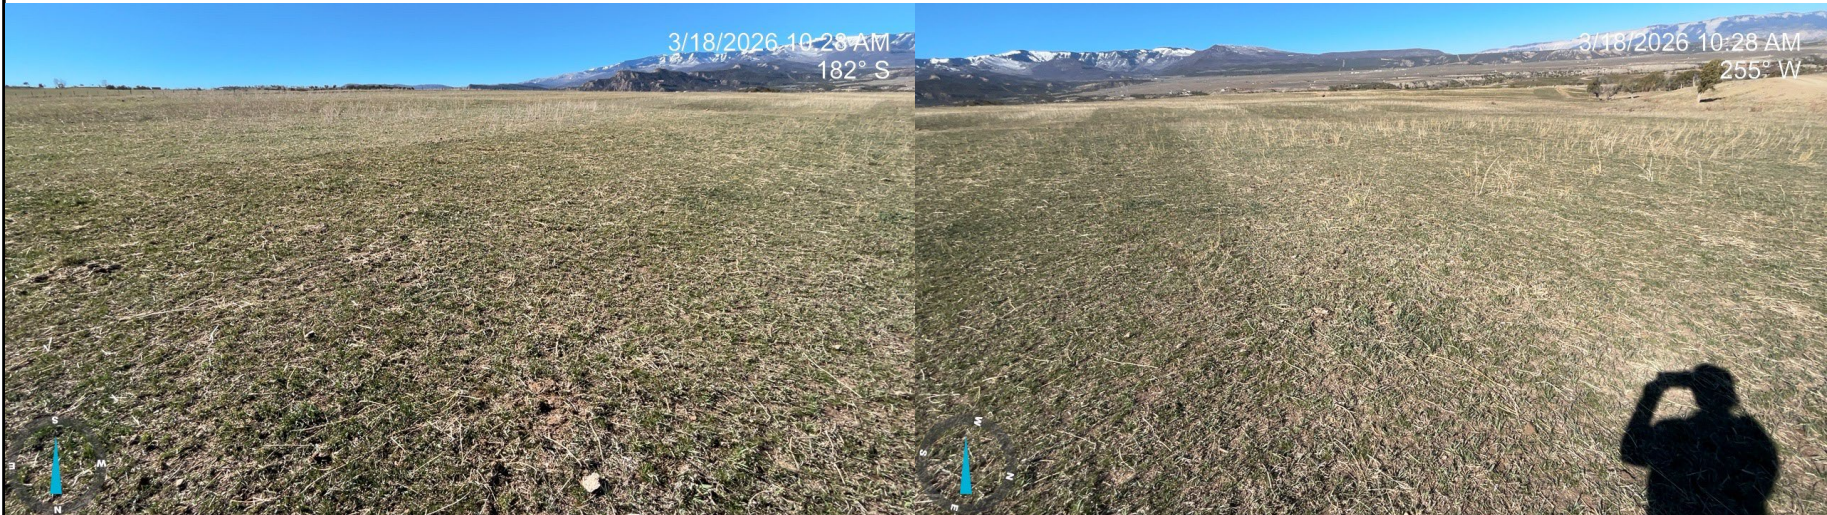
**Photo 6:** Photos showing a nearby reference area located directly south across the road from the location. A follow-up inspection will be conducted during future growing seasons to collect additional information regarding the reference area and to evaluate weed control efforts at the location.
