# Inspection Photos

Operator: QB Energy Operating LLC #10844

Location ID: 323970

Inspection Doc: 719200961

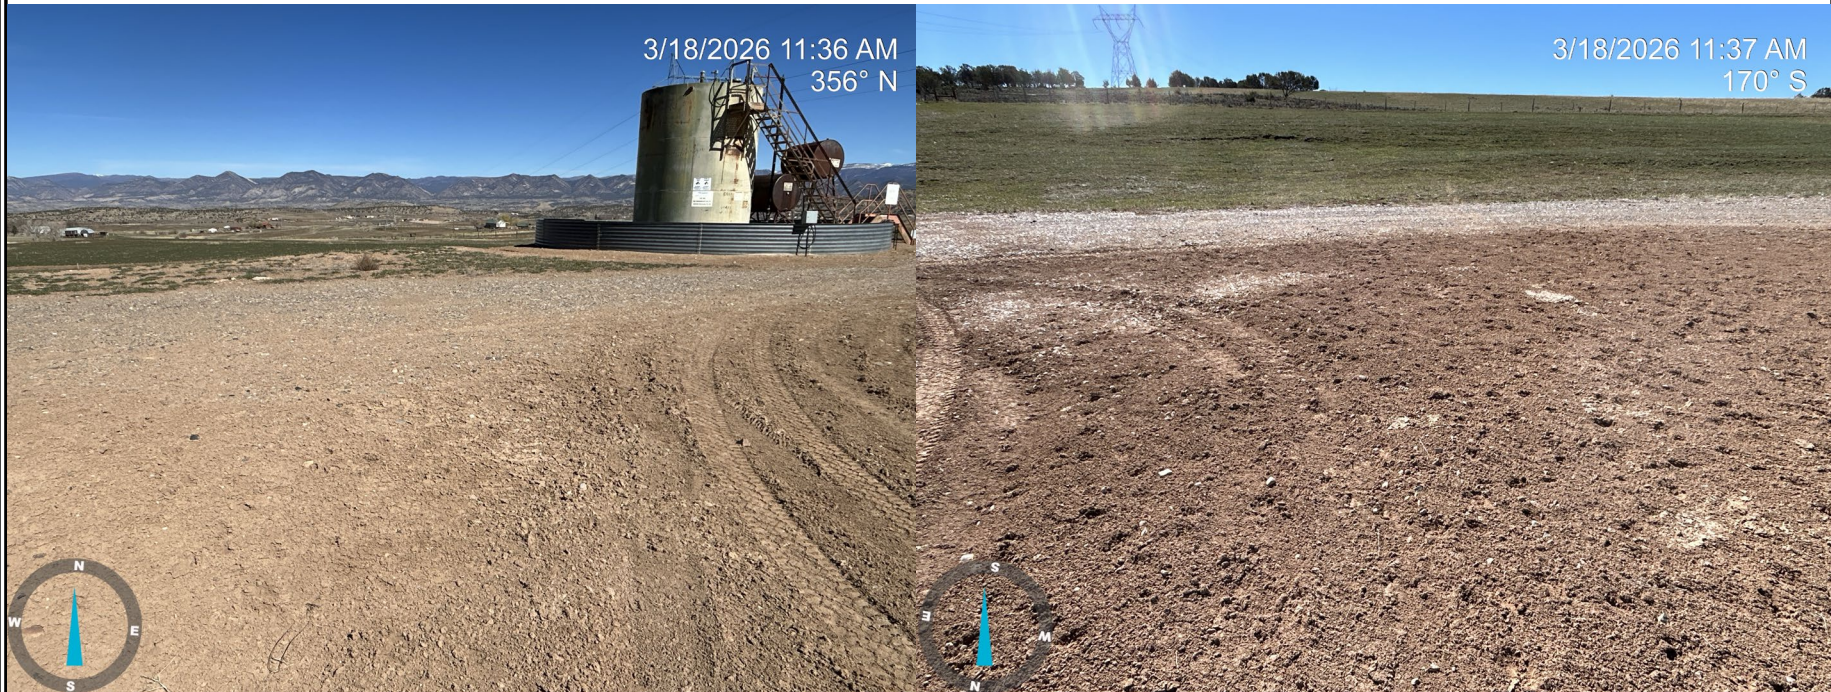
**Photo 1:** Photos showing an overview of the location looking north and south, respectively.

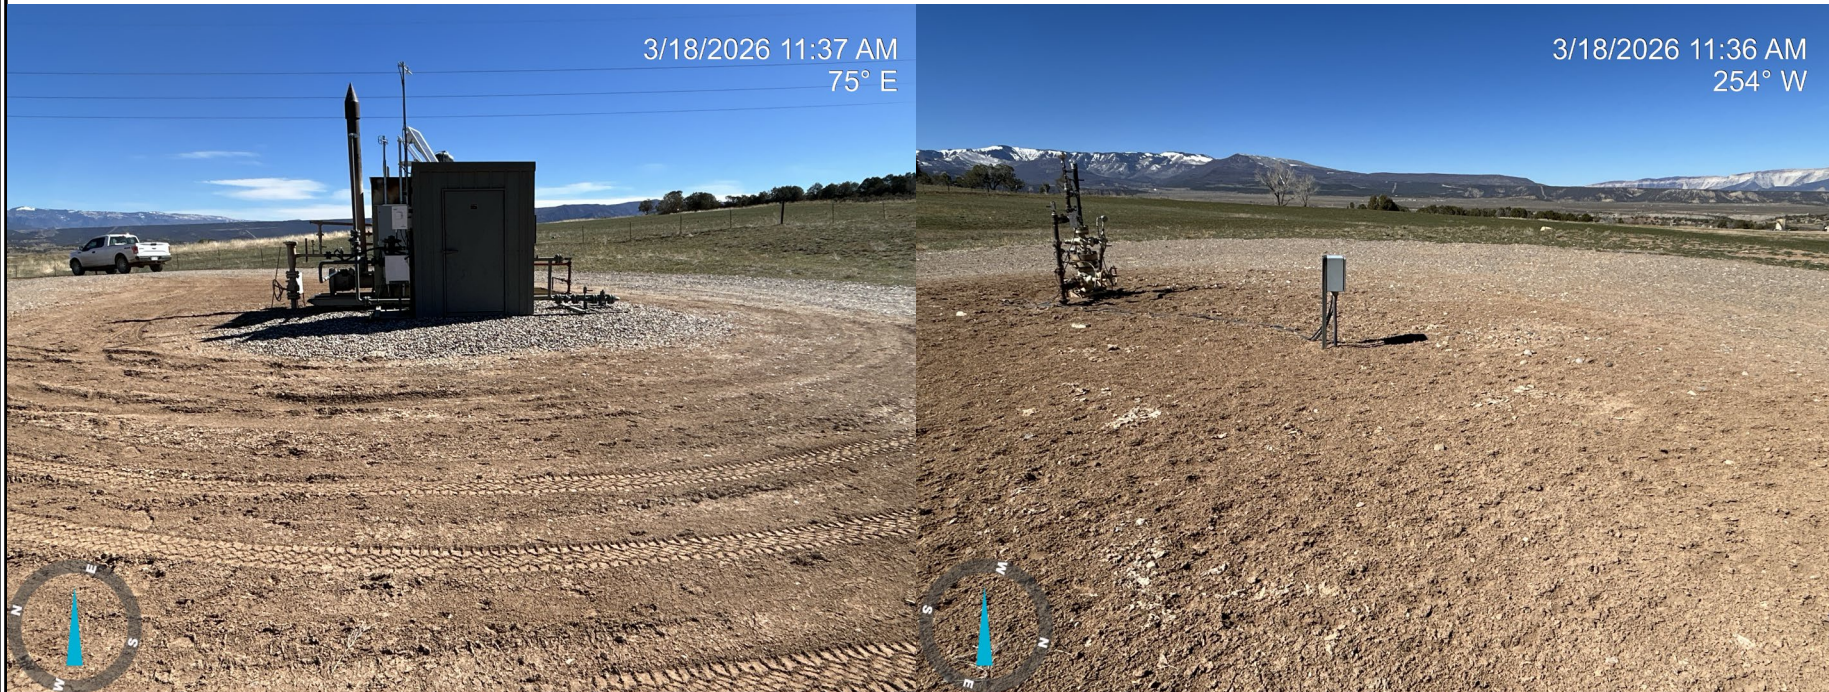
**Photo 2:** Photos showing an overview of the location looking east and west, respectively.

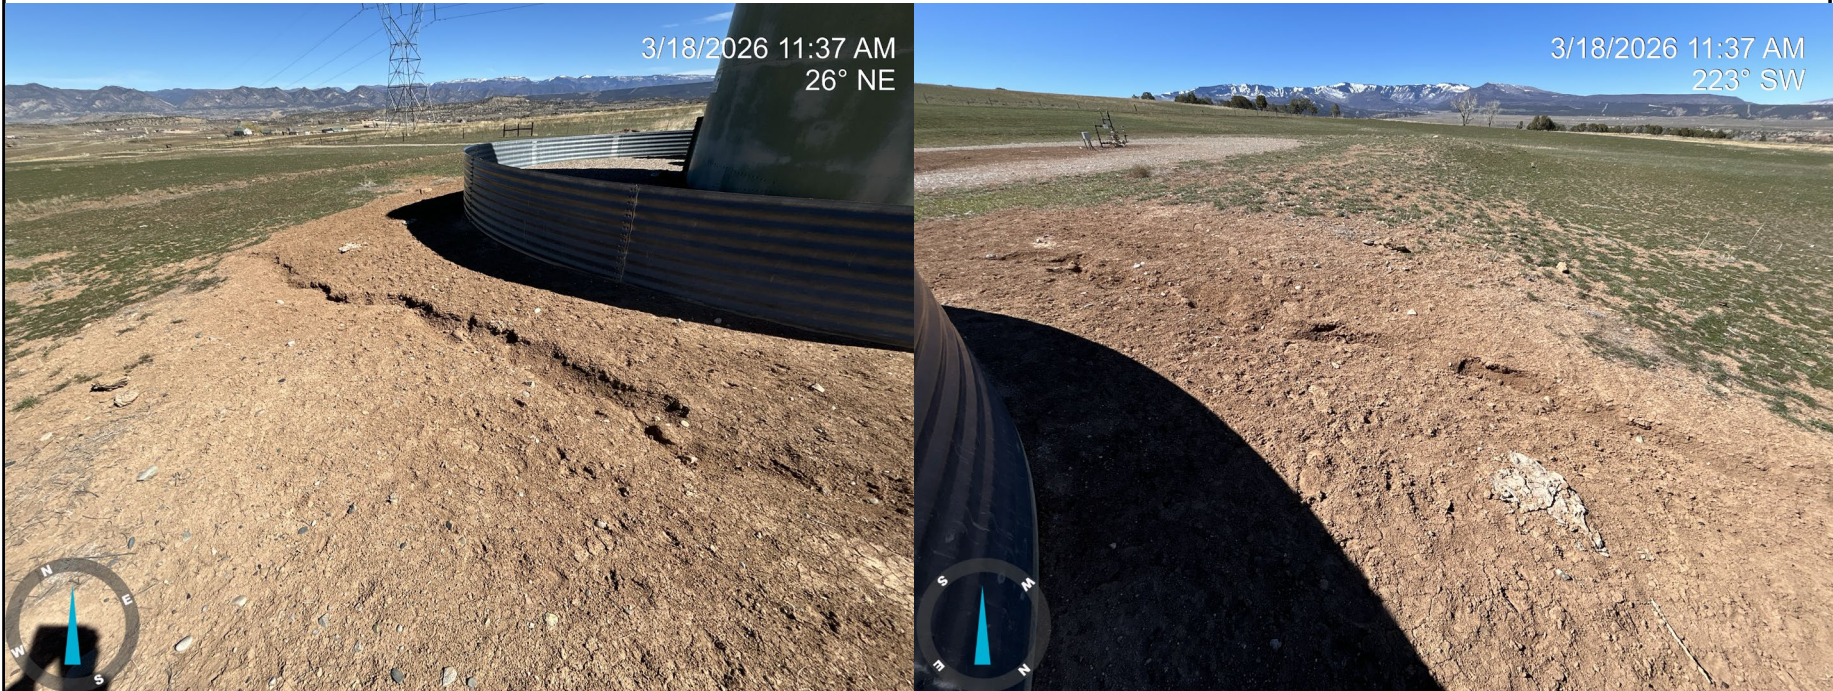
**Photo 3:** Photos showing rilling and erosion that is occurring on the western side of the tank battery equipment. Stormwater BMP's appear to be missing or insufficient; comply with Rule 1002.f.

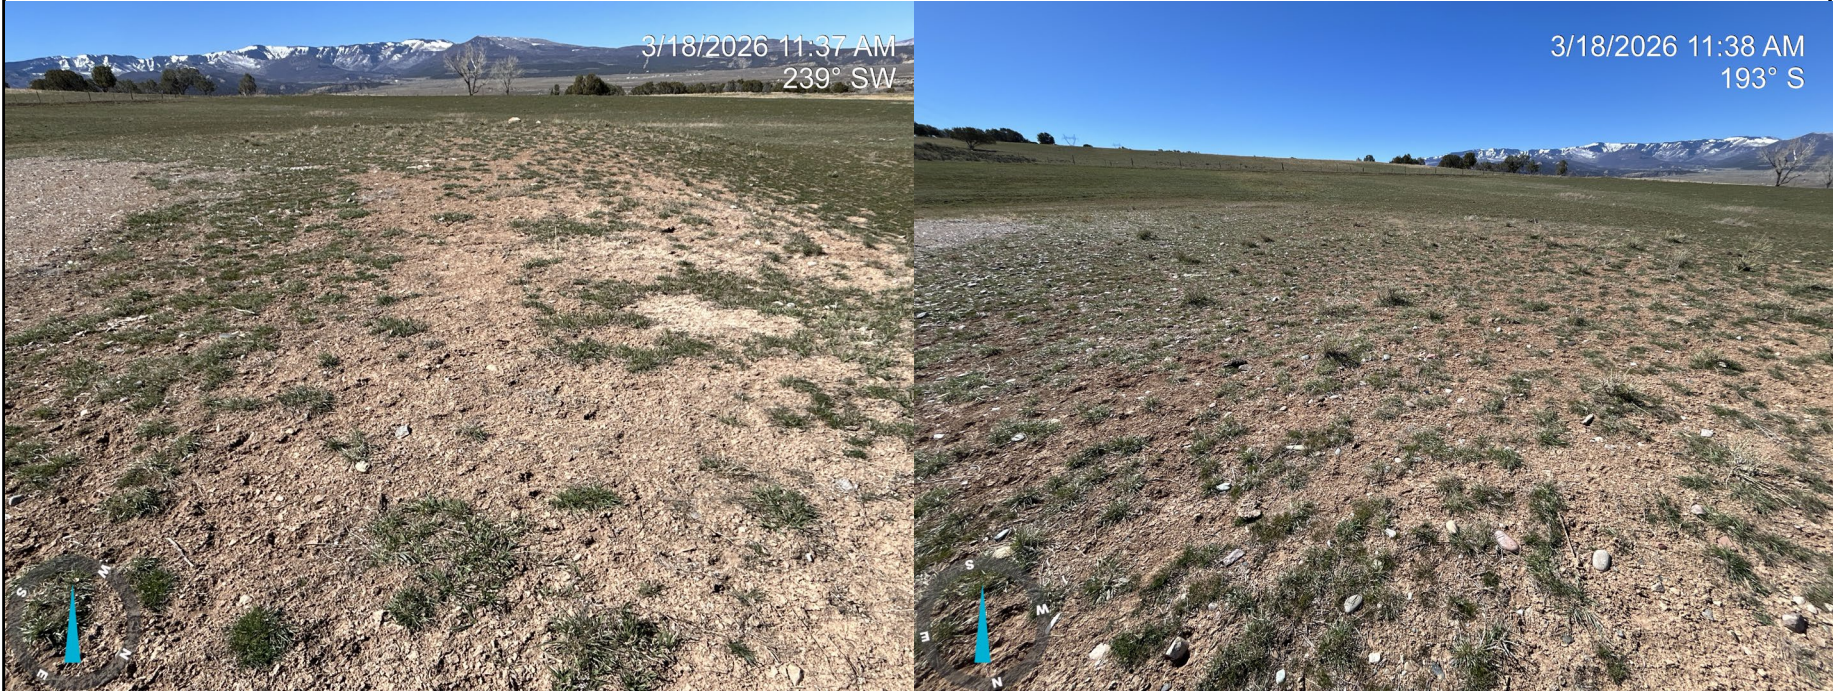
**Photo 4:** Photos showing the northern and western interim areas, respectively. Interim areas are patchy in some places; overall interim areas appear to be progressing towards 1003 reclamation requirements.
