Inspection Photos

Operator: QB Energy Operating LLC #10844

Location ID: 334987

Inspection Doc: 719200963

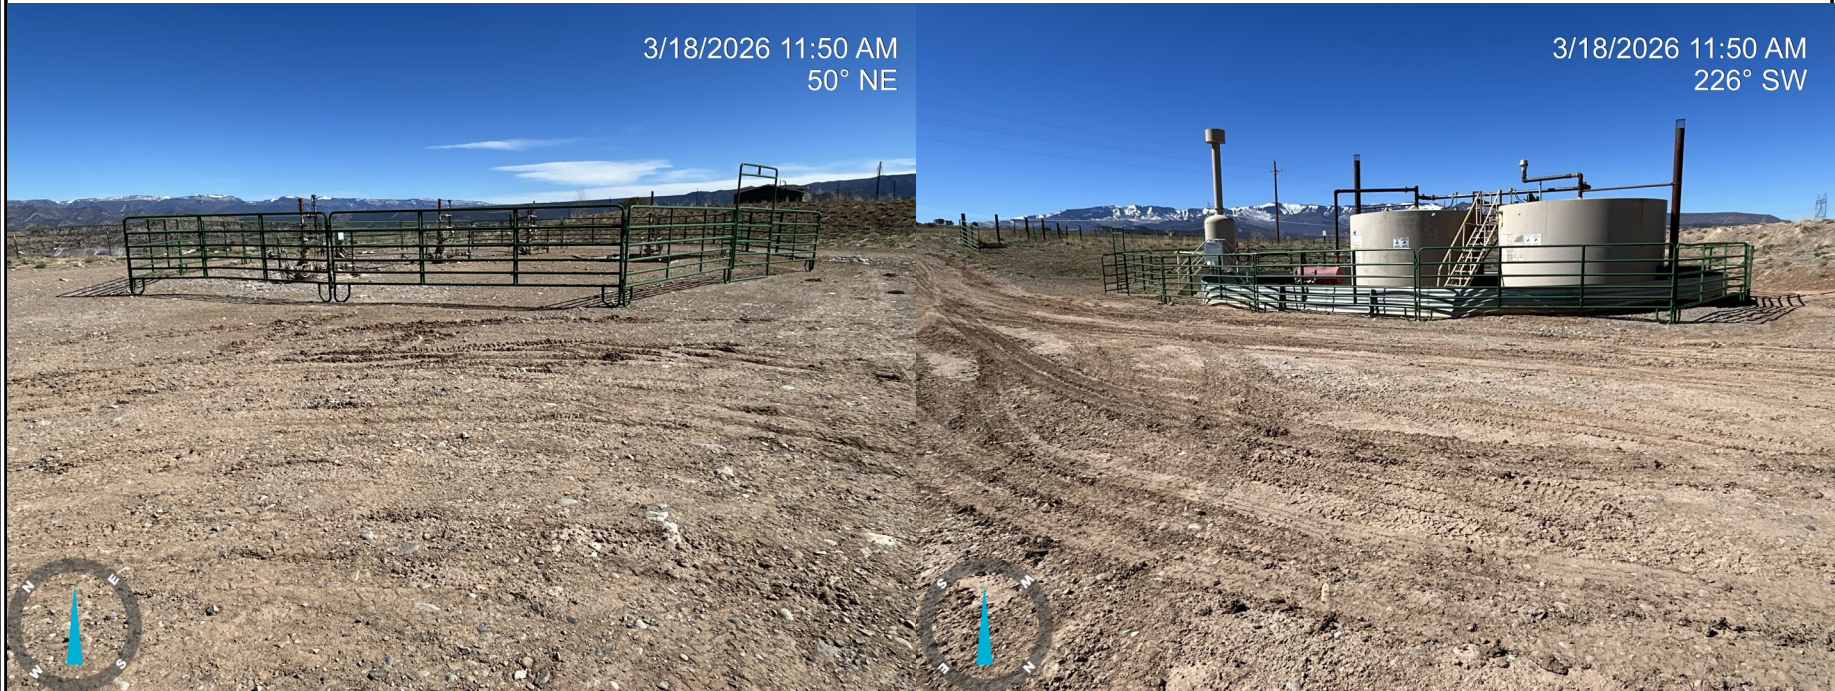
Photo 1: Photos showing an overview of the location looking northeast and southwest, respectively.

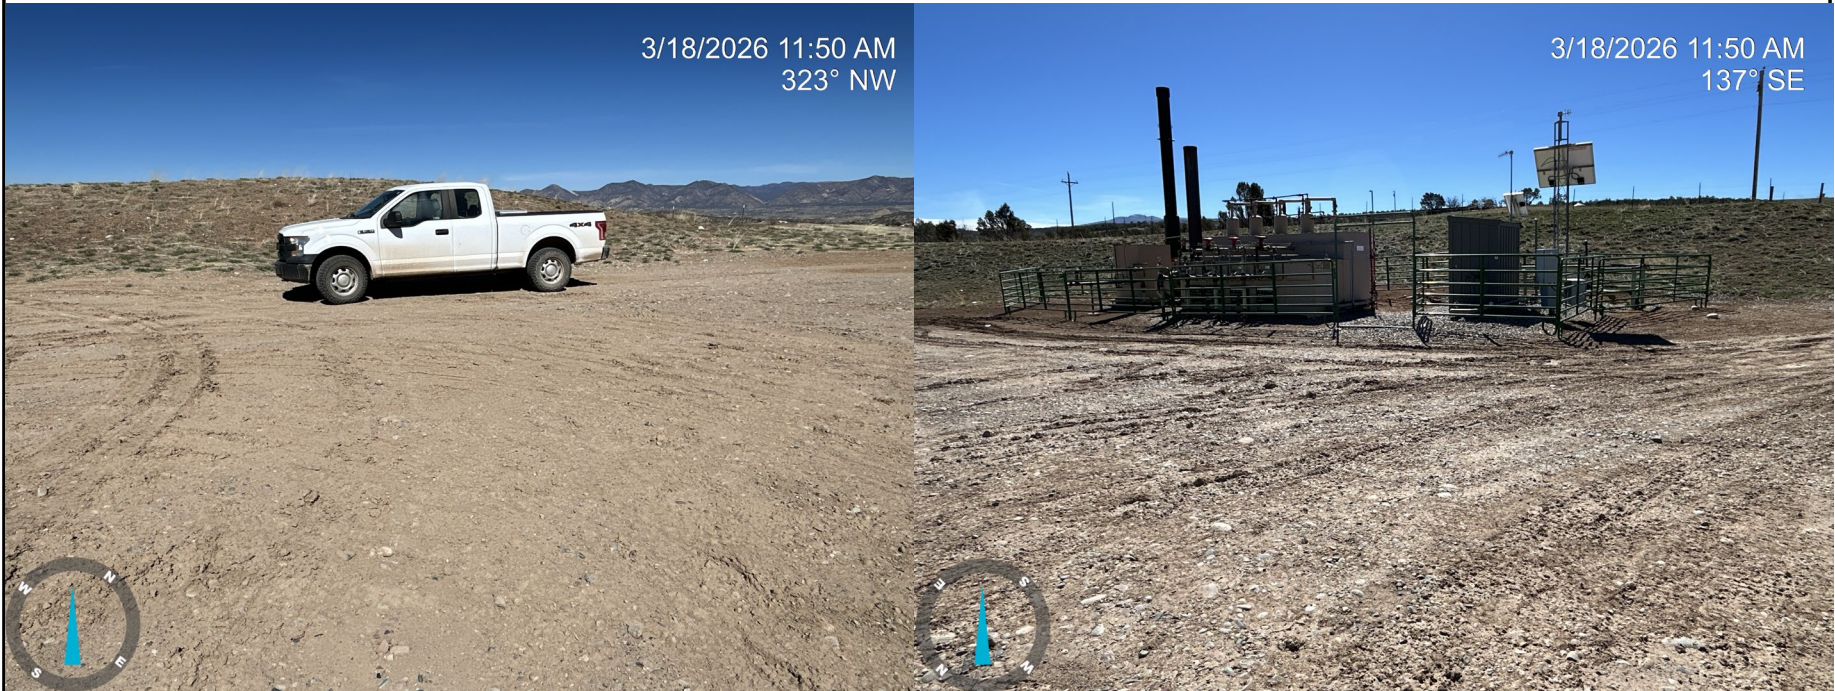
Photo 2: Photos showing an overview of the location looking northwest and southeast, respectively.

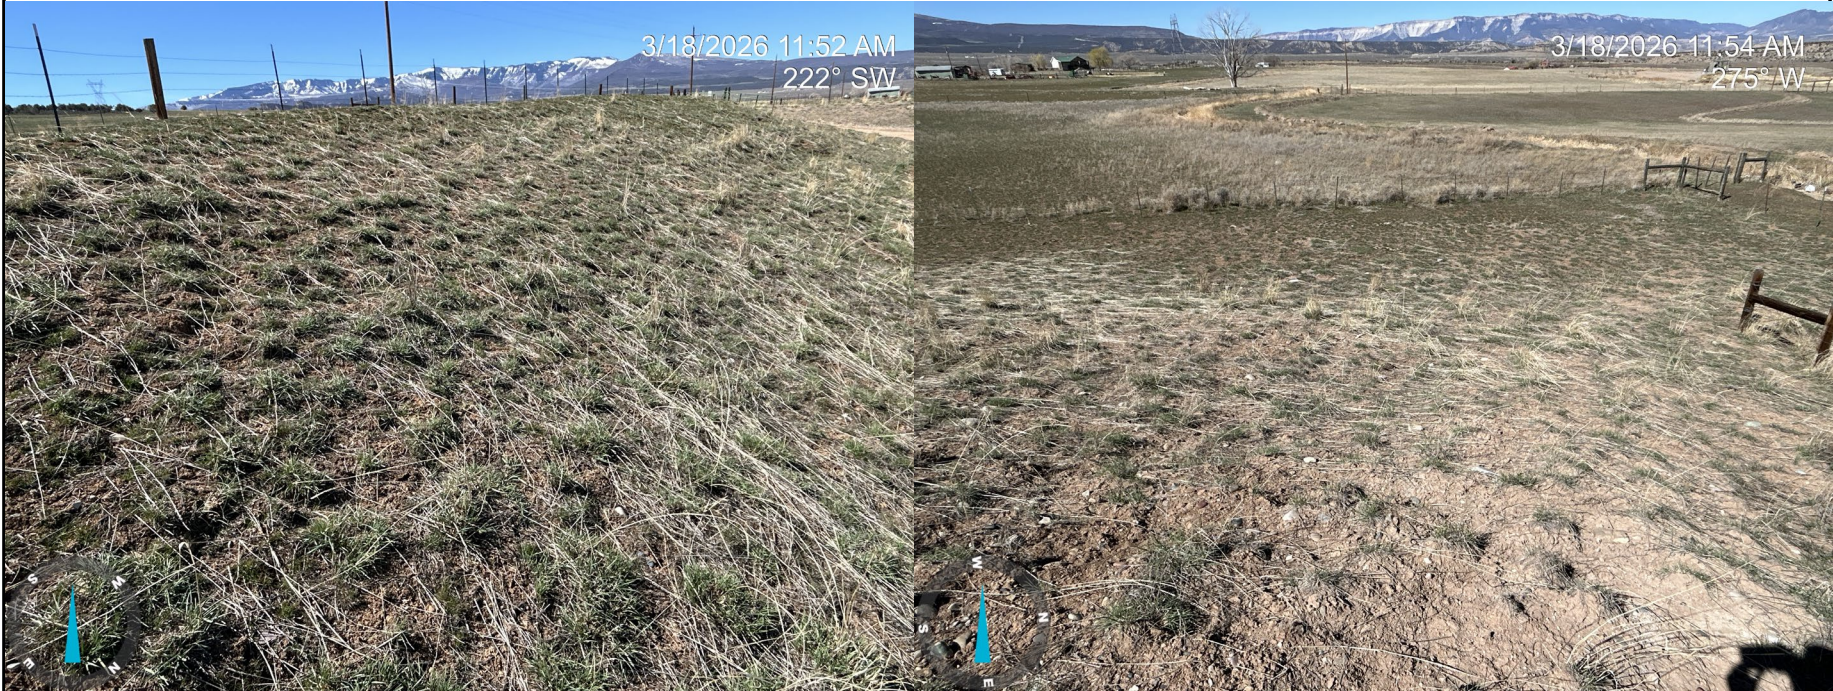
Photo 3: Photos showing an overview of the eastern and northwestern interim areas, respectively. Interim areas are progressing towards 1003 reclamation requirements.

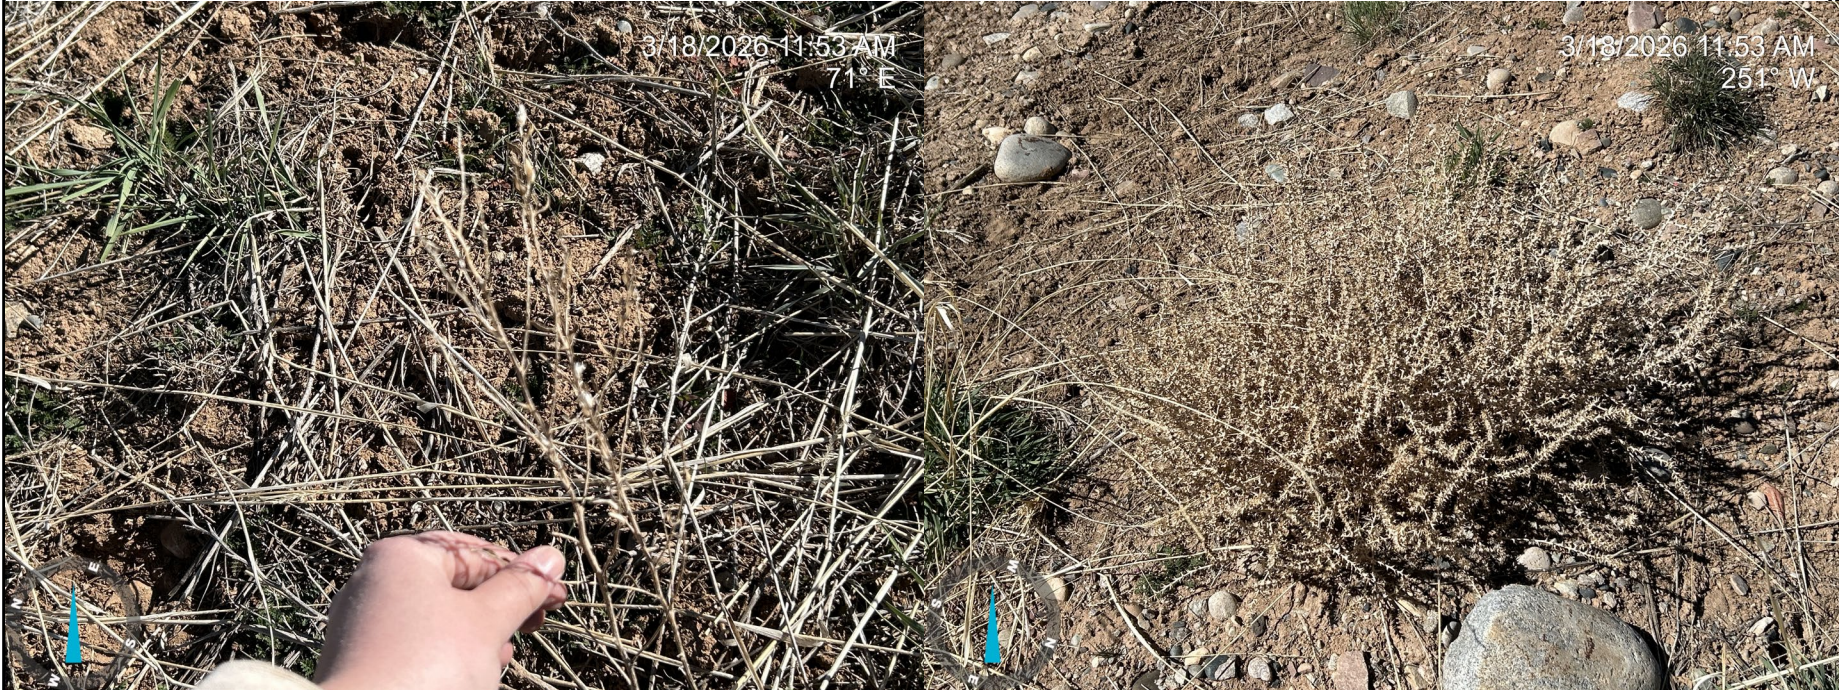
Photo 4: Photos showing one (1) Russian knapweed individual that is present on the eastern portion of the interim area. Prickly Russian thistle is present in tertiary amounts. Ongoing weed monitoring and management is recommended at this location.

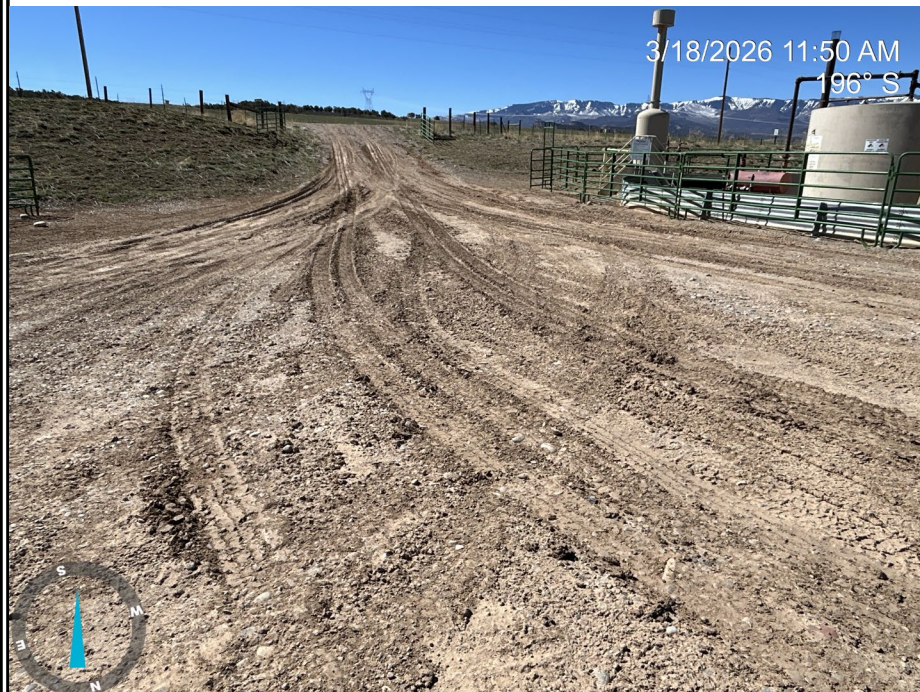
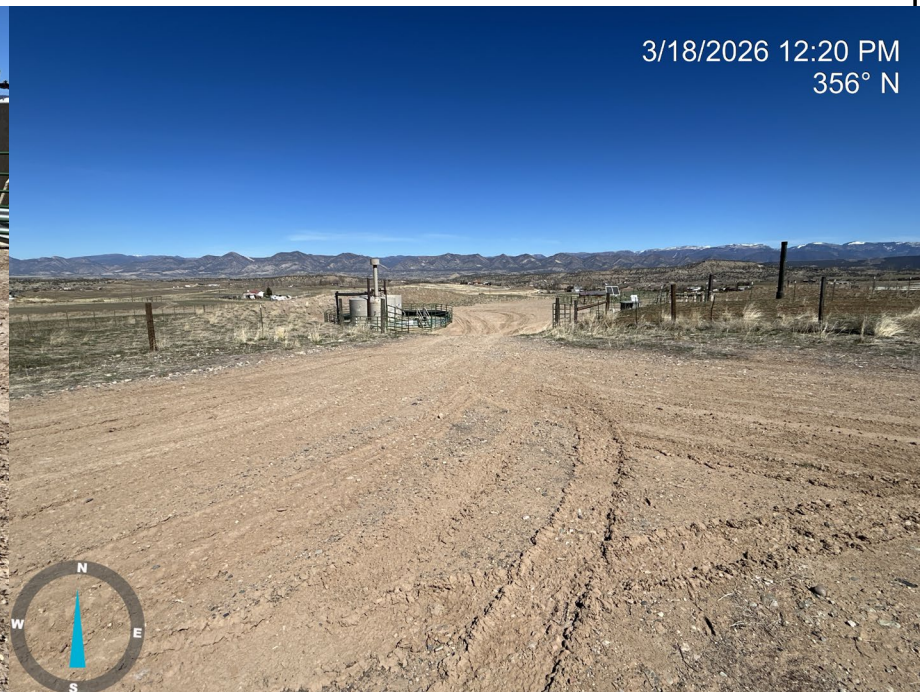
Photo 5: Photos showing examples of vehicle rutting and sediment tracking that is occurring on the working pad surface and at the entrance to the location; maintenance is required. Comply with 1002.f.
