INSPECTION PHOTOS

Well: HILL RANCH 27-12R & V

INSPECTION DOC #: 716302092

Operator: OGRIS OPERATING LLC 10758

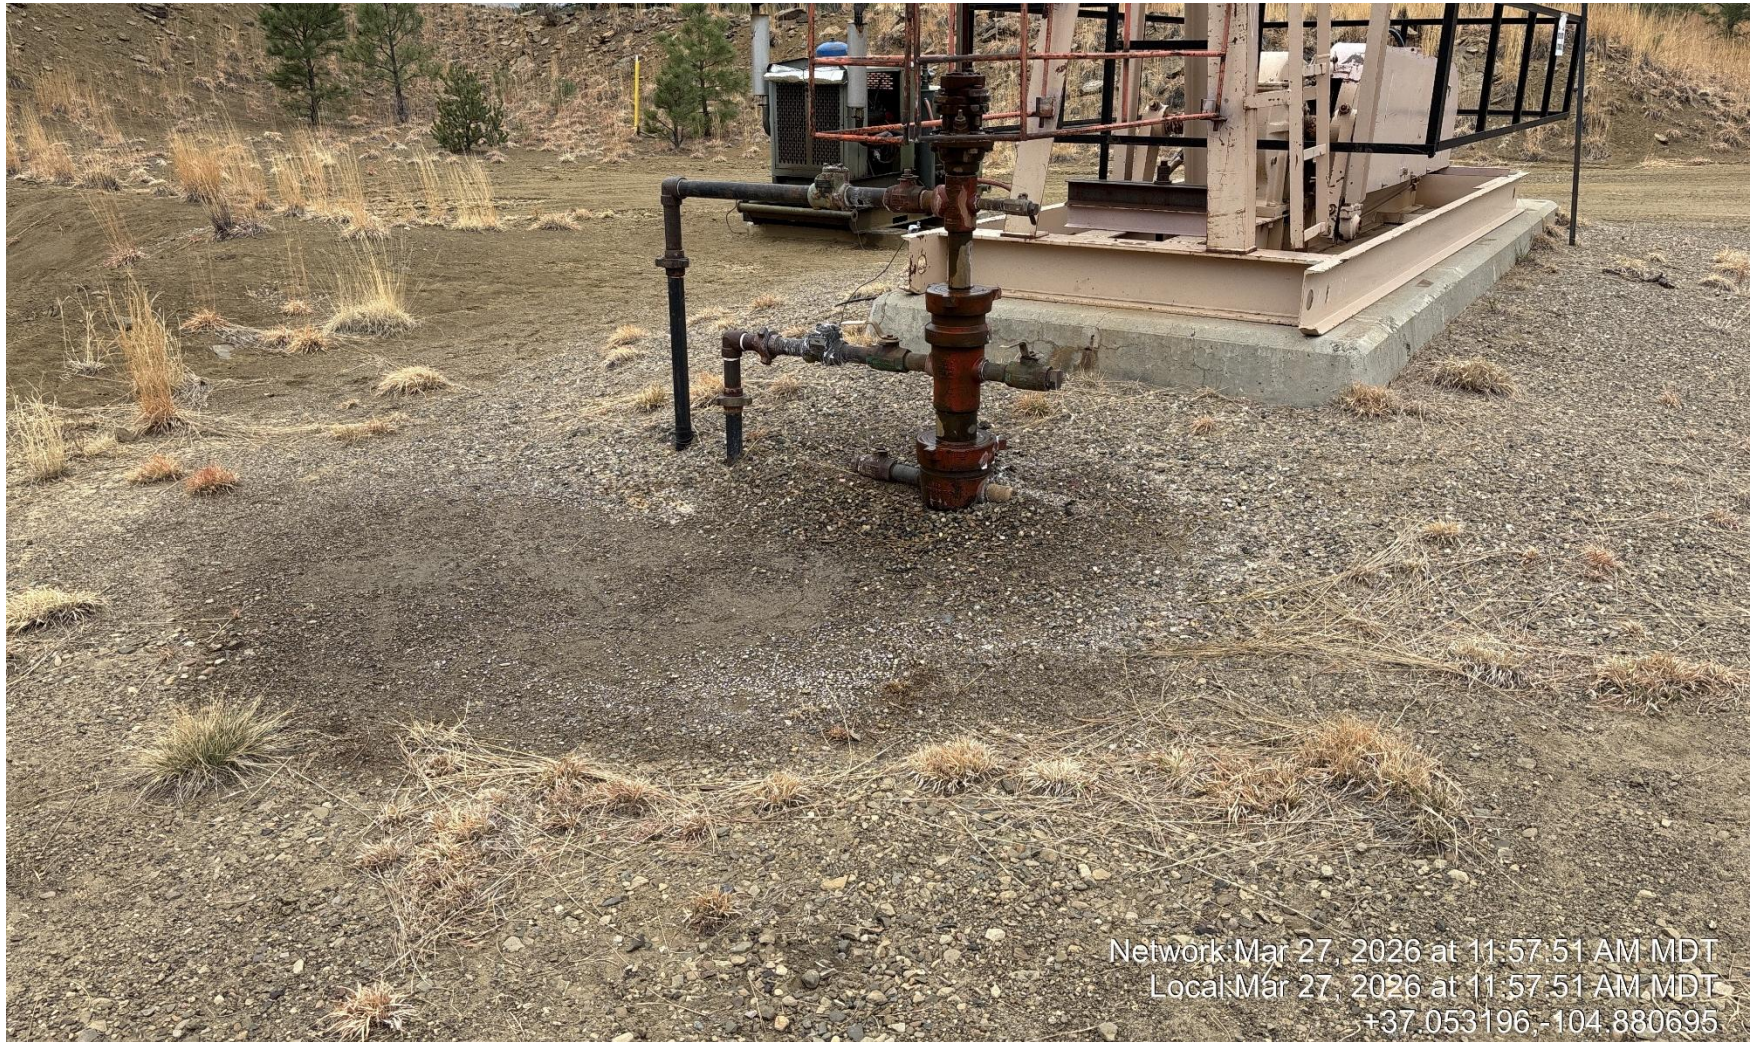
PHOTO 6: UNUSED EQUIPMENT (PRIME MOVER ENGINE SKIT IS NOT USABLE ON R WELL). THIS TYPE OF WORK CANNOT BE PERFORMED ON LOCATION. REMOVE UNUSED EQUIPMENT PER RULE 606. CA DATE 4/2/2026.

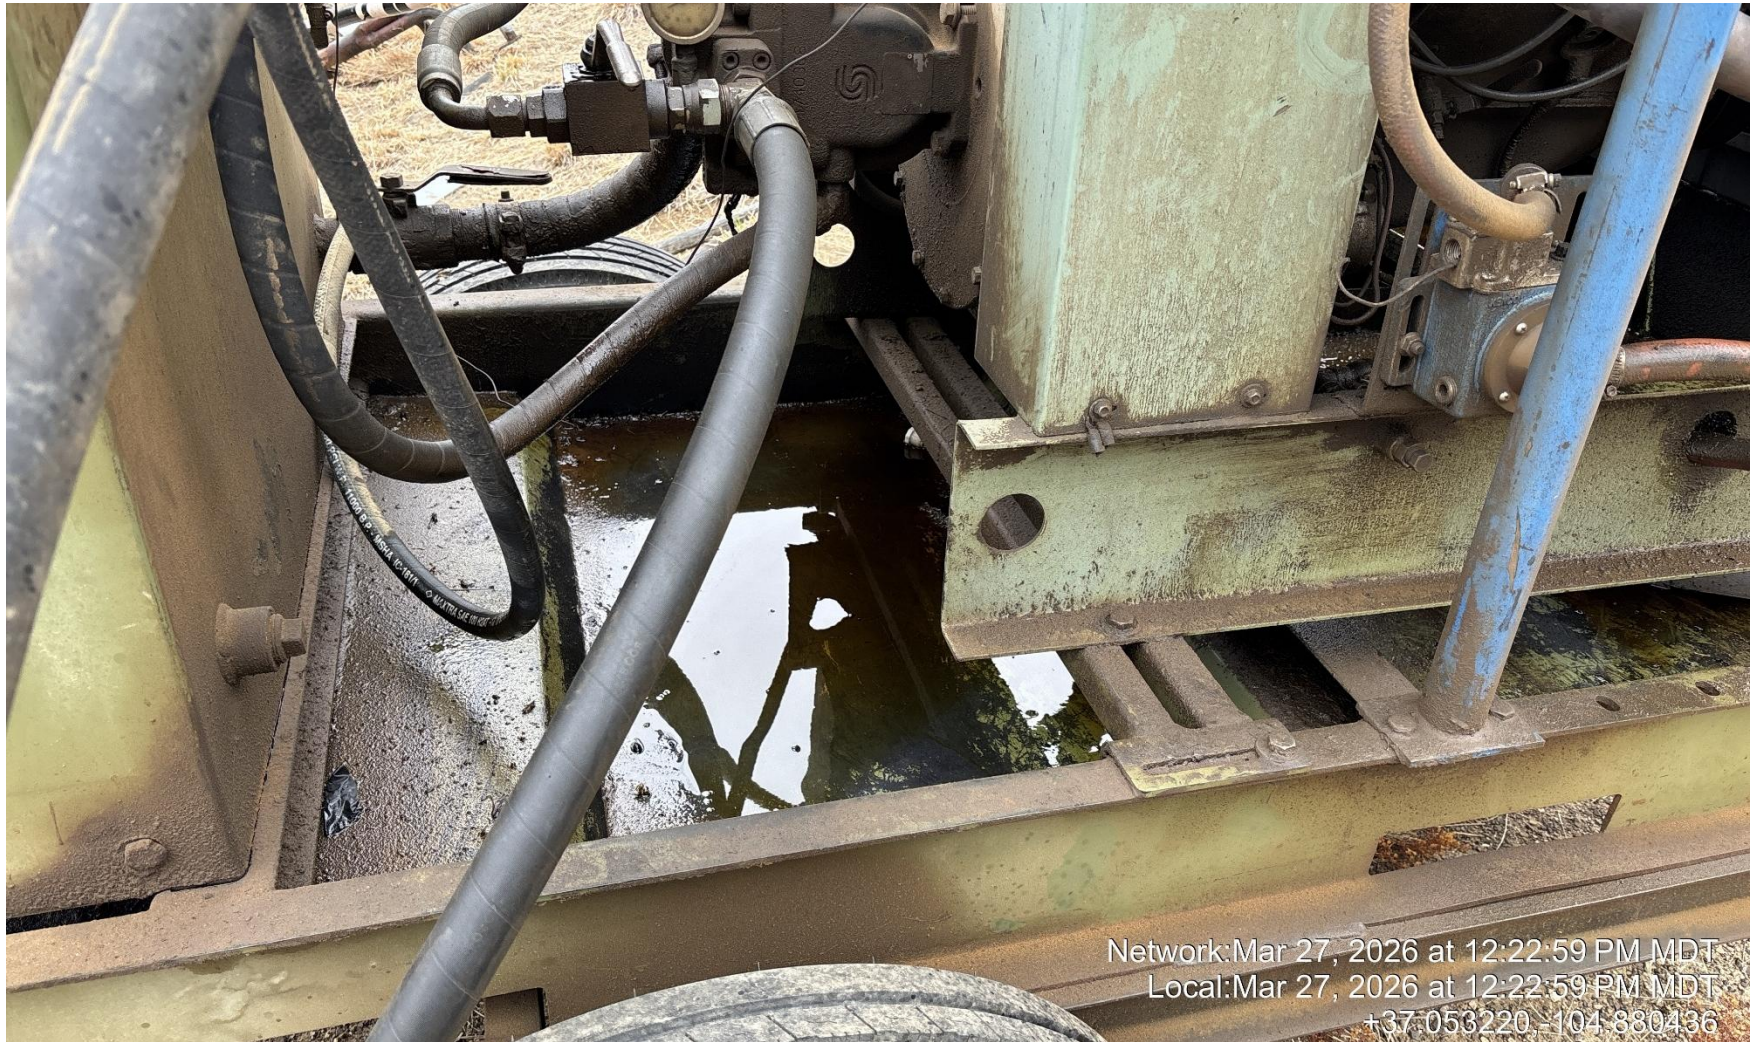
PHOTO 7: ALLTHOUGH IT APPEARS THAT THE CA FROM PREVIOUS INSPECTION WAS ADDRESSED THE CONDITIONS THAT CREATED THE CA STILL EXISTSON V WELL. Securely fasten all valves, pipes, fittings, and Production Facilities to ensure good mechanical condition, inspect at regular intervals and maintain in good mechanical condition. Engineer, operate, and maintain equipment within the manufacturer’s recommended specifications per Rule 608.e. CA DATE 4/2/2026.
