Final Reclamation Inspection

Operator: KIMBARK OIL & GAS COMPANY

Facility ID: 116857

Inspection Photos
Location Name: MESSEX STATE PIT
Facility ID: 116857

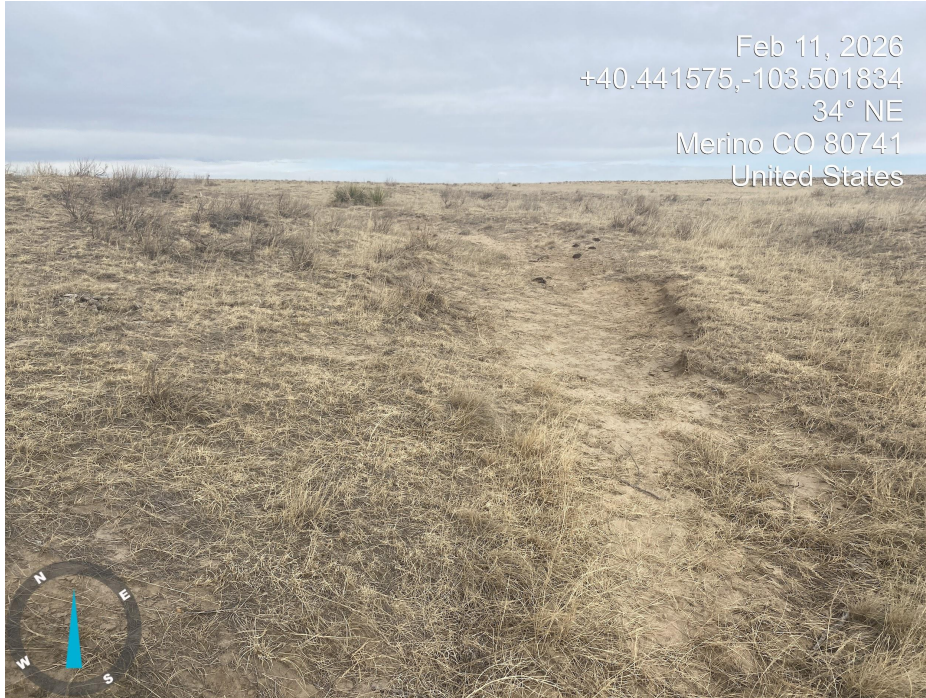
Photo 1. Photo taken from the access road near the pit location, facing northeast, showing bare areas from a cattle trail. The access road was not contoured and is still visible.

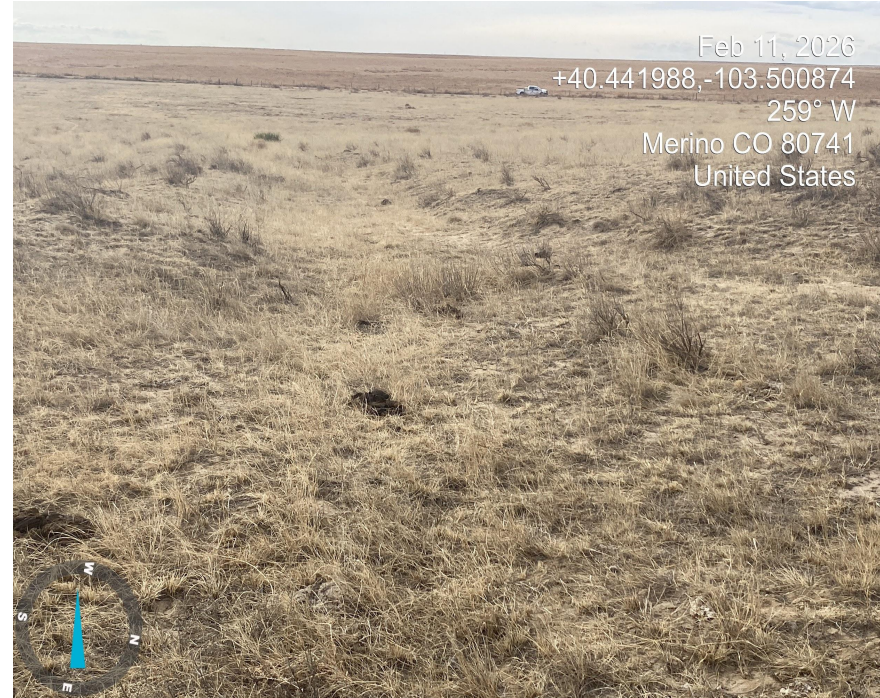
Photo 2. Photo taken from the access road facing west showing that the access road was not contoured, and a depression is still visible. Desirable vegetation growing, including native grasses and shrubs.

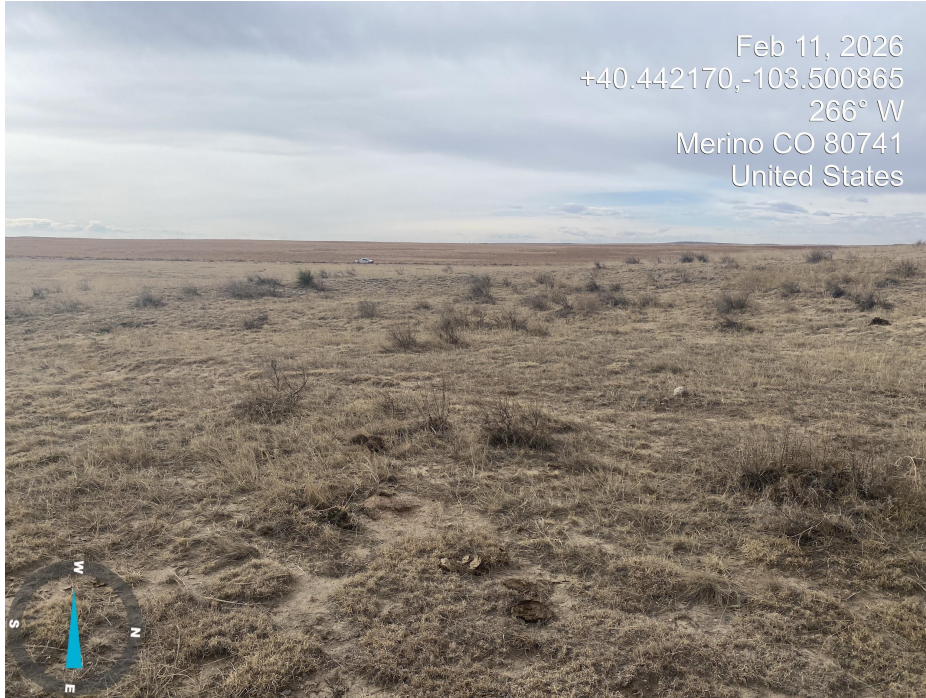
Photo 3. Photo taken on the east side of pit location facing west showing an overview of location. Small areas of exposed soil and grass species are slightly stunted.

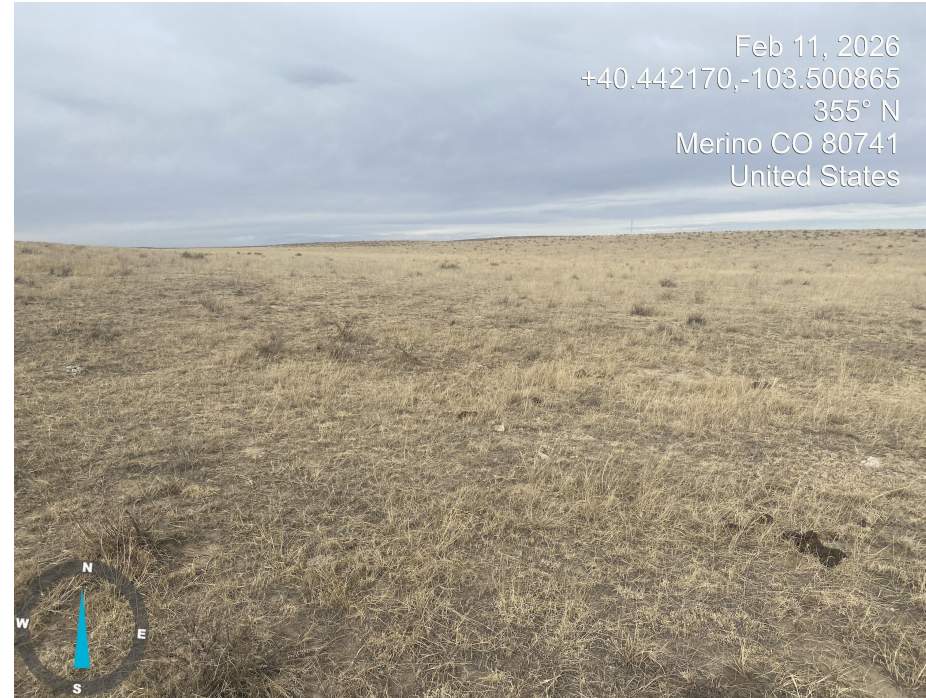
Photo 4. Photo taken on the east side of pit location facing north showing an overview of location with desirable vegetation growth.

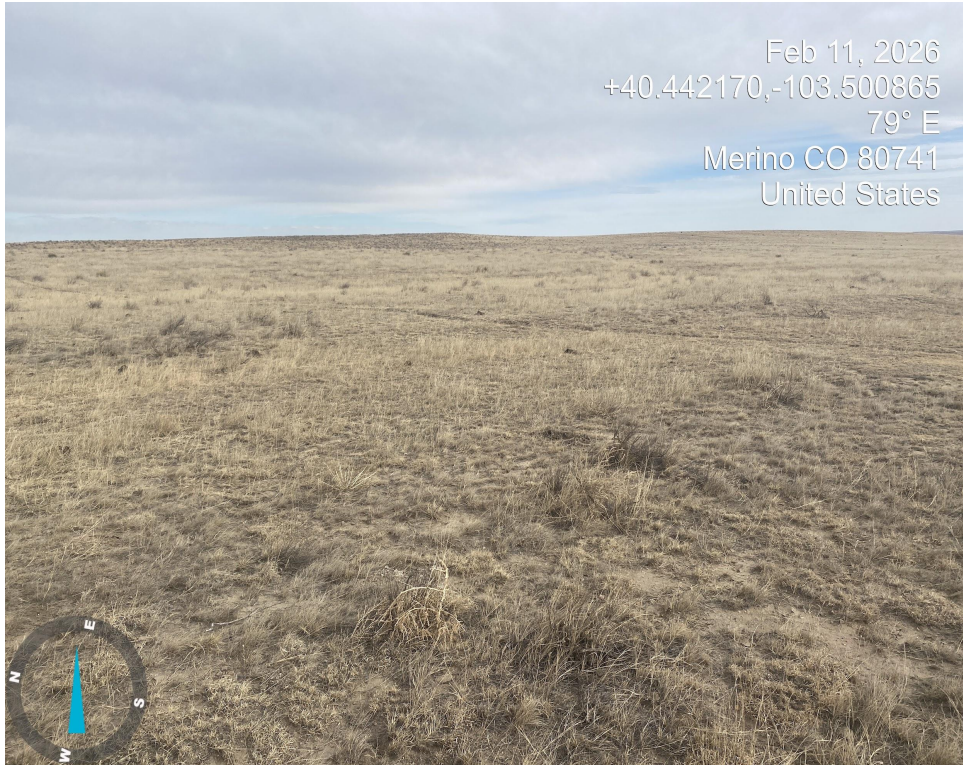
Photo 5. Photo taken on the east side of the pit, facing east, showing an overview of the area with desirable vegetation growth.

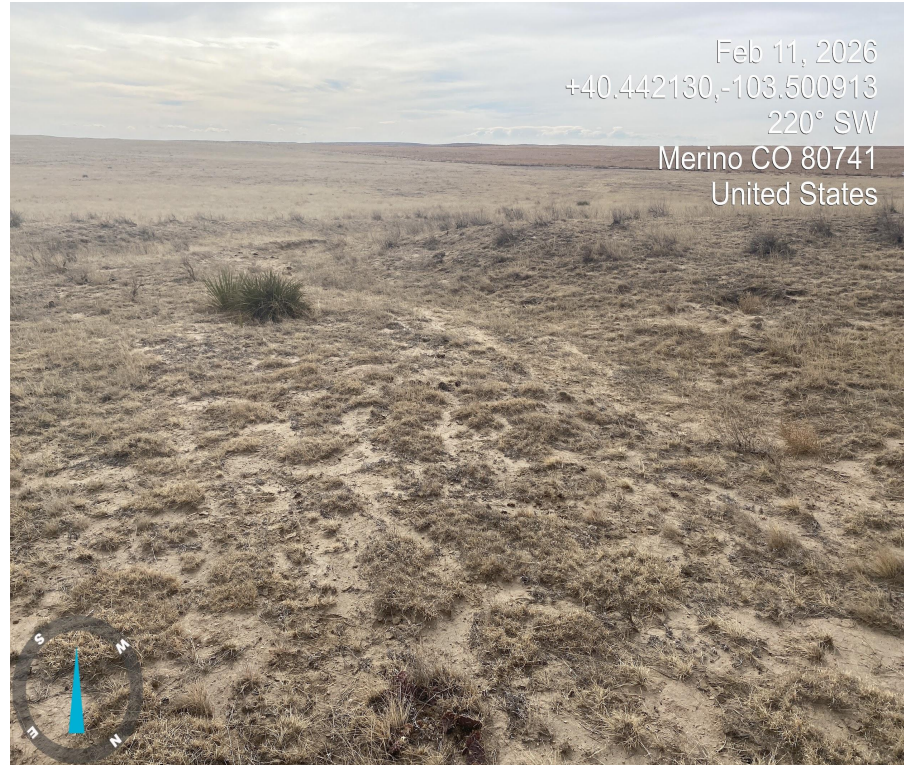
Photo 6. Photo taken on the southwestern side of the pit, facing southwest, showing an overview of the area with desirable vegetation. Some bare soil and erosion are present.

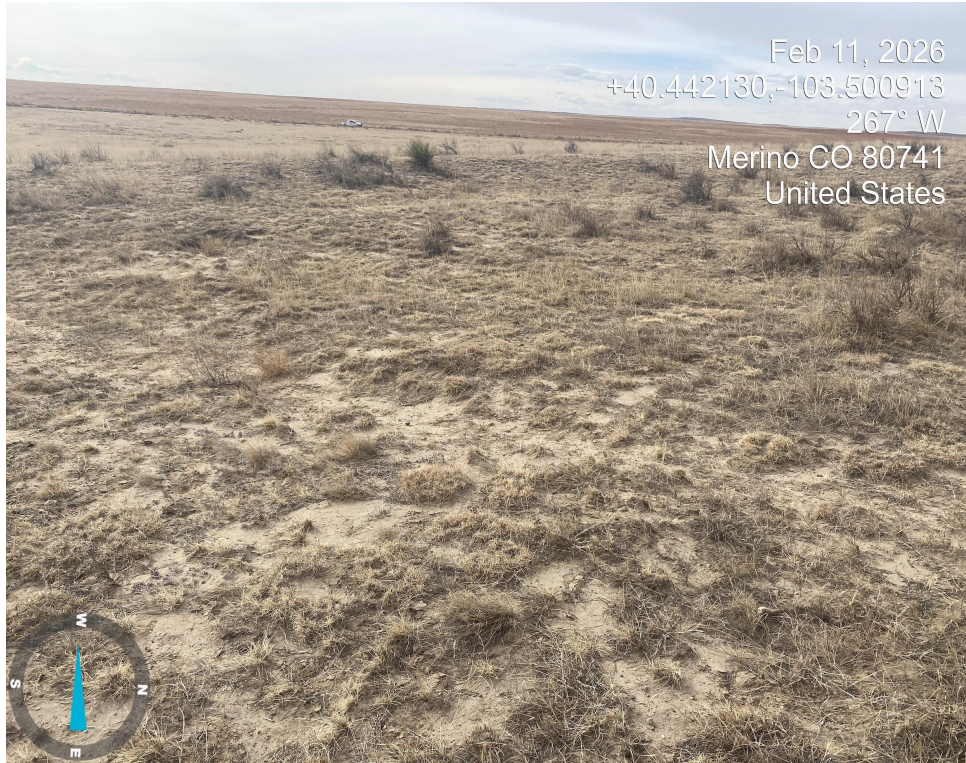
Photo 7. Photo taken from west side of the pit facing west. Vegetation around the location are desirable grass and shrub species and some bare soil present.

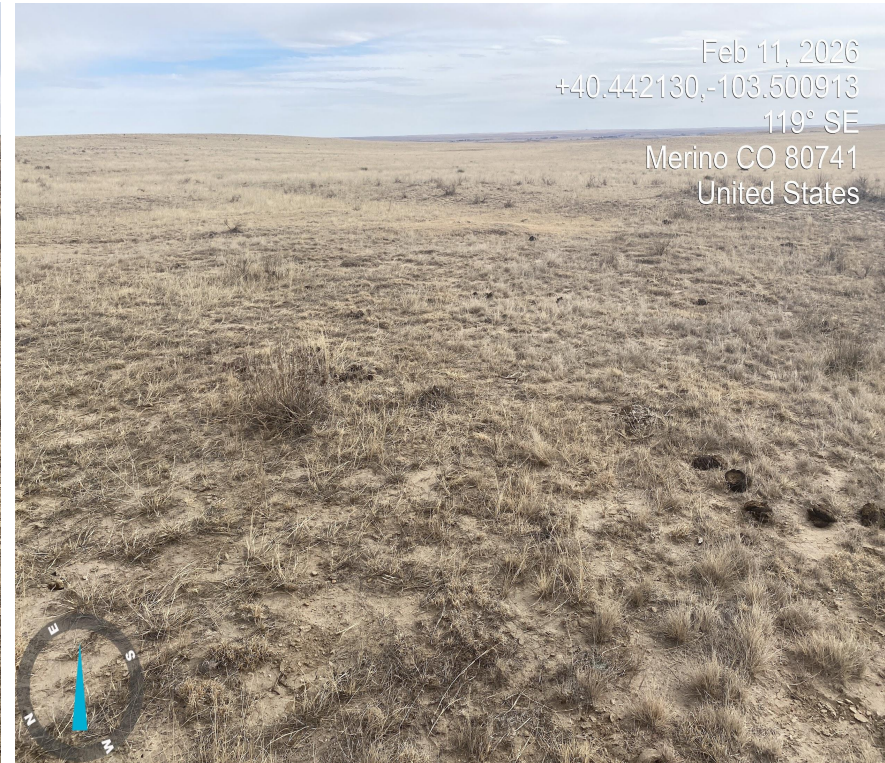
Photo 8. Photo taken from west side of the pit facing southeast. Vegetation around the location are desirable grass and shrub species.

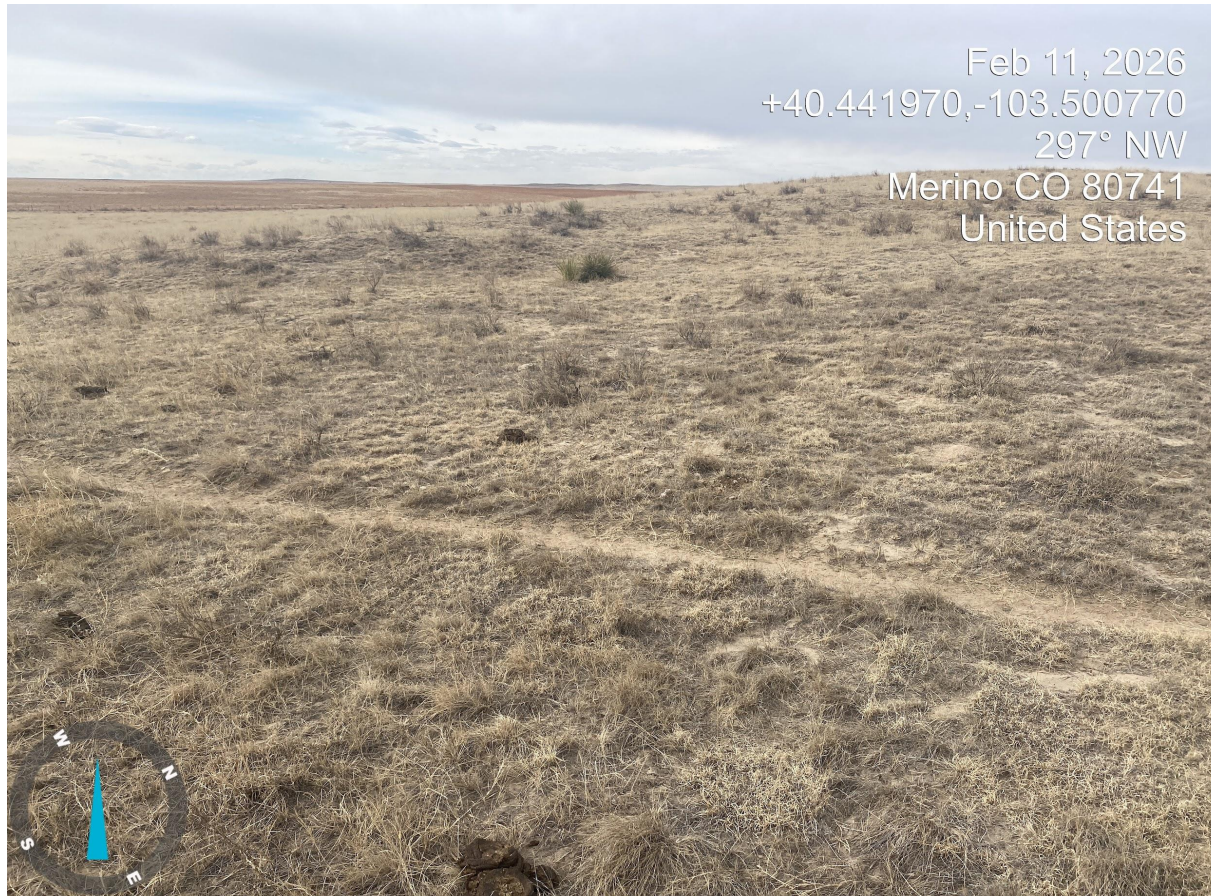
Photo 9. Photo taken from south side of the location facing west. Cattle trail present and vegetation around the location are desirable grass and shrub species.

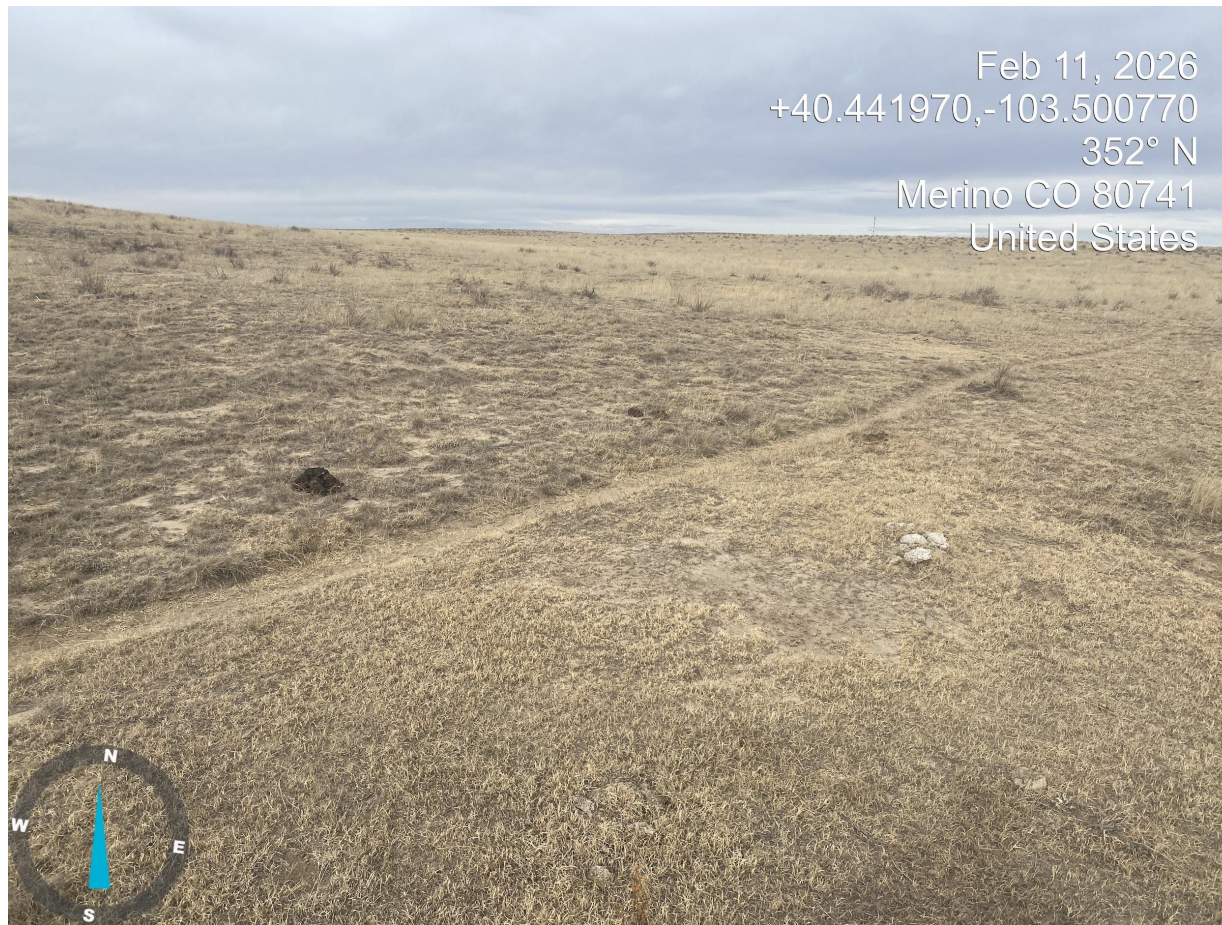
Photo 10. Photo taken from southeast side of the location facing north. See comment under photo 9.

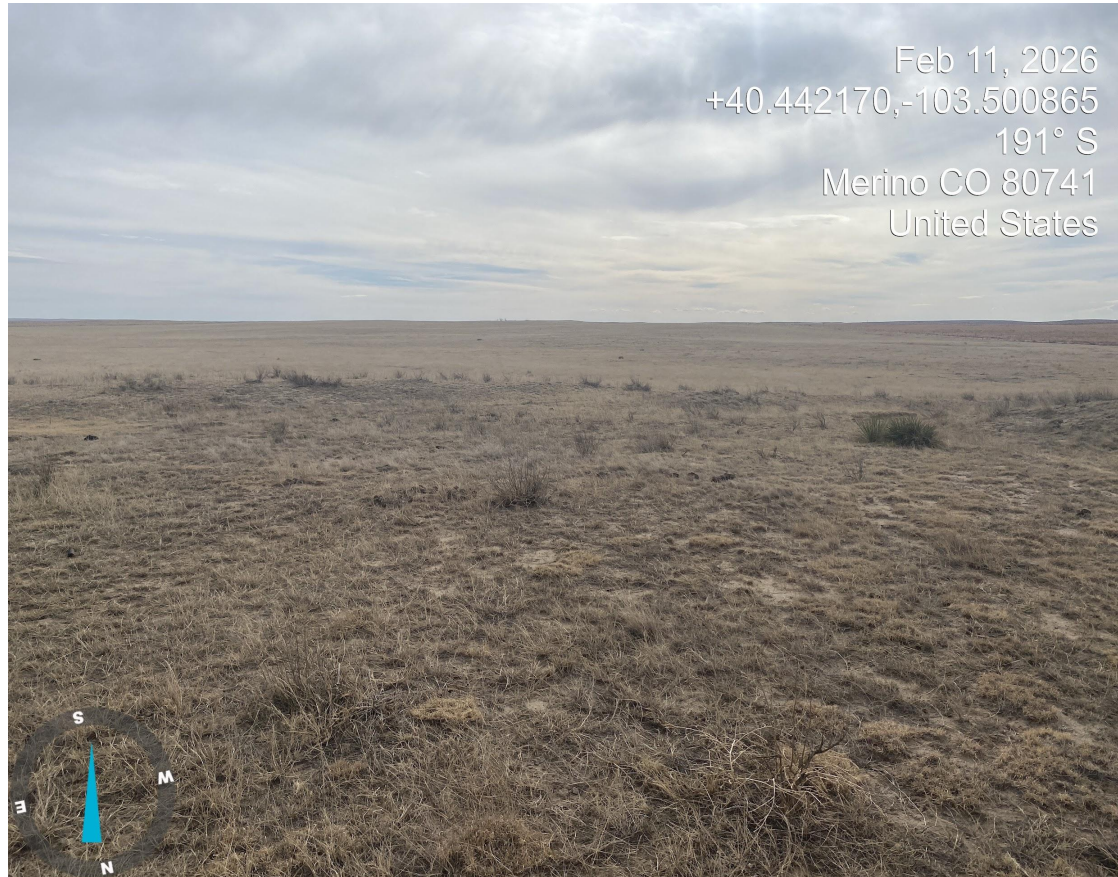
Photo 11. Photo taken from the northern edge of location facing south. See comment under photo 5
