Final Reclamation and Stormwater Inspection

Operator: IMPETRO RESOURCES LLC - 10690

Location ID: 316923

Well Name: STATE #1

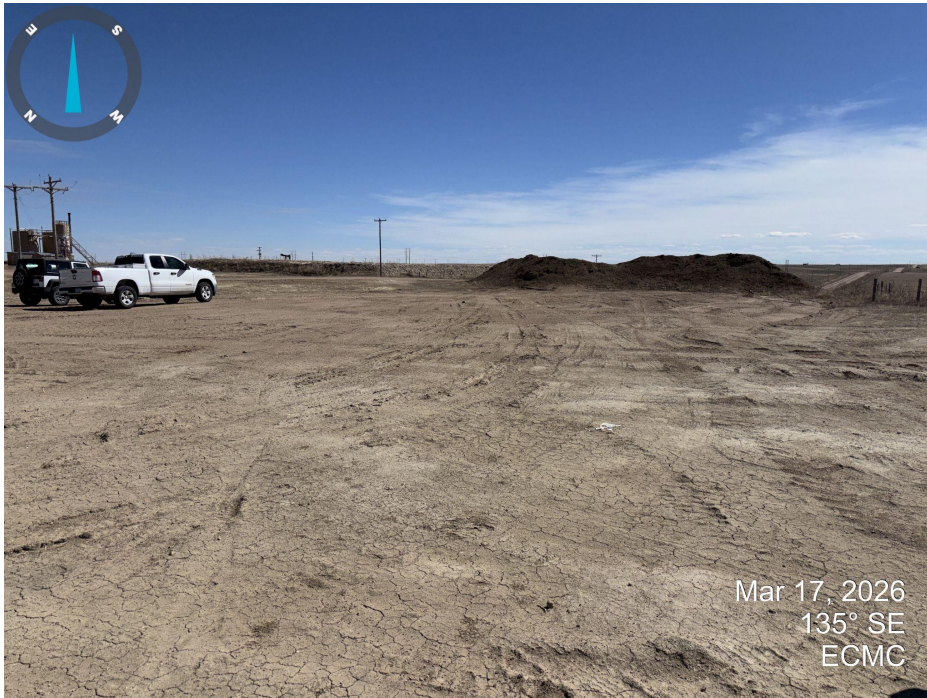
Photo 1. Looking southeast across the former tank battery area. No reclamation activity observed.

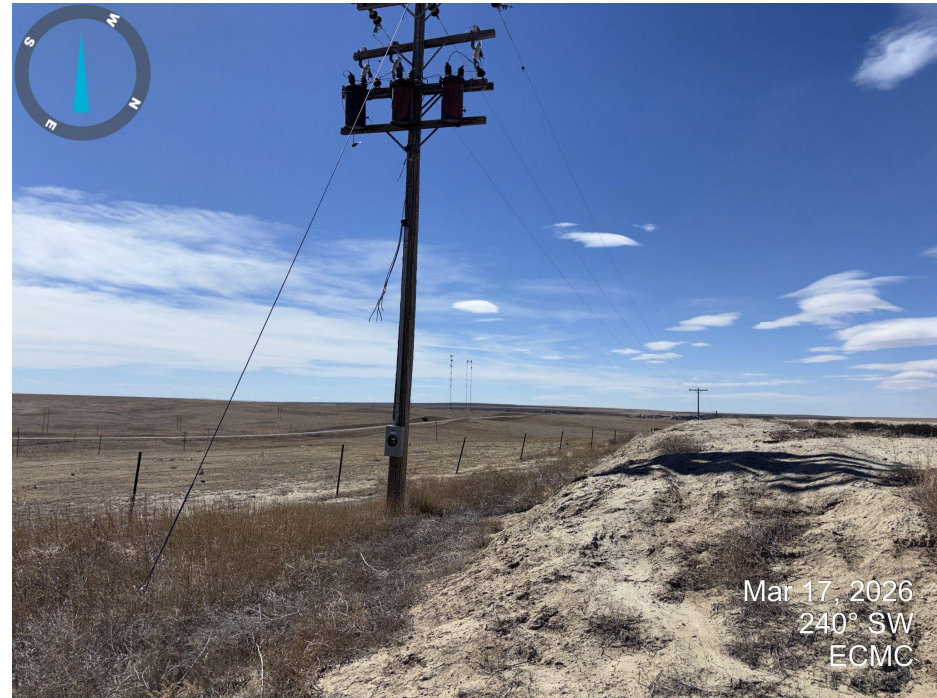
Photo 2. Electric poles terminate at the tank battery and remain in place.

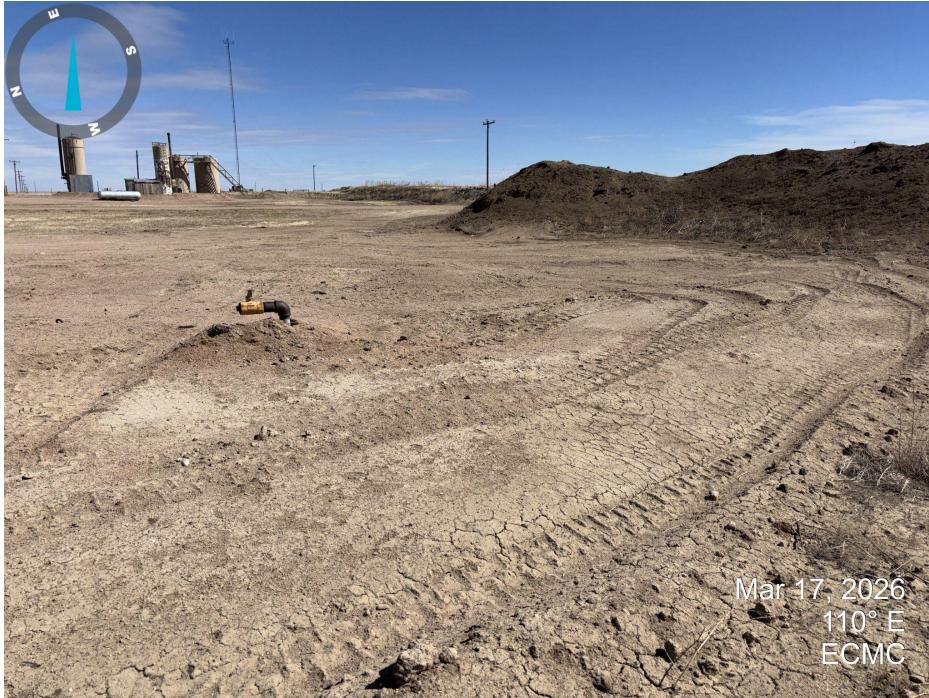
Photo 3. Looking east across the former tank battery area. Pipe riser remains on location. Contaminated soil pile does not have any stormwater BMPs surrounding it.

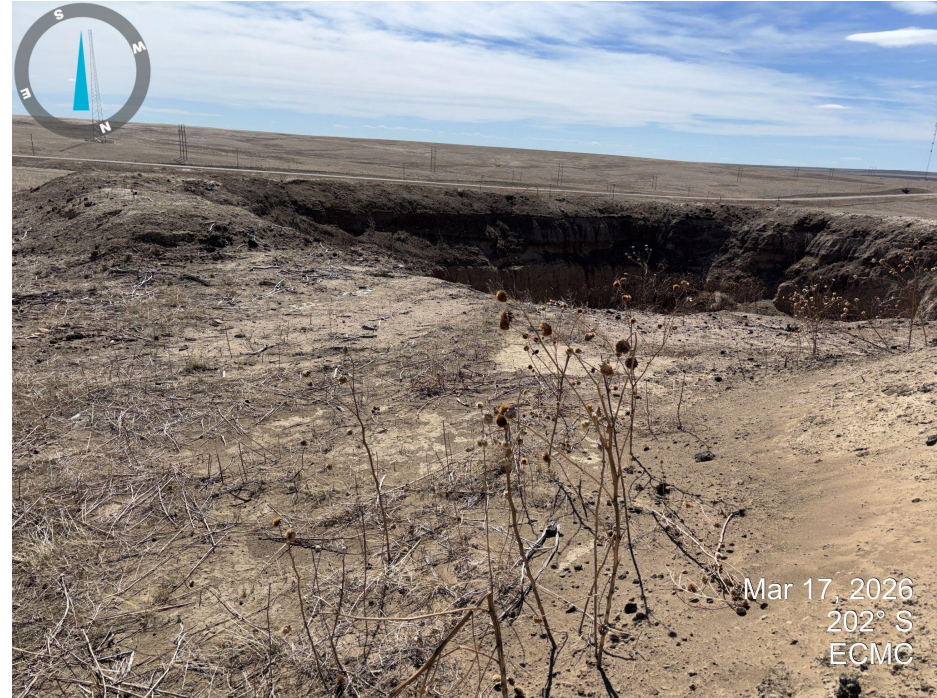
Photo 4. Looking west across the southernmost pit (ID 440212). Pit remains. There may have been some recent excavation work in and around the pit.

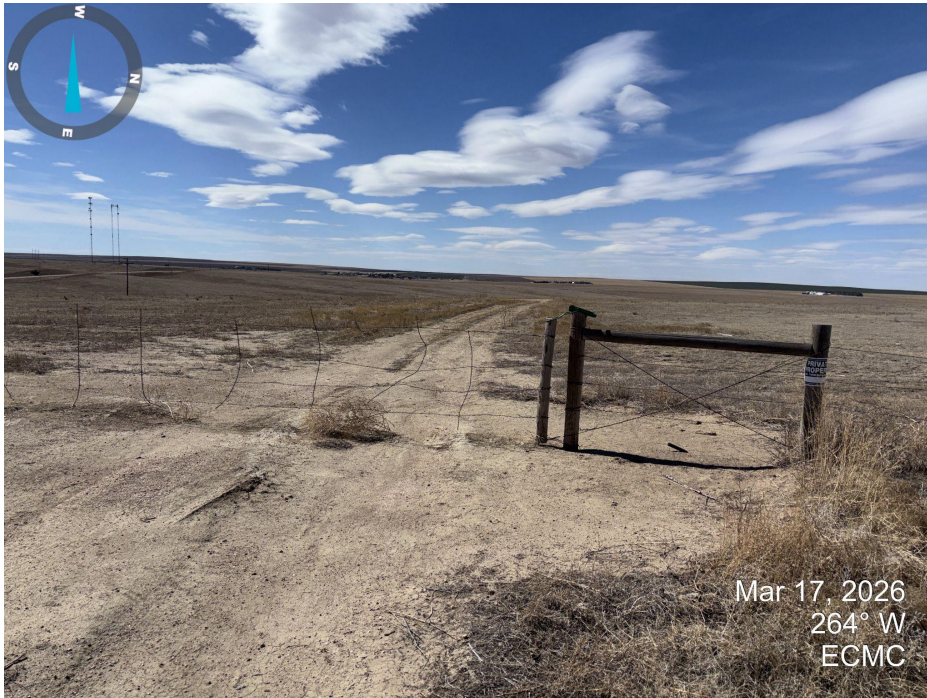
Photo 5. Looking west down the access road towards the wellhead. The access road remains.

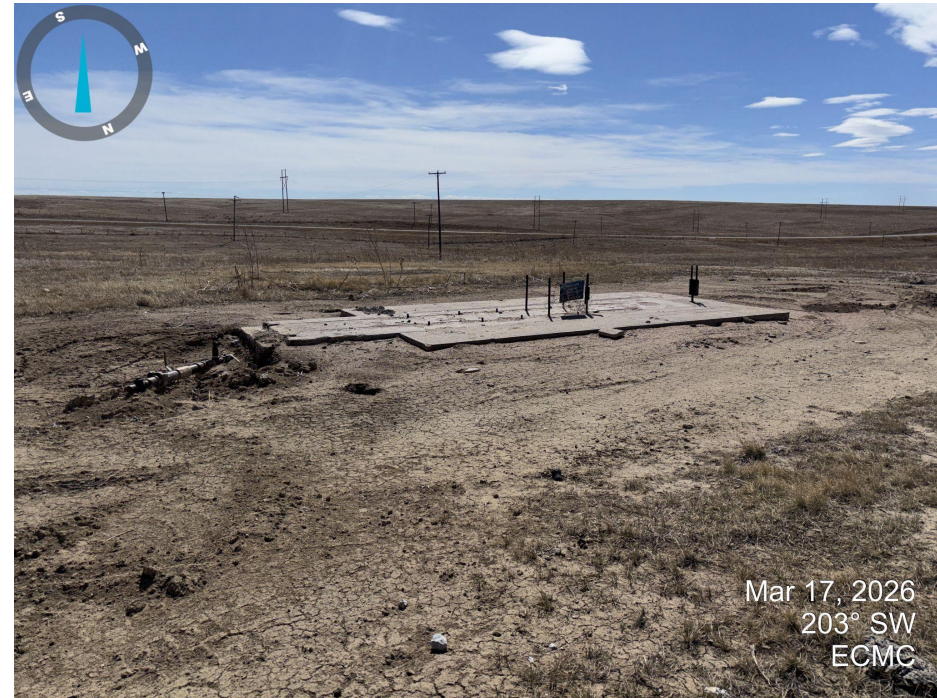
Photo 6. Looking South across the wellhead area. Pipe riser, concrete pad and electrical poles remain. Subsidence was observed around the wellbore.

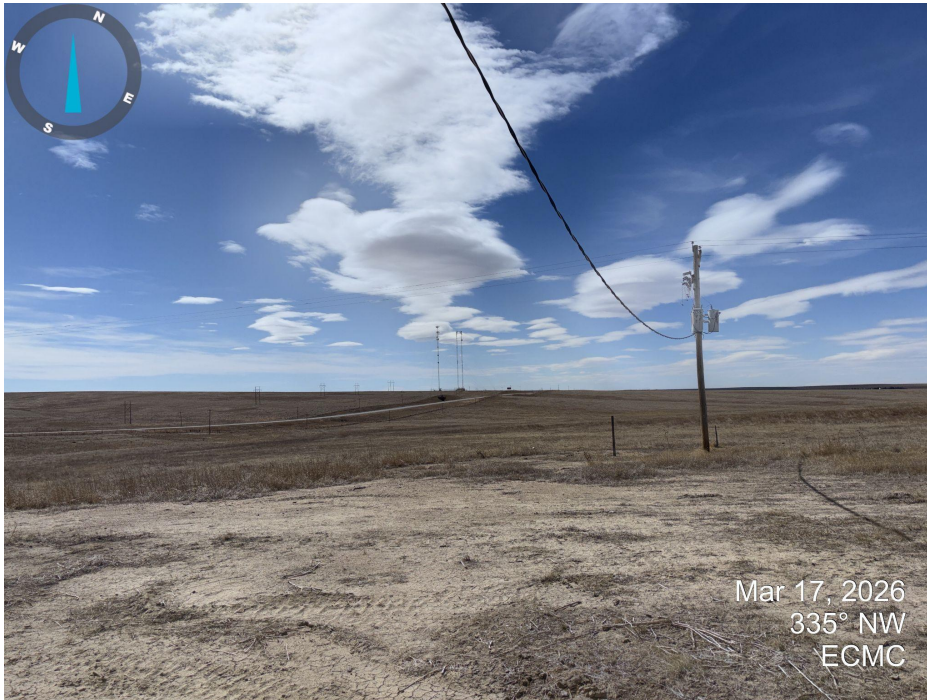
Photo 7. Electric service travels westbound along highway 36 from the well and tank battery location. It appears that the electric line served only this well and the former tank battery on the west side of county road U.

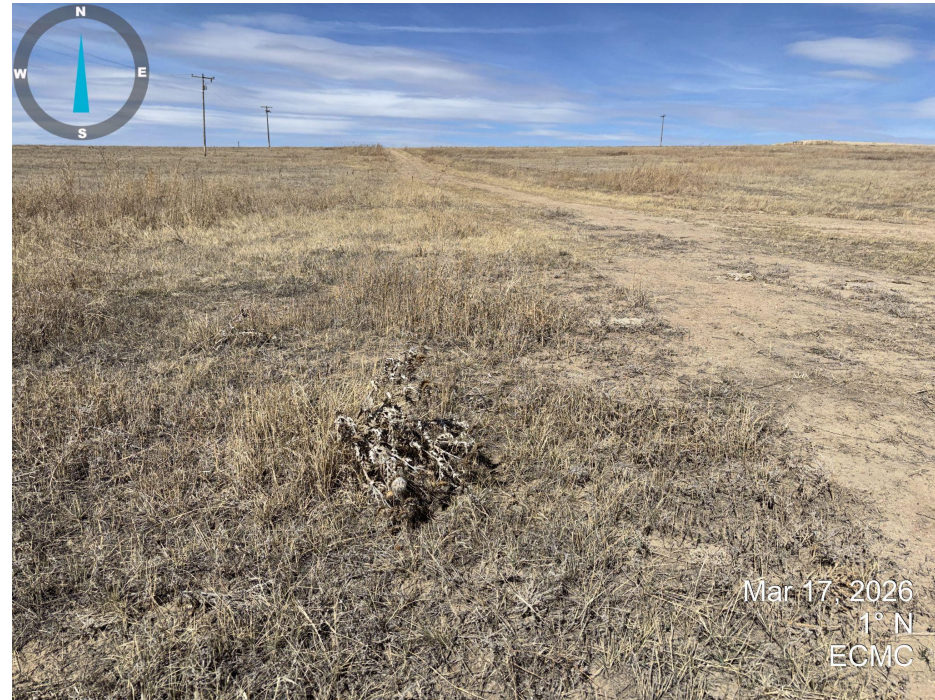
Photo 8. Photo taken west of the well location looking north up the access road. List B noxious weed scotch thistle was observed on location.

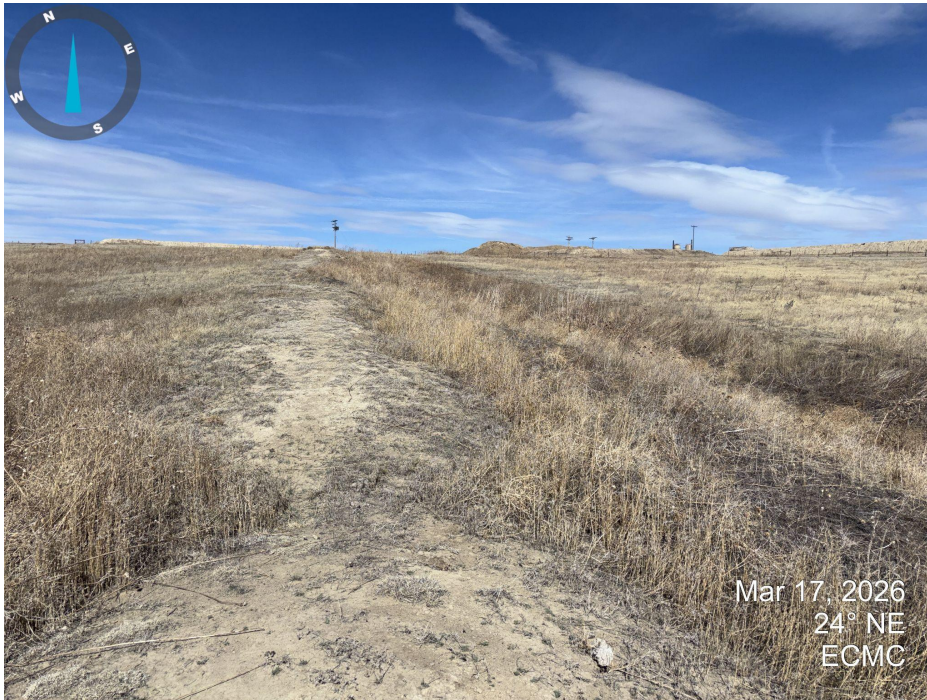
Photo 9. Looking north along the ditch and berm south of the tank battery location. The ditch and berm remains.
