Inspection Photos

Operator: GRMR Oil and Gas LLC #10524

Location ID: 313249

Inspection Doc: 719201007

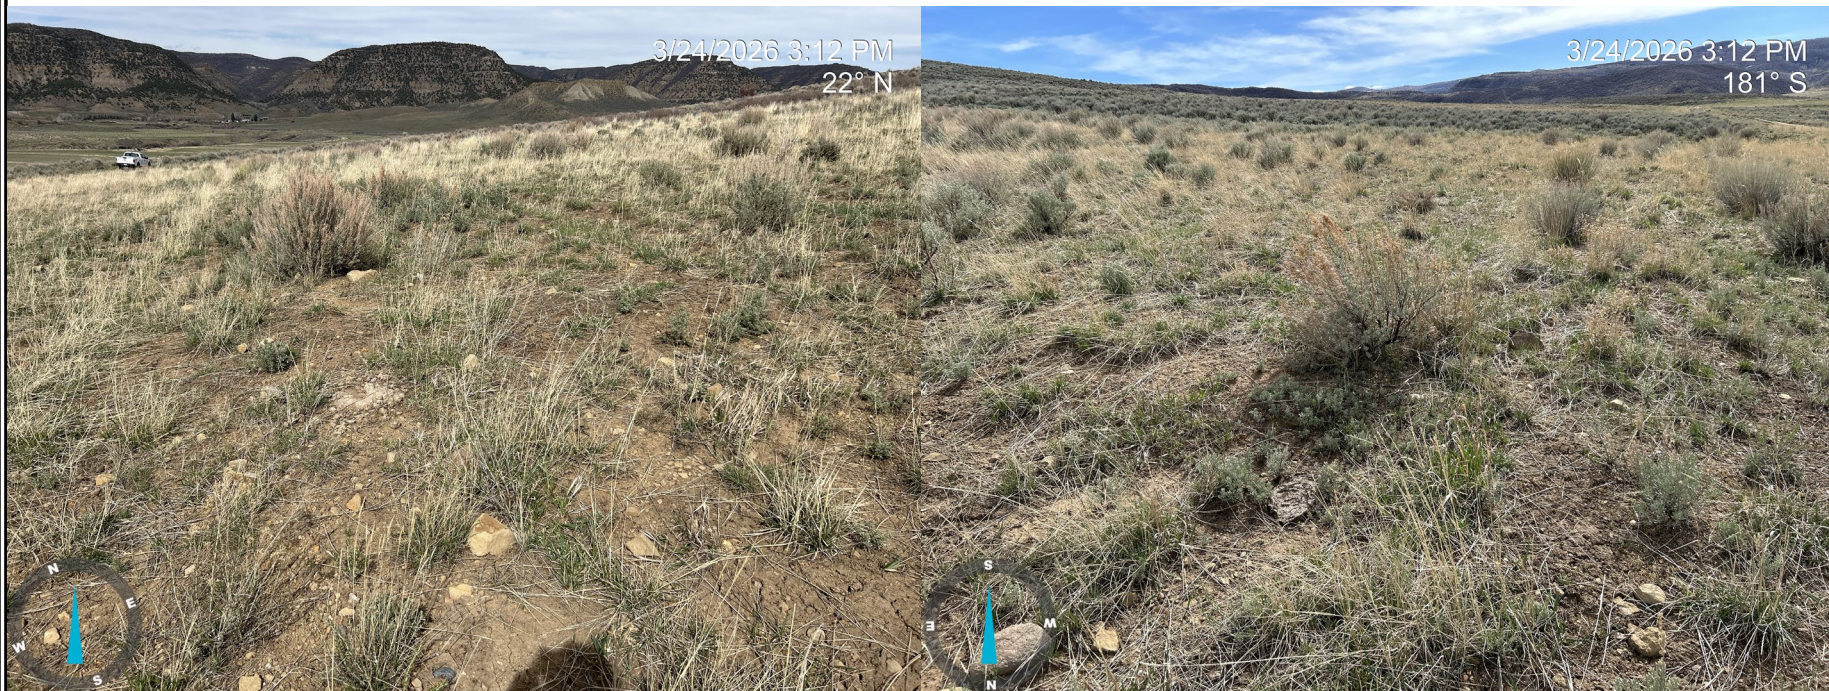
Photo 1: Photos showing an overview of the location looking north and south, respectively. Vegetation appears to meet 1004 reclamation requirements of desirable, perennial and uniform vegetation of at least eighty (80) percent cover.

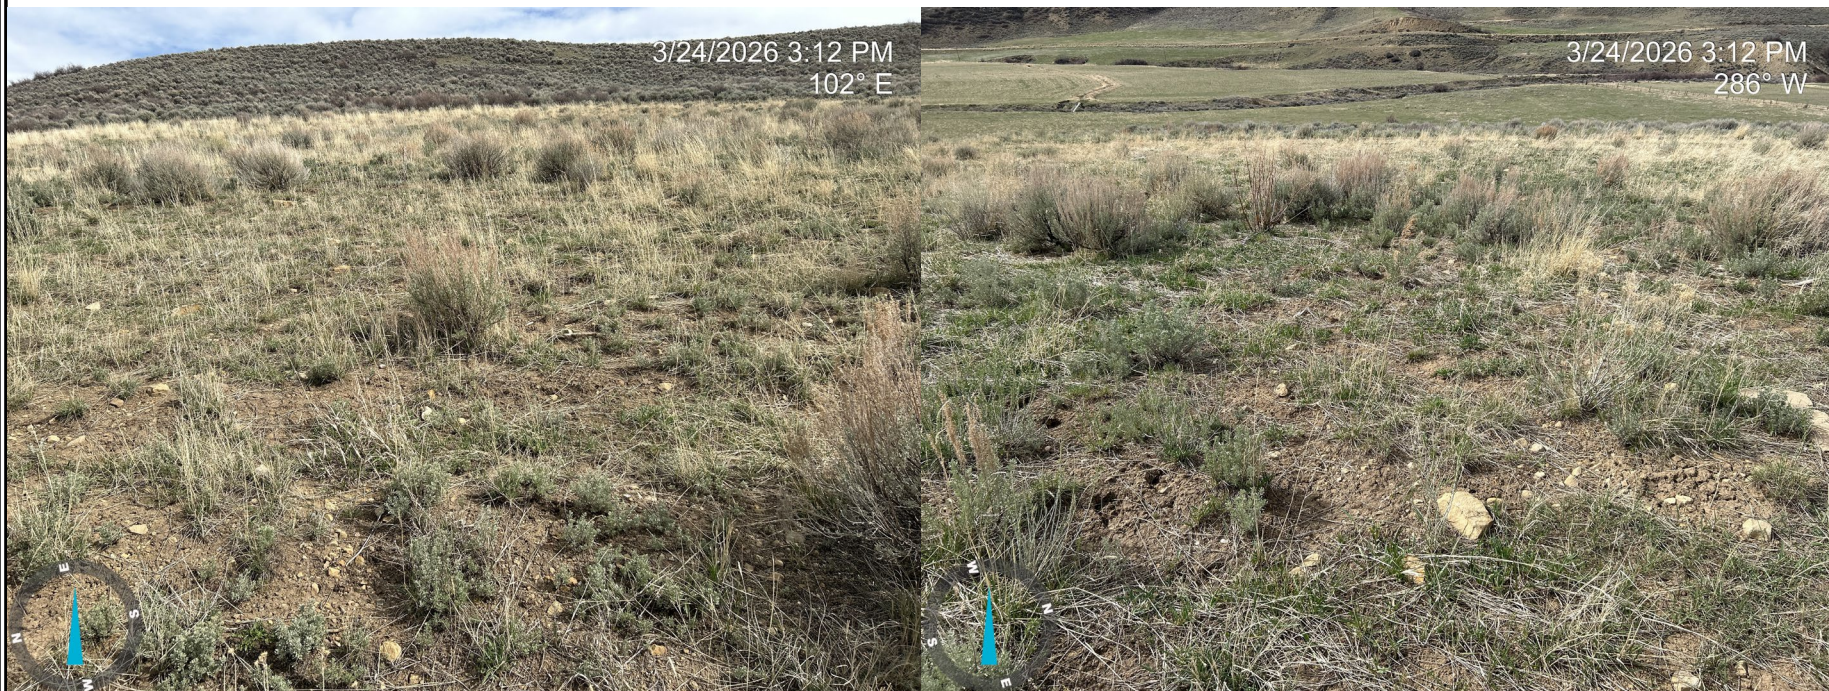
Photo 2: Photos showing an overview of the location looking east and west, respectively. Vegetation appears to meet 1004 reclamation requirements of desirable, perennial and uniform vegetation of at least eighty (80) percent cover.

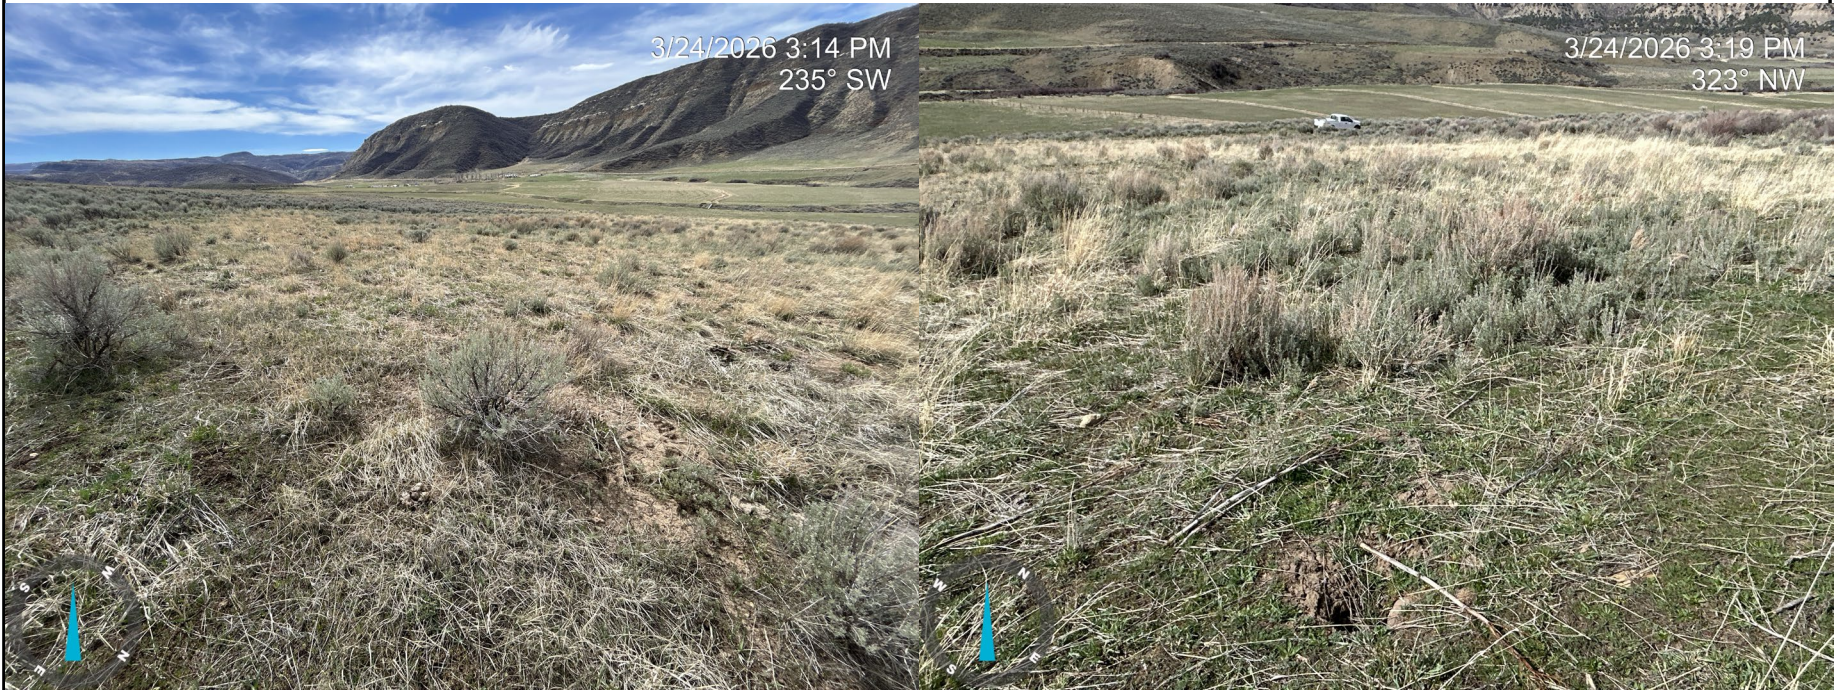
Photo 3: Photos showing an overview of the southern and northern portions of the location, respectively.

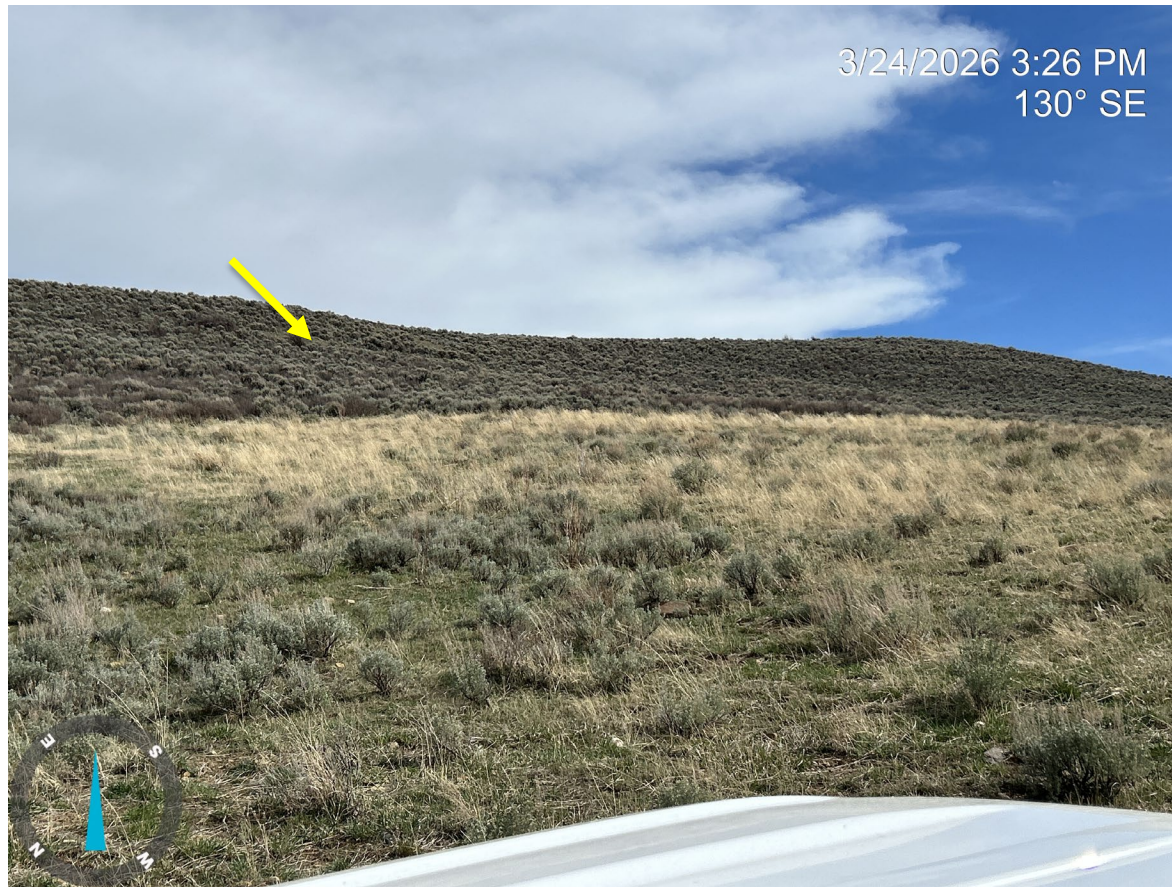
Photo 4: Photo showing a general overview of the location from the access road. Yellow arrow shows the nearby reference area.

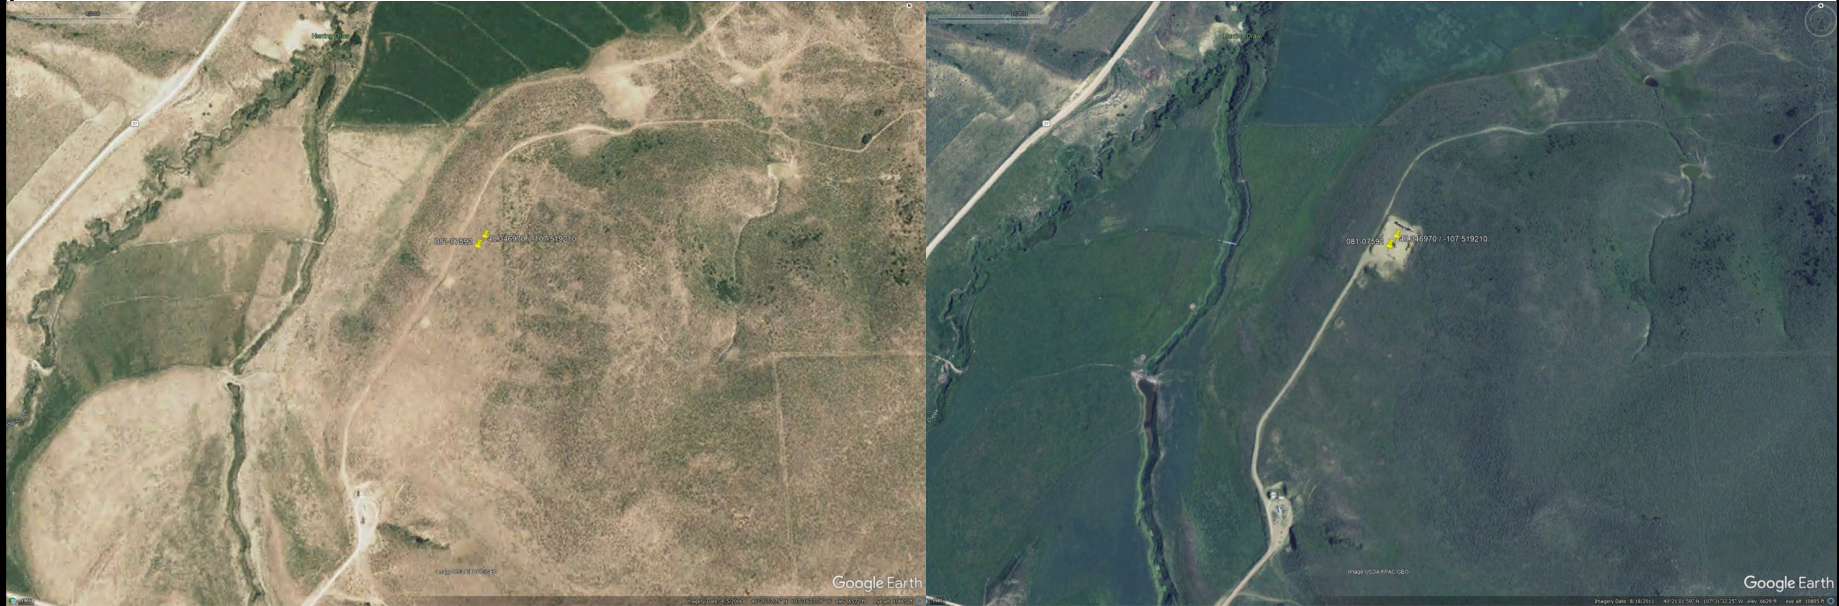
Photo 5: Photos showing Google Earth imagery of the location from 2006 and 2011, respectively. The access road appears to pre-exist Oil & Gas activities.

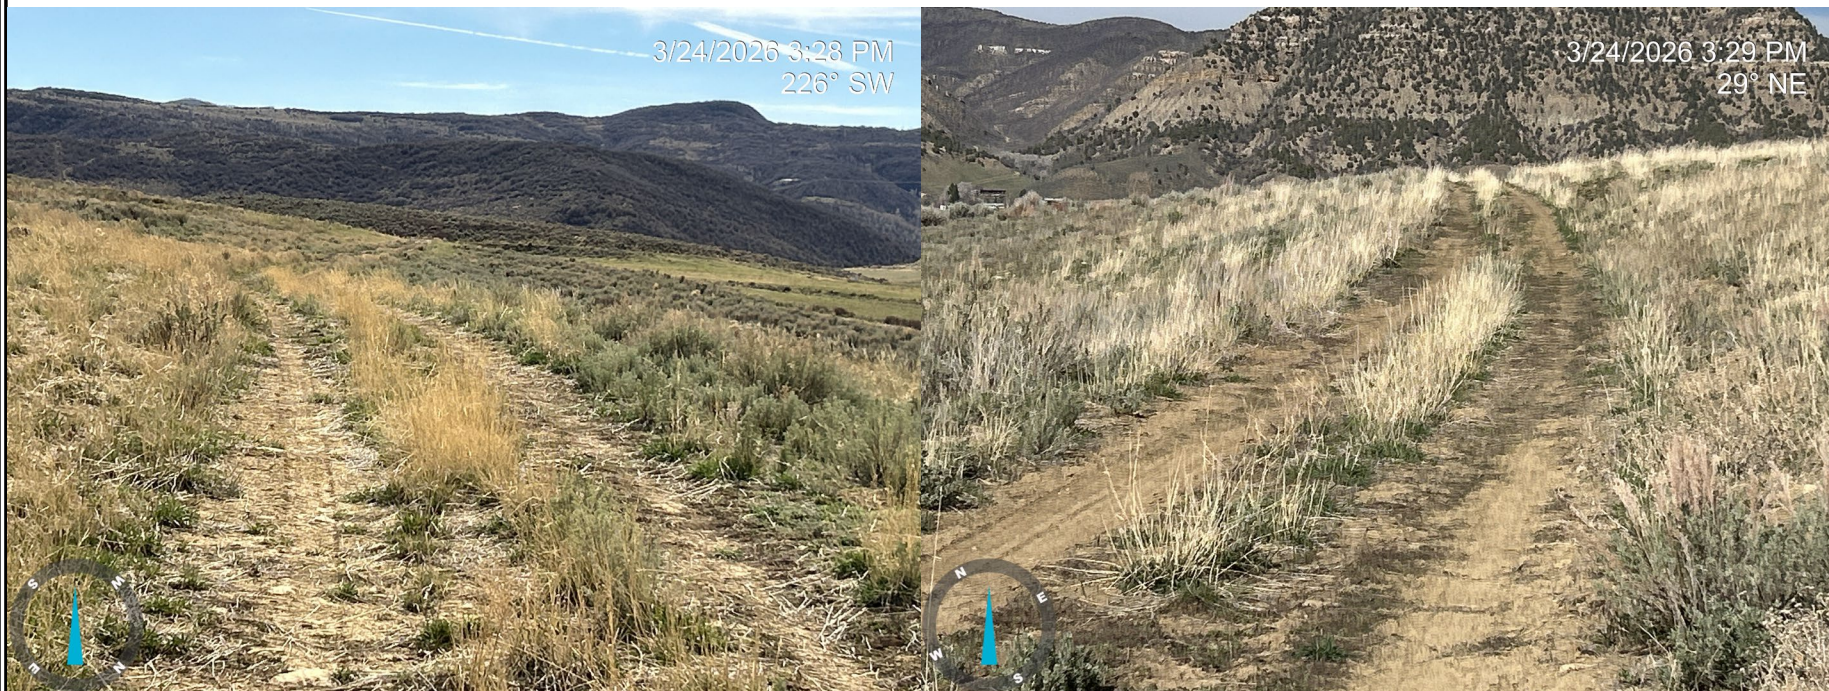
Photo 6: Photos showing an overview of the access road next to the location. The road pre-dates the location; however, gravel has been removed and this portion of the road reseeded.

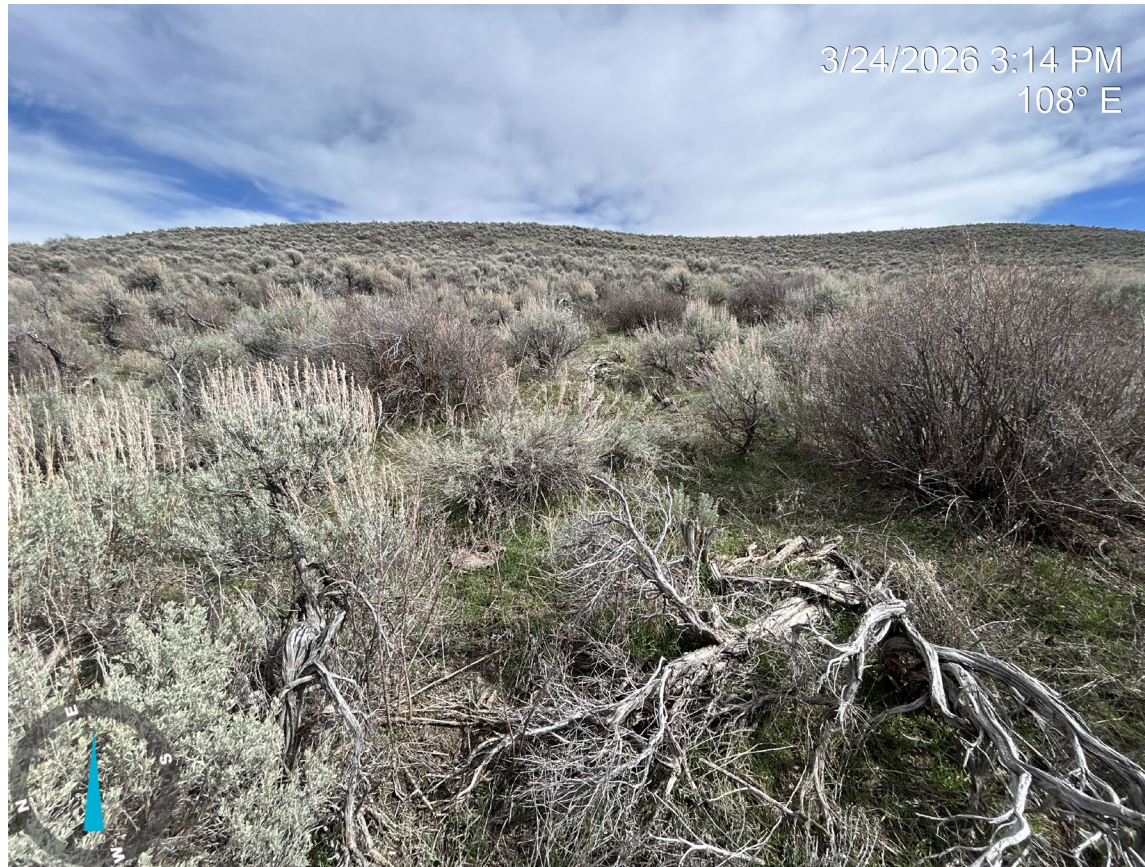
Photo 7: Photo showing an example of the nearby reference area, directly east of the location. The reference area is characterized as a big sagebrush shrubland.
