Final Reclamation Inspection

Operator: KERR MCGEE OIL & GAS ONSHORE LP - 47120

Location ID: 328225

Inspection Photos
Location Name: HSR-TEACHER #10-14A
Location ID: 328225

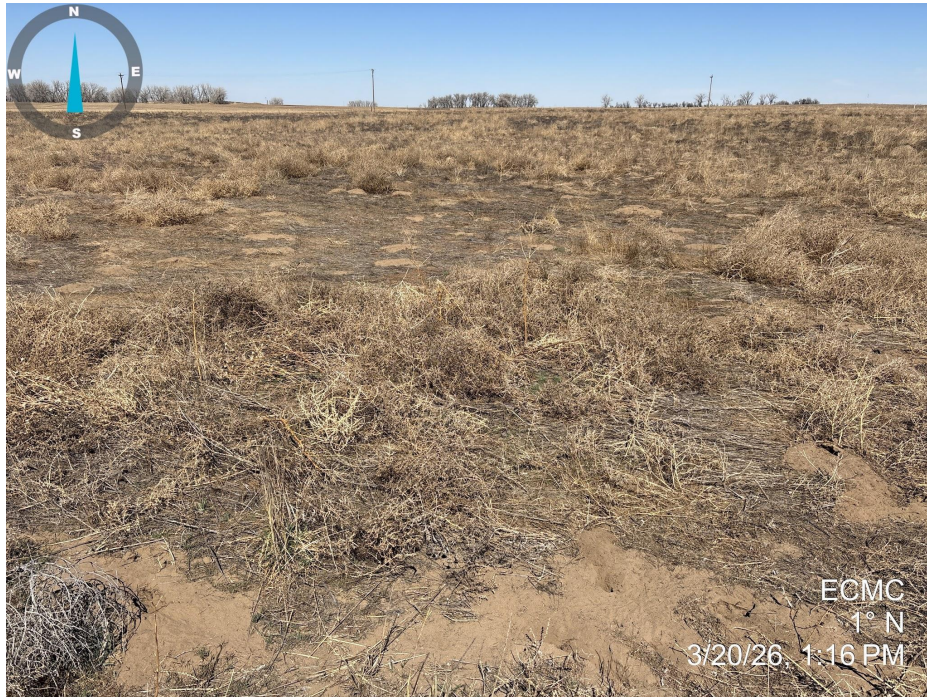
Photo 1. Photo taken of the well location, facing north. Photo illustrates that final reclamation activities appear to have taken place at the location, but vegetation establishment does not meet Rule 1004 standards. Weedy annual vegetation including russian thistle (*Salsola tragus*) and cheatgrass (*Bromus tectorum*) were observed at the location.

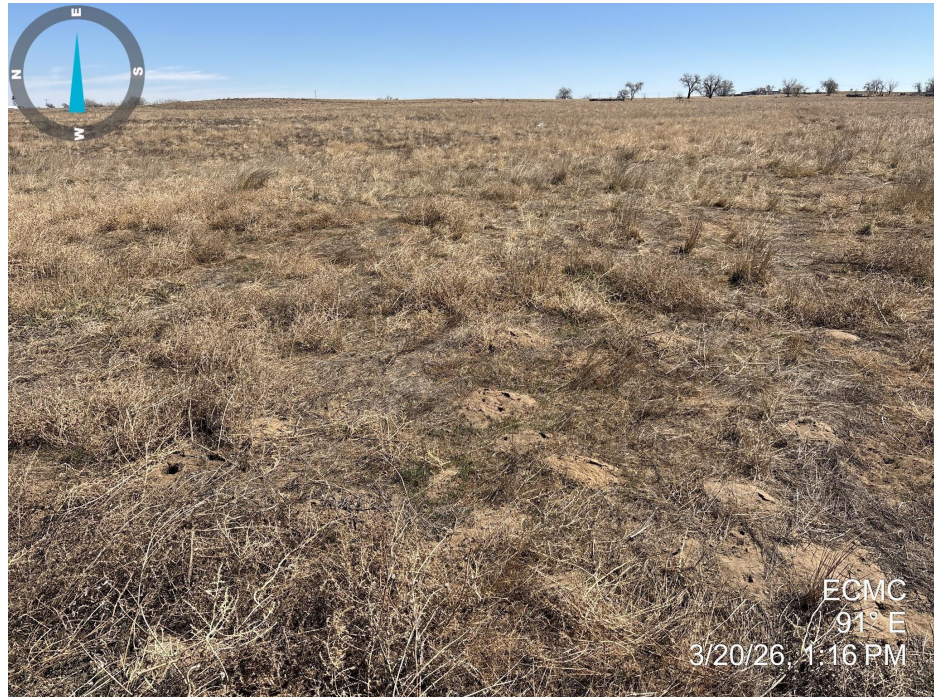
Photo 2. Photo taken of the well location, facing east. See comments under Photo 1.

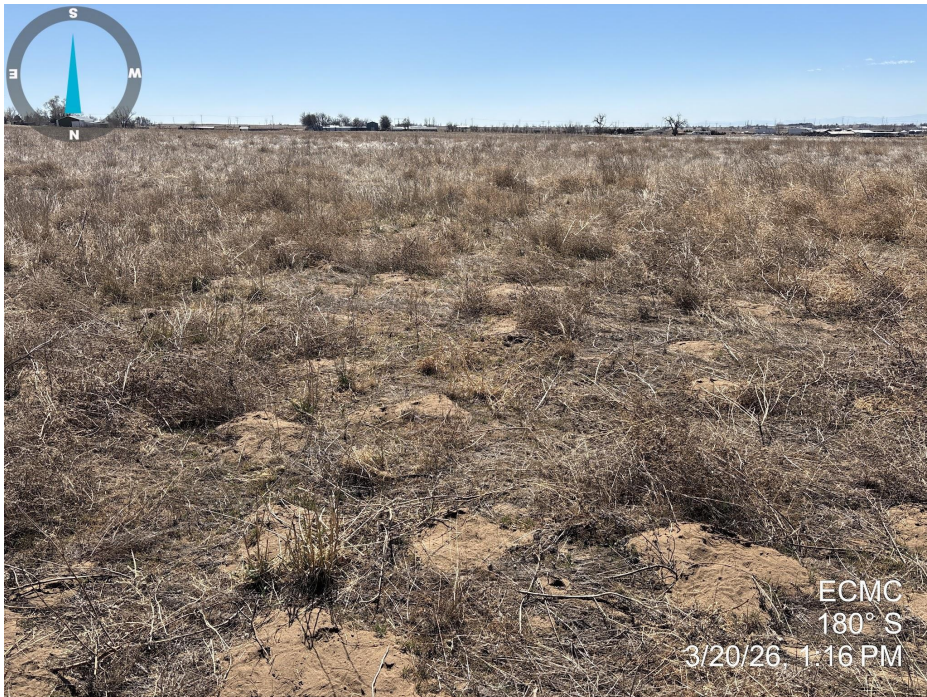
Photo 3. Photo taken of the well location, facing south. See comments under Photo 1.

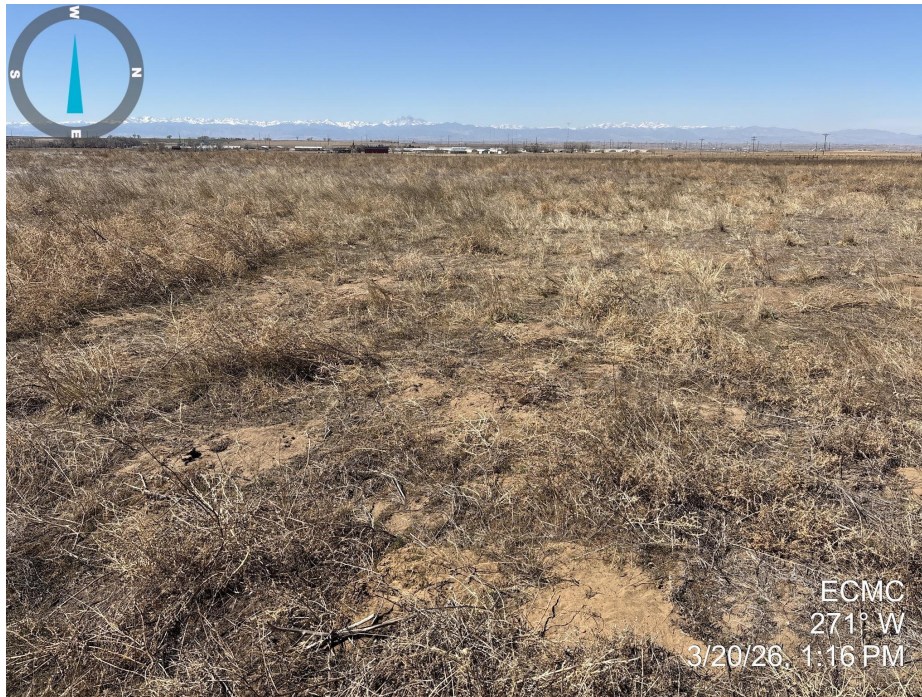
Photo 4. Photo taken of the well location, facing west. See comments under Photo 1.

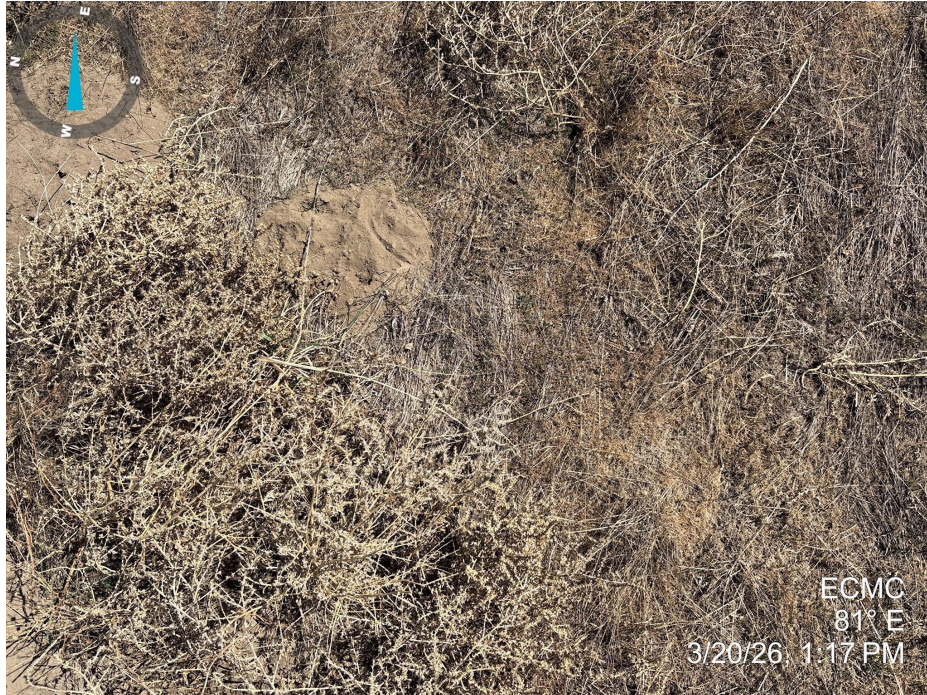
Photo 5. Photo taken of ground cover at the well location. Photo illustrates weedy annual vegetation including russian thistle (*Salsola tragus*).

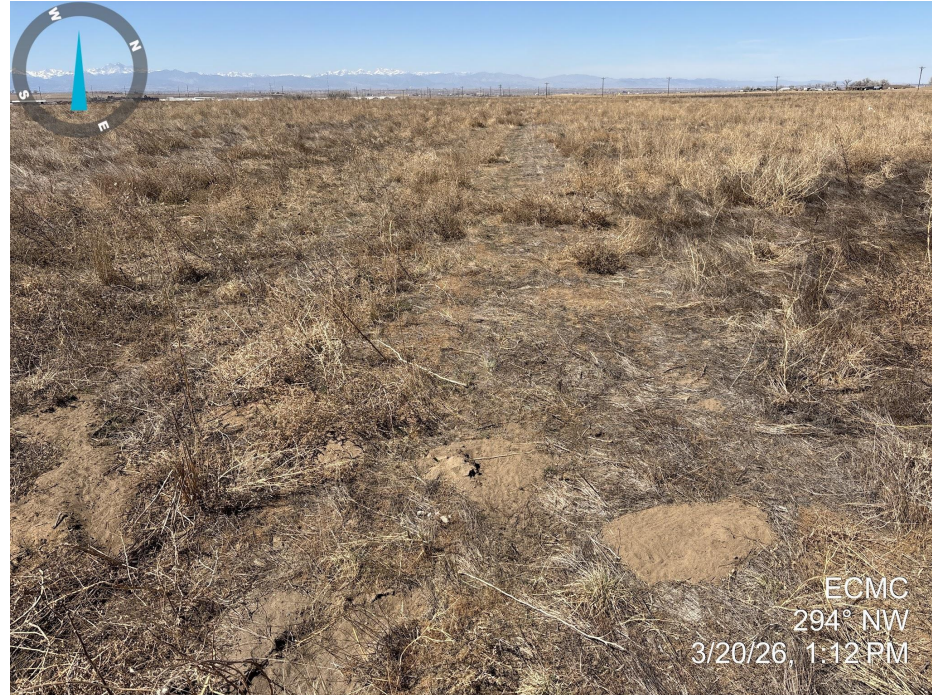
Photo 6. Photo taken of the access road to the location, facing northwest. Photo illustrates that reclamation activities appear to have taken place along the road, but vegetation has not established to Rule 1004 standards. Weedy annual vegetation including russian thistle (*Salsola tragus*) was observed.

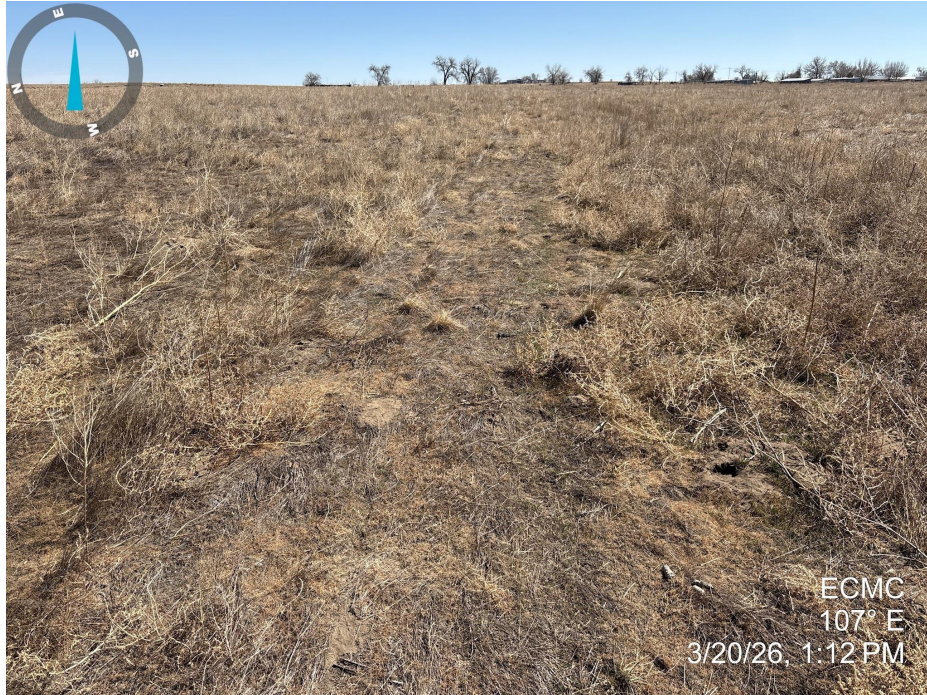
Photo 7. Photo taken of the access road to the location, facing east, away from the location. See comments under Photo 6.

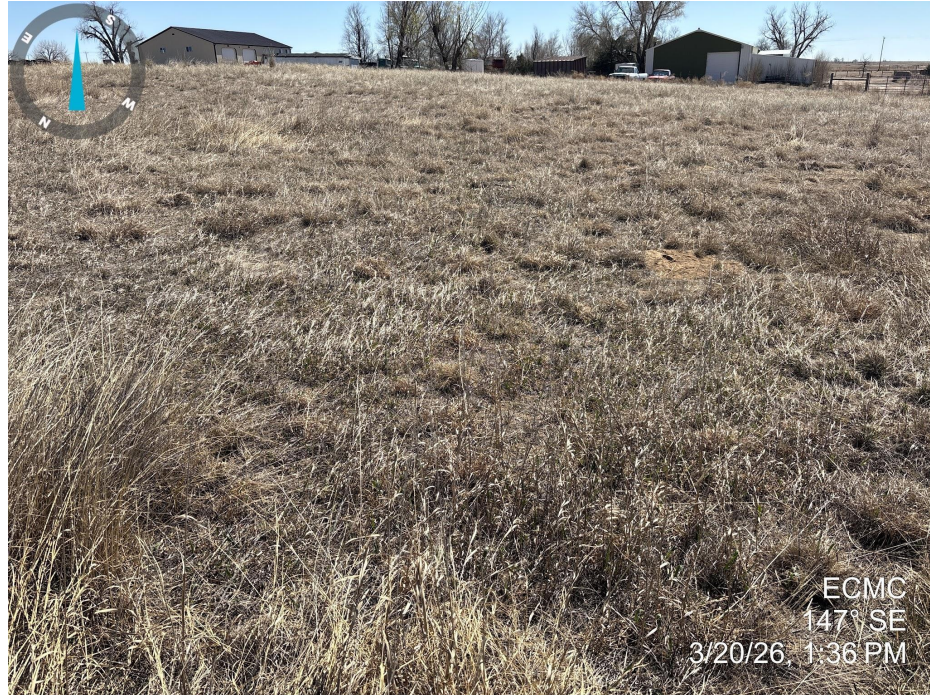
Photo 8. Photo taken of the reference area to the location, south of the location, facing southeast. Photo illustrates perennial grass and weedy annual vegetation.
