Final Reclamation Inspection

Operator: KERR MCGEE OIL & GAS ONSHORE LP - 47120

Location ID: 332479

Inspection Photos
Location Name: PENTON #23-11
Location ID: 332479

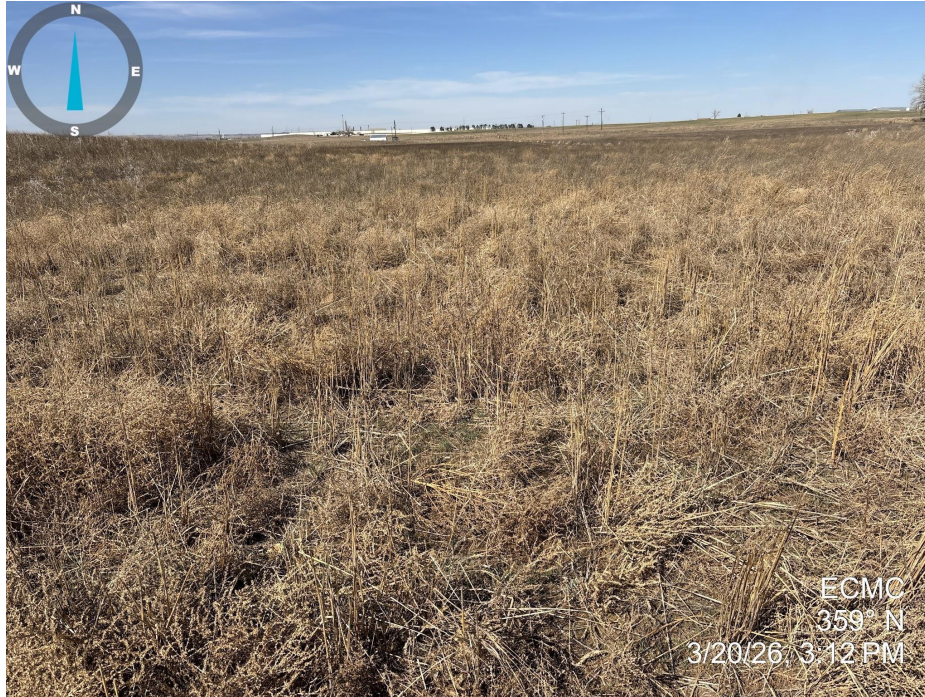
Photo 1. Photo taken of the well location, facing north. Photo illustrates that final reclamation activities appear to have taken place at the location, but vegetation establishment does not yet meet Rule 1004 standards. Weedy annual vegetation including russian thistle (*Salsola tragus*) was observed at the location.

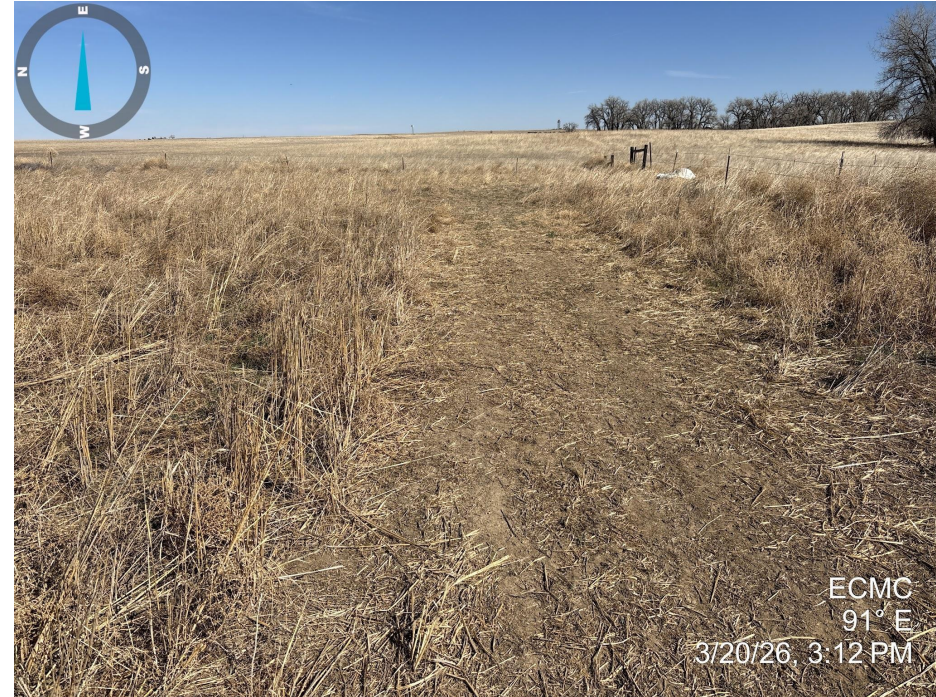
Photo 2. Photo taken of the well location, facing east. See comments under Photo 1.

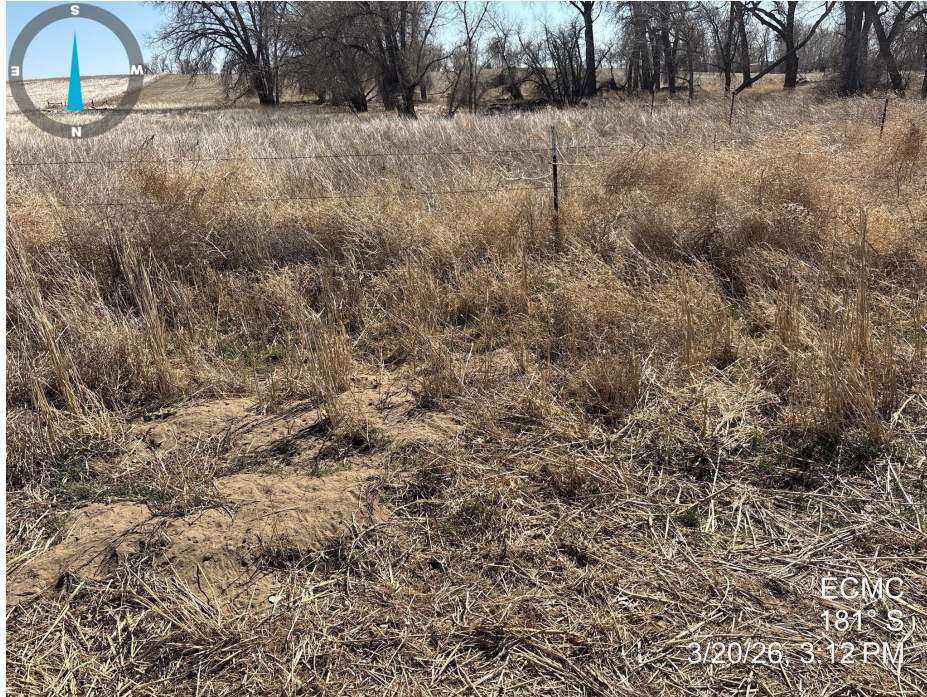
Photo 3. Photo taken of the well location, facing south. See comments under Photo 1.

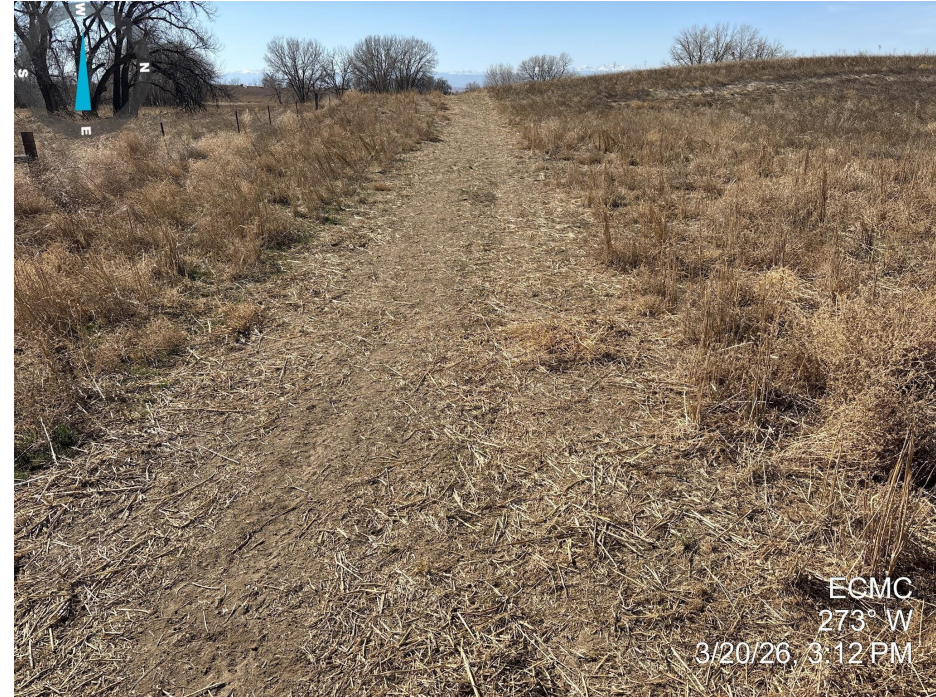
Photo 4. Photo taken of the well location, facing west. See comments under Photo 1. Photo illustrates that final reclamation activities have taken place along the access road.

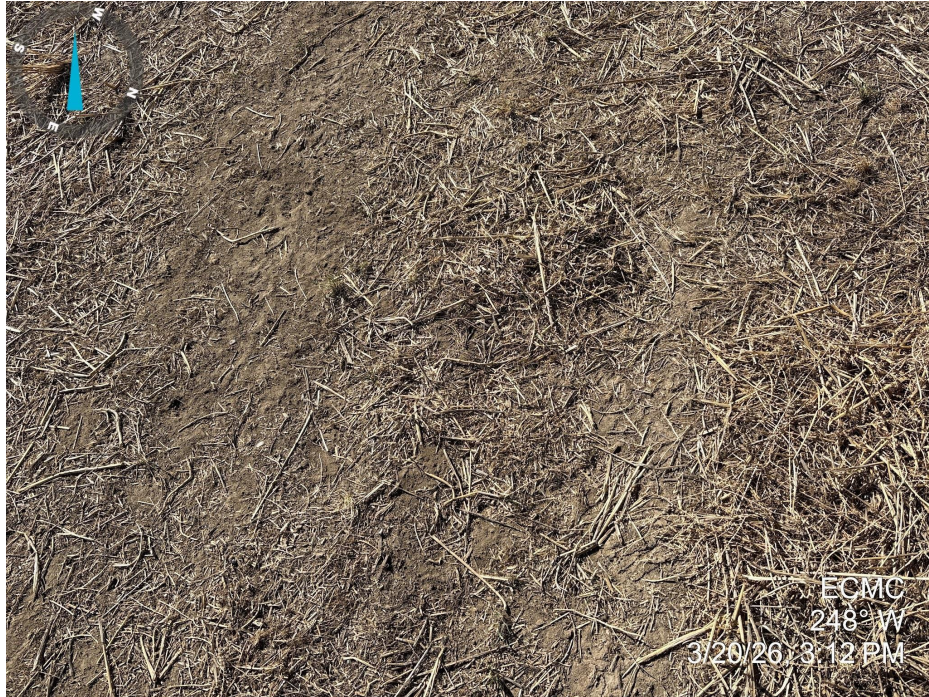
Photo 5. Photo taken of ground cover at the well location. Photo illustrates mulch and bare ground.

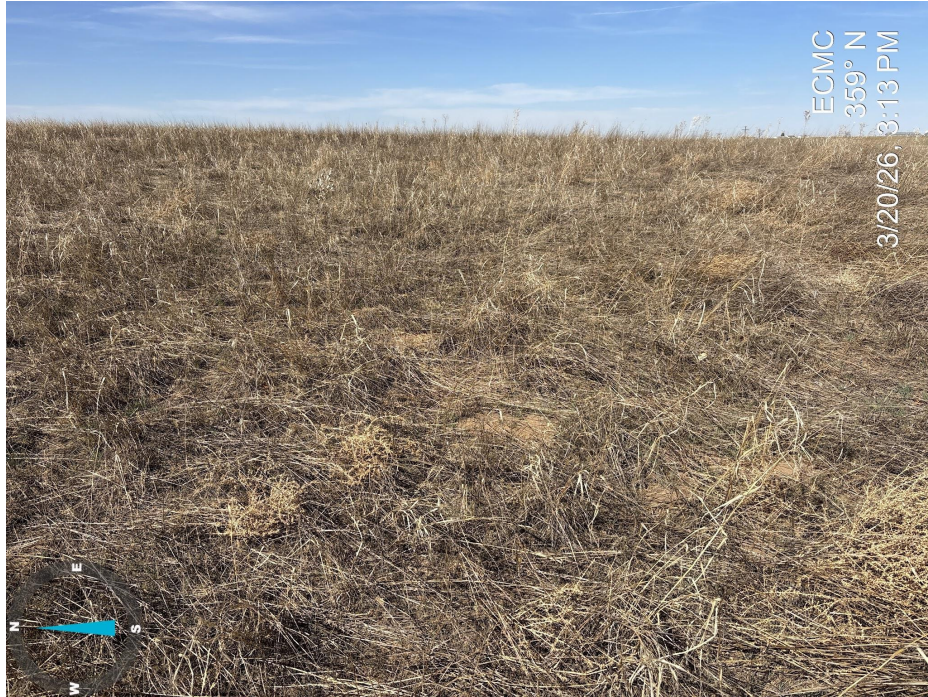
Photo 6. Photo taken of the reference area to the location, northwest of the location, facing north. Photo illustrates perennial grass and weedy annual vegetation.
