Final Reclamation and Stormwater Inspection

Operator: KERR MCGEE OIL & GAS ONSHORE LP - 47120

Location ID: 310593

Well Name: ENTERPRISE- USX XX #21-6

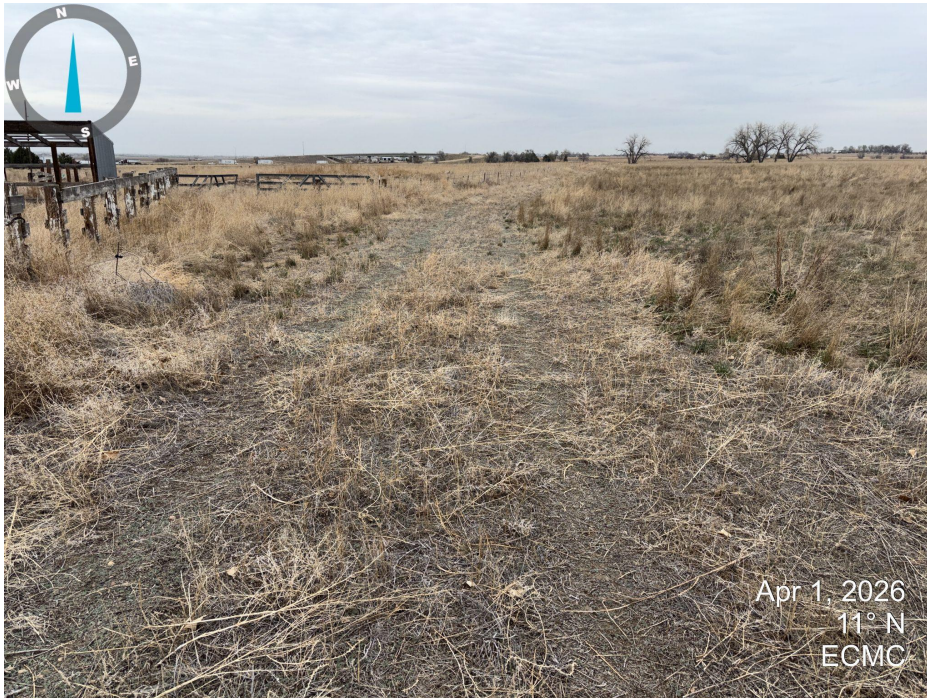
Photo 1. Looking North down the former access road from the tank battery location. The first approximately 500 ft of access road has little desirable vegetation establishment and consists primarily of undesirable weeds such as kochia and russian thistle.

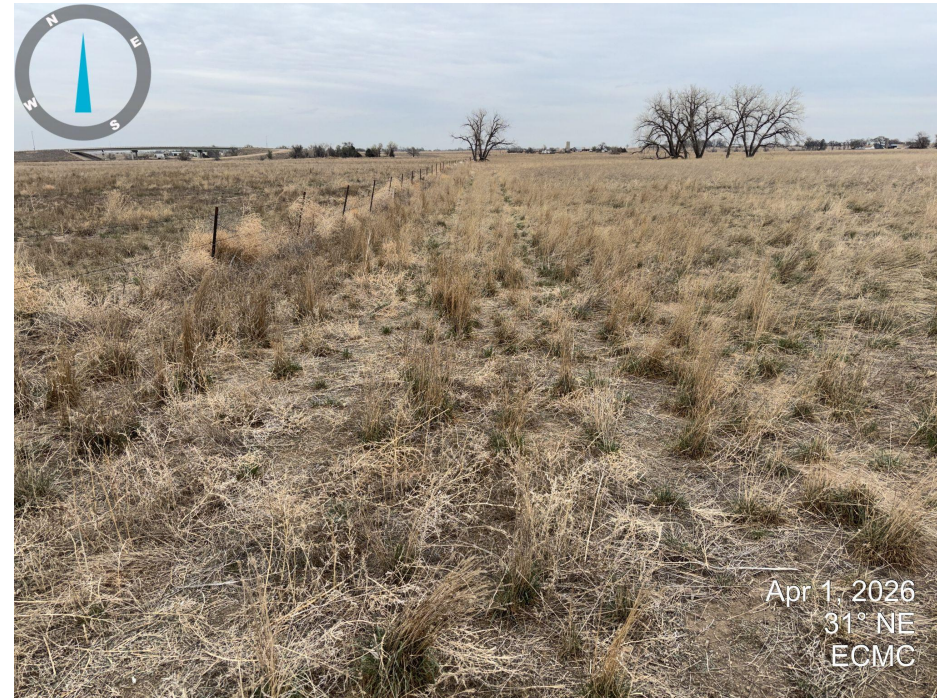
Photo 2. Looking down the northern part of the access road towards the well location. This picture was taken near a fence junction to the west. Desirable perennial vegetation has established on this portion of the former access road.

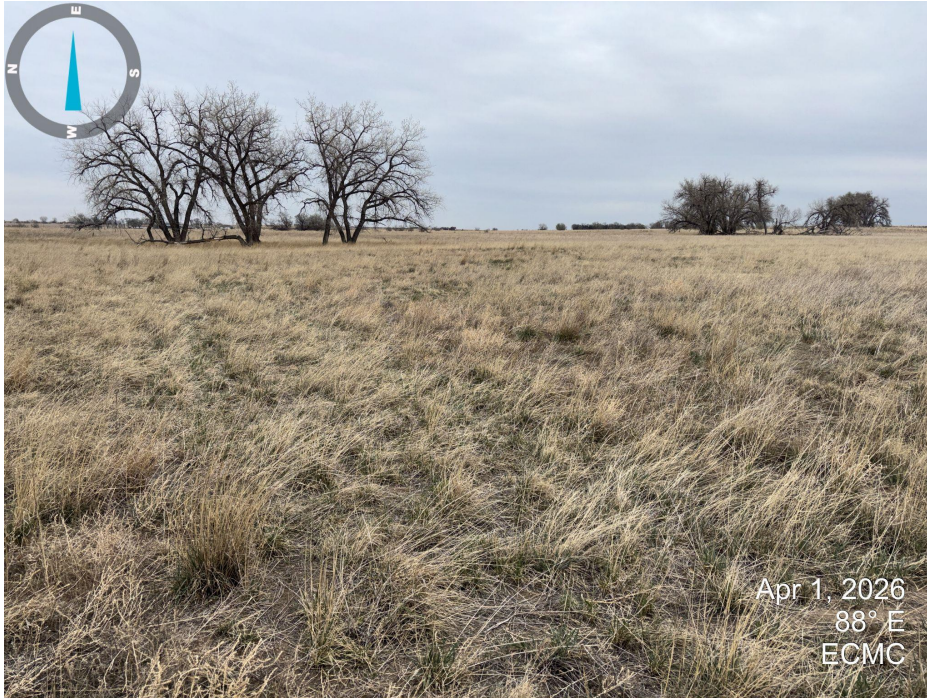
Photo 3. Looking east across the location. No oil and gas equipment remains on the location. Desirable perennial species such as crested wheatgrass and western wheatgrass were observed throughout the location and appear to be progressing towards 80% coverage of the reference area.

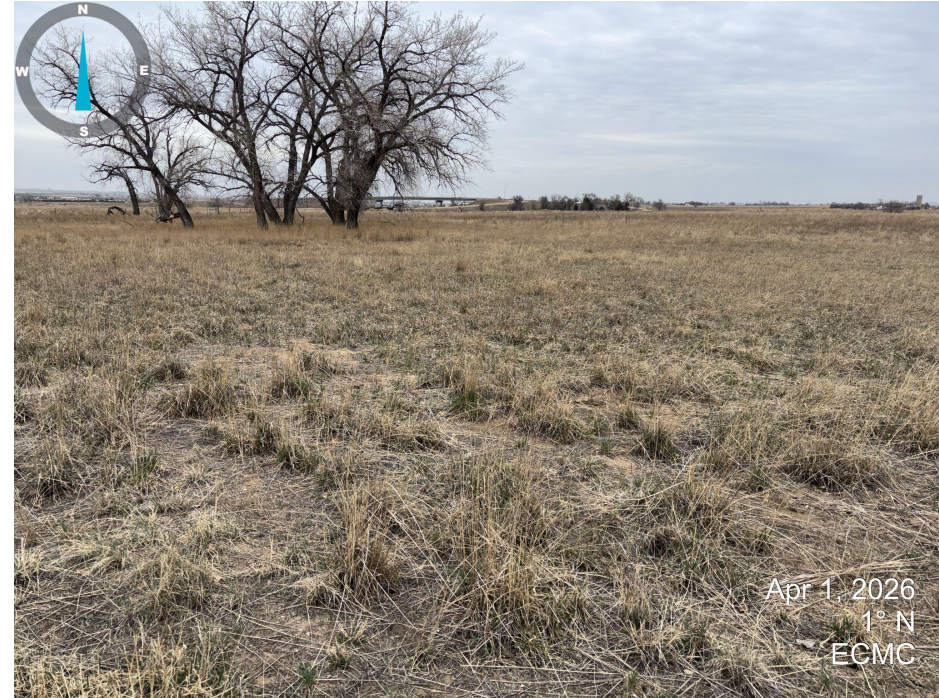
Photo 4. Looking north from wellbore. See photo 3 comments.

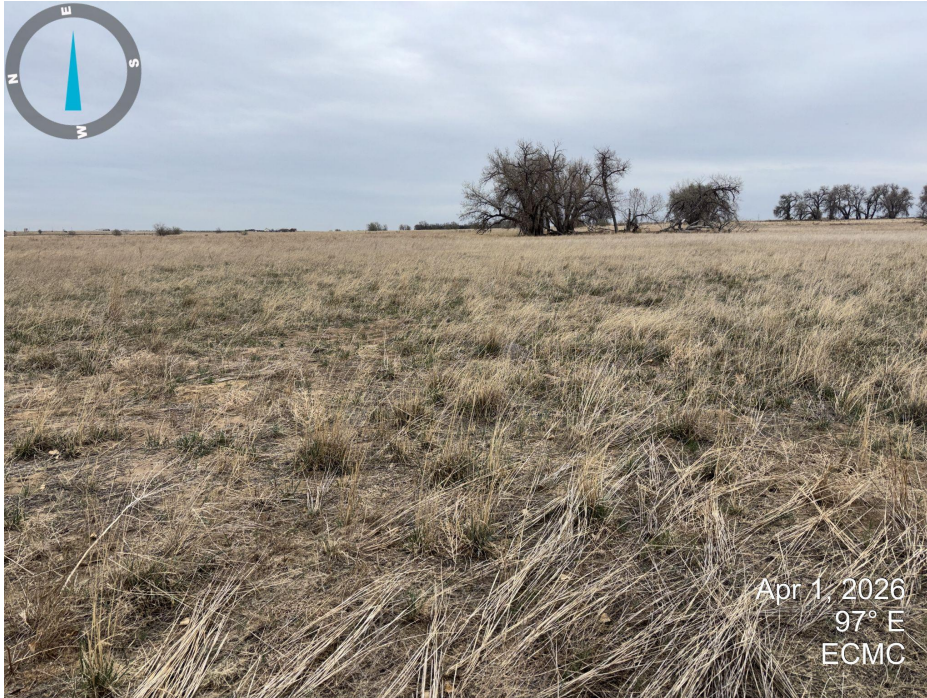
Photo 5. Looking east from wellbore. See photo 3 comments.

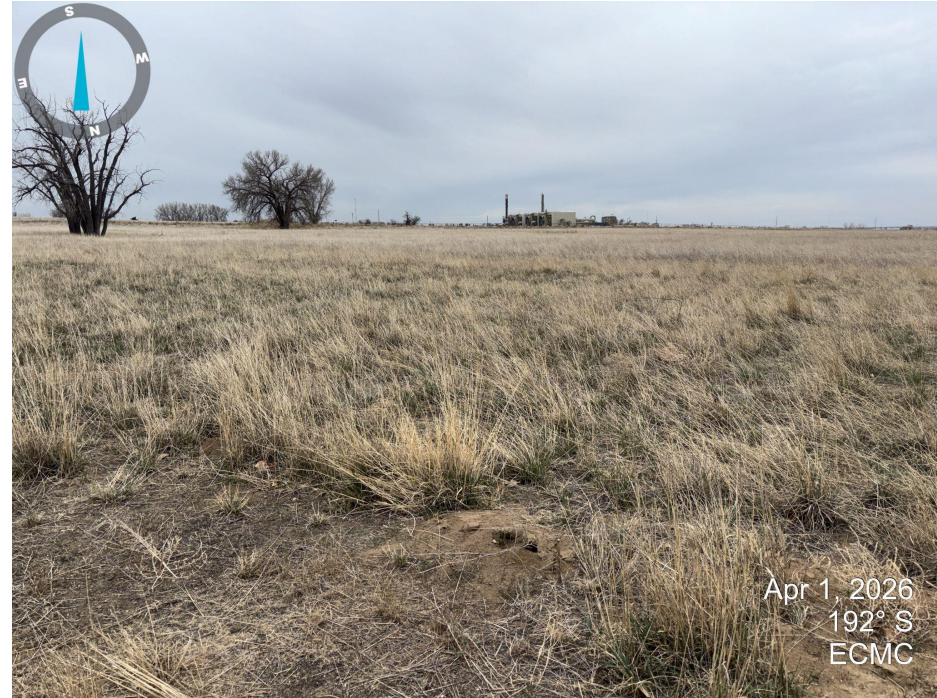
Photo 6. Looking south from wellbore. See photo 3 comments.

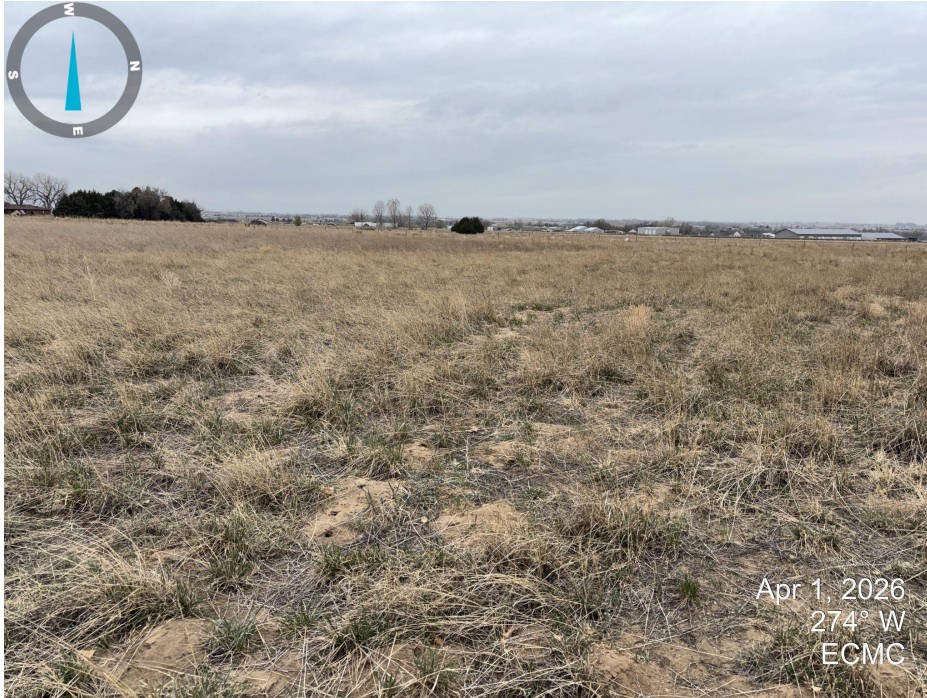
Photo 7. Looking west from wellbore. See photo 3 comments.

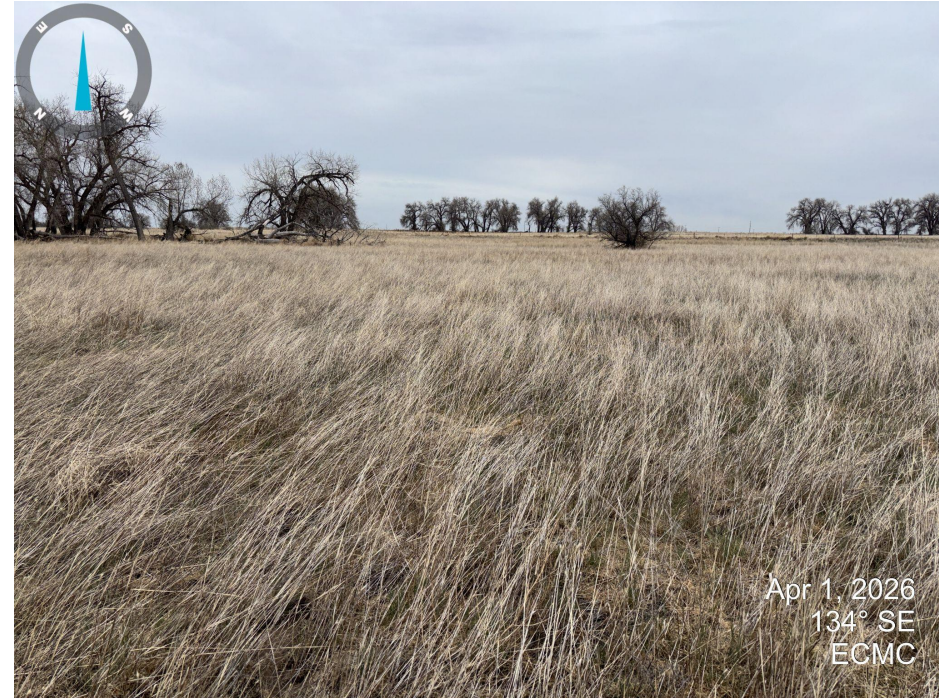
Photo 8. Reference vegetation to the east of well location. Vegetation consists primarily of crested wheatgrass and western wheatgrass. List C noxious weed cheatgrass is also present in the reference area.
