Final Reclamation Inspection

Operator: PDC ENERGY INC - 69175

Location ID: 319628

Inspection Photos
Location Name: BEEBE DRAW #1
Location ID: 319628

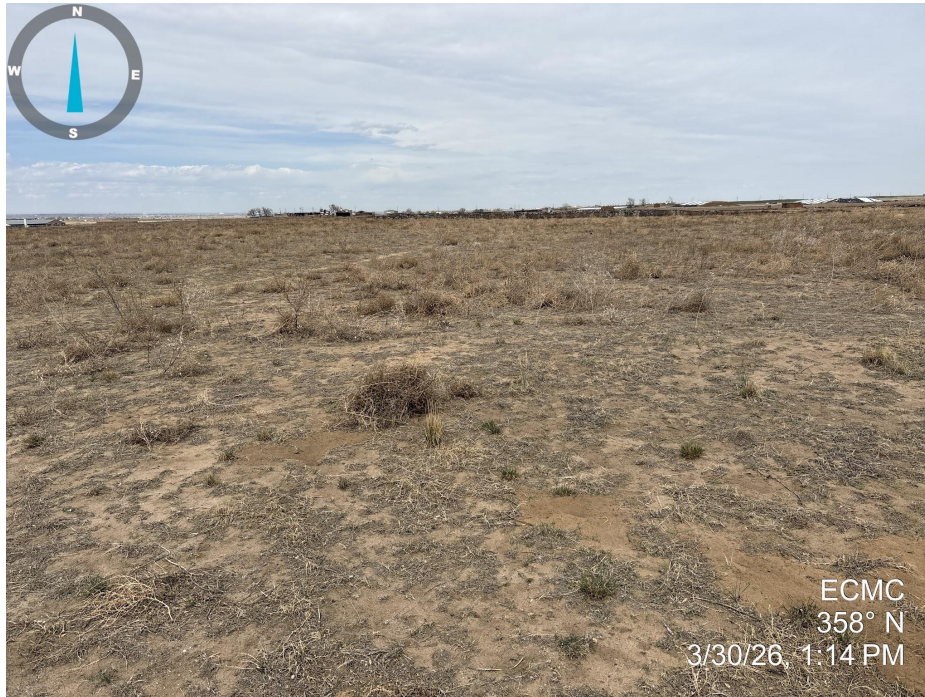
Photo 1. Photo taken of the well location, facing north. Photo illustrates that final reclamation activities appear to have taken place at the location, but vegetation establishment does not meet Rule 1004 standards. Weedy annual vegetation including russian thistle (*Salsola tragus*) and kochia (*Bassia scoparia*) were observed at the location.

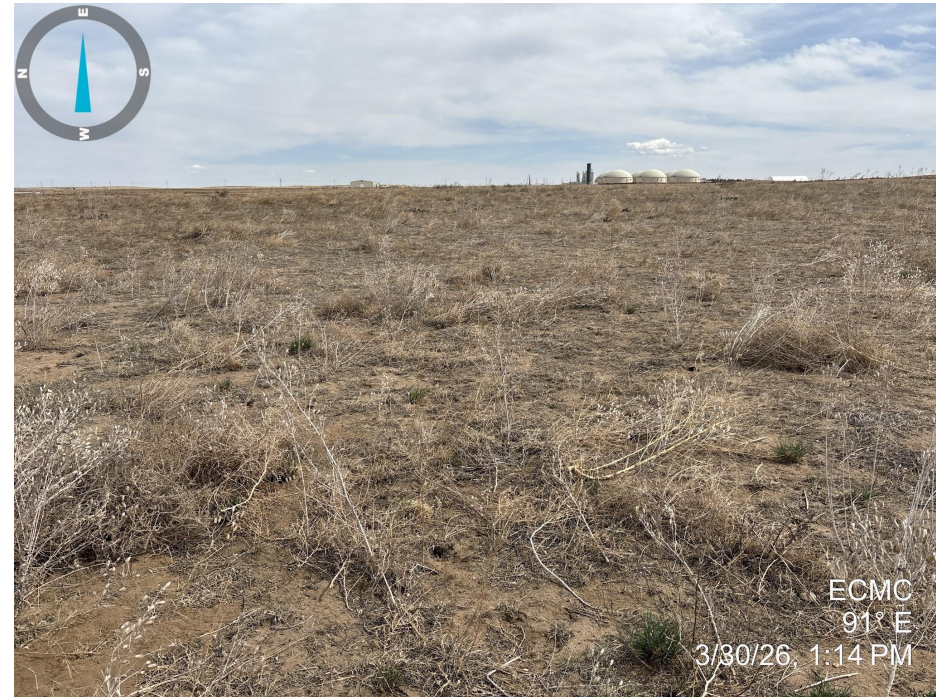
Photo 2. Photo taken of the well location, facing east. See comments under Photo 1.

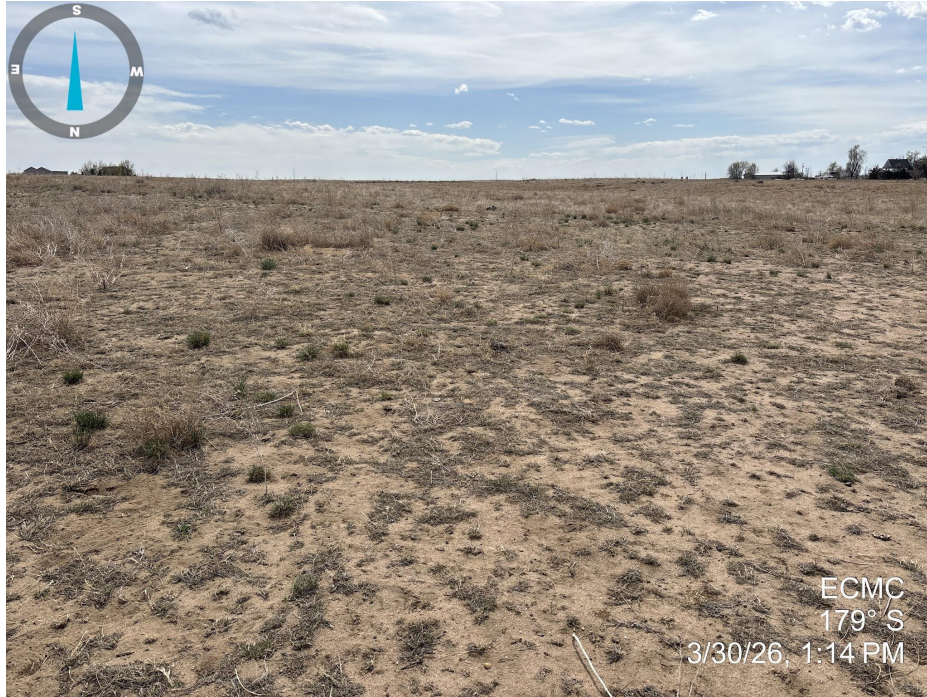
Photo 3. Photo taken of the well location, facing south. See comments under Photo 1.

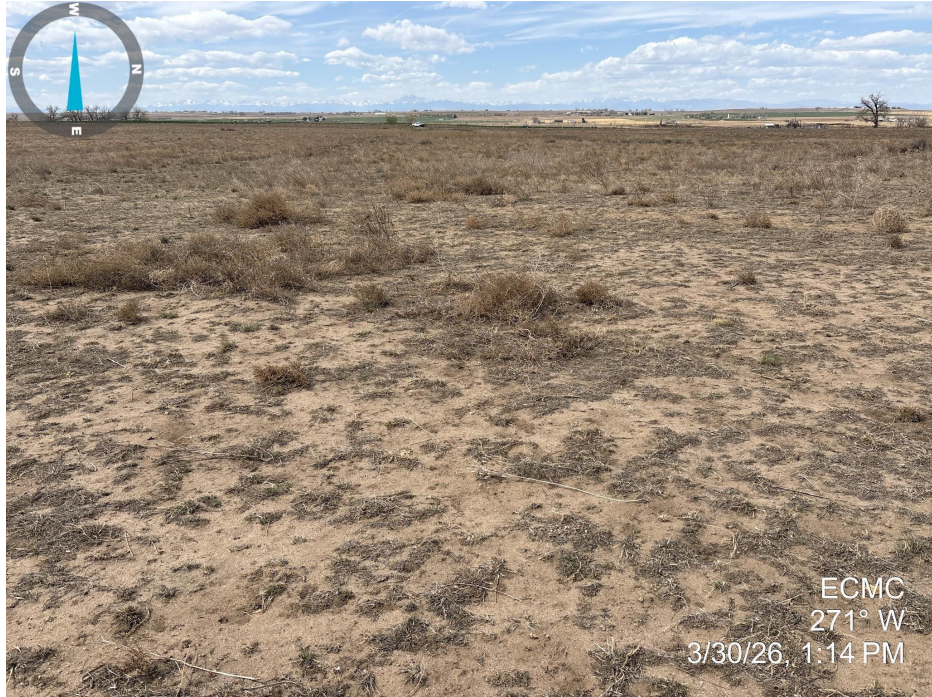
Photo 4. Photo taken of the well location, facing west. See comments under Photo 1.

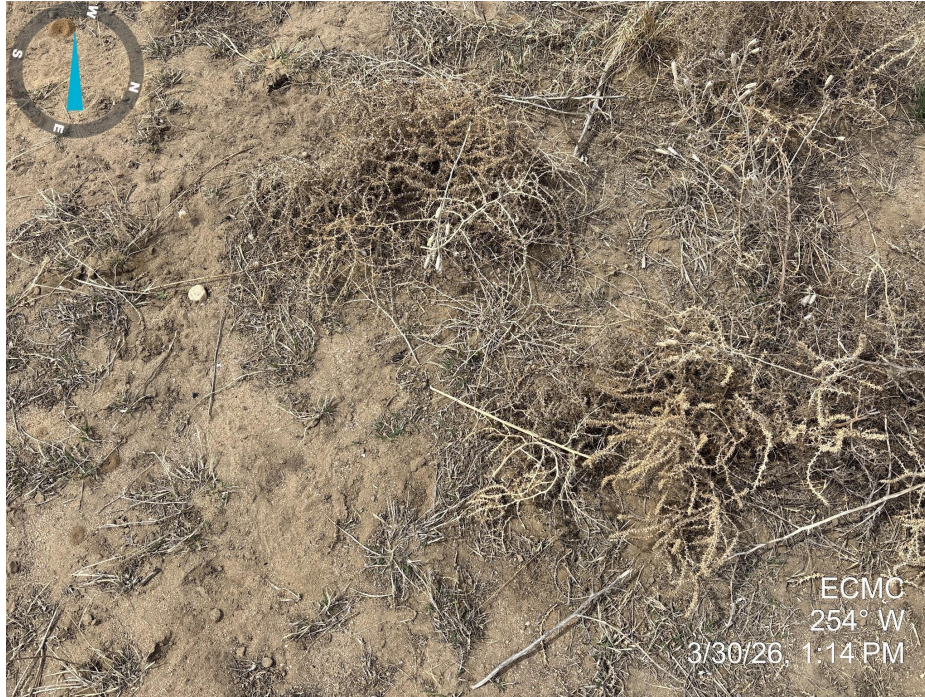
Photo 5. Photo taken of ground cover at the well location. Photo illustrates bare ground, perennial grass, and weedy annual vegetation including russian thistle (*Salsola tragus*).

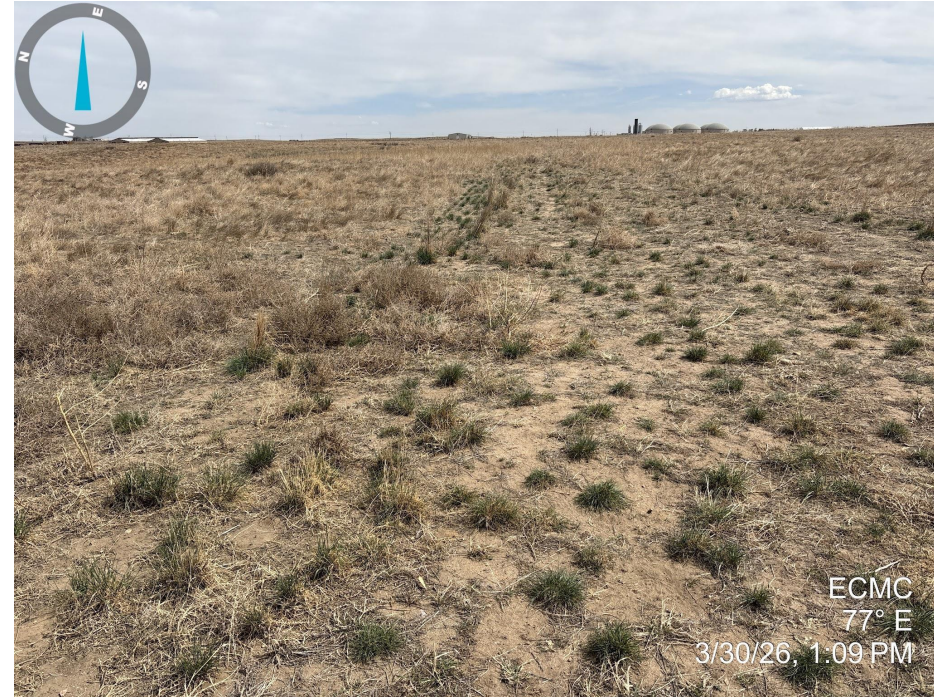
Photo 6. Photo taken of the access road to the well location, facing east. Photo illustrates that reclamation activities appear to have taken place along the road, but vegetation has not established to Rule 1004 standards. Weedy annual vegetation including russian thistle (*Salsola tragus*) was observed.

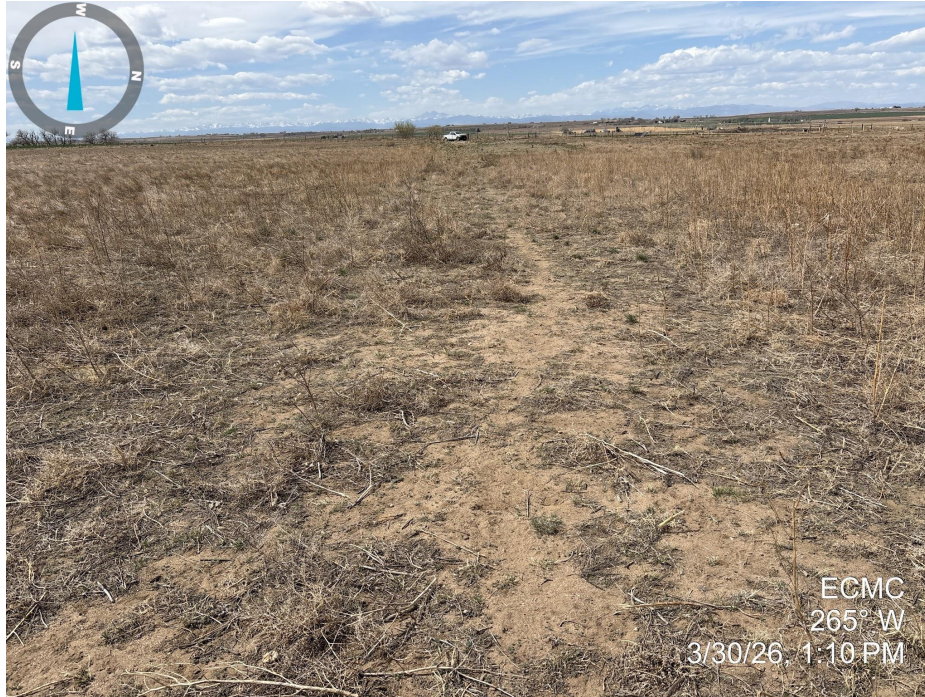
Photo 7. Photo taken of the access road to the well location, facing west, away from the location. See comments under Photo 6.

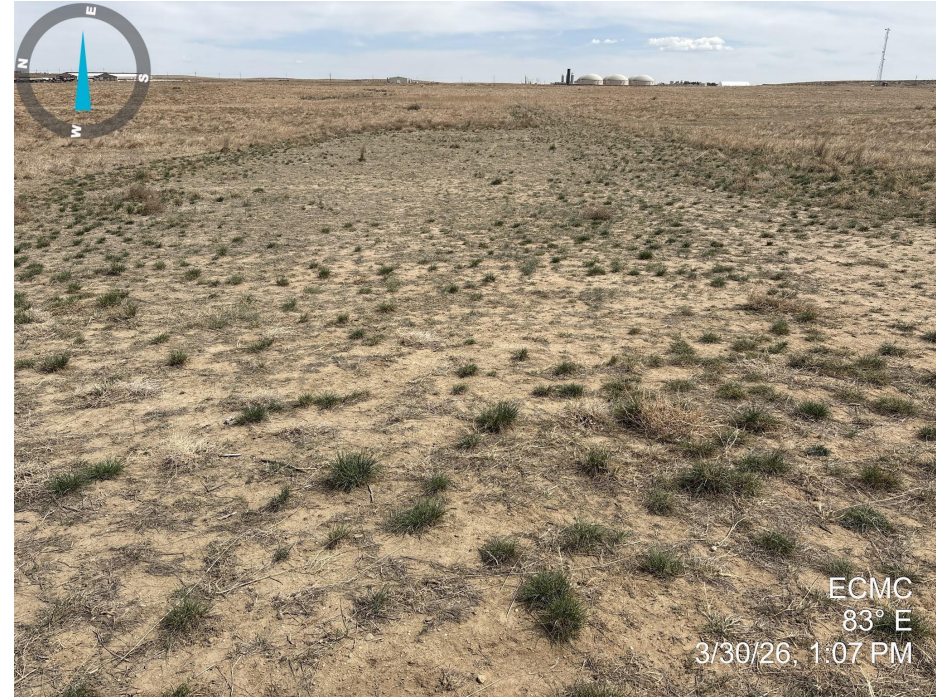
Photo 8. Photo taken of the tank battery location, facing east. Photo illustrates that final reclamation activities have taken place and perennial grass is establishing. However, vegetation establishment does not meet Rule 1004 standards.

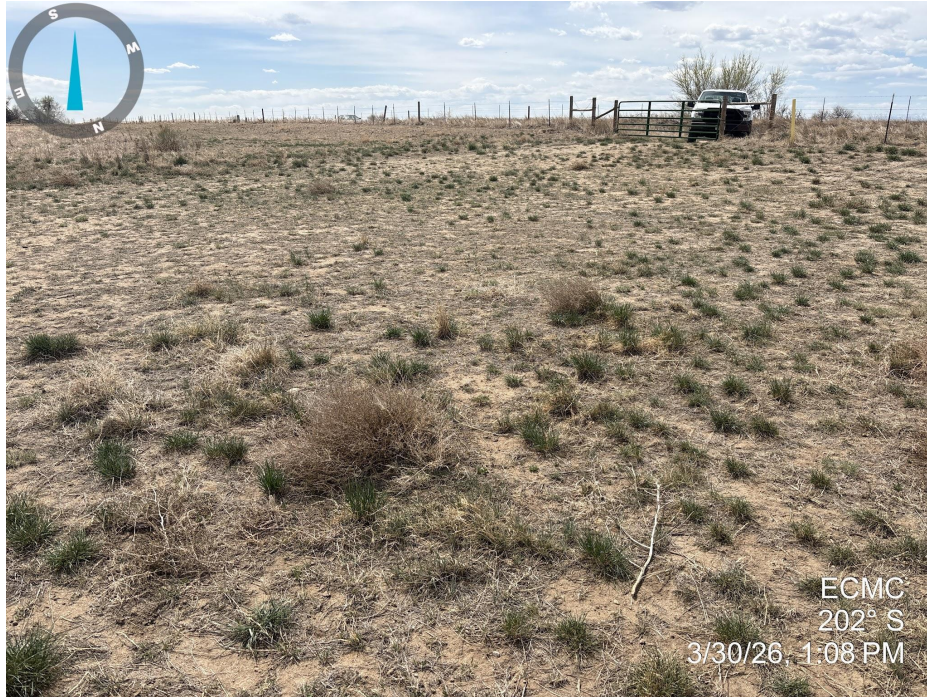
Photo 9. Photo taken of the tank battery location, facing south. See comments under Photo 8.

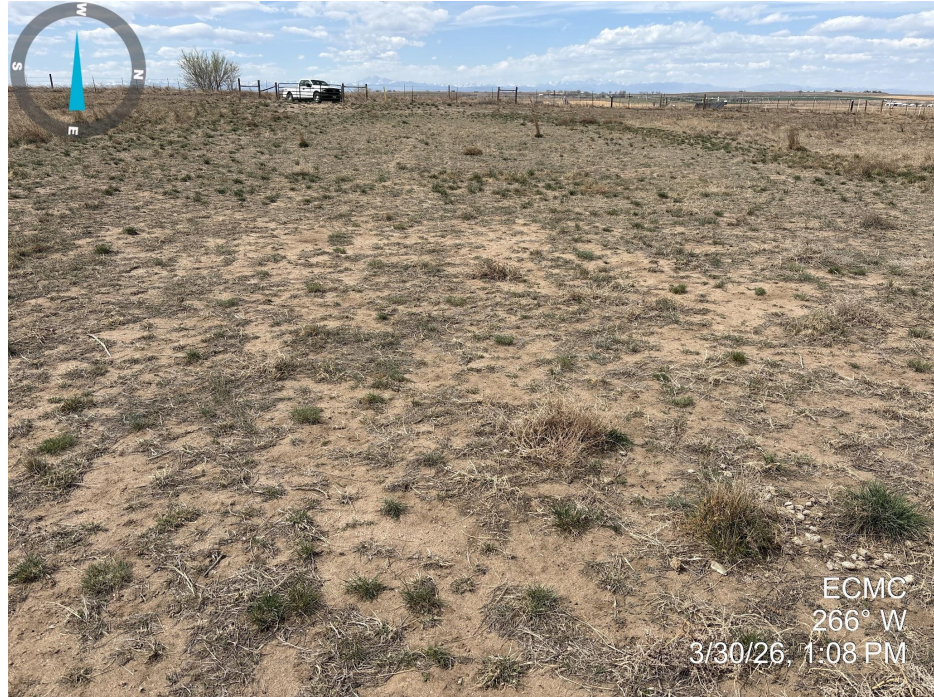
Photo 10. Photo taken of the tank battery location, facing west. See comments under Photo 8.

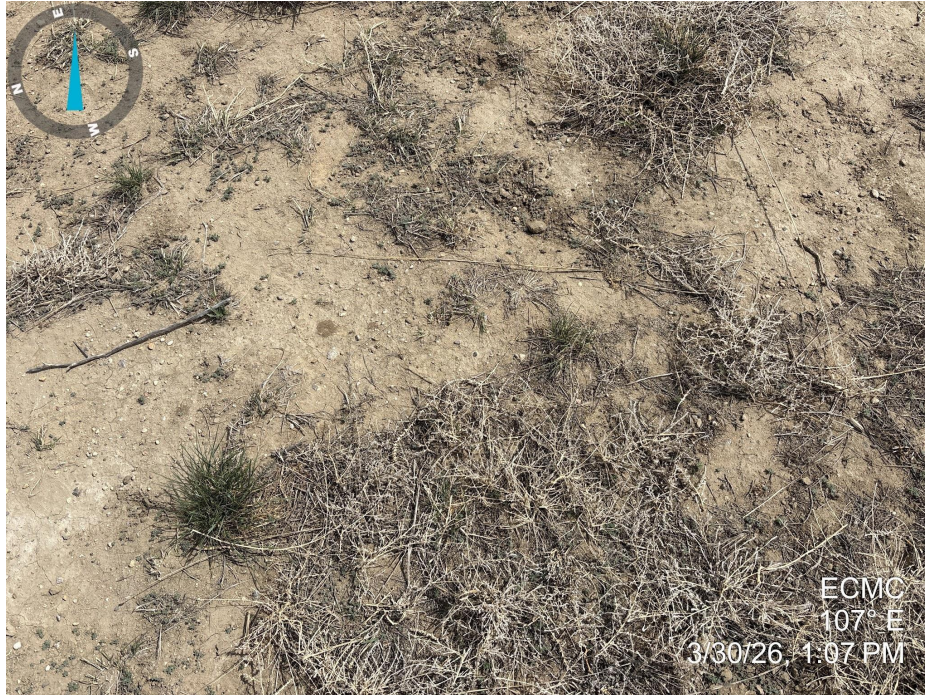
Photo 11. Photo taken of ground cover at the tank battery location. Photo illustrates bare ground, perennial grass, and weedy annual vegetation including kochia (*Bassia scoparia*).

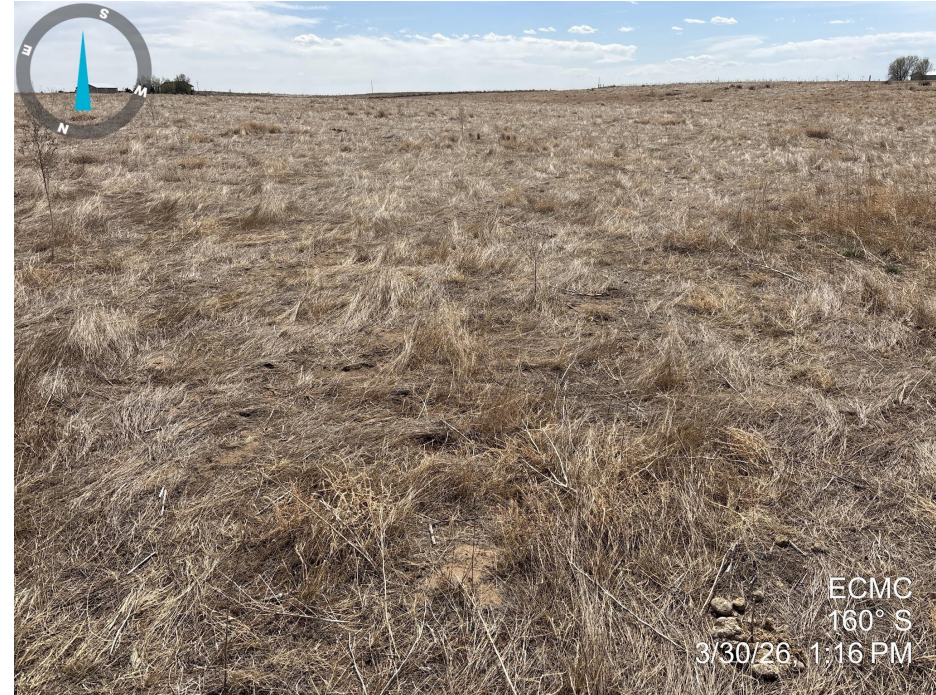
Photo 12. Photo taken of the reference area to the location, south of the well location, facing south. Photo illustrates perennial grass and weedy annual vegetation.
