Final Reclamation Inspection

Operator: NOBLE ENERGY INC - 100322

Location ID: 332373

Inspection Photos
Location Name: OTIS STATE G #36-19
Location ID: 332373

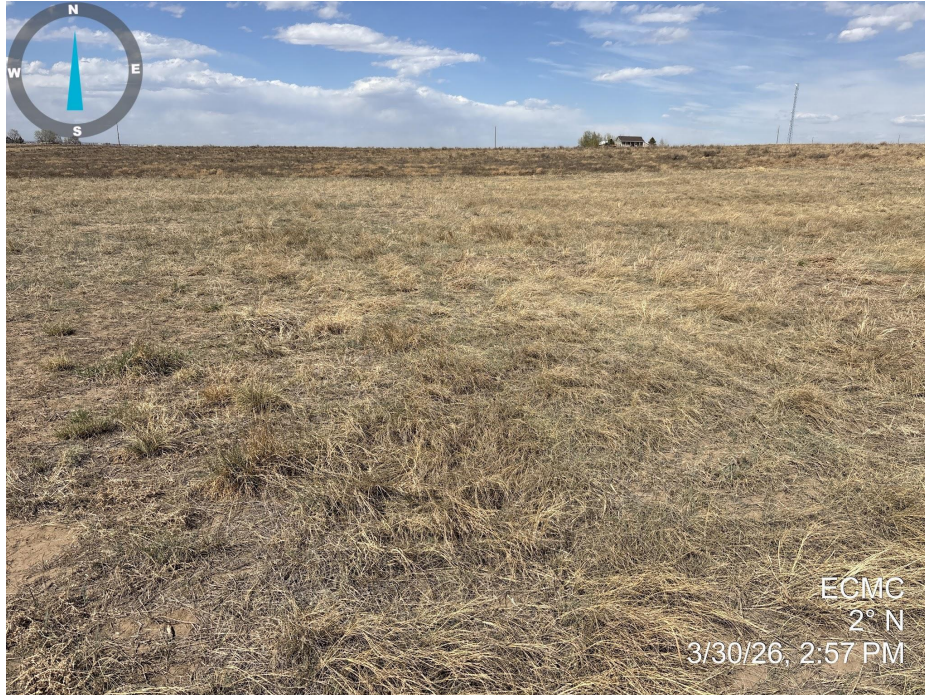
Photo 1. Photo taken of the well location, facing north. Photo illustrates that final reclamation activities appear to have taken place and perennial vegetation is establishing at the location. However, vegetation establishment does not meet Rule 1004 standards.

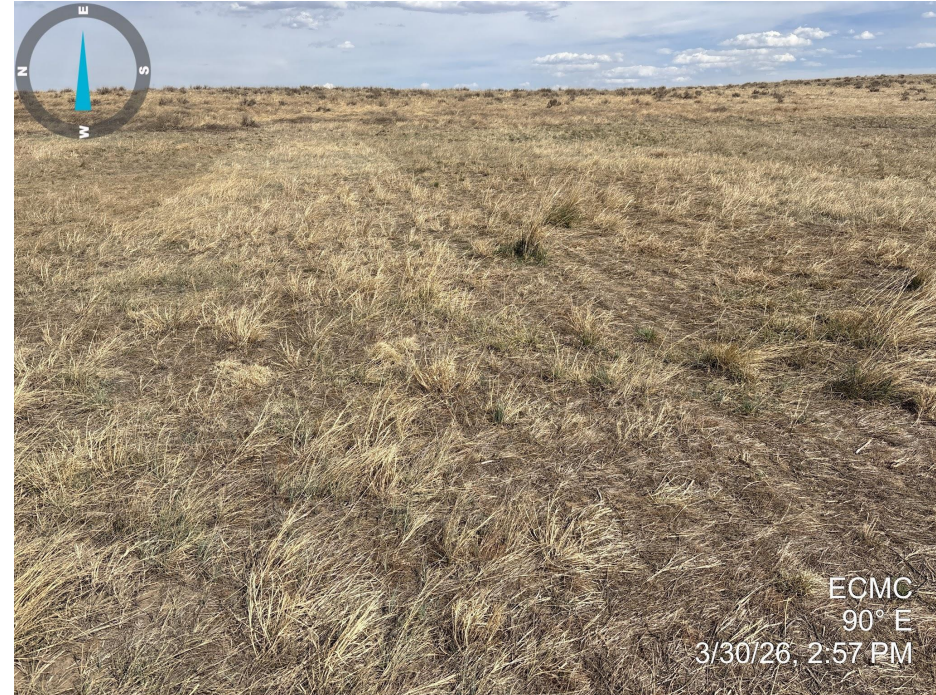
Photo 2. Photo taken of the well location, facing east. See comments under Photo 1.

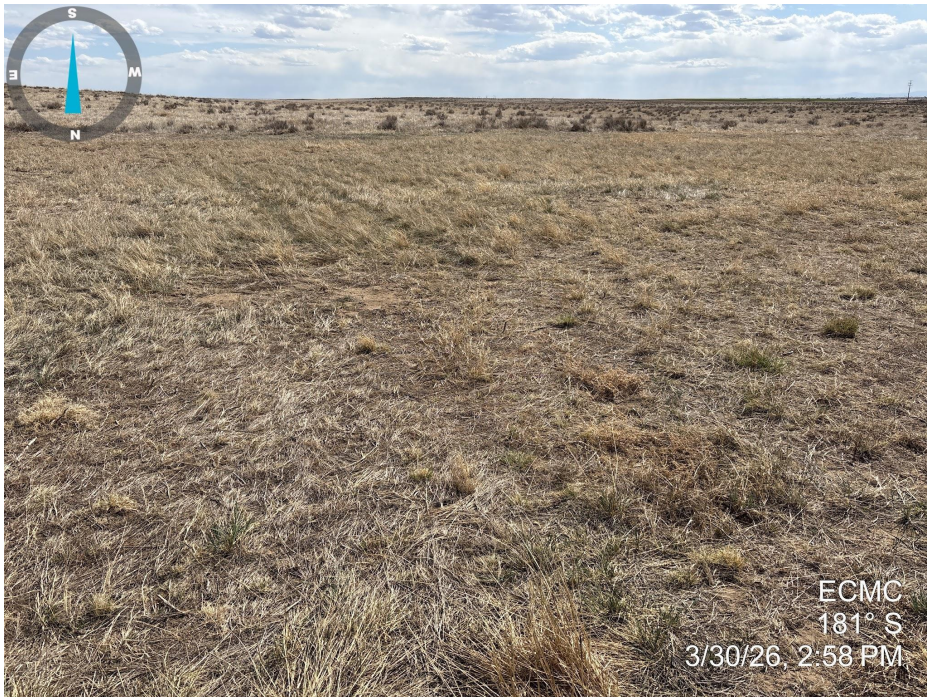
Photo 3. Photo taken of the well location, facing south. See comments under Photo 1.

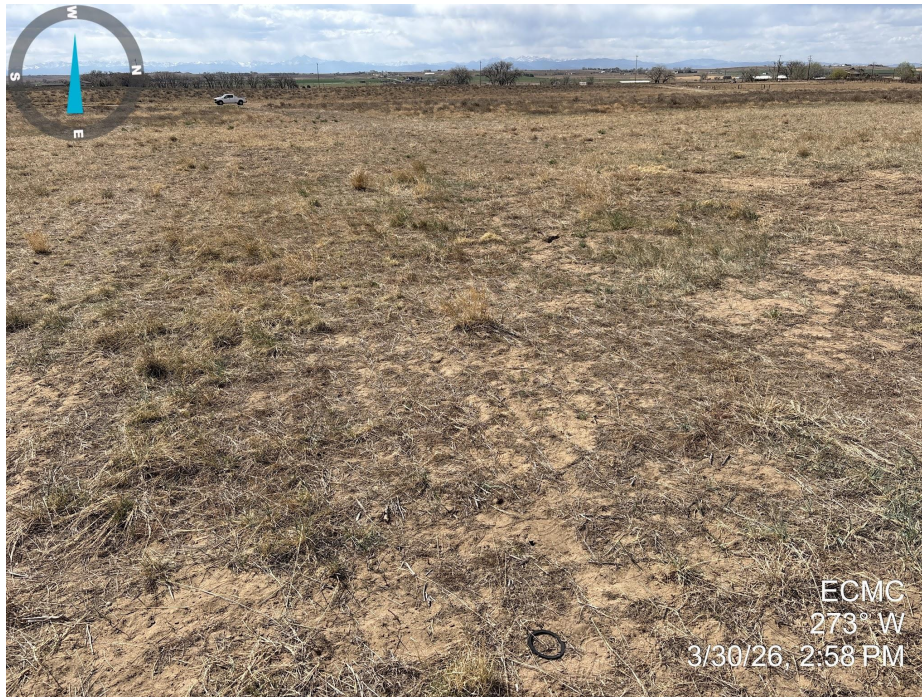
Photo 4. Photo taken of the well location, facing west. See comments under Photo 1.

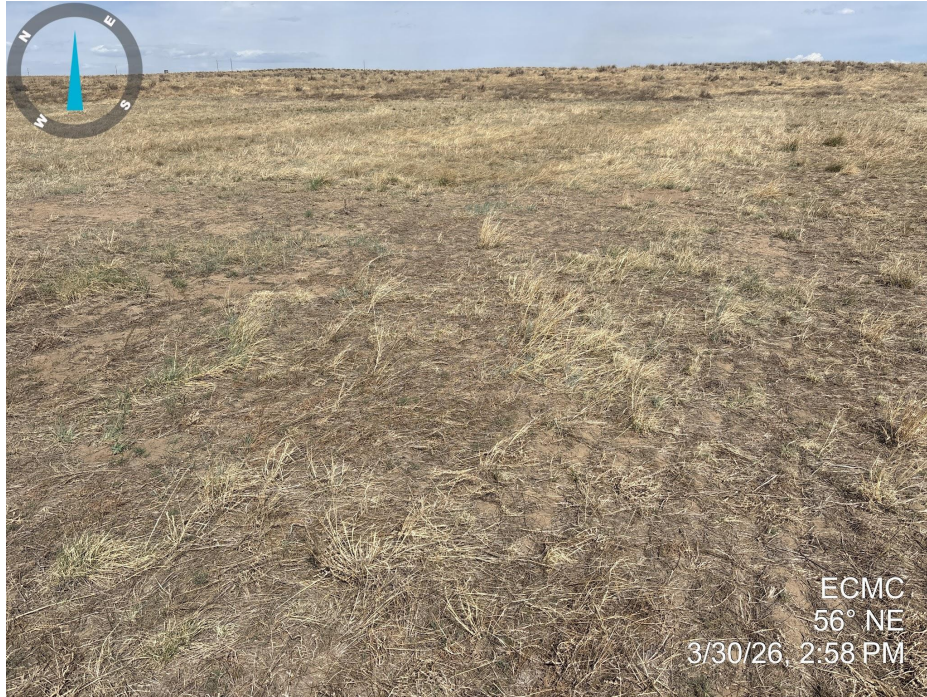
Photo 5. Photo taken of the well location, facing northeast. See comments under Photo 1.

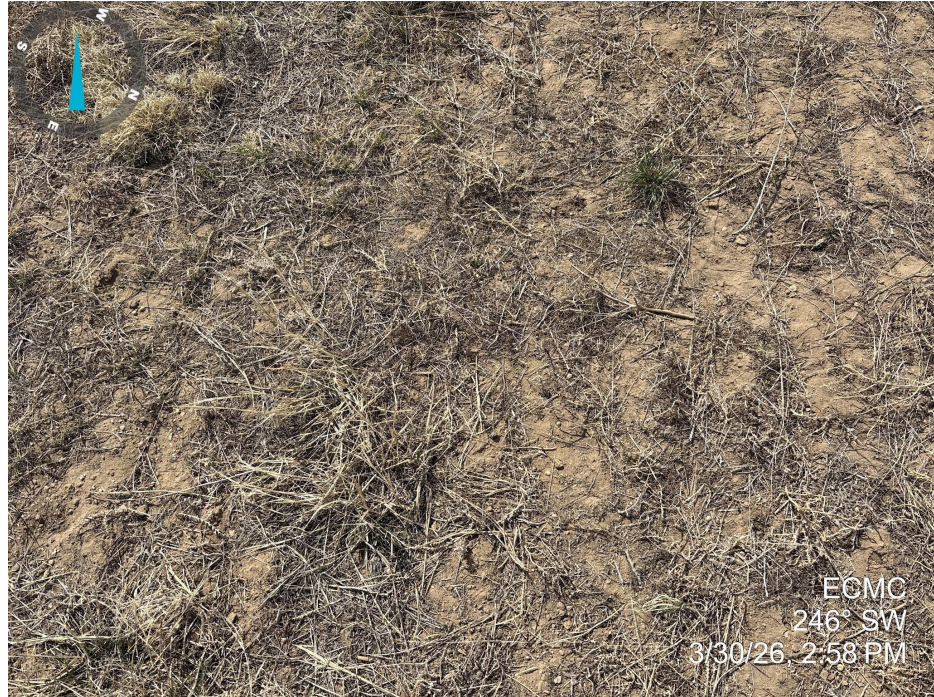
Photo 6. Photo taken of ground cover at the well location. Photo illustrates bare ground, perennial grass, and evidence of drill rows from seeding.

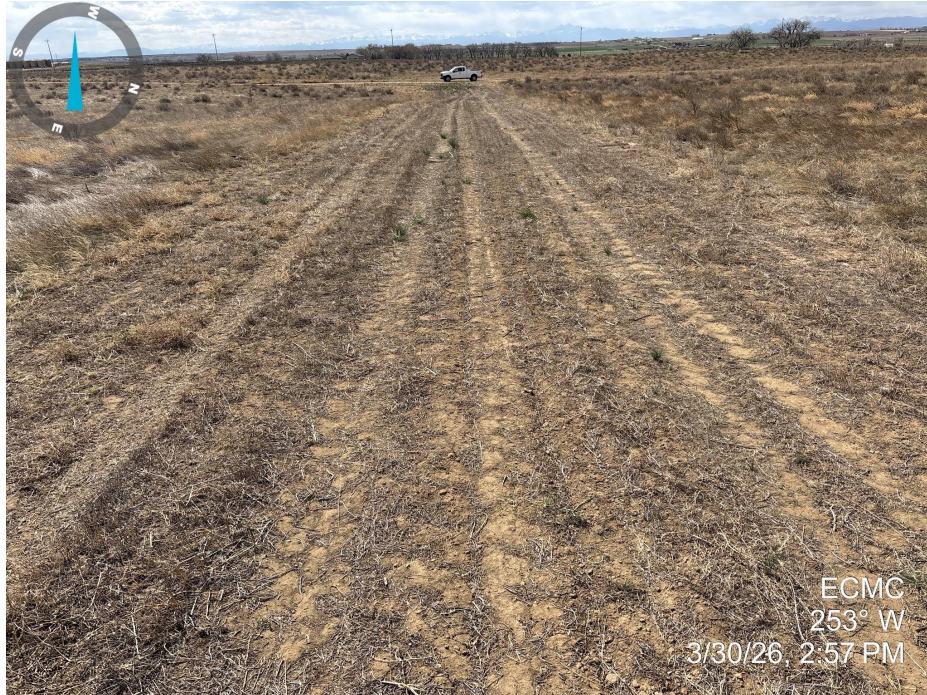
Photo 7. Photo taken of the access road to the well location, facing west. Photo illustrates that final reclamation activities appear to have taken place along the road, but vegetation has not established to Rule 1004 standards.

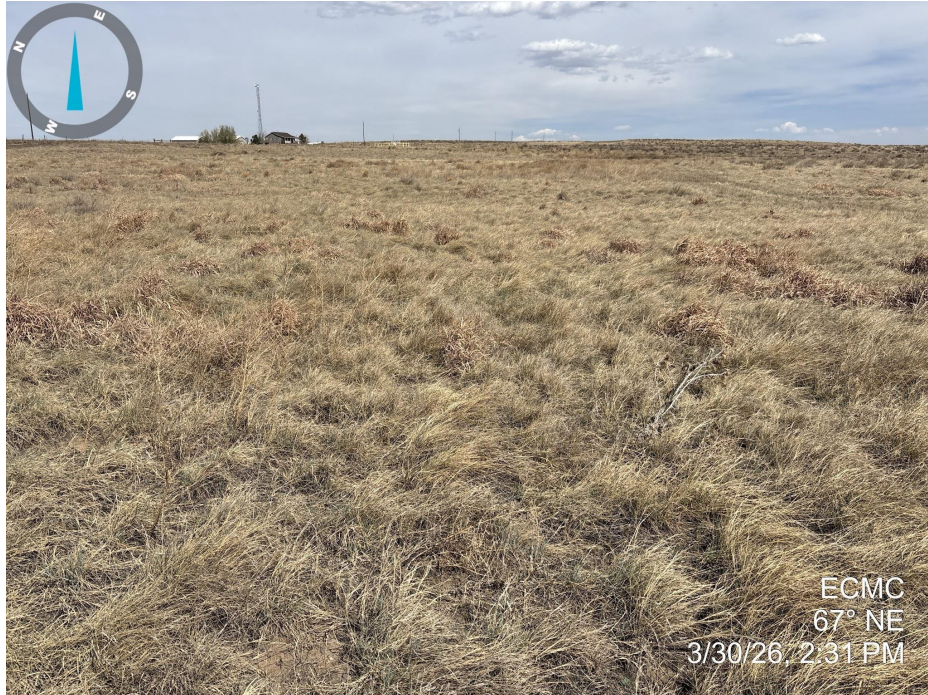
Photo 8. Photo taken of the reference area to the location, facing northeast. Photo illustrates perennial grass vegetation.
