# Inspection Photos

Operator: GRMR Oil and Gas LLC #10524

Location ID: 312930

Inspection Doc: 719201007

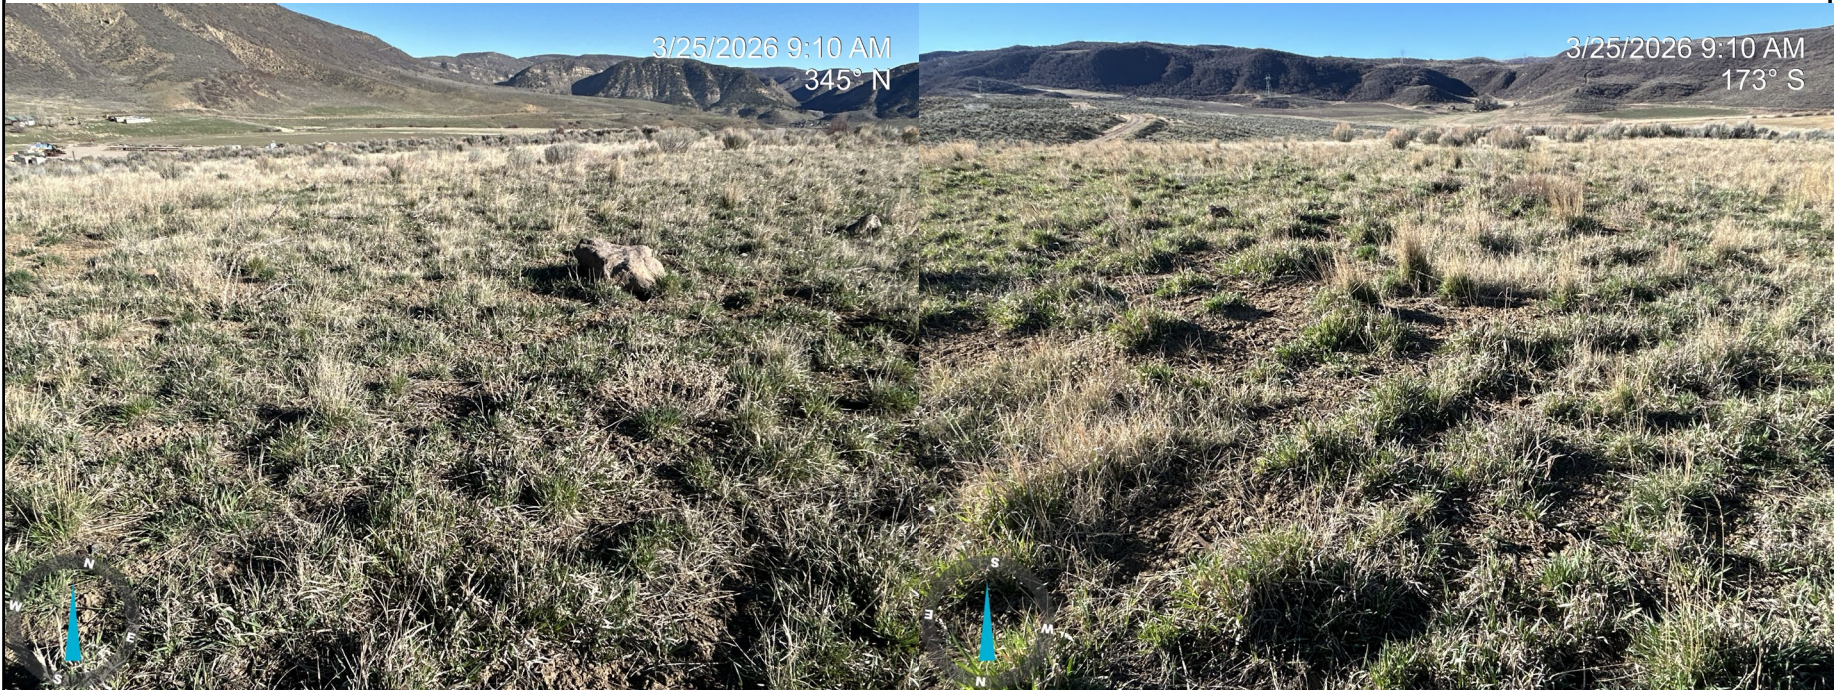
**Photo 1:** Photos showing an overview of the location looking north and south, respectively. Desirable, perennial and uniform vegetation is present.

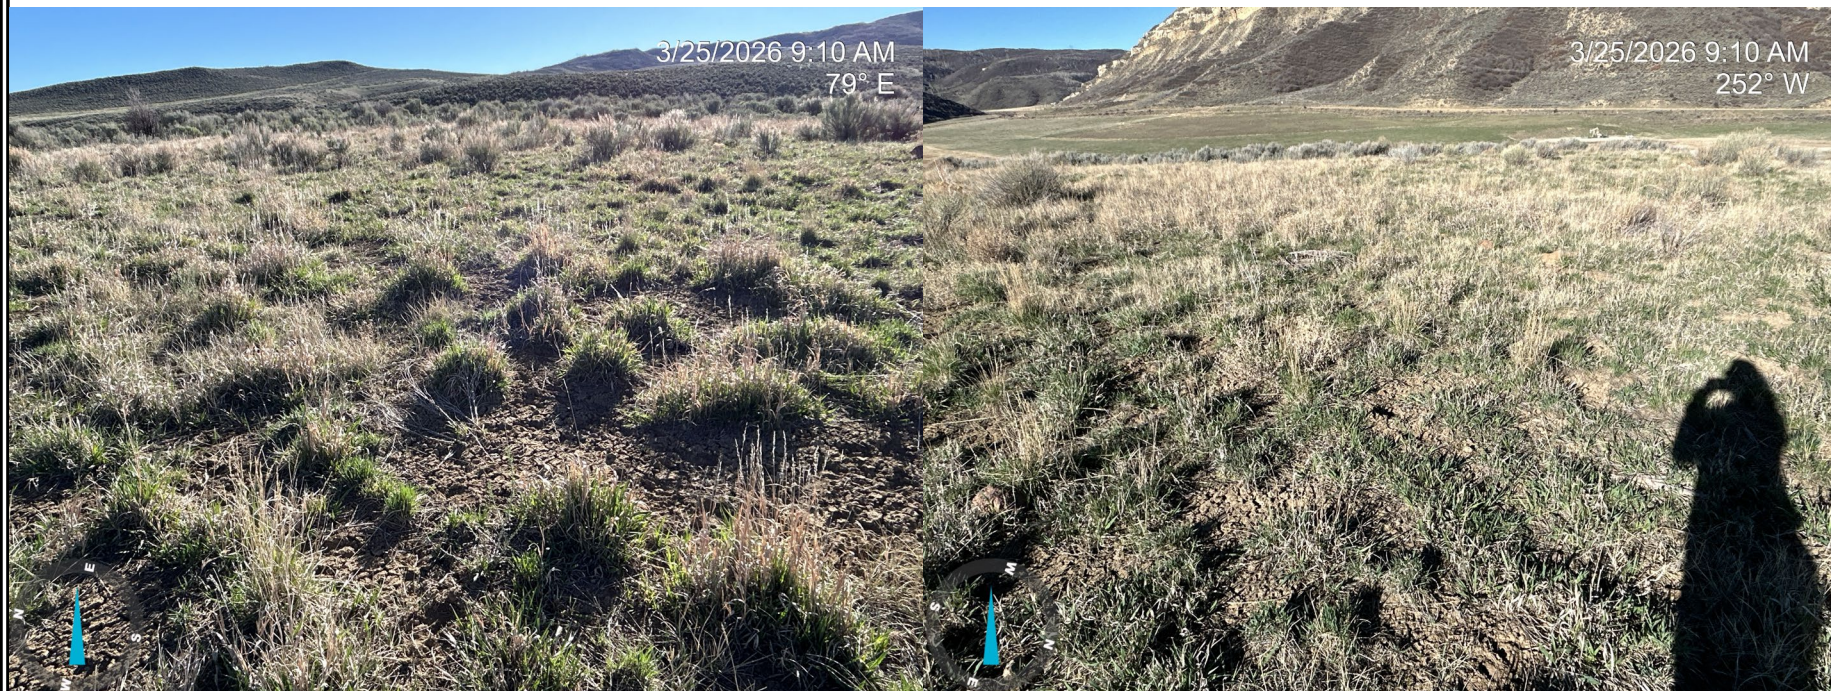
**Photo 2:** Photos showing an overview of the location looking east and west, respectively. Desirable, perennial and uniform vegetation is present.

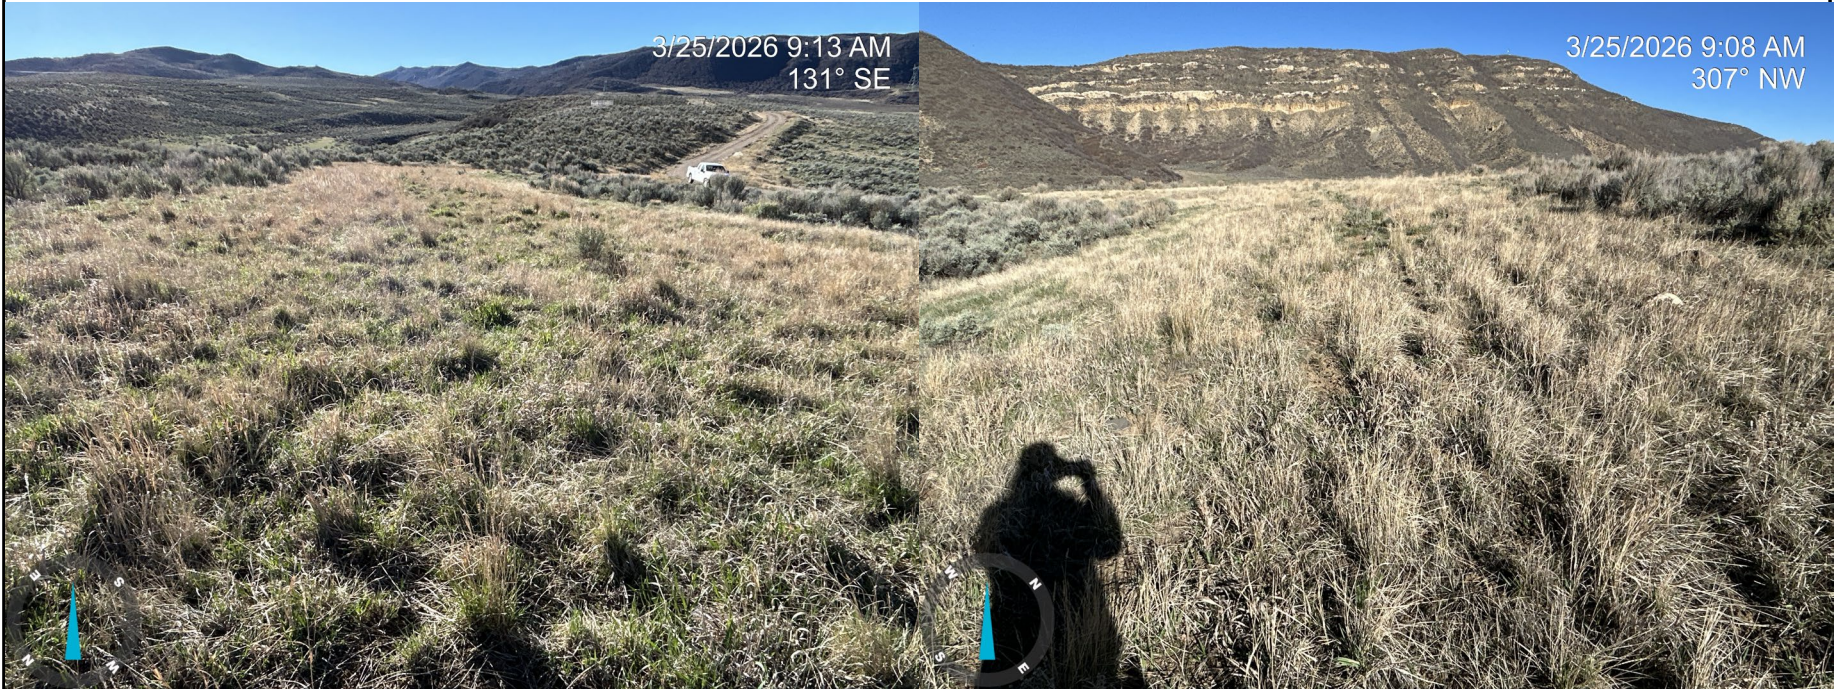
**Photo 3:** Photos showing the southern access road leading to the location has been reclaimed.

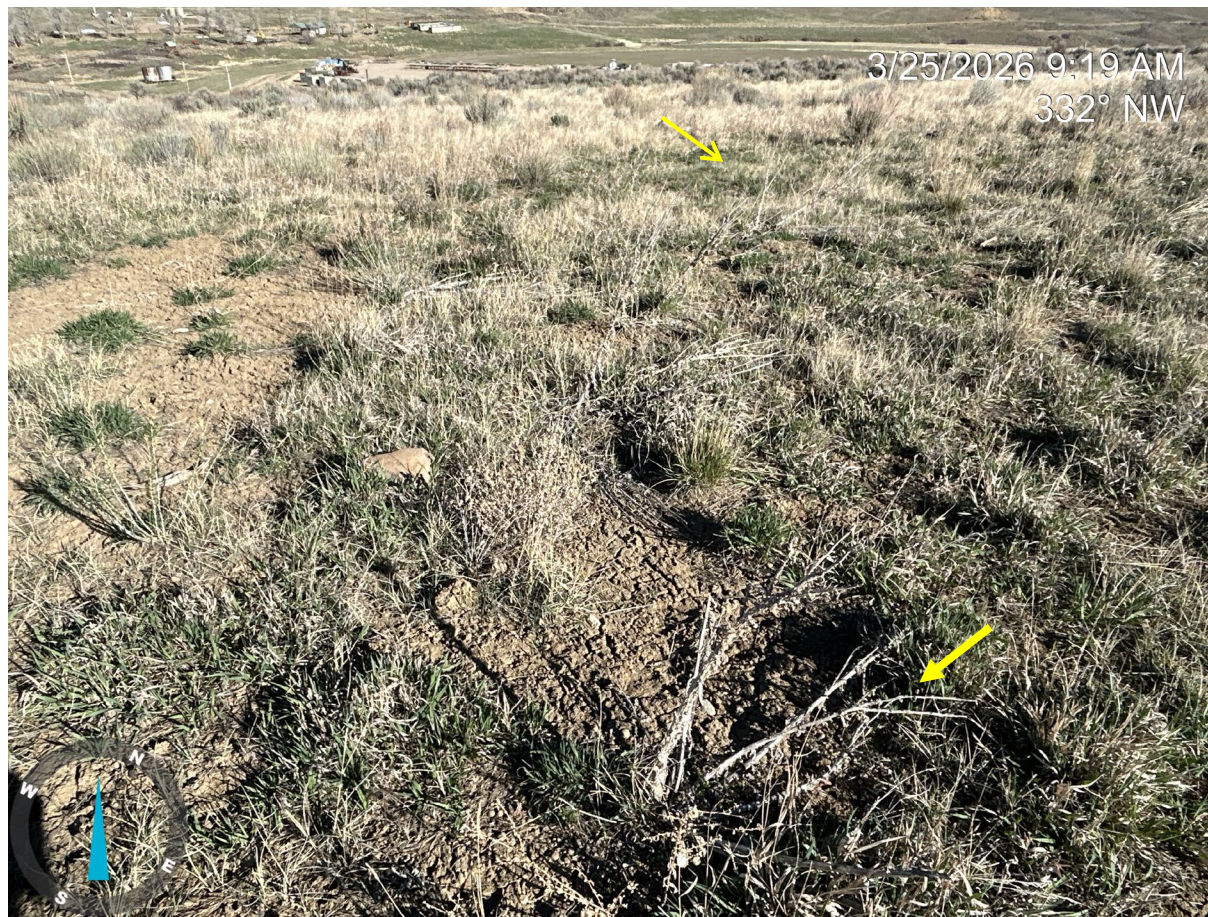
**Photo 4:** Photo showing a small patch of Canada thistle, a List B noxious weed, is present at the northwestern end of the location. Weed management is required before the location receives a passing final reclamation inspection.

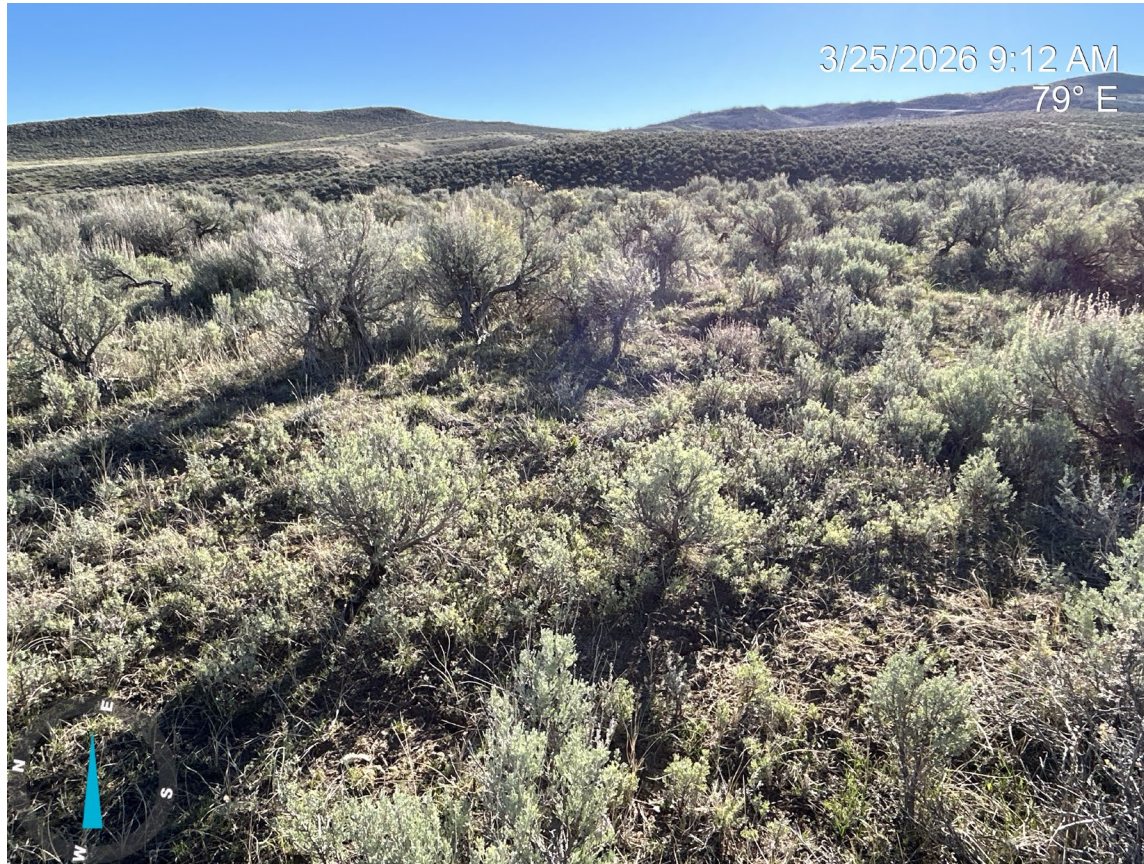
**Photo 5:** Photos showing the nearby eastern reference area is characterized as a big sagebrush shrubland.
