Spill/Release (Form 19): Site
Documentation and Analytical
Laboratory Results

Critter Creek 16" LACT Unit Spill/Release

Incident Date: January 17, 2026

Operator: Summit Midstream

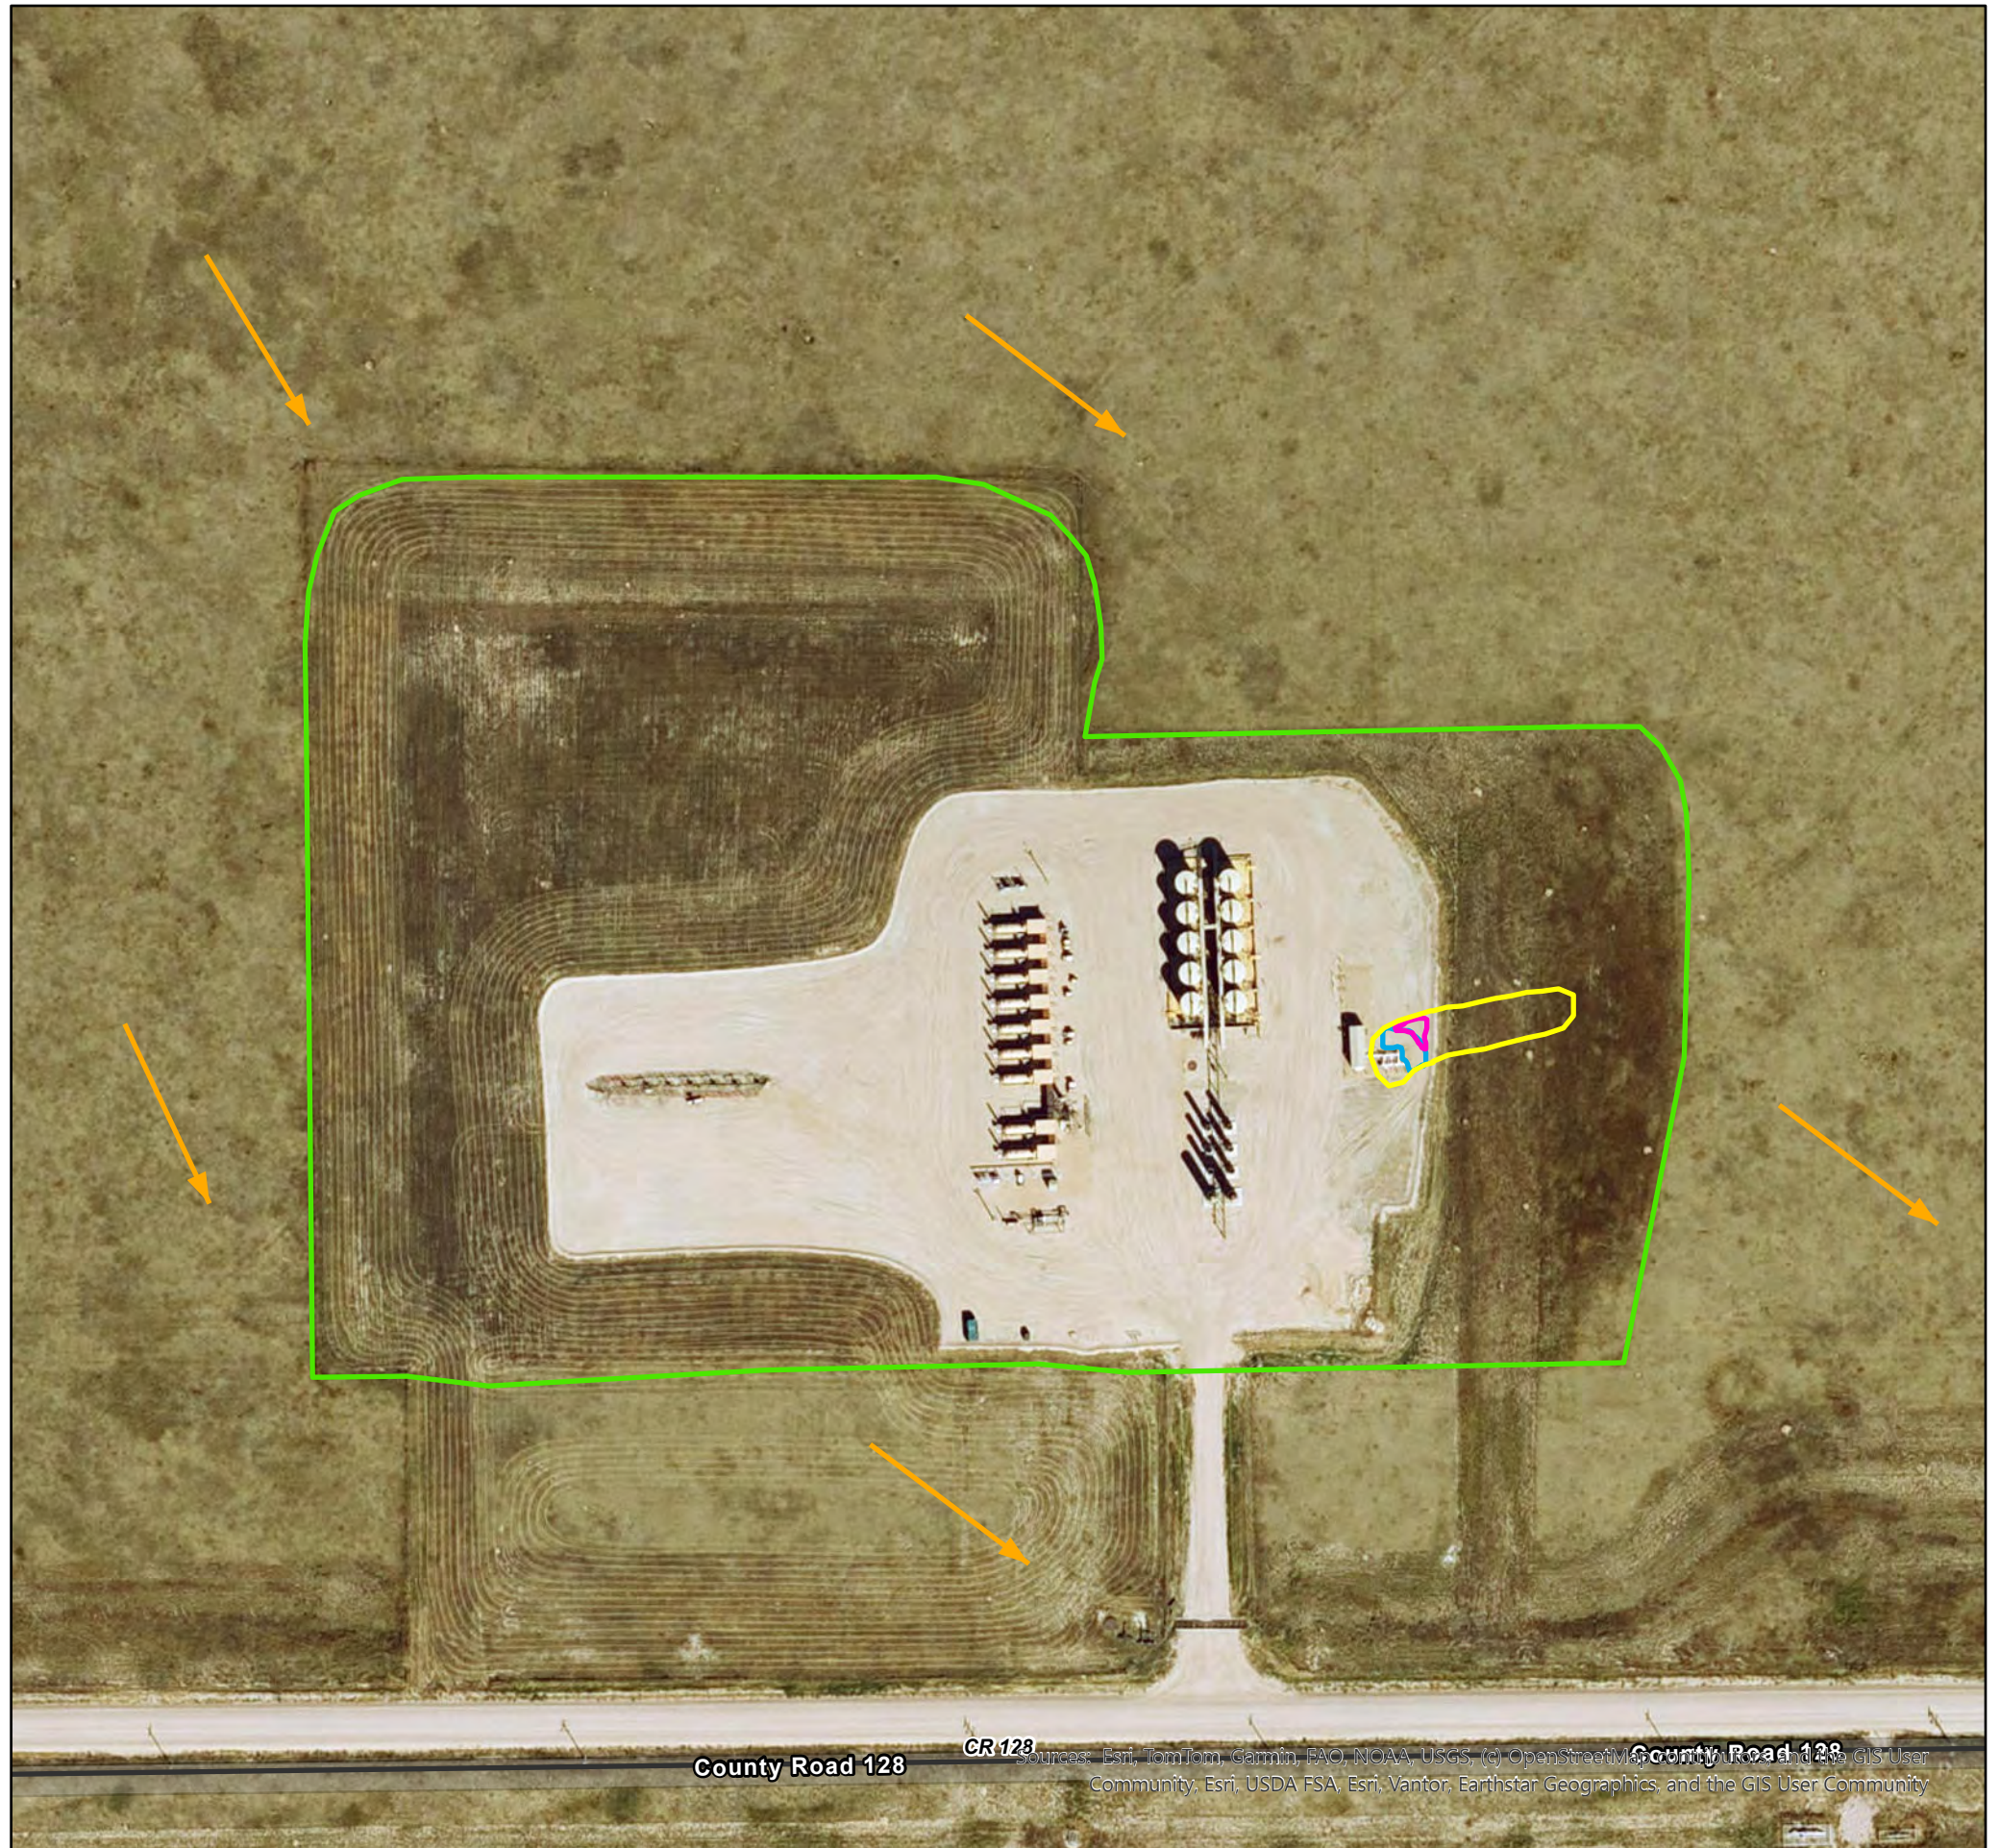
Excavation Area Map

- Flow
- ▭ Pad Disturbance Boundary
- ▭ 2" Excavation Area
- ▭ 6" Excavation Area
- ▭ 12" Excavation Area
- Weld Local

On February 18, 2026, H2E directed a targeted excavation at the spill location to further assess and remediate potentially impacted soil at the Critter Creek 16" LACT Unit (40.916346, -104.430332). During excavation, soil was screened using a photoionization detector (PID) to evaluate the presence of volatile organic compounds (VOCs) and to delineate the horizontal and vertical extent of any potential impacts. Excavation continued until PID readings indicated that VOCs were no longer detectable.

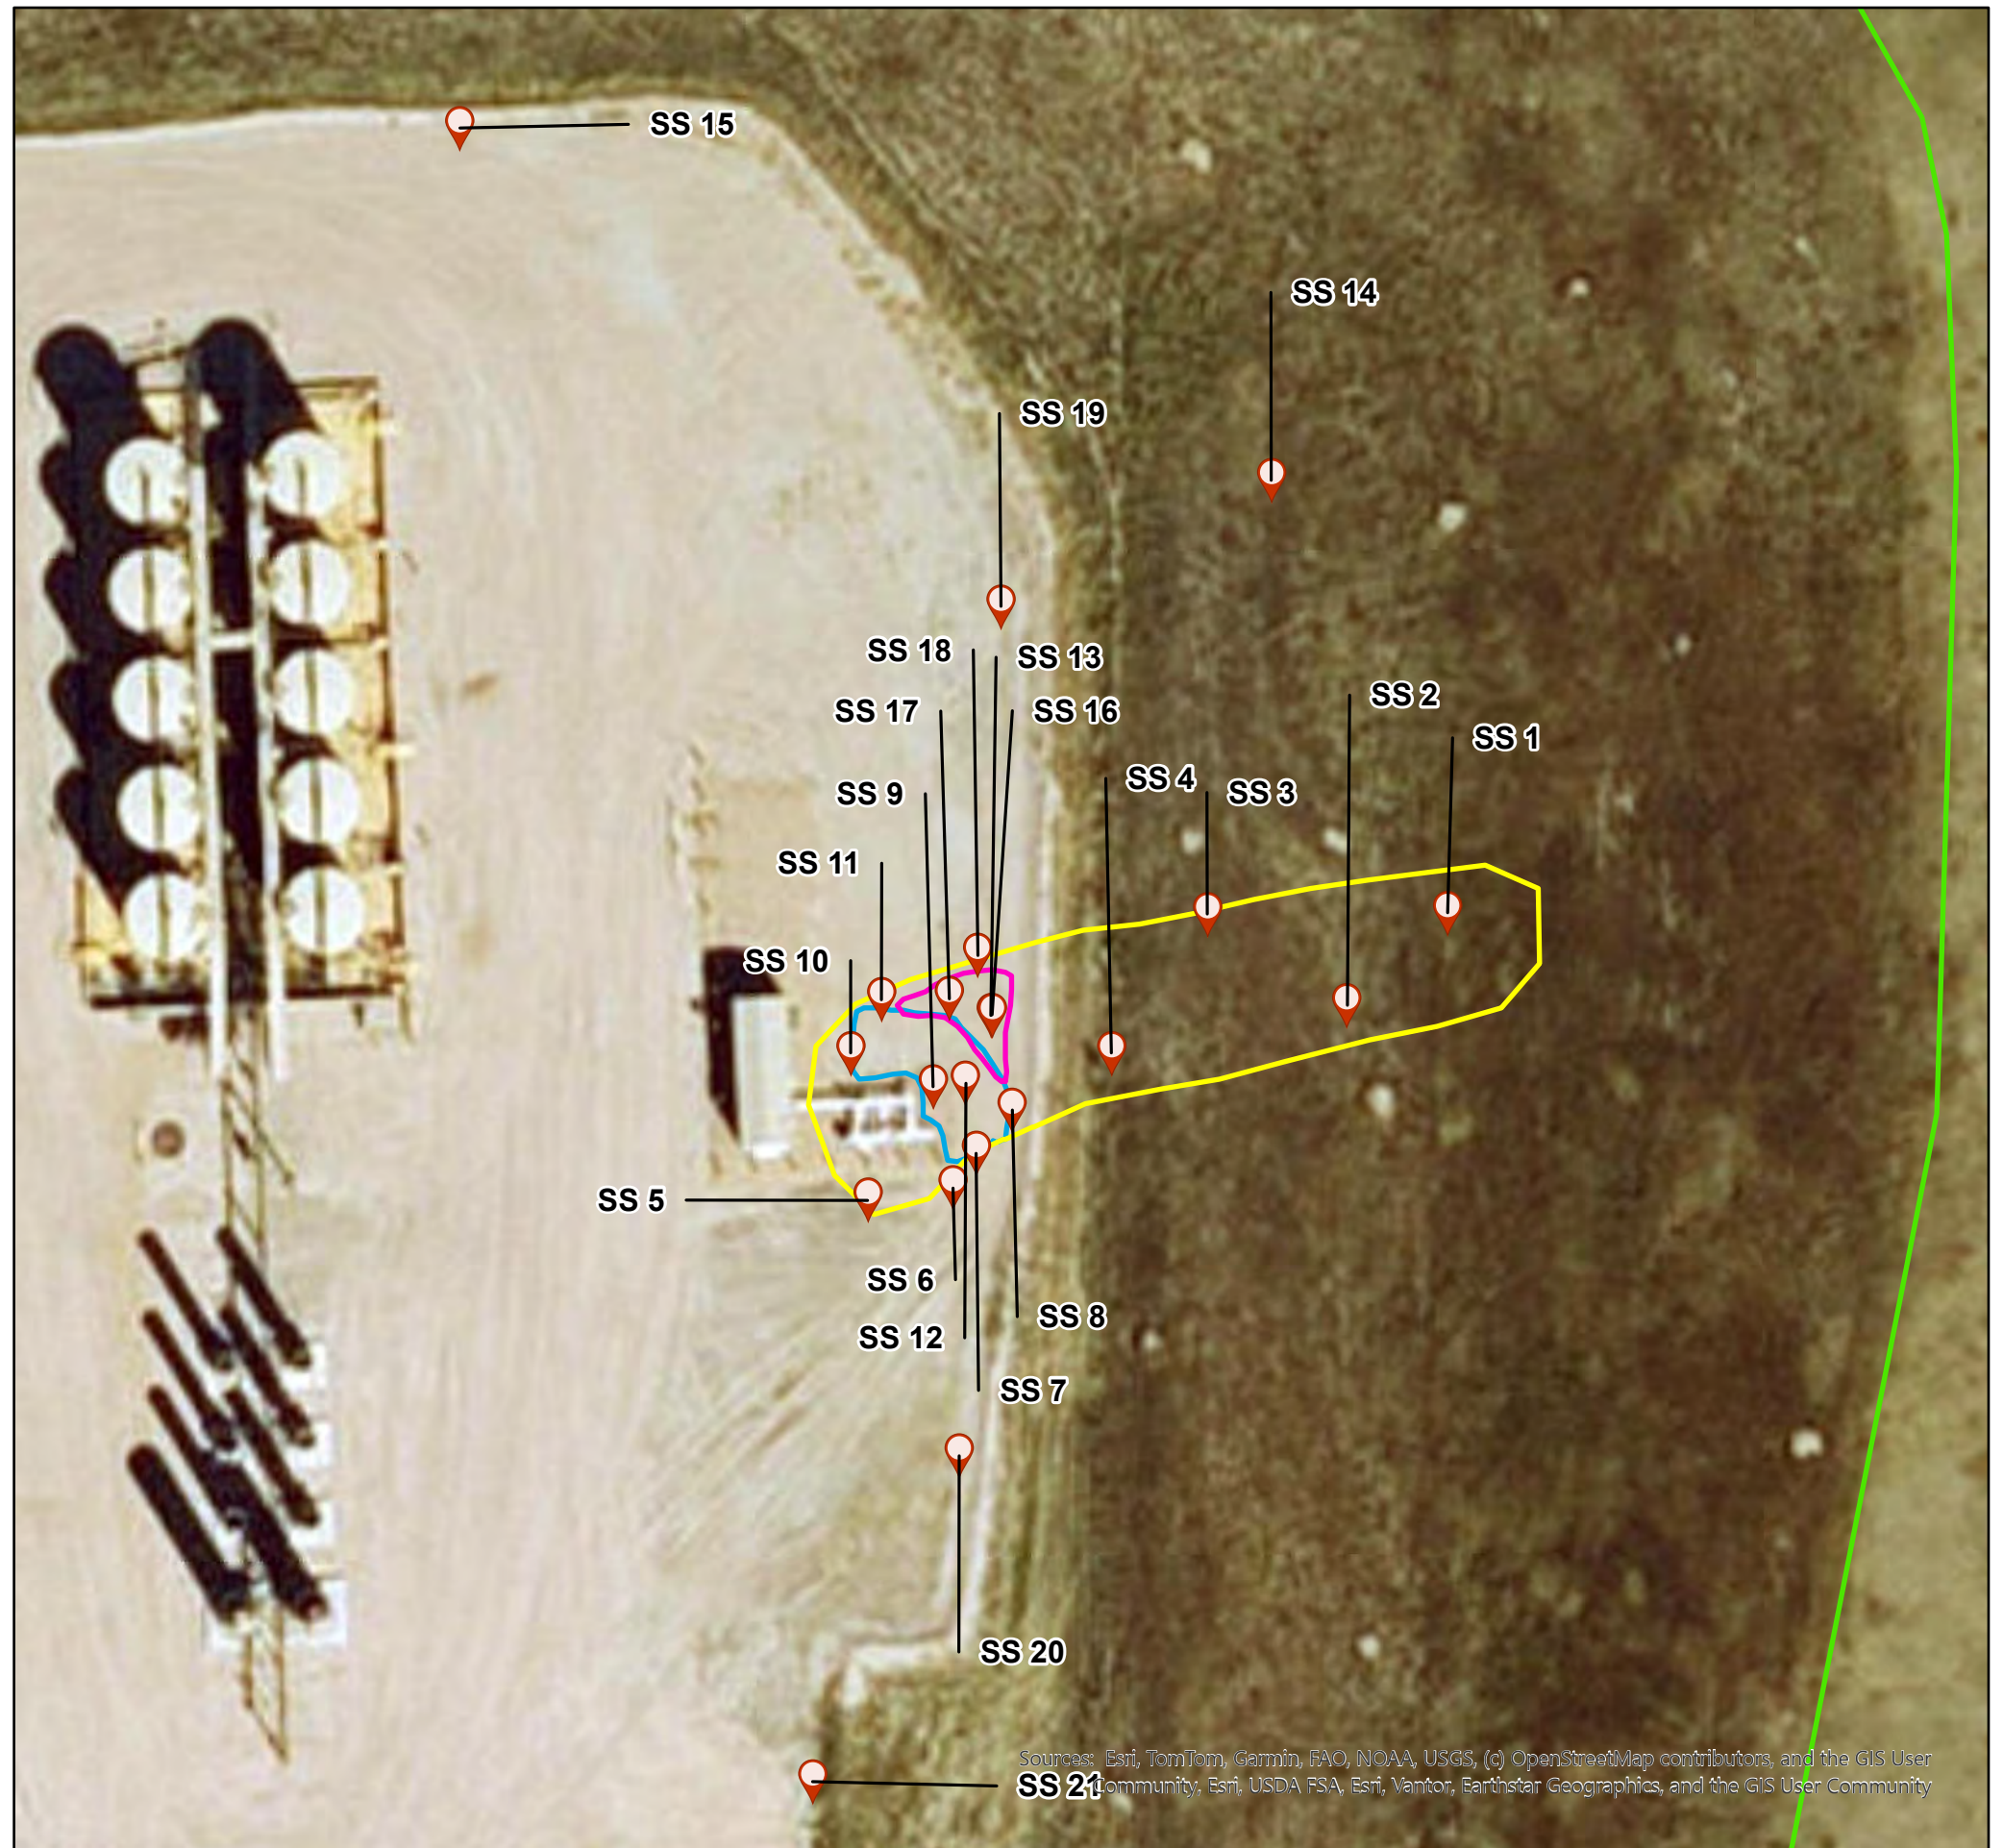
Excavation Area Map

- Soil Sample Location
- Pad Disturbance Boundary
- 2" Excavation Area
- 6" Excavation Area
- 12" Excavation Area

During the investigation, no visible soil staining was observed, and no petroleum-related odors were identified. Once excavation limits were reached based on PID screening results, soil samples were collected to support site characterization and submitted for laboratory analysis.

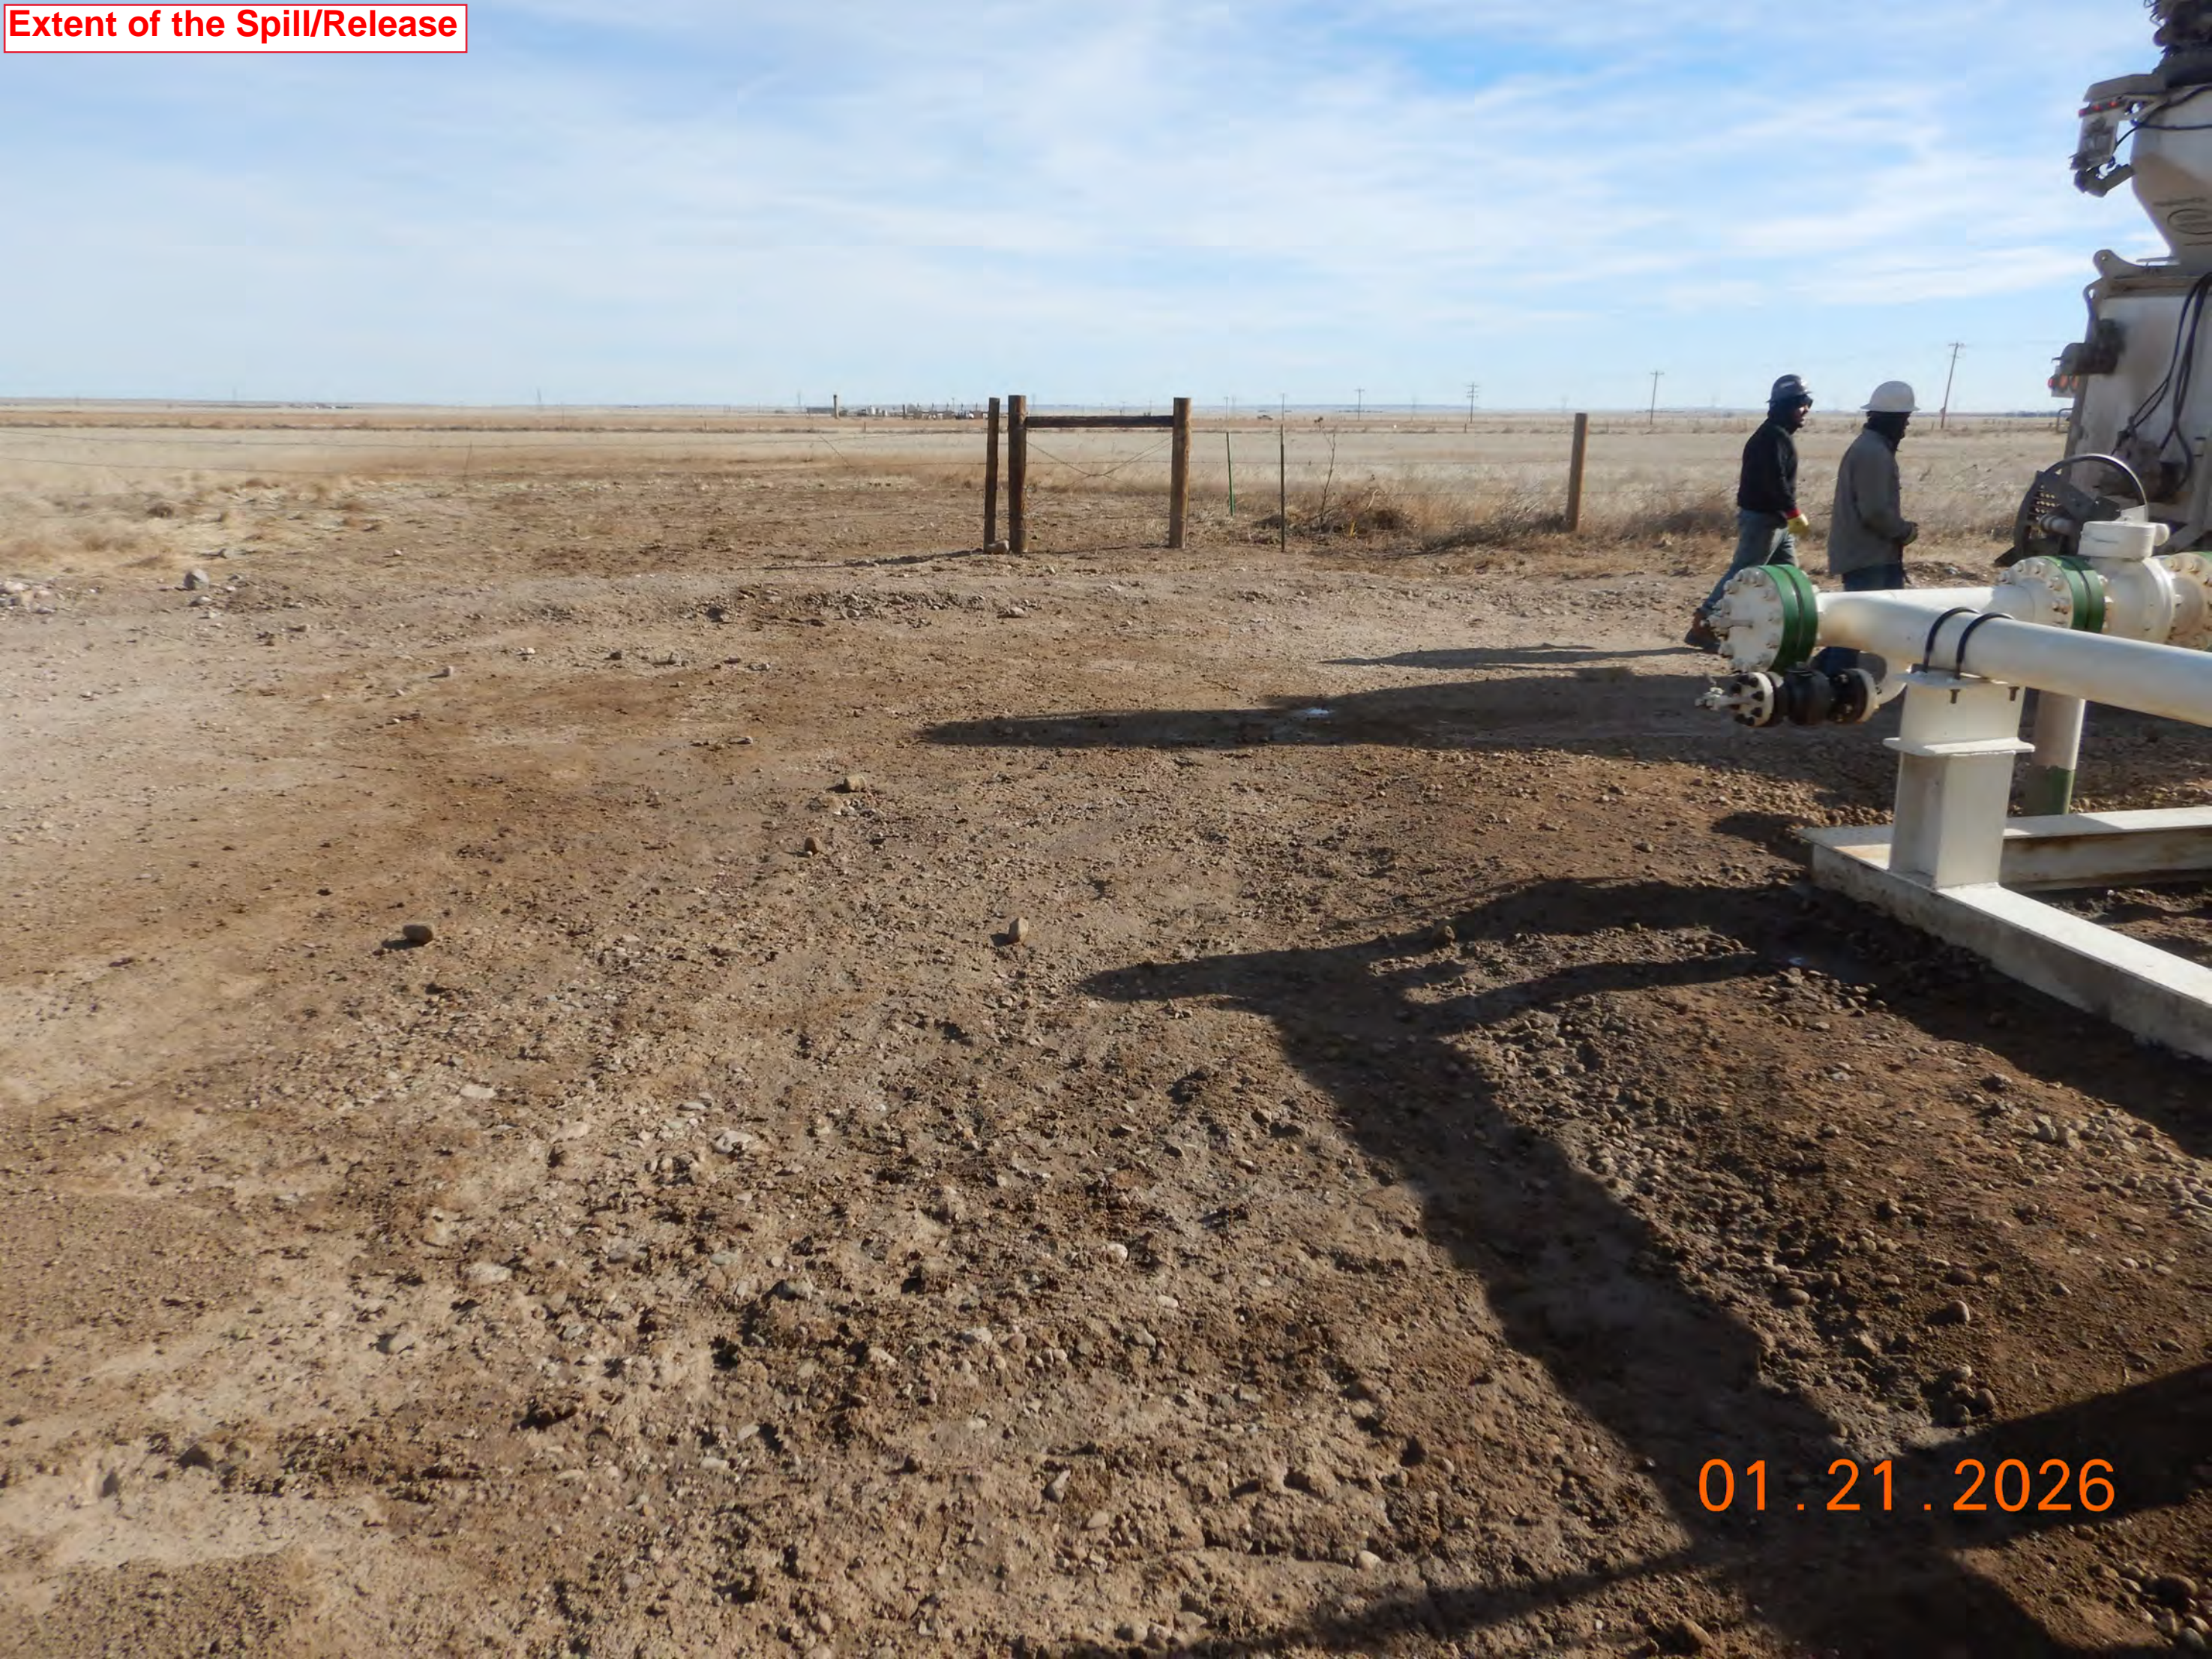
01.21.2026

On January 17, 2026, a release was discovered at the Critter Creek 16" LACT Unit as a result of a cracked ¾-inch nipple that allowed product to spray onto the surrounding ground surface. Upon discovery, immediate response actions were implemented. The LACT unit was shut down, isolated, and shut in to prevent any additional product from being released. Initial cleanup activities included the use of a vacuum truck to recover liquid products present on the ground surface prior to infiltration into underlying soils.

Source of Spill/Release
3/4" Nipple on LACT Unit 2

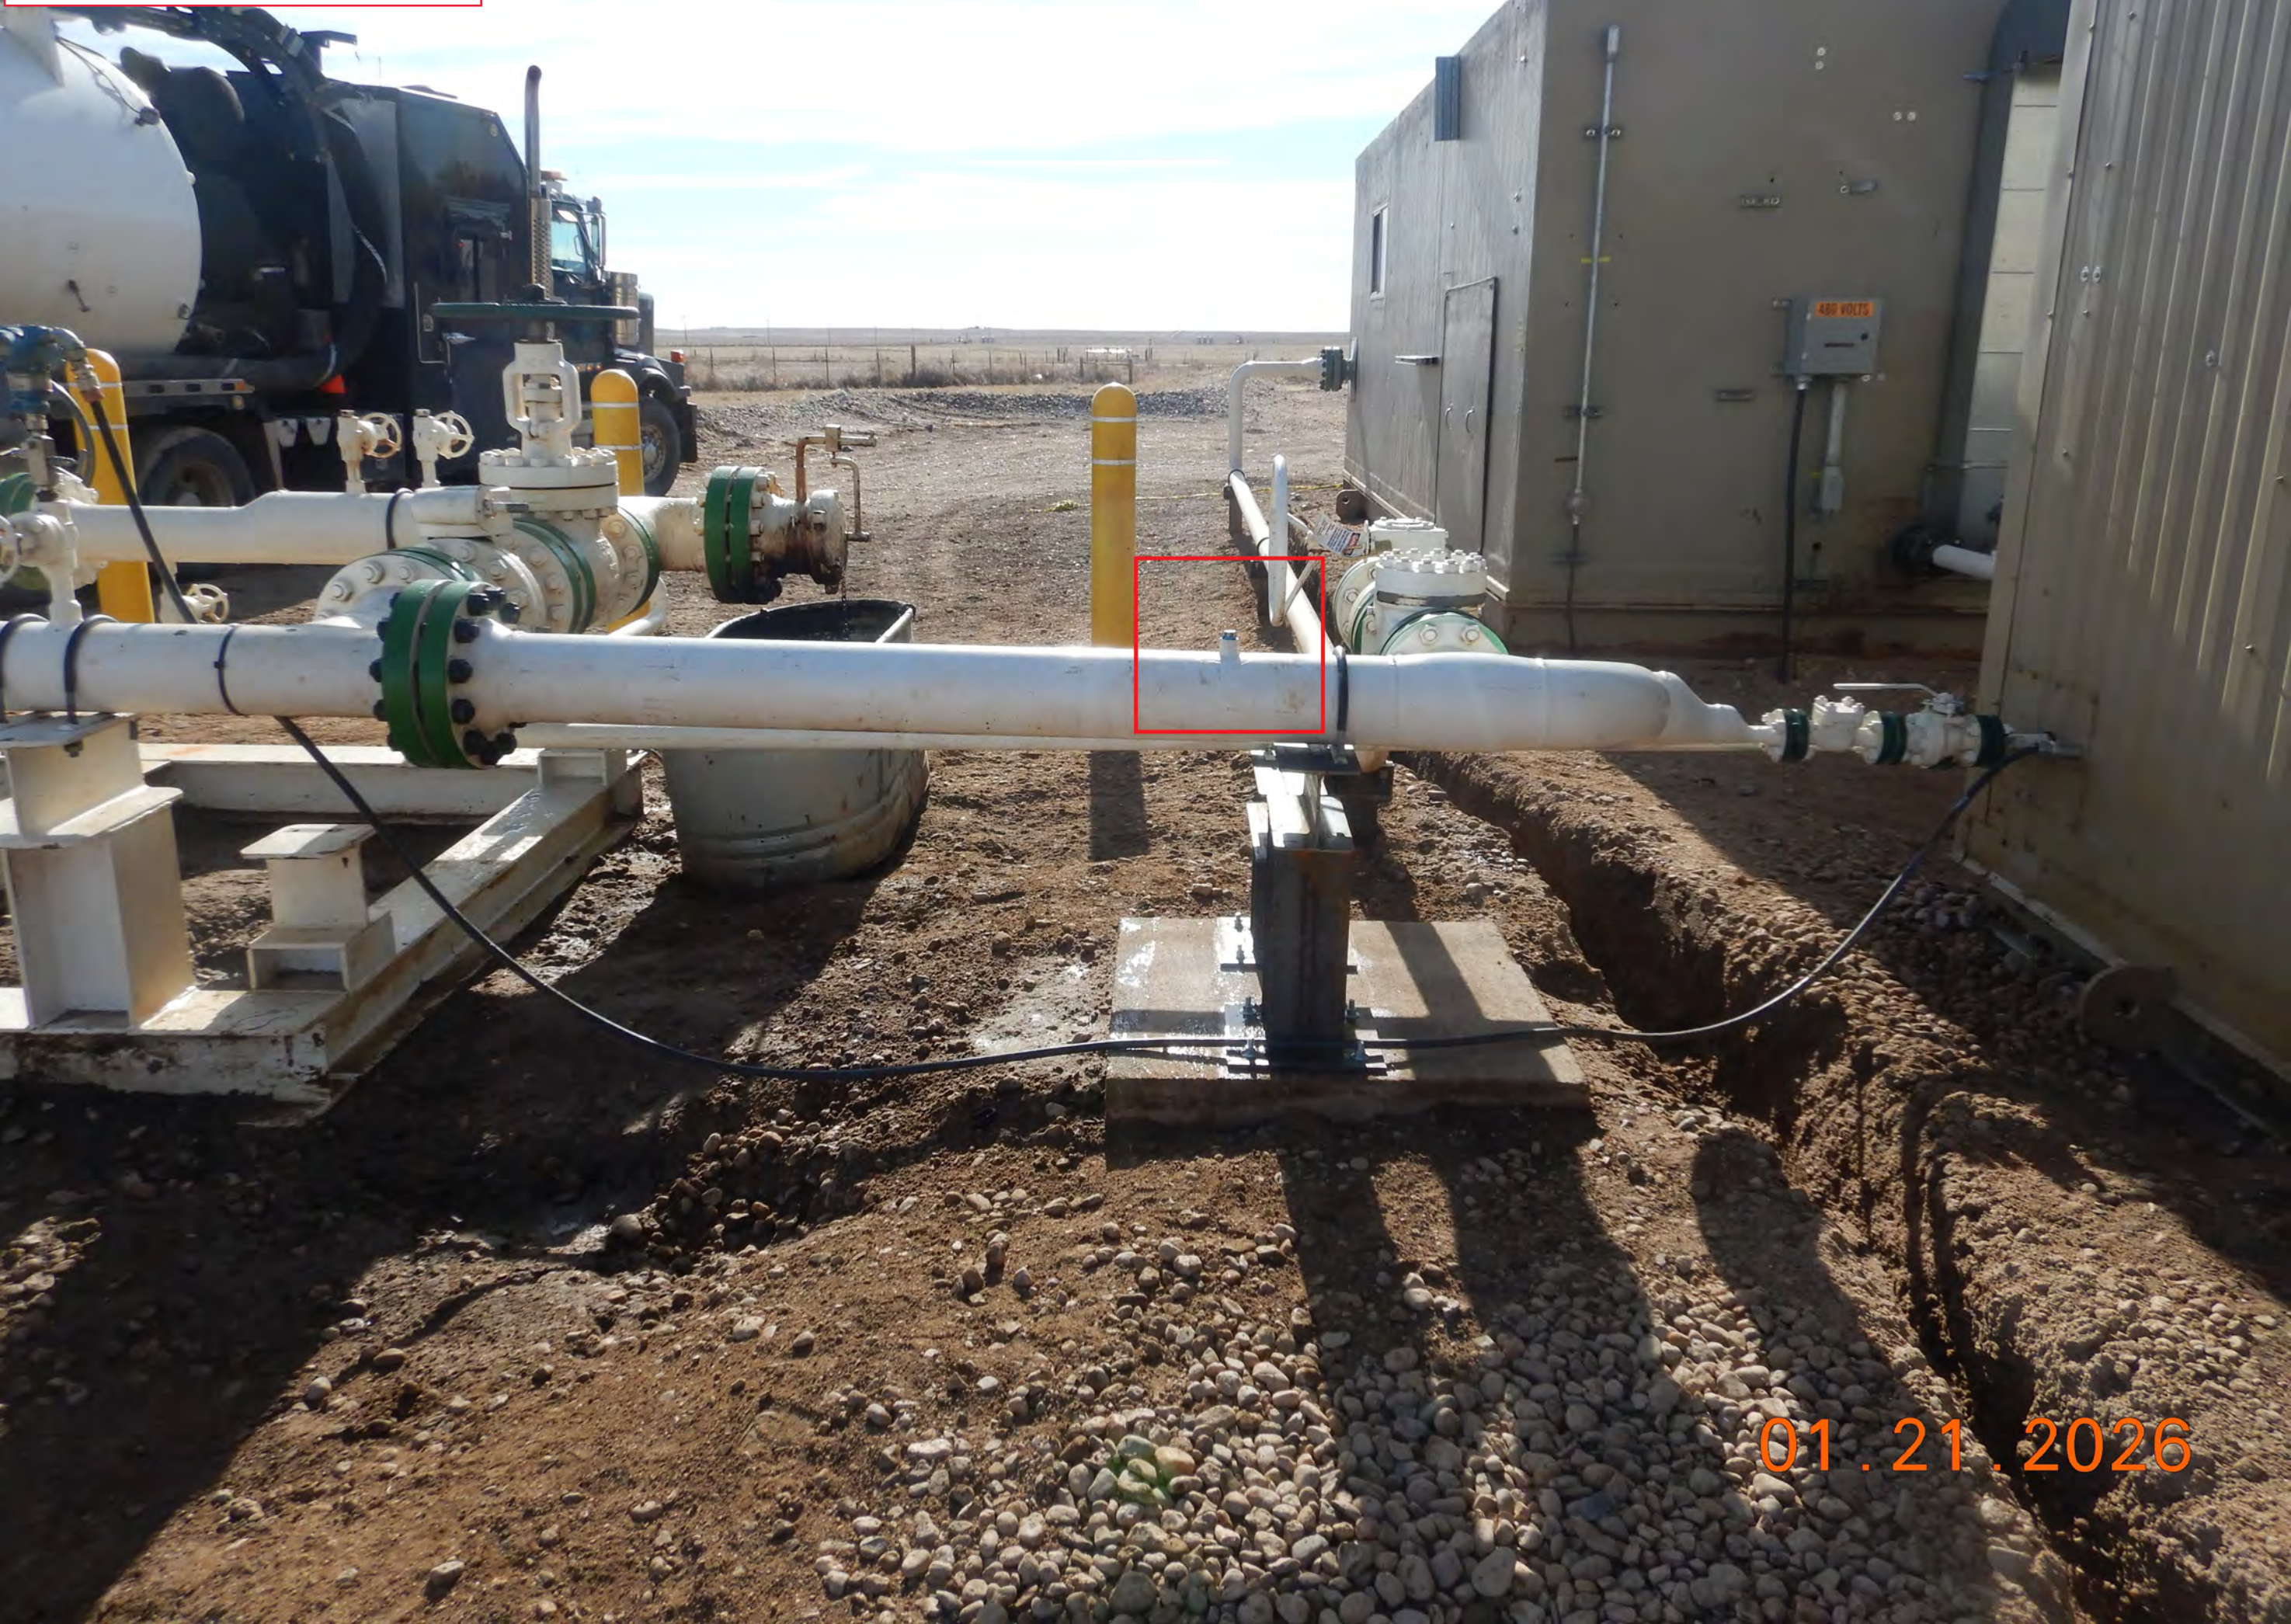
01.21.2026

Initial Cleanup
Hydro-Vac Truck

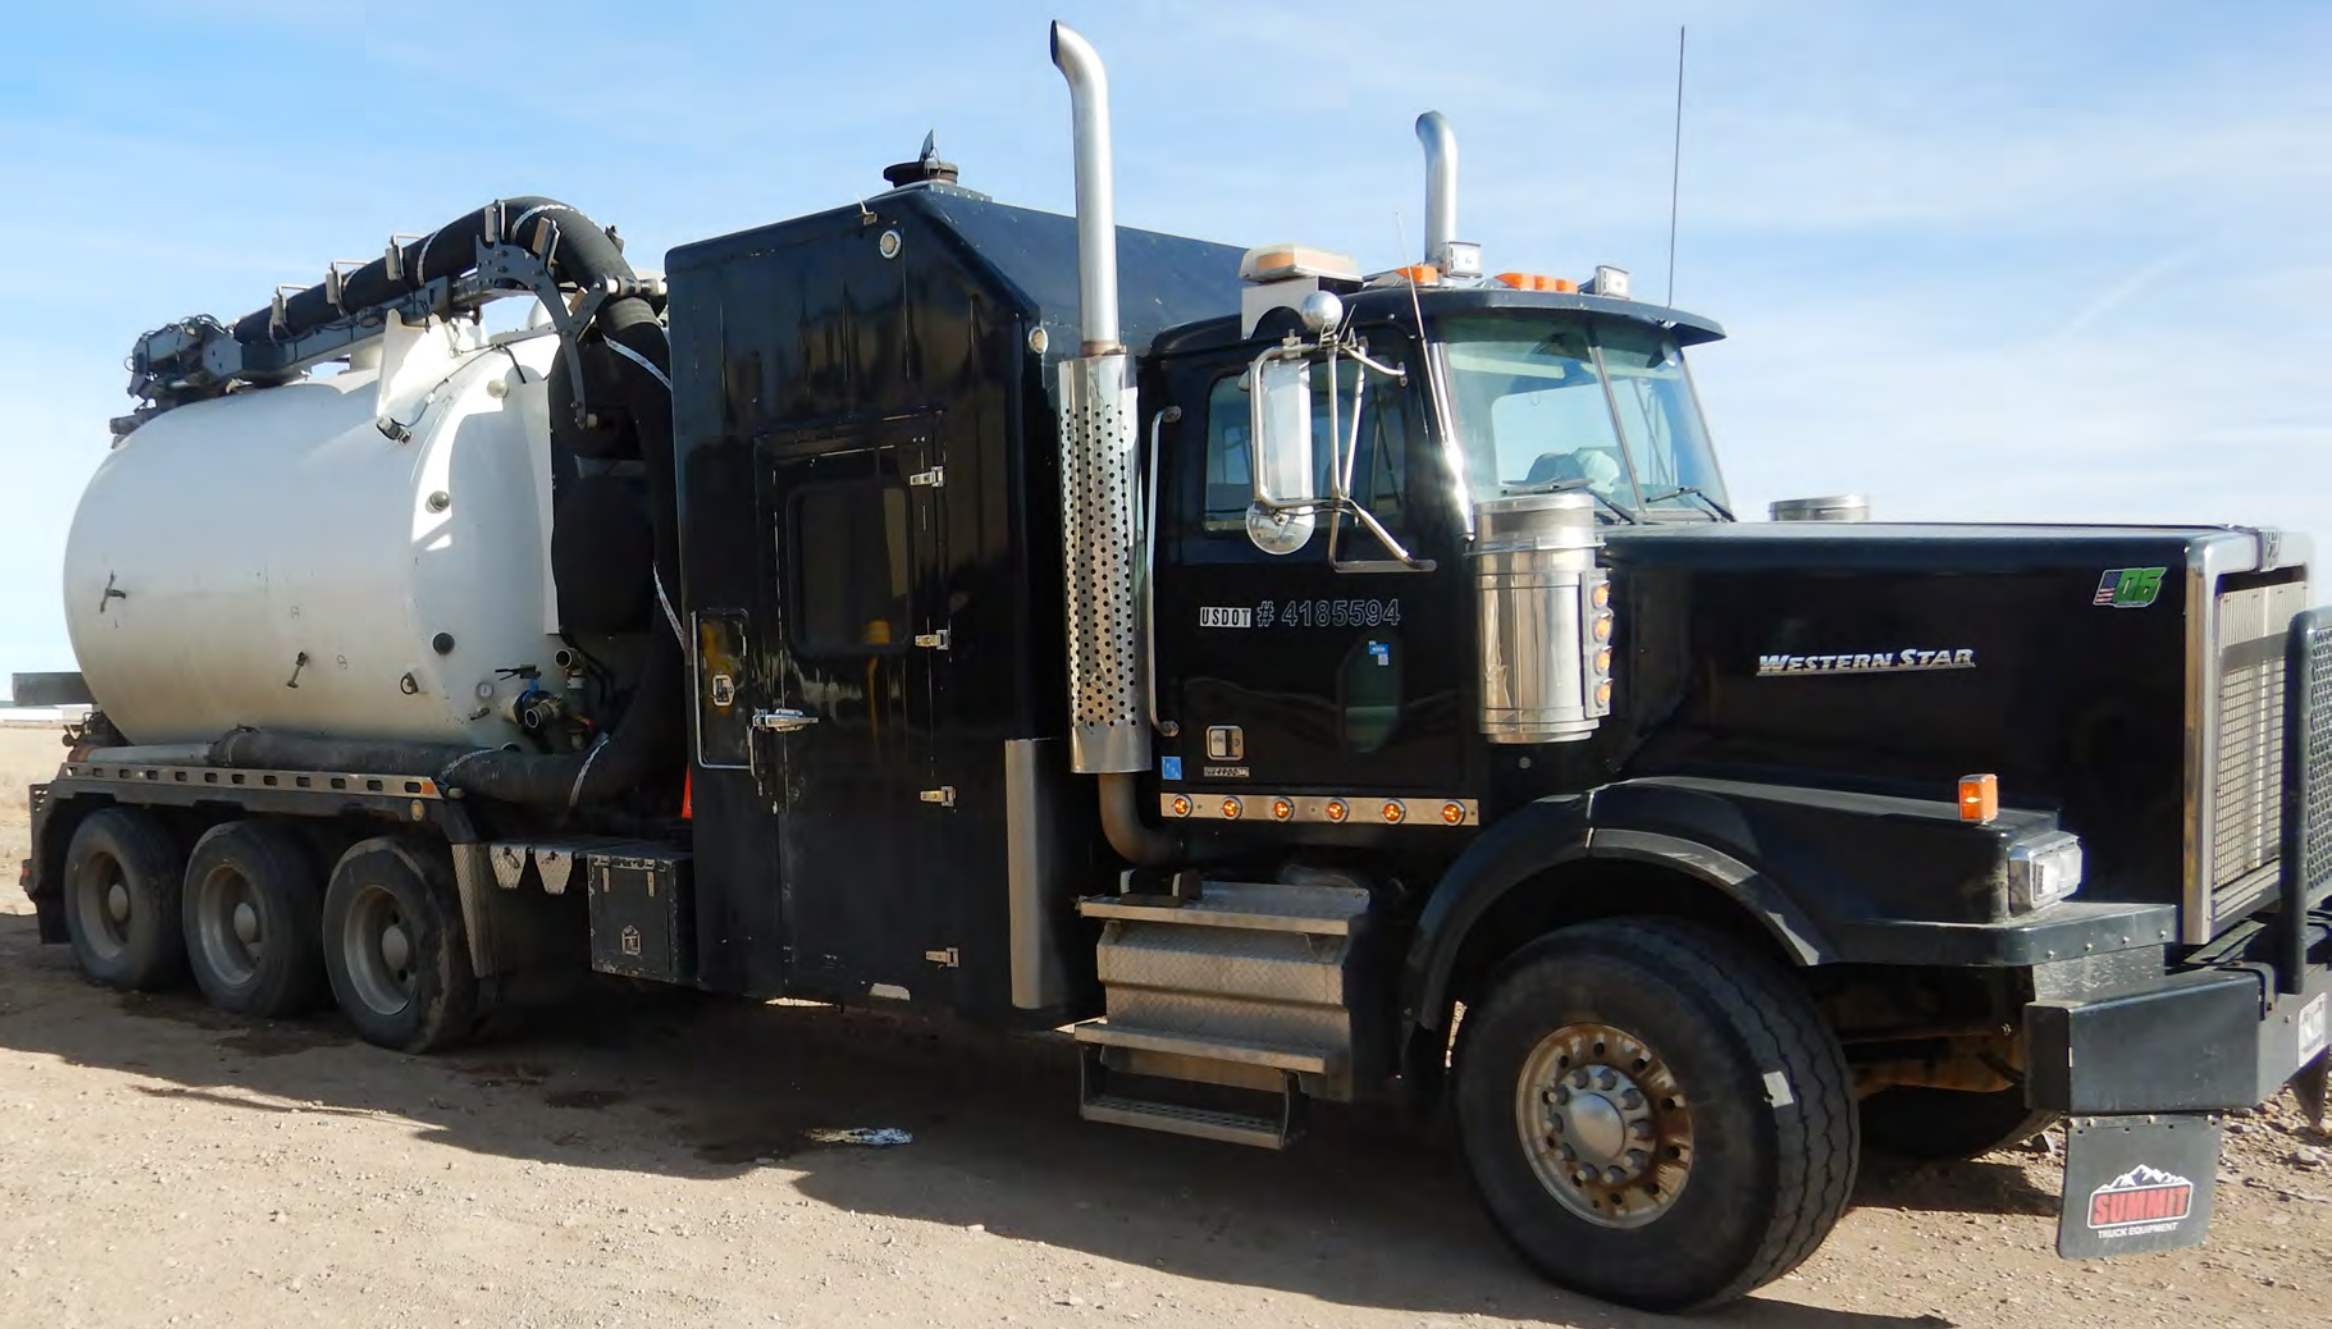
01.21.2026

Cleanup Activity
12" Excavation Area

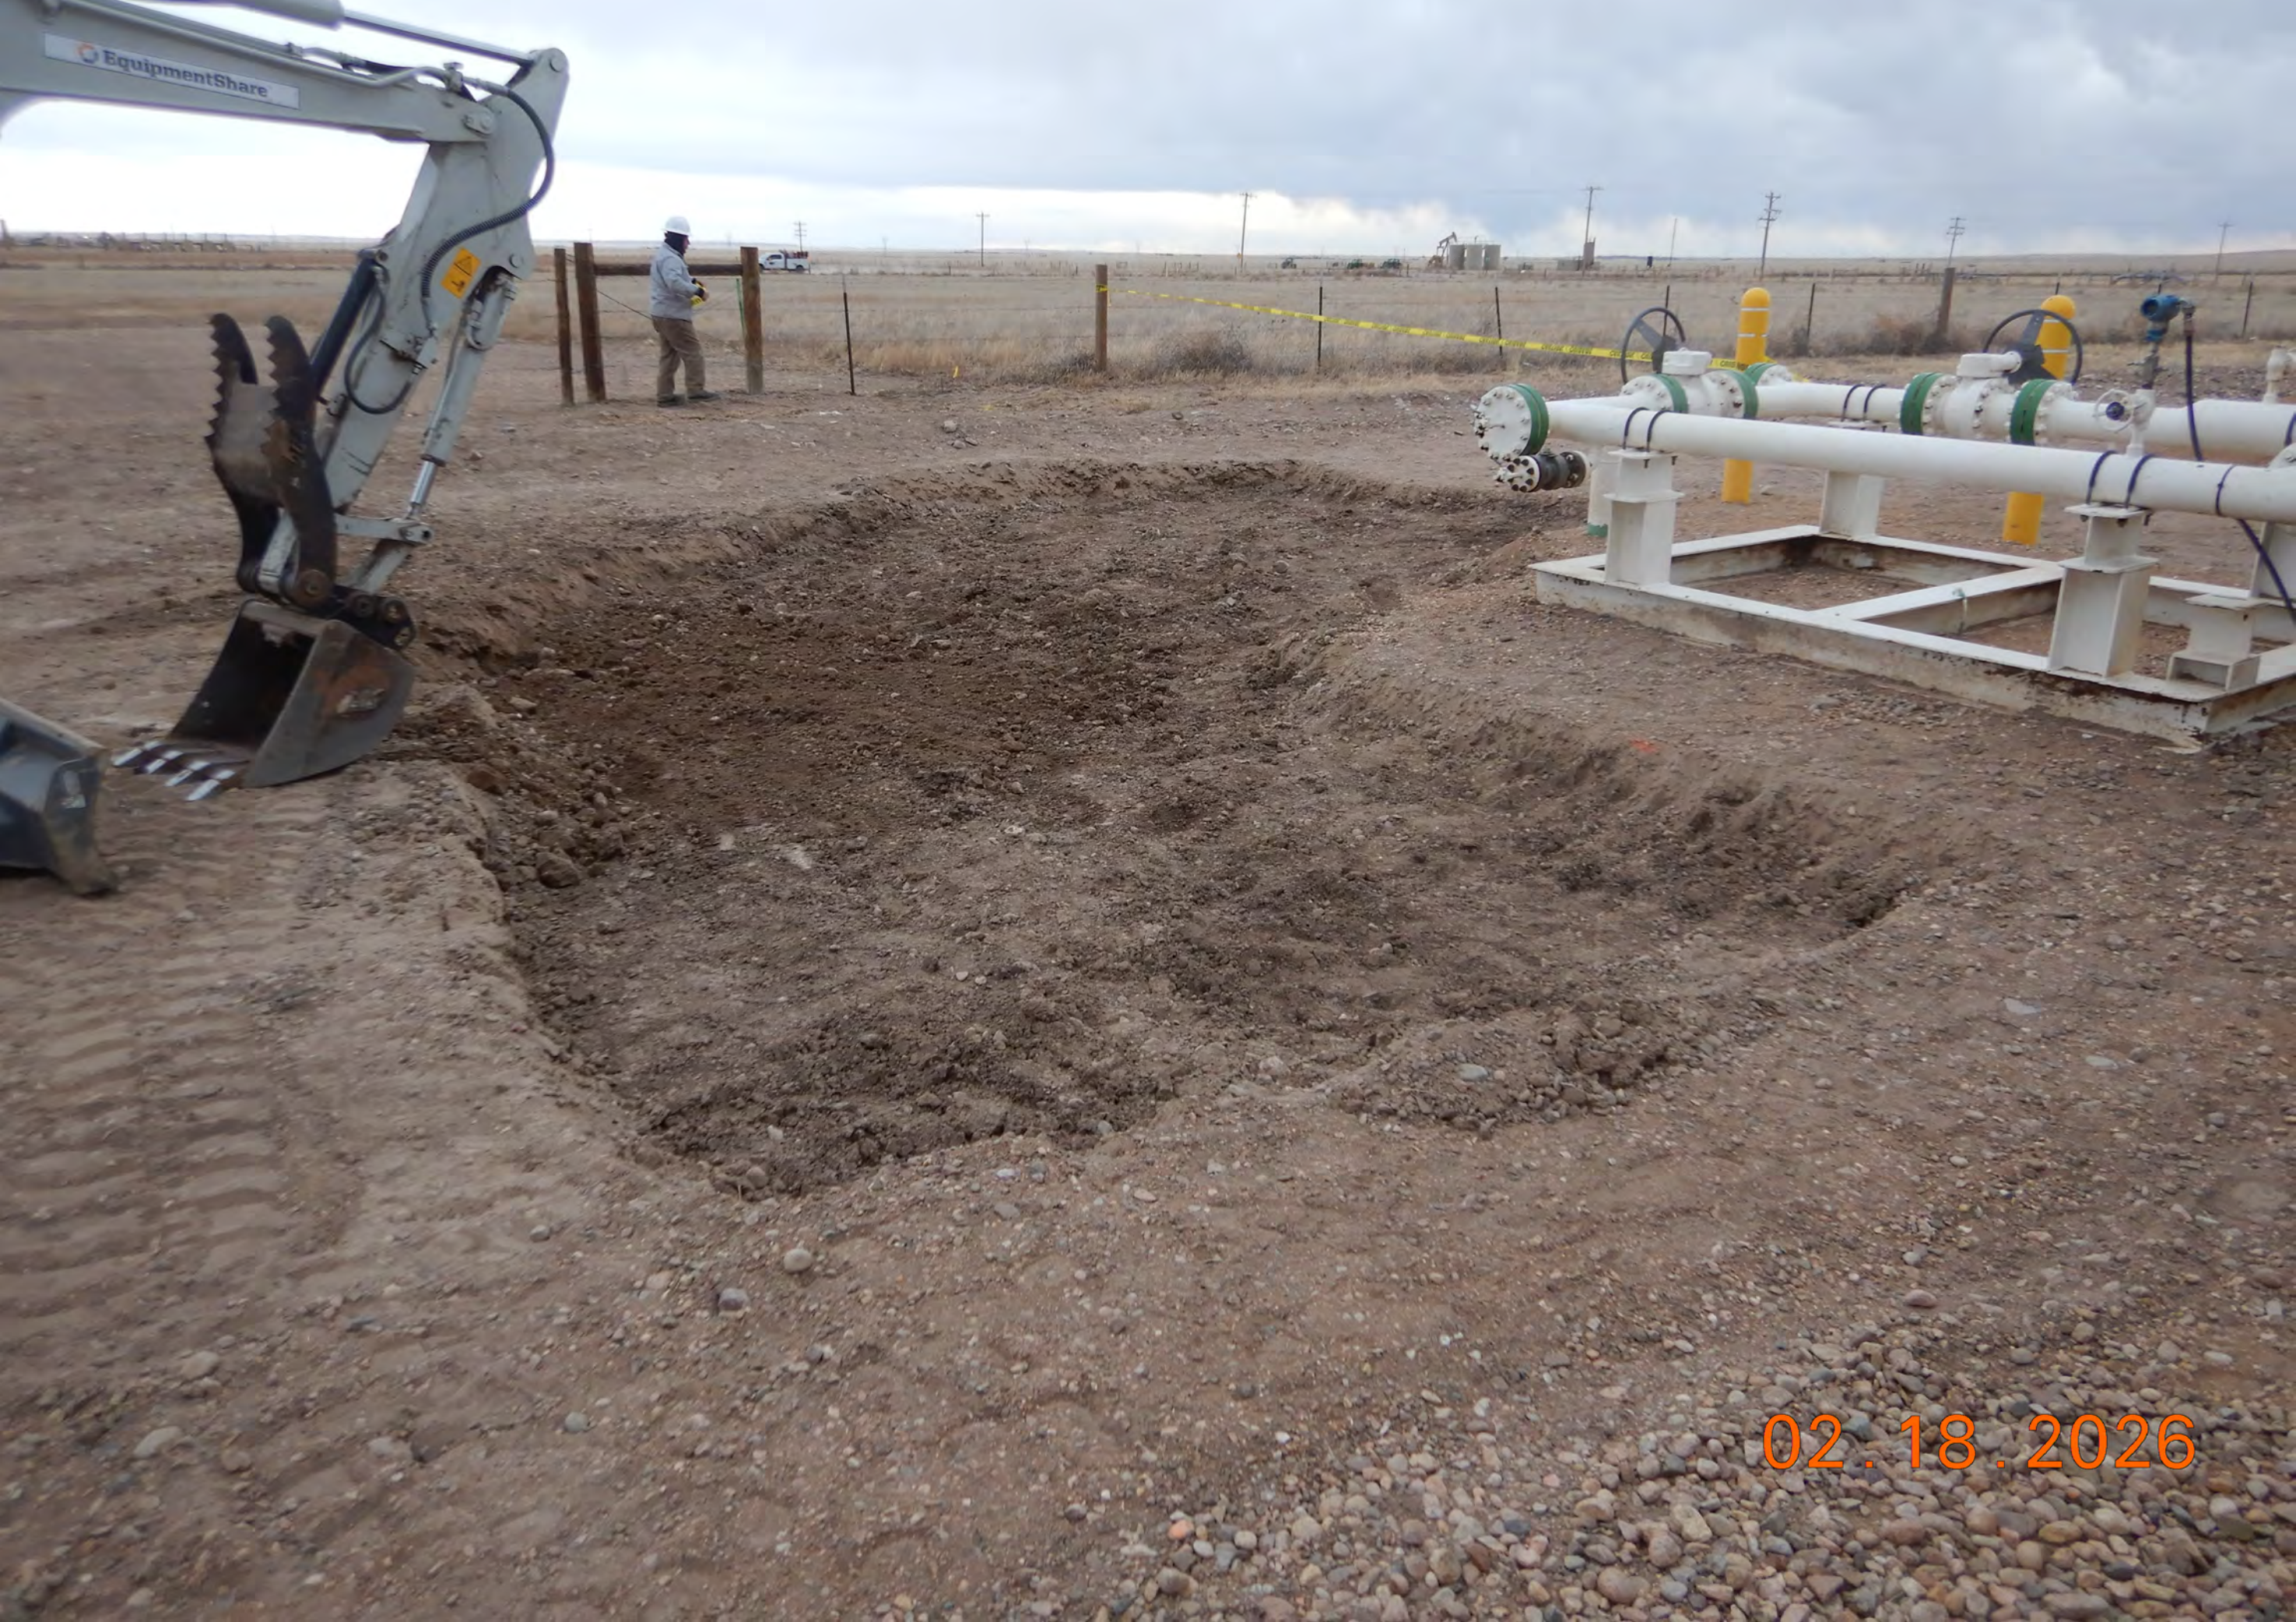
02.18.2026

Cleanup Activity
2" Excavation Area
