Spill/Release (Form 19): Site
Documentation and Analytical
Laboratory Results

Critter Creek 16" LACT Unit Spill/Release

Incident Date: January 17, 2026

Operator: Summit Midstream

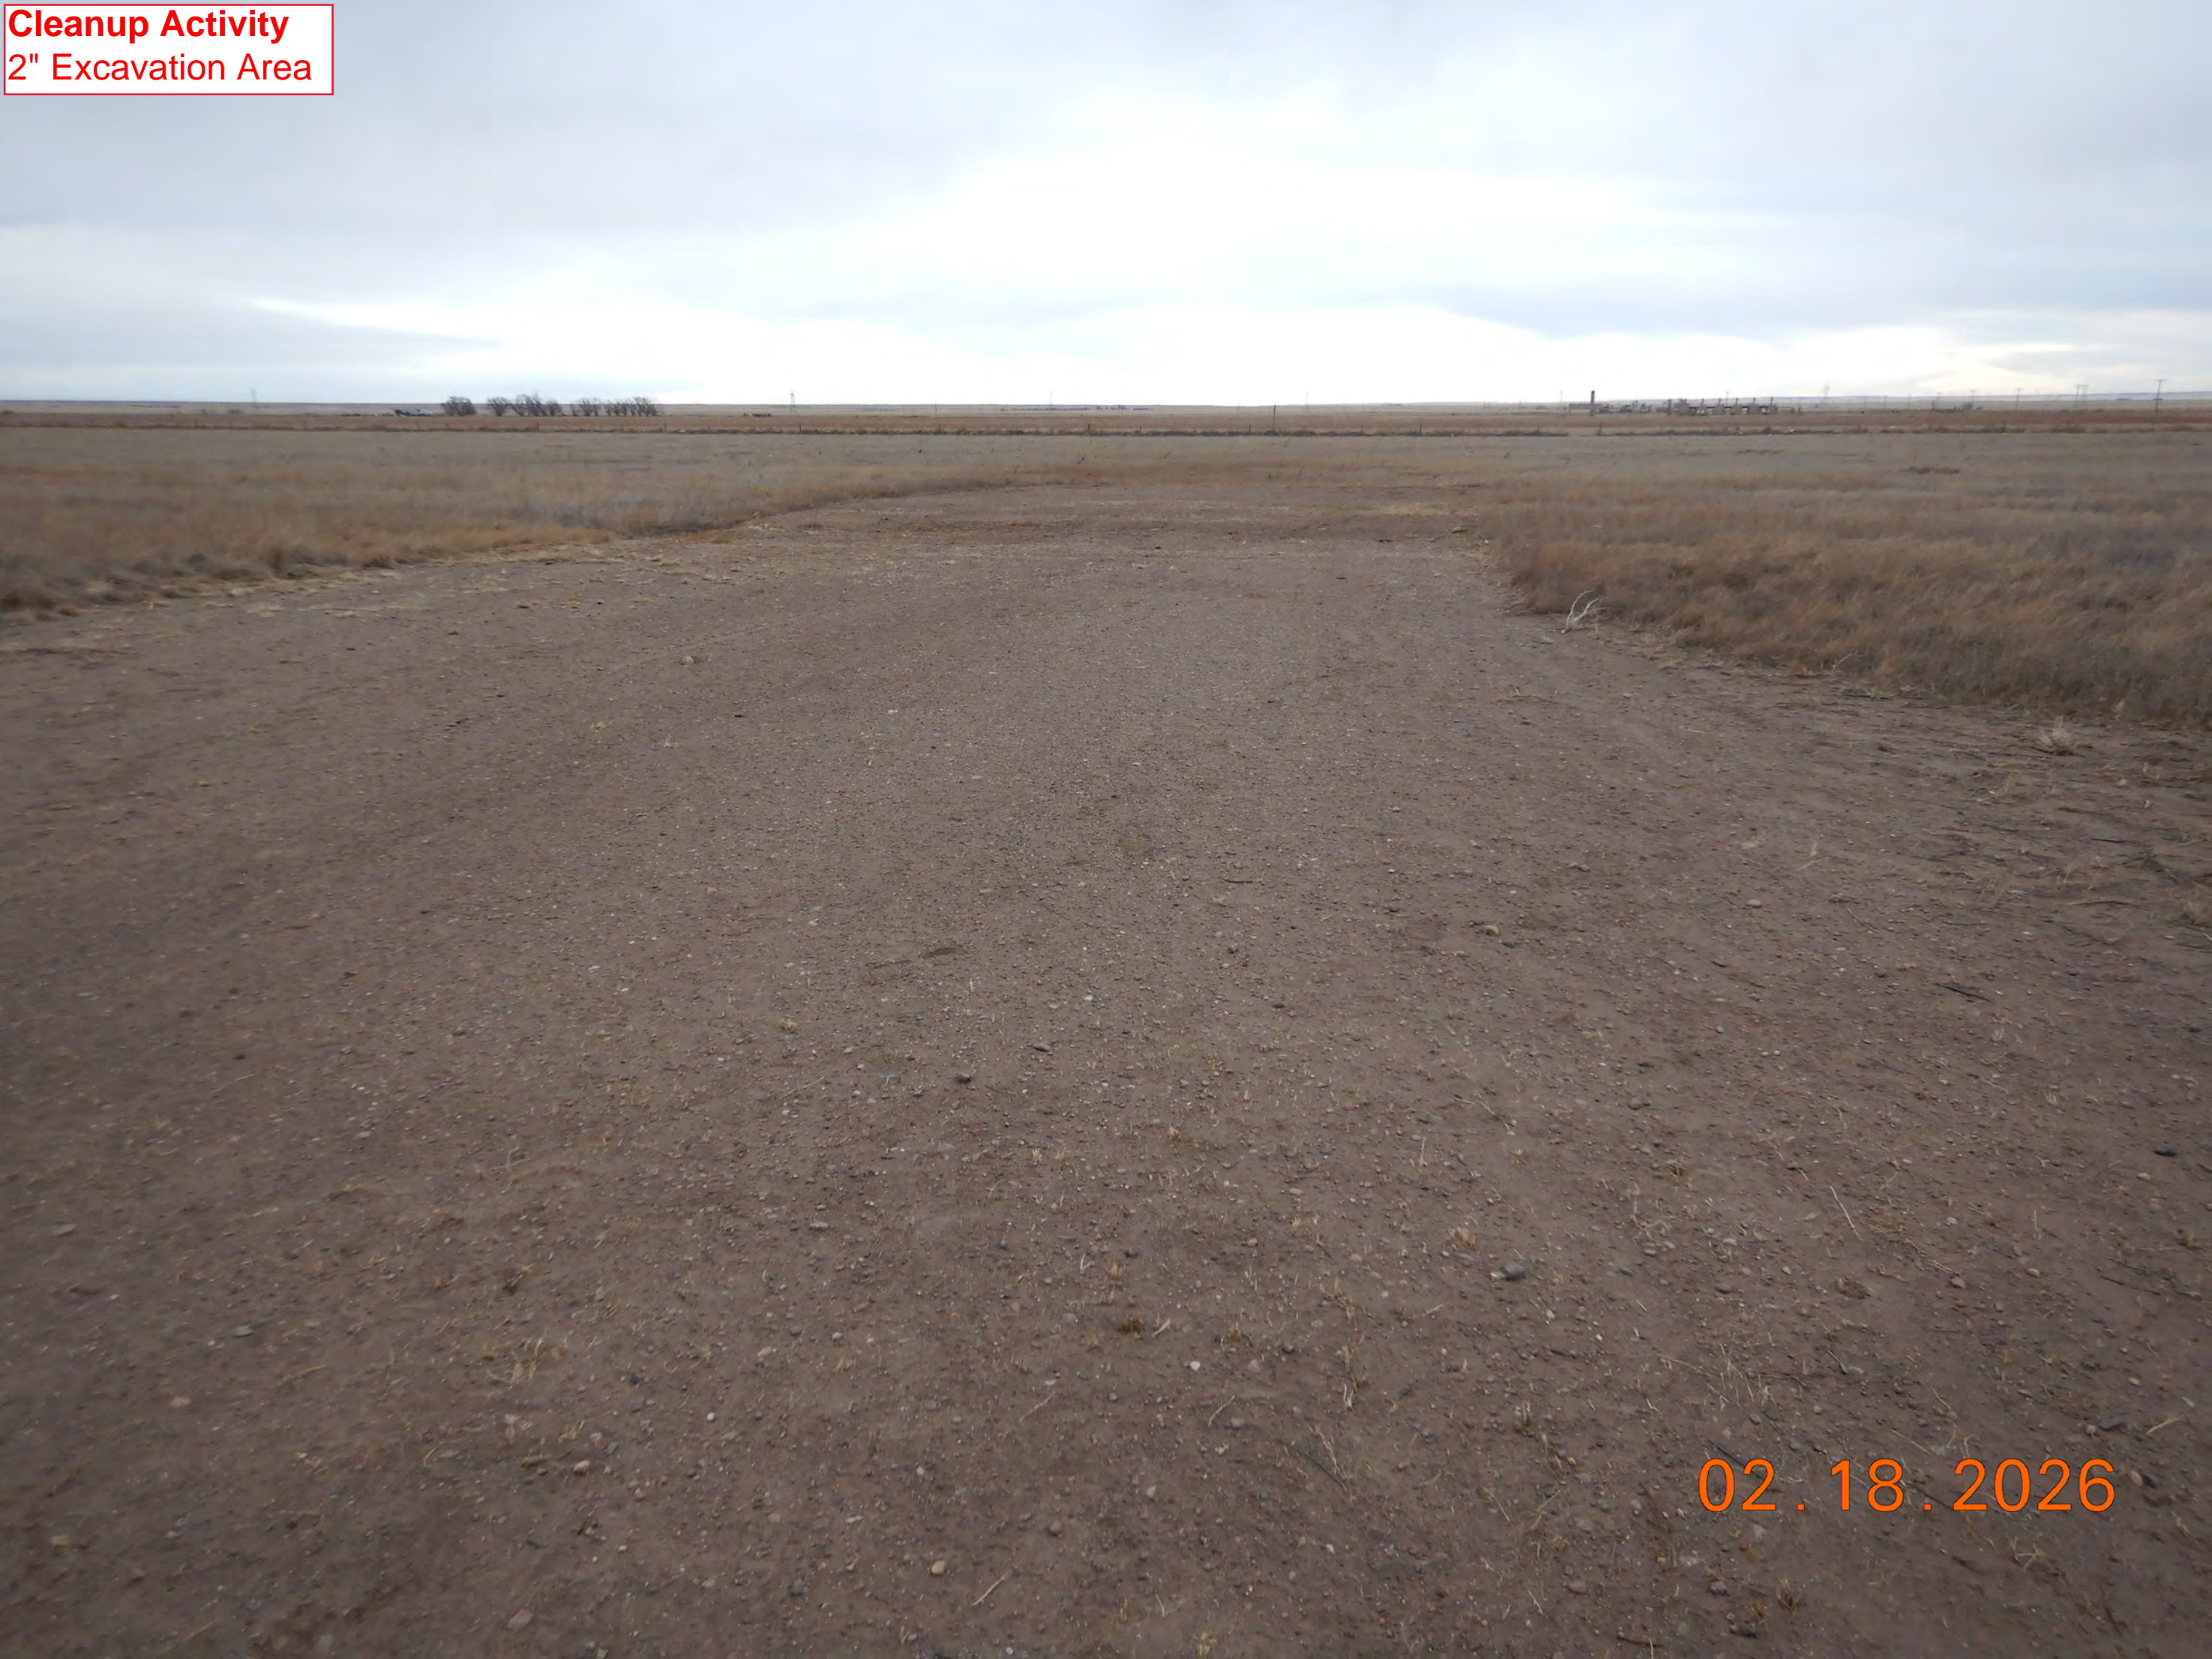
02.18.2026

Cleanup Activity
6" Excavation Area

One soil sample, identified as Sample 13, exhibited an elevated EC value. In response to this result, additional excavation was conducted in the affected area. Following the additional soil removal, confirmation soil samples and additional background samples were collected and submitted for EC analysis. Review of the subsequent analytical results indicated that no elevated EC values remained following completion of the additional excavation activities.
