Form 27 Data Package

Dutch Lake 24-22H
Remediation #: 43215

Prepared for:
Highpoint Operating Corporation - 10071

Corrective Action Plan

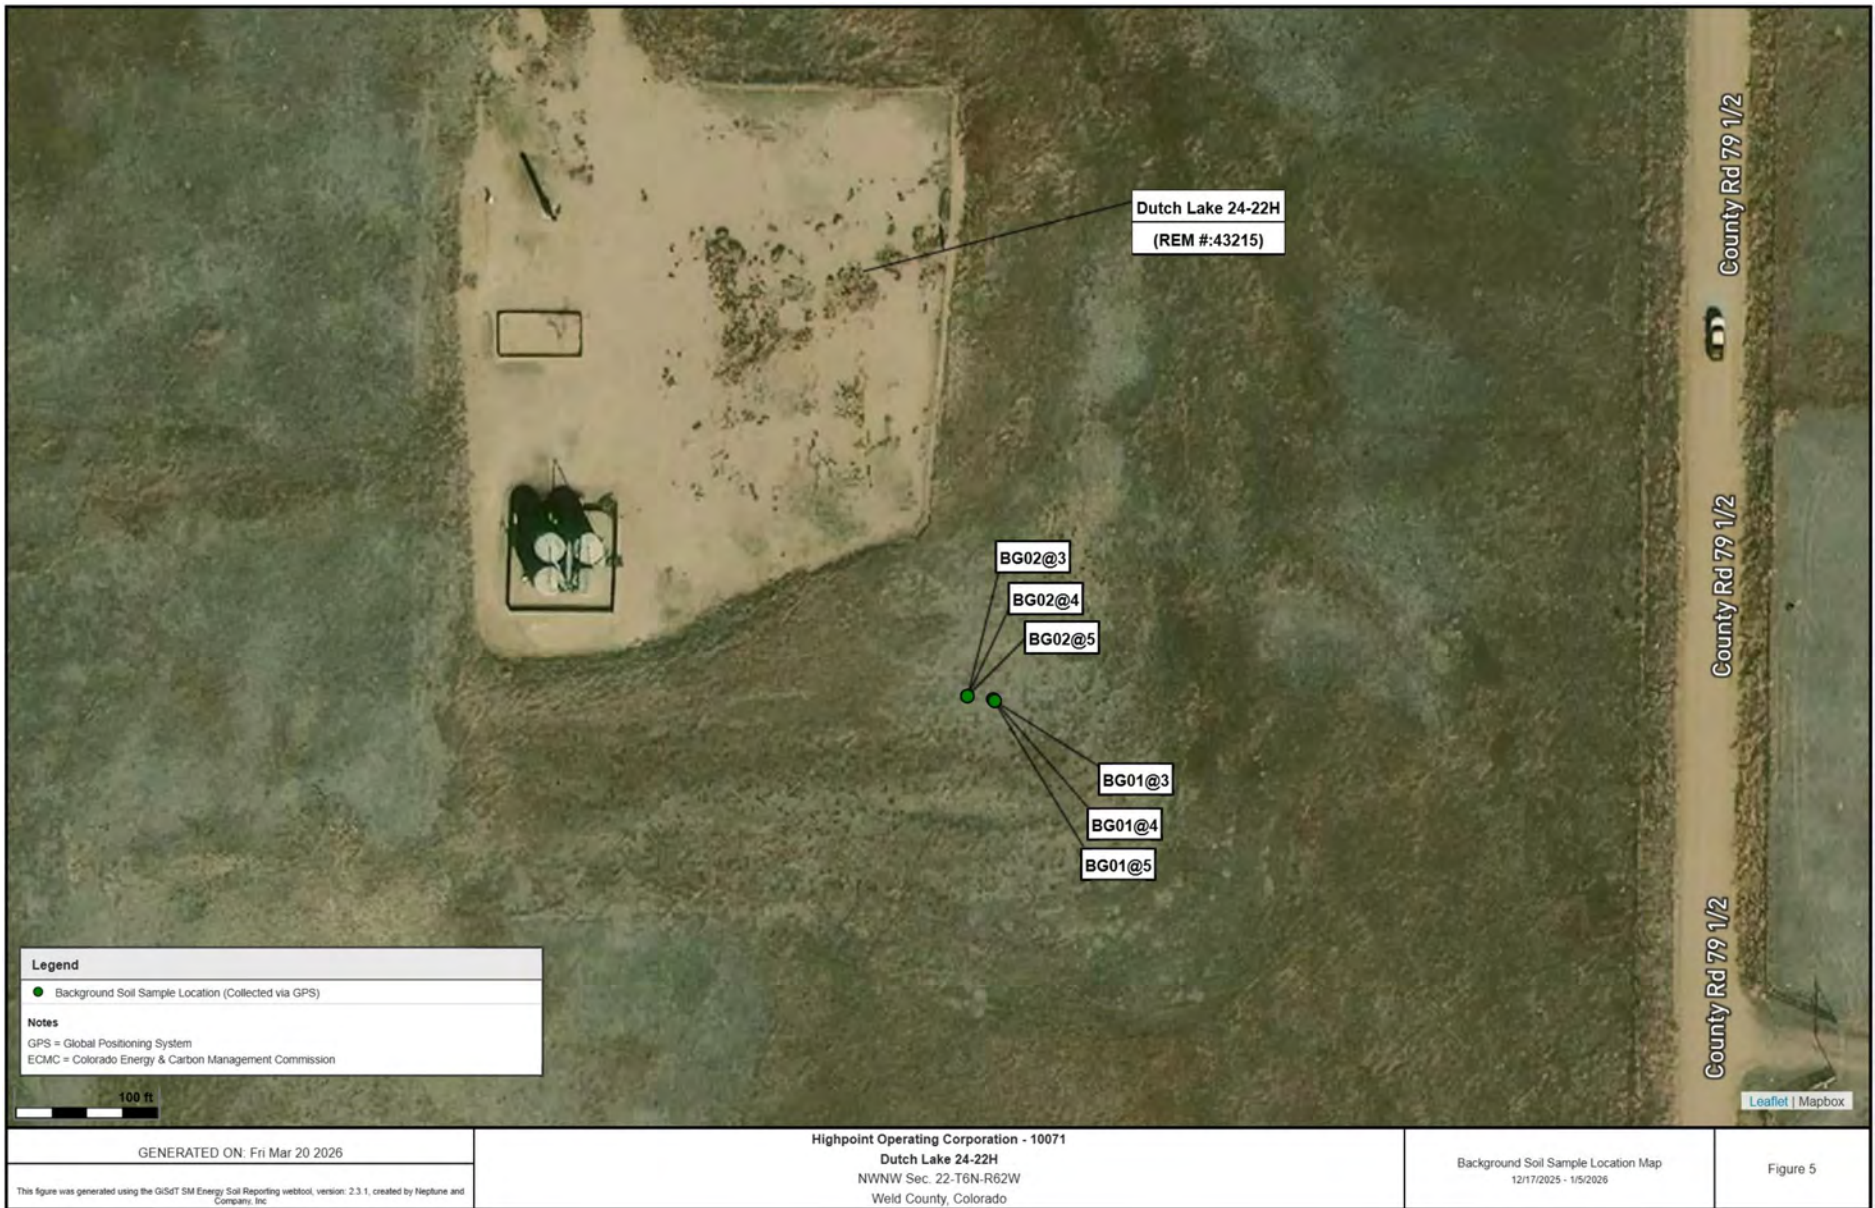
See the attached **Decommissioning Form** for a list of soil samples and their associated soil types and depths. See the attached **Table 4** and **Table 5** for a summary of the analytical results of the background soil samples. See the attached **Figure 5** for the locations of the background soil samples. A **Photographic Log** of background soil samples is also attached.
