# Inspection Photos

**Operator:** TEP Rocky Mountain LLC #96850

**Location ID:** 427776

**Inspection Doc:** 719201049

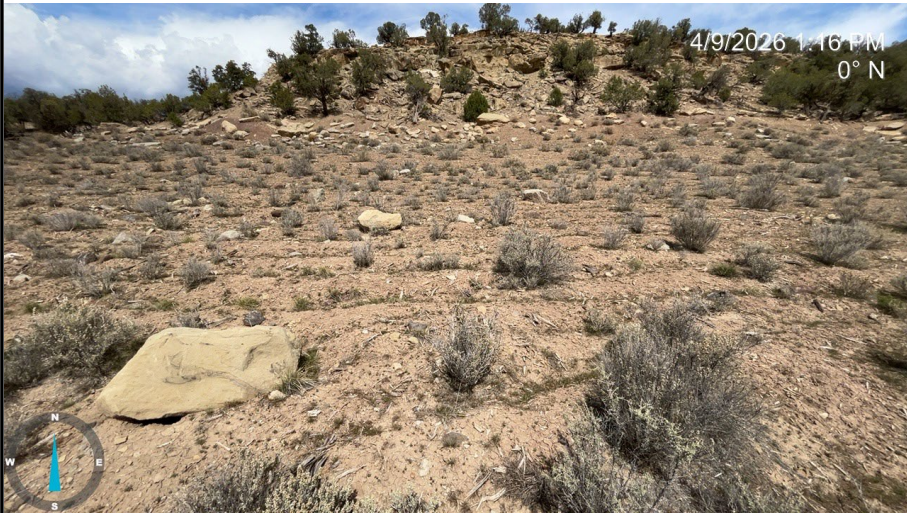
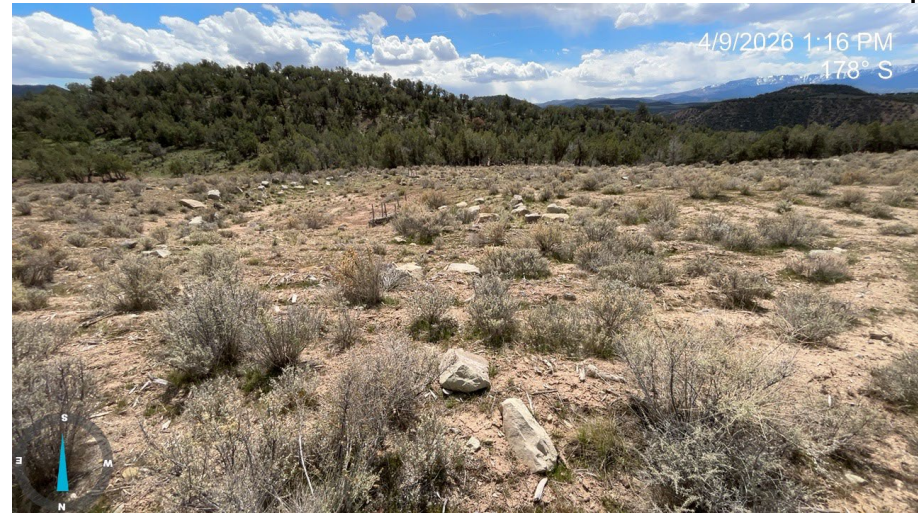
**Photo 1:** Photos showing an overview of the location looking north and south, respectively.

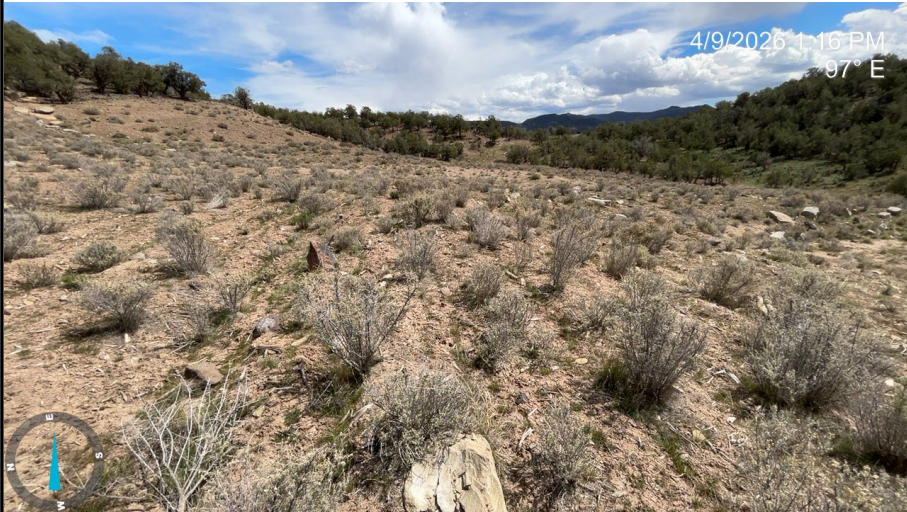
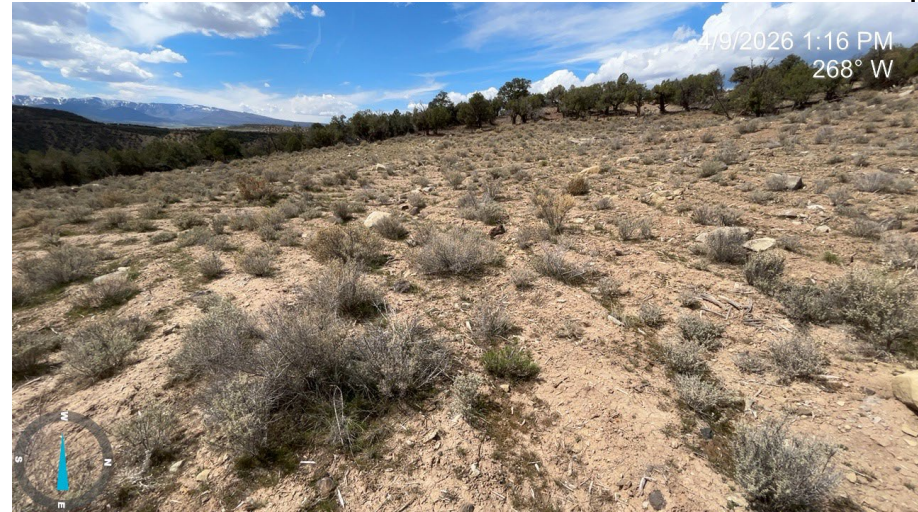
**Photo 2:** Photos showing an overview of the location looking east and west, respectively.

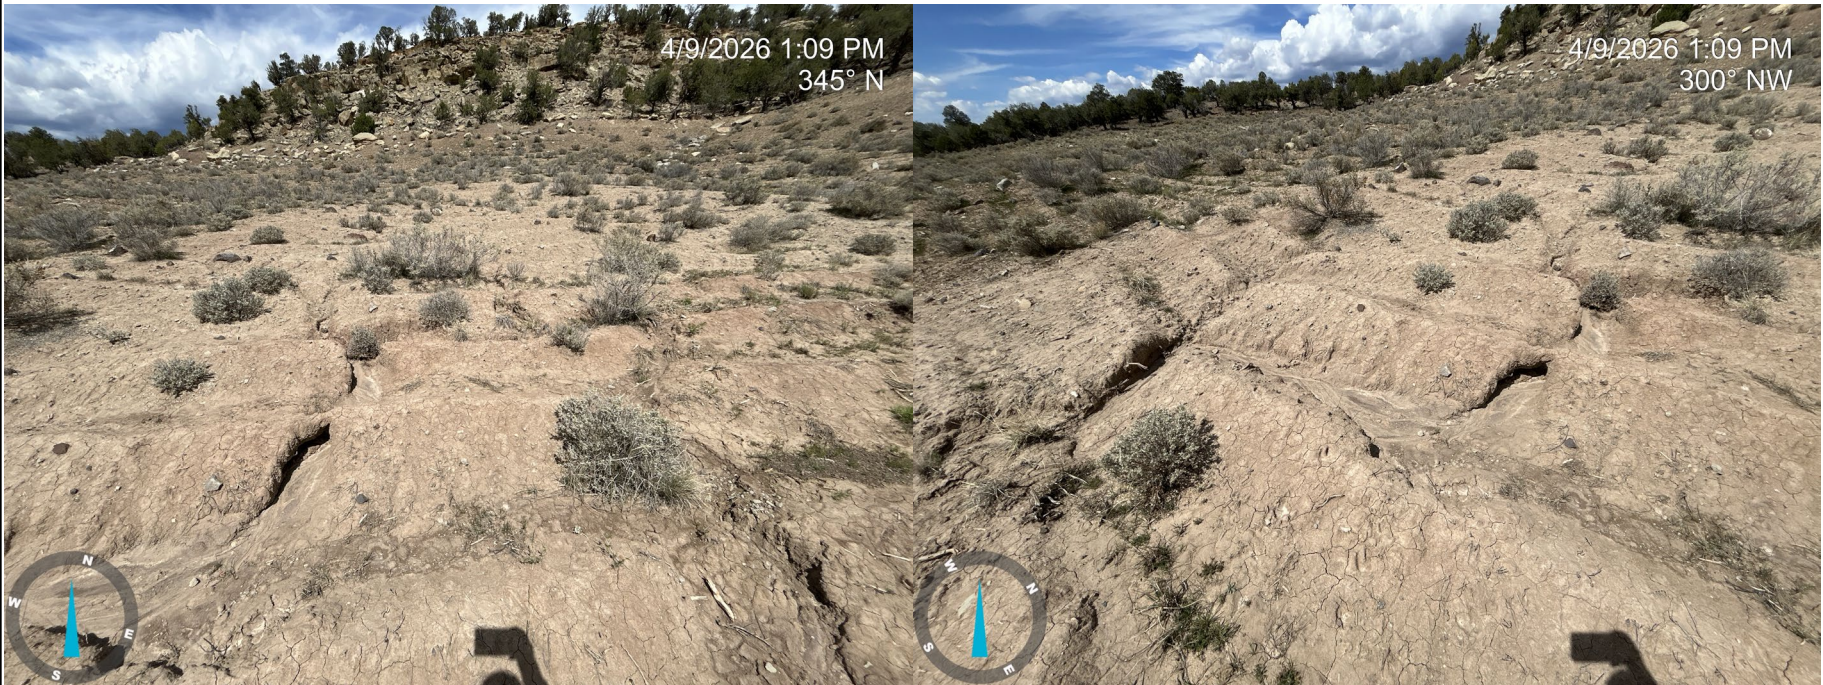
**Photo 3:** Vegetation is not uniform at the east-central portion of the location; erosion and rilling is occurring in bare areas.

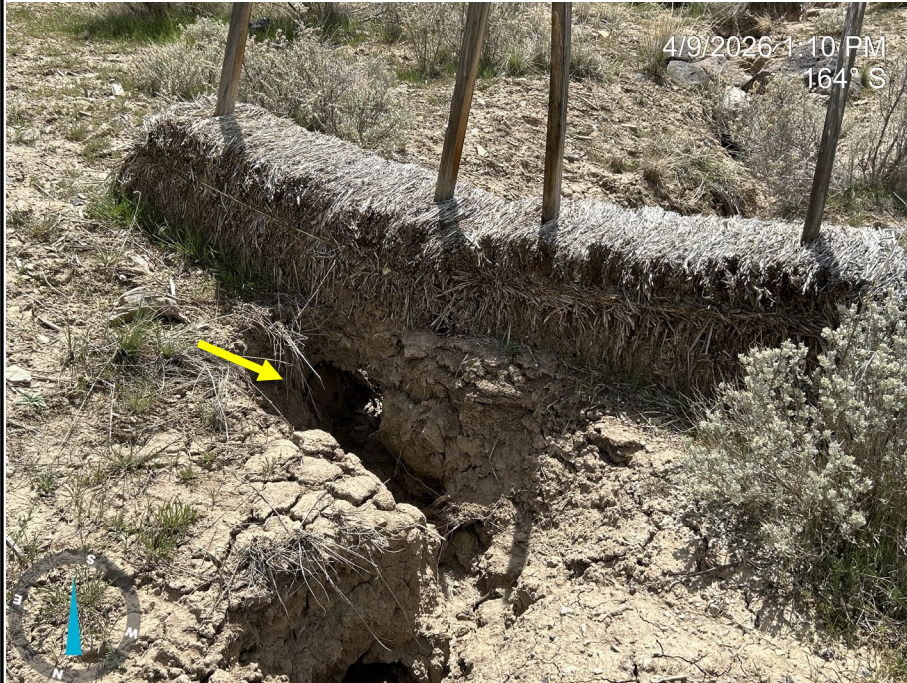
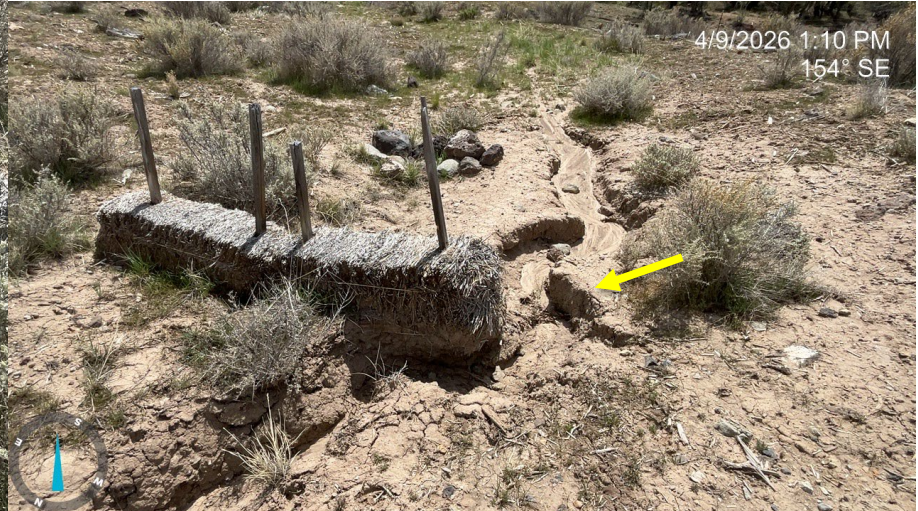
**Photo 4:** Erosion, soil tunneling and rilling is occurring underneath around straw hay bales used as stormwater controls at the location; maintenance is required. Comply with Rule 1002.f.

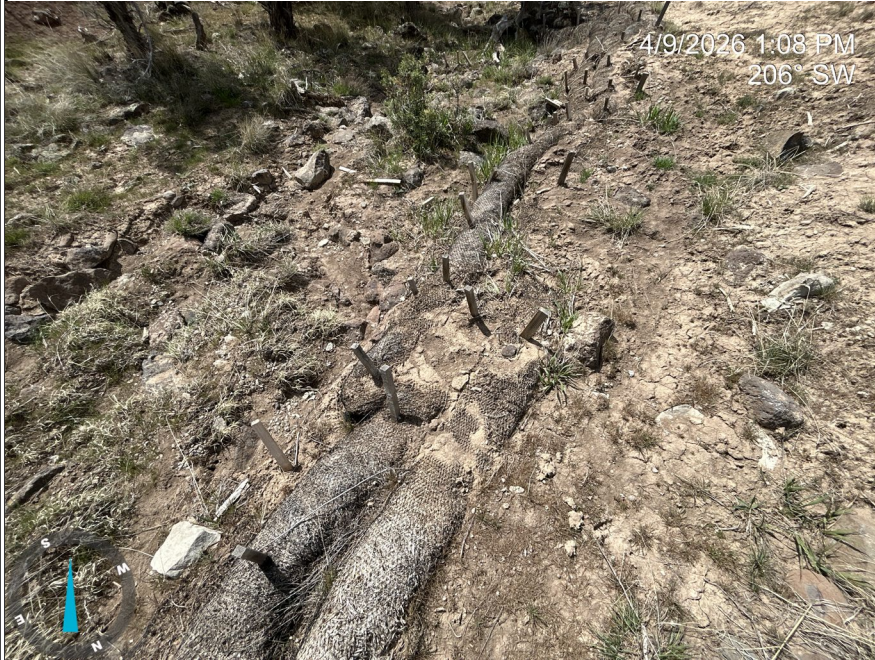
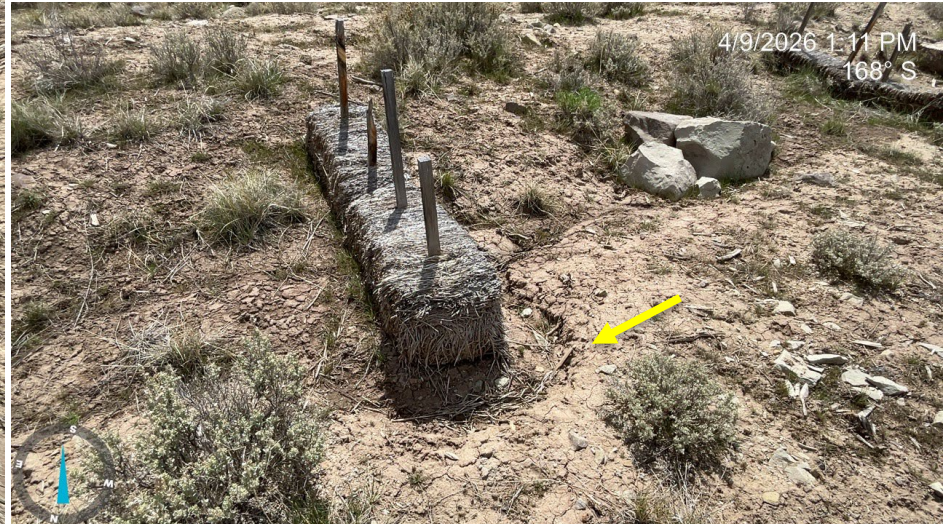
**Photo 5:** Photos showing straw wattles that are laden with sediment and straw bales with erosion cutting around them. Maintenance is required; comply with Rule 1002.f.

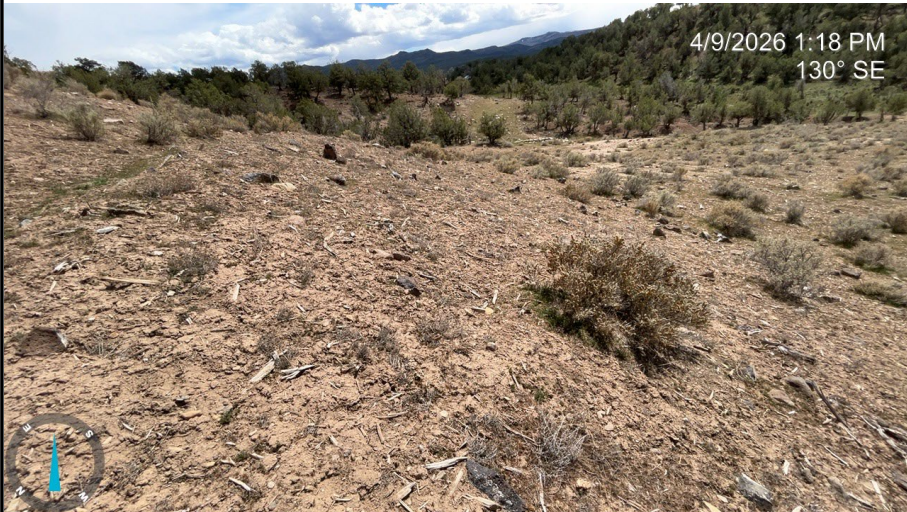
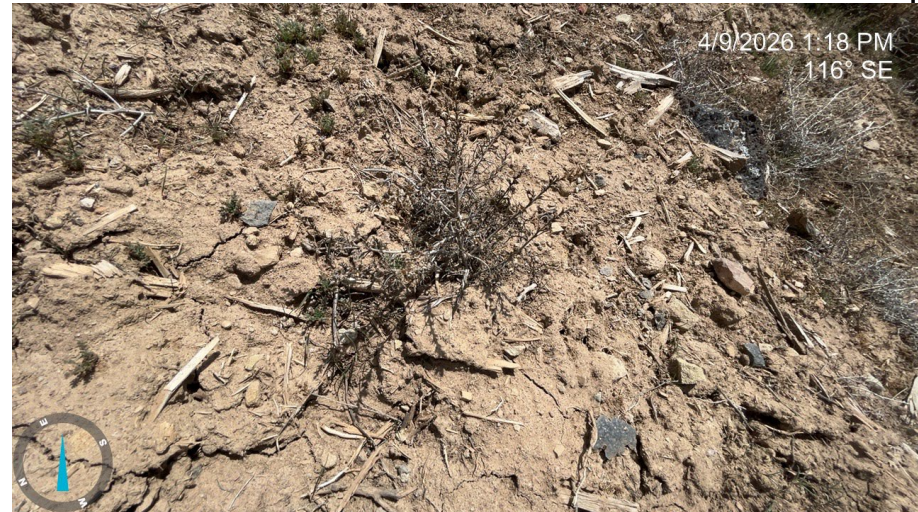
**Photo 6:** Photos showing the northern hillside is predominantly prickly Russian thistle (grey material), an undesirable annual plant species.

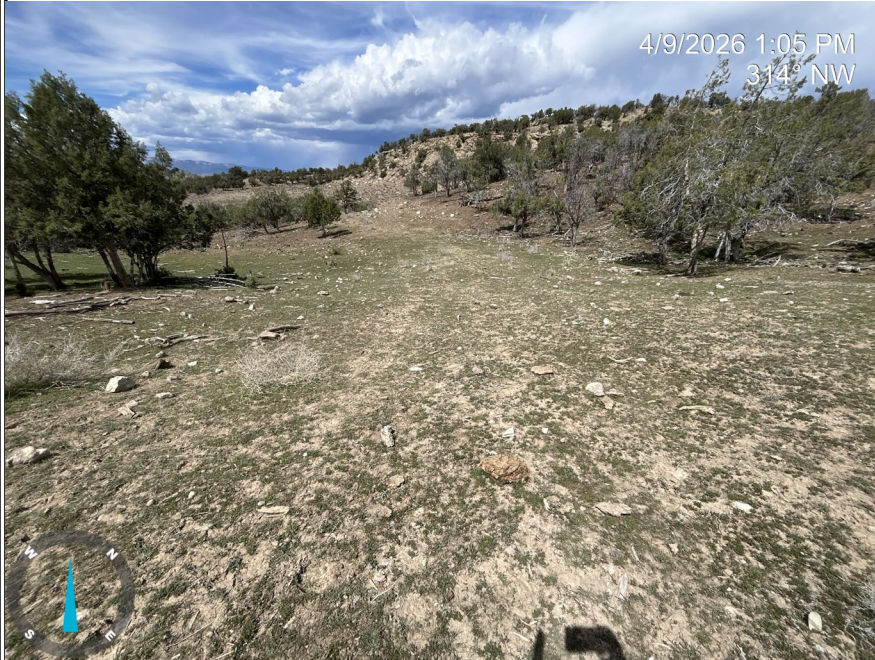
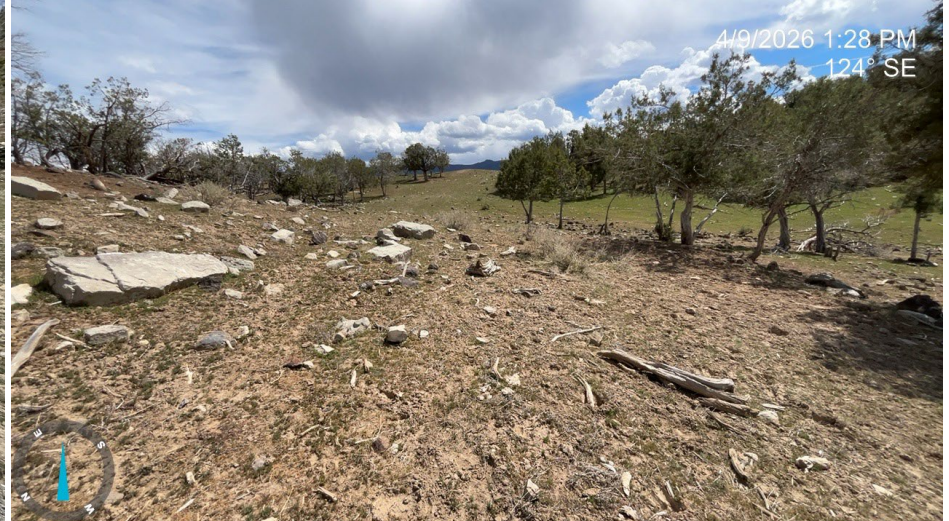
**Photo 7:** Photos showing the access road leading to the location has been reclaimed pursuant to 1004 reclamation requirements. The access road is used by cattle.
