# Inspection Photos

**Operator:** Matrix Oil Corporation #10402

**Location ID:** 428755

**Inspection Doc:** 719201054

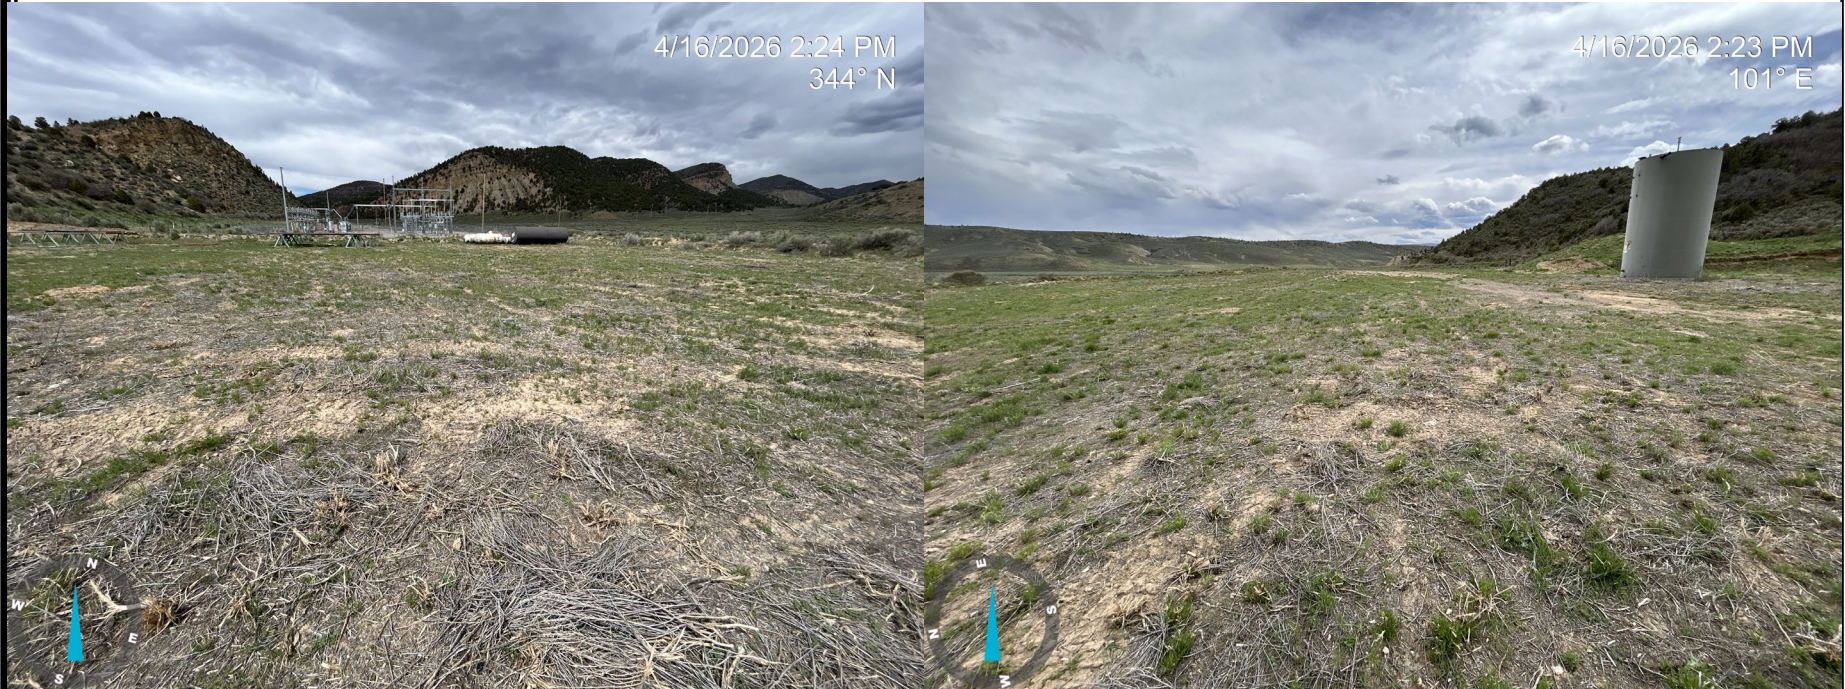
**Photo 1:** Photos showing an overview of the location looking north and east, respectively.

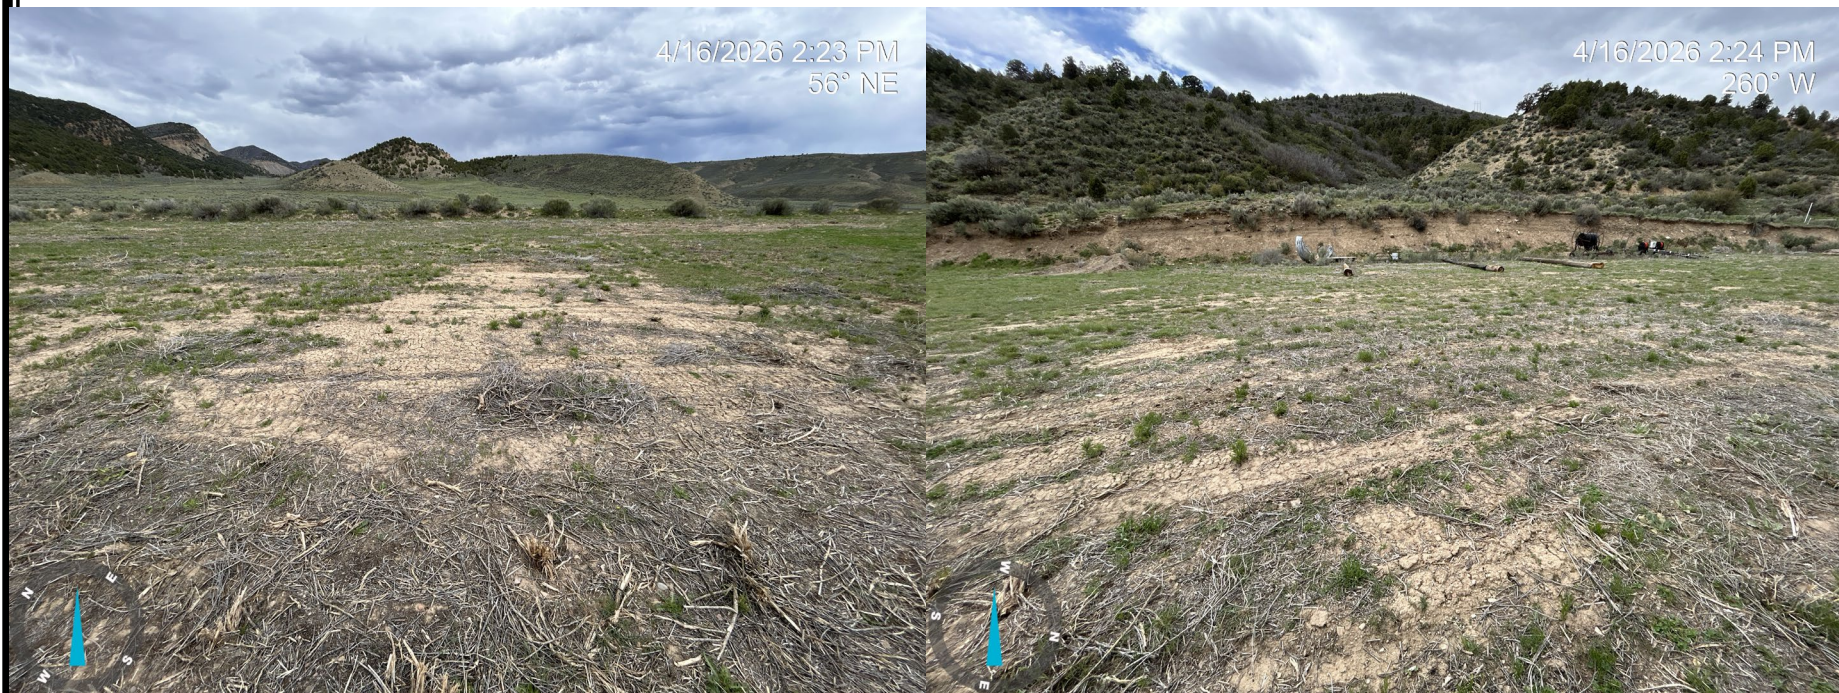
**Photo 2:** Photos showing an overview of the location looking northeast and west, respectively.

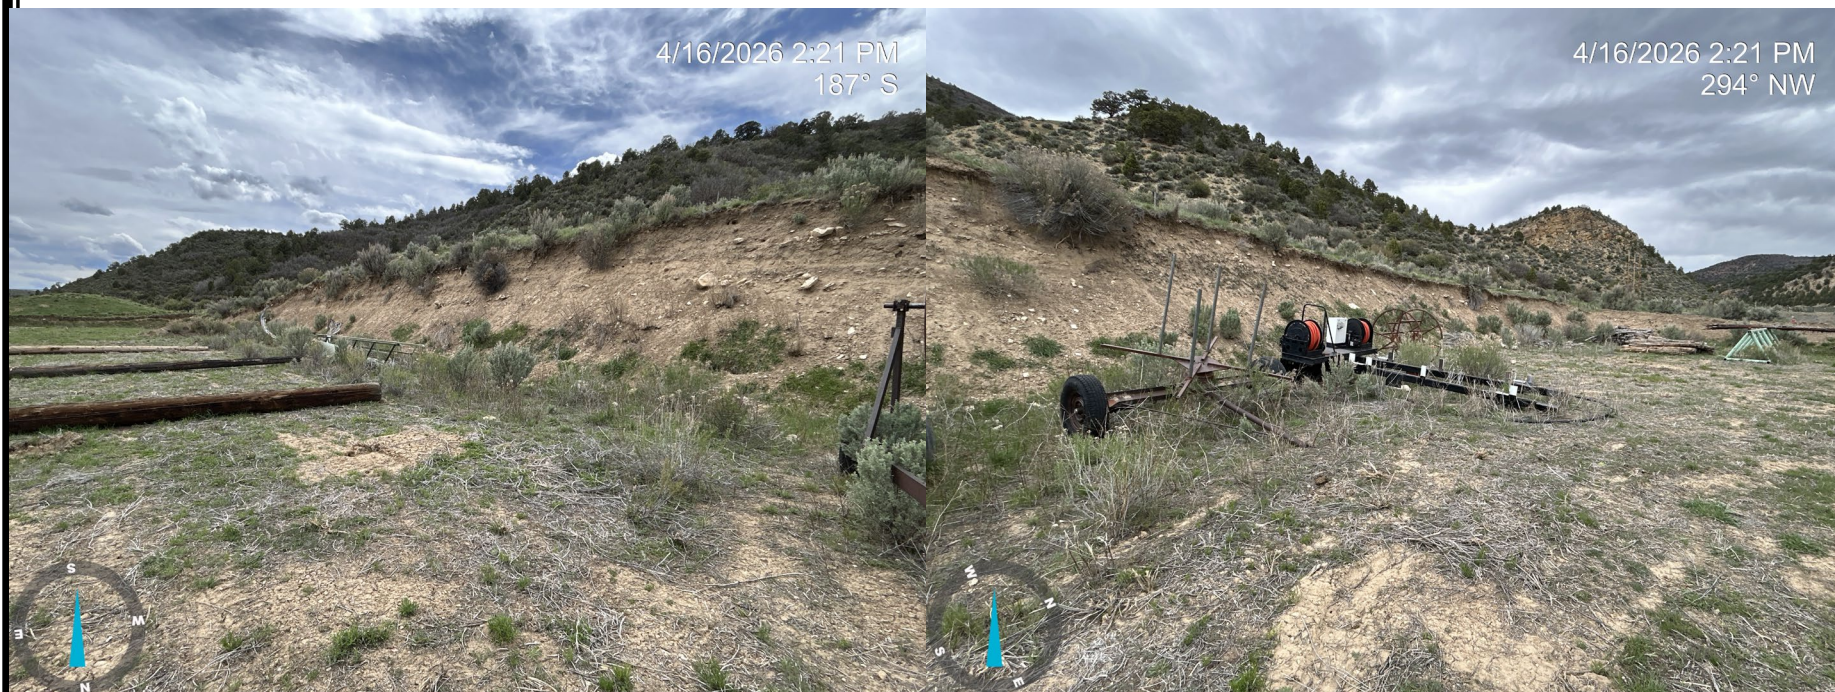
**Photo 3:** Photos showing the western cut slope. Scarping appears to be occurring. Rule 1002.f. is not waivable per Rule 1001.c.; comply with Rule 1002.f. and stabilize cut slopes.

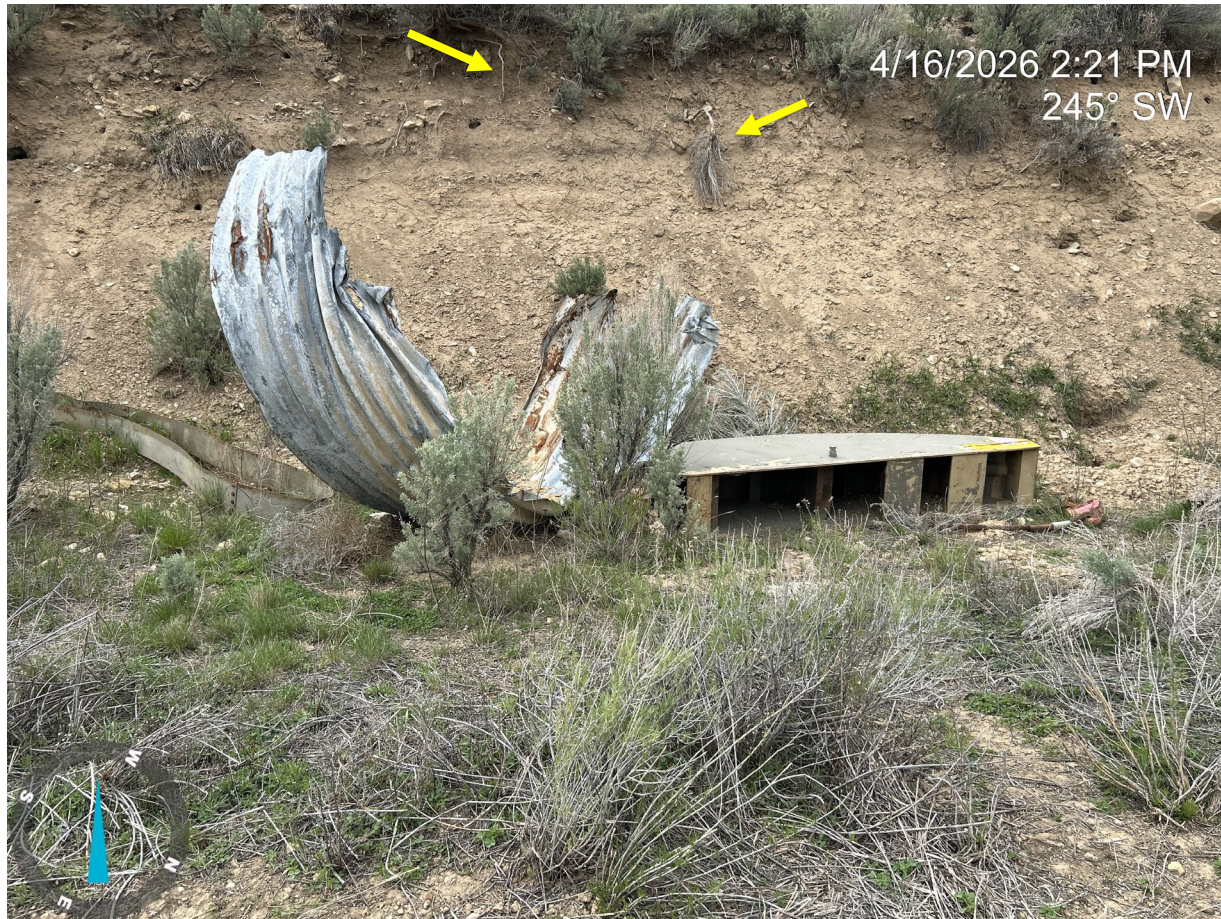
**Photo 4:** Photo showing exposed roots (yellow arrow) on the western cut slope, indicating erosion and degradation.

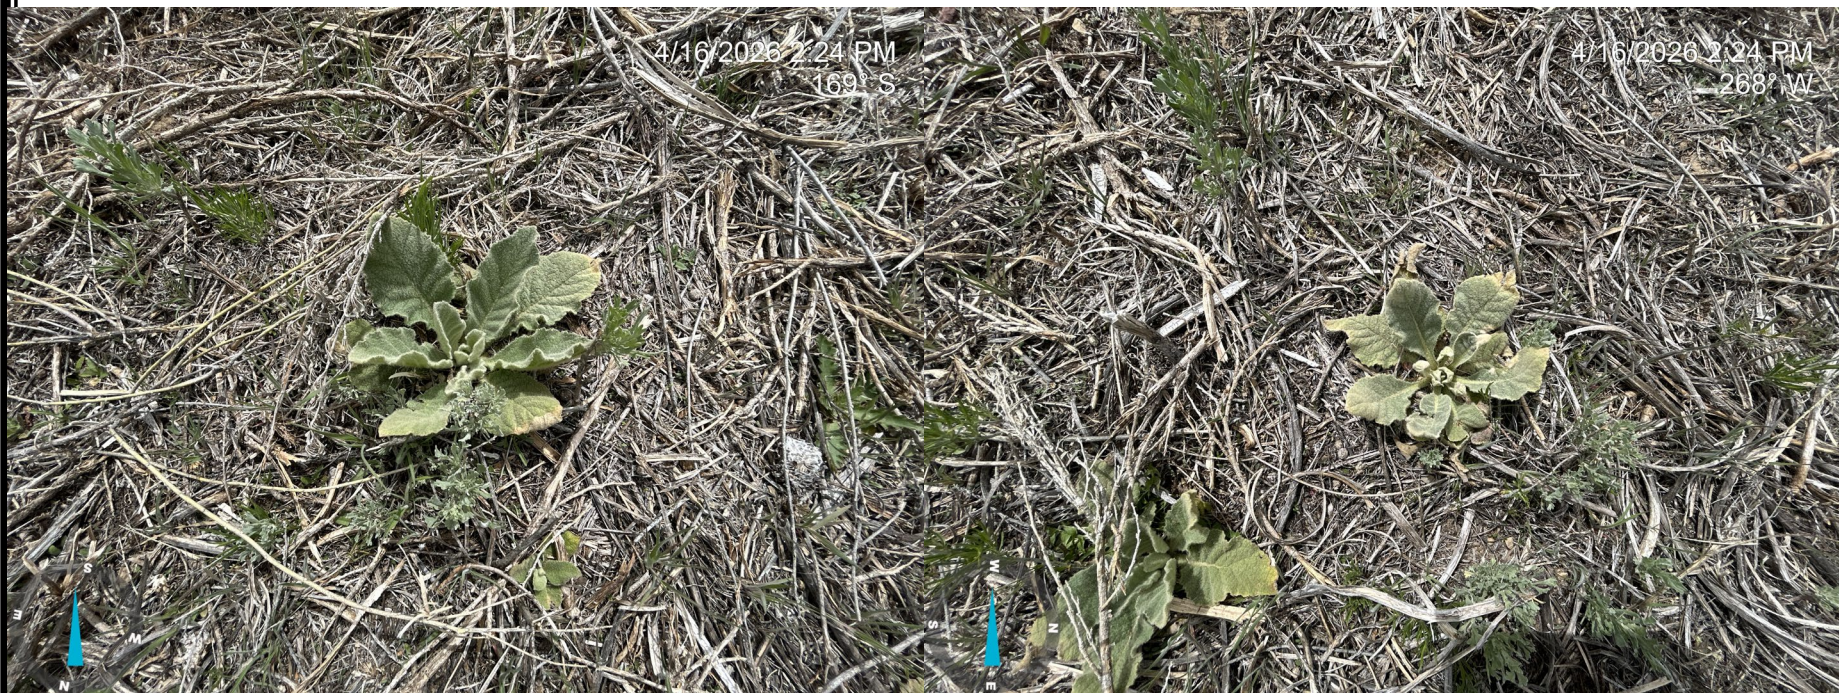
**Photo 5:** Photos showing an example of common mullein, a List C noxious weed, is present throughout the location. Weed management is required per Rules 606.c. and 1004.e.

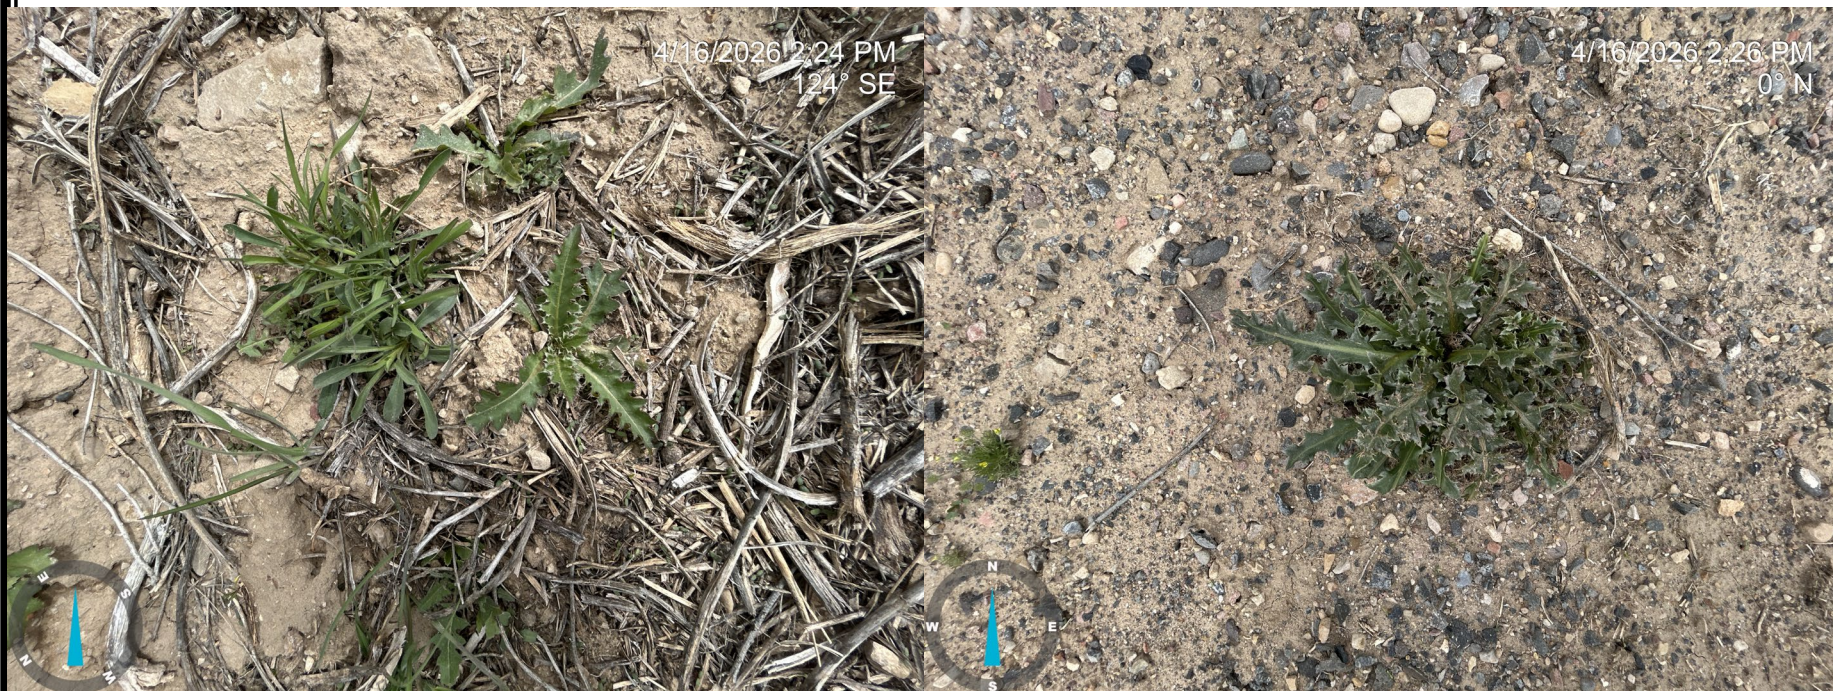
**Photo 6:** Photos showing an example of young thistle basal rosettes, likely Canada thistle (a List B noxious weed), that is present throughout the location. Weed management is required per Rules 606.c. and 1004.e.

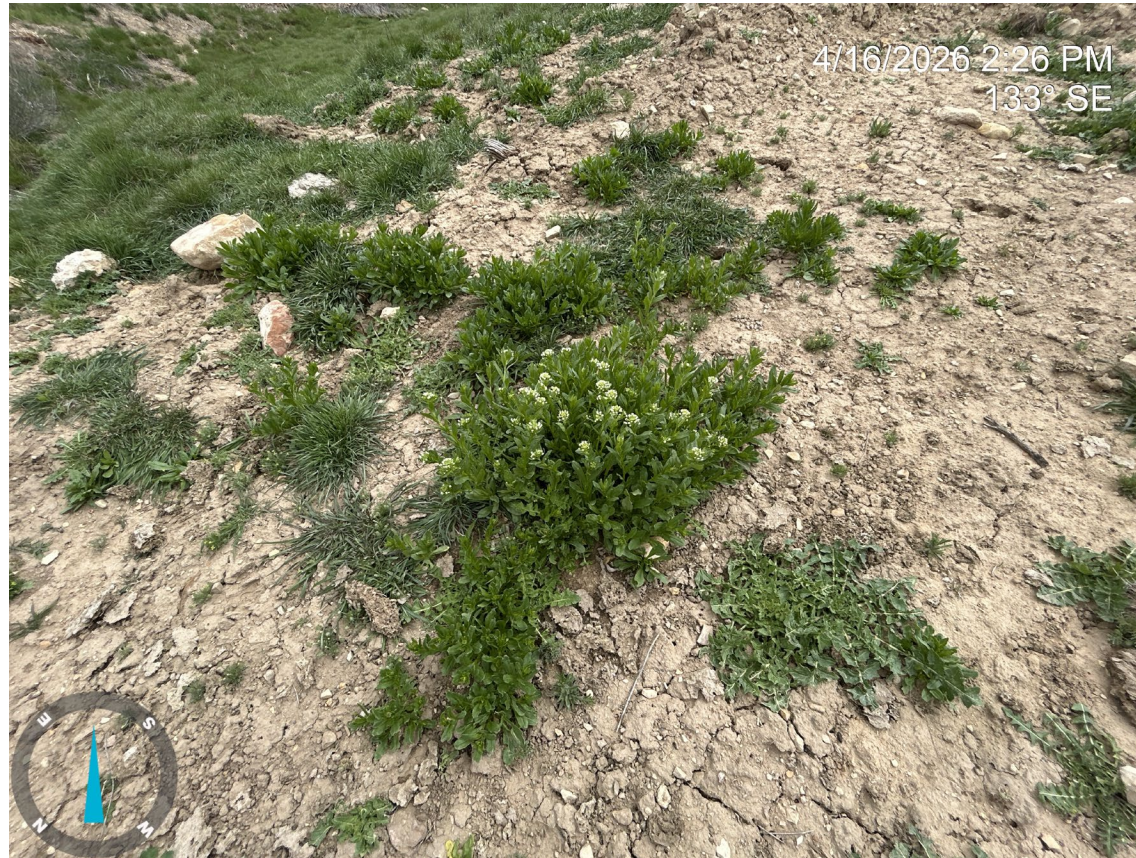
**Photo 7:** Photos showing an example of whitetop and thistle rosettes, likely Canada thistle (both a List B noxious weed), that are present throughout the location. Weed management is required per Rules 606.c. and 1004.e.

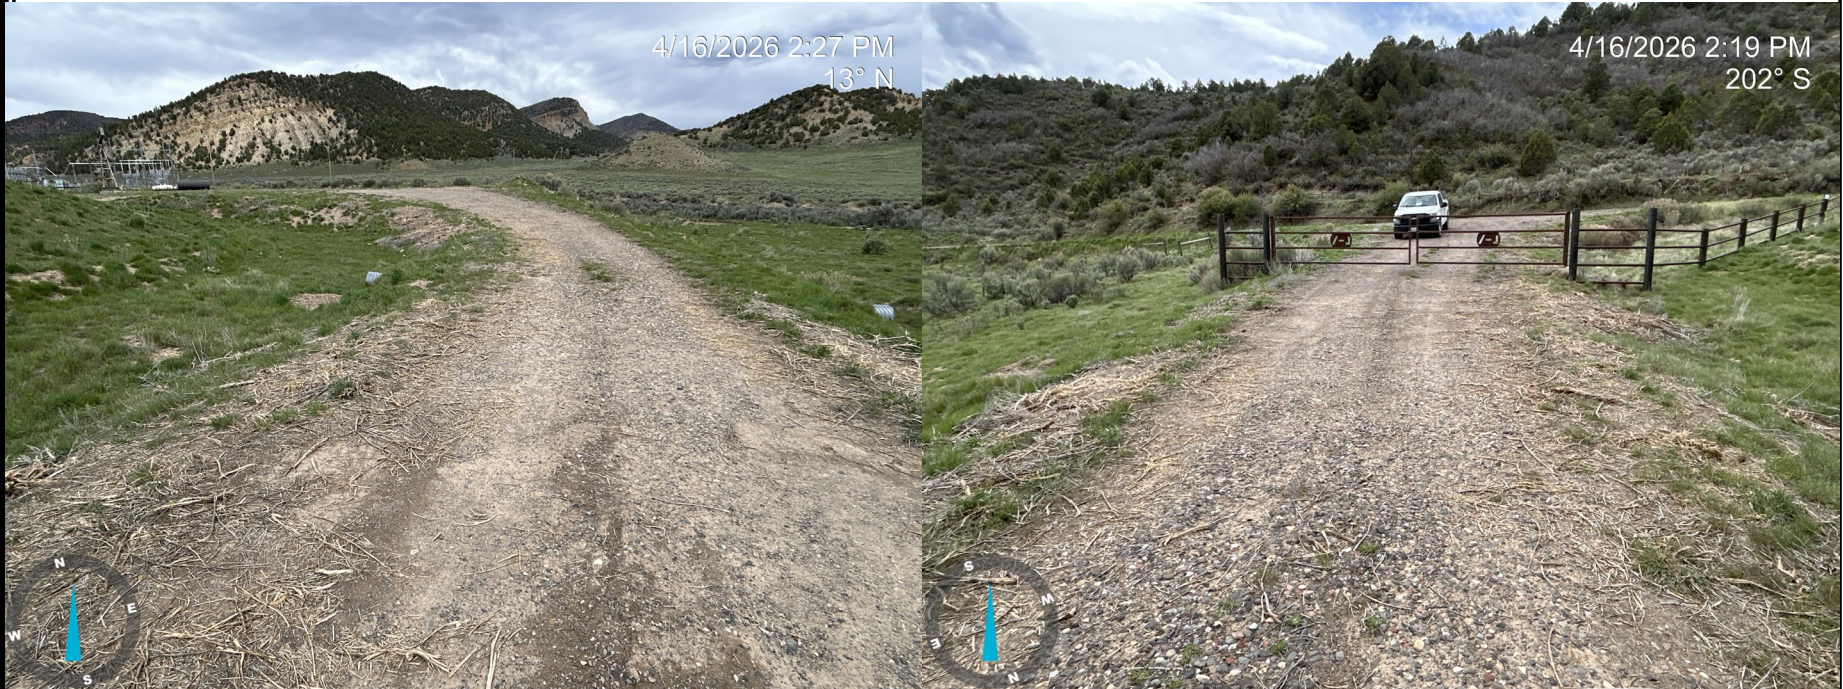
**Photo 8:** Photos showing the access road; the location has a pending Variance request (Docket #220700196) to leave the access road unreclaimed.

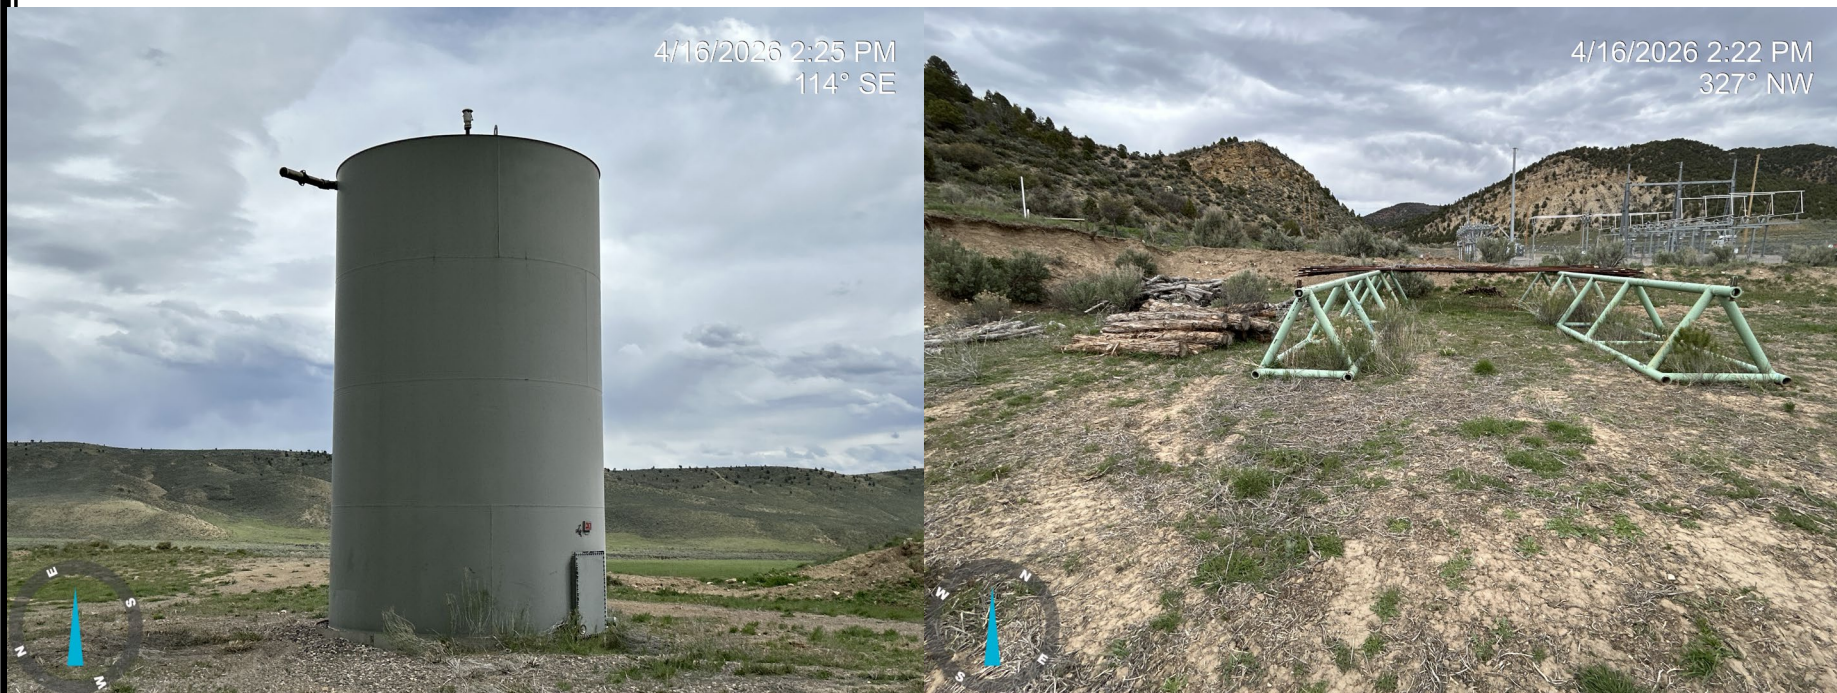
**Photo 9:** Photos showing an example of equipment at the location that was purchased/stored by the Surface Owner. Operator has submitted a bill of sale.
