# Final Reclamation Inspection

April 3, 2026

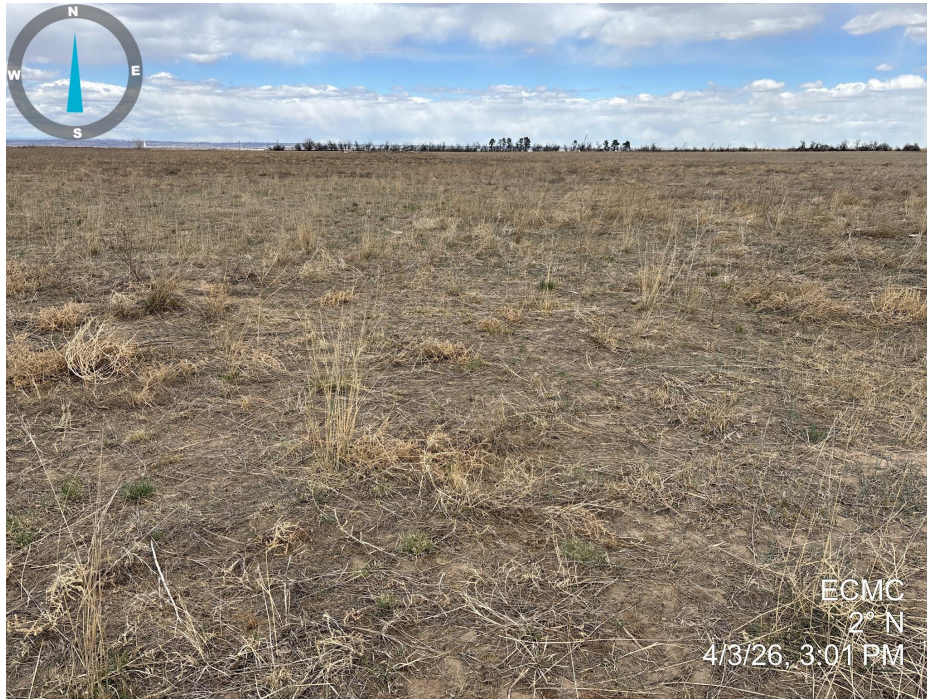
**Photo 1.** Photo taken of the well location, facing north. Photo illustrates that final reclamation activities appear to have taken place, but vegetation establishment does not meet Rule 1004 standards. Weedy annual vegetation including russian thistle (*Salsola tragus*) and cheatgrass (*Bromus tectorum*) was observed across the location.

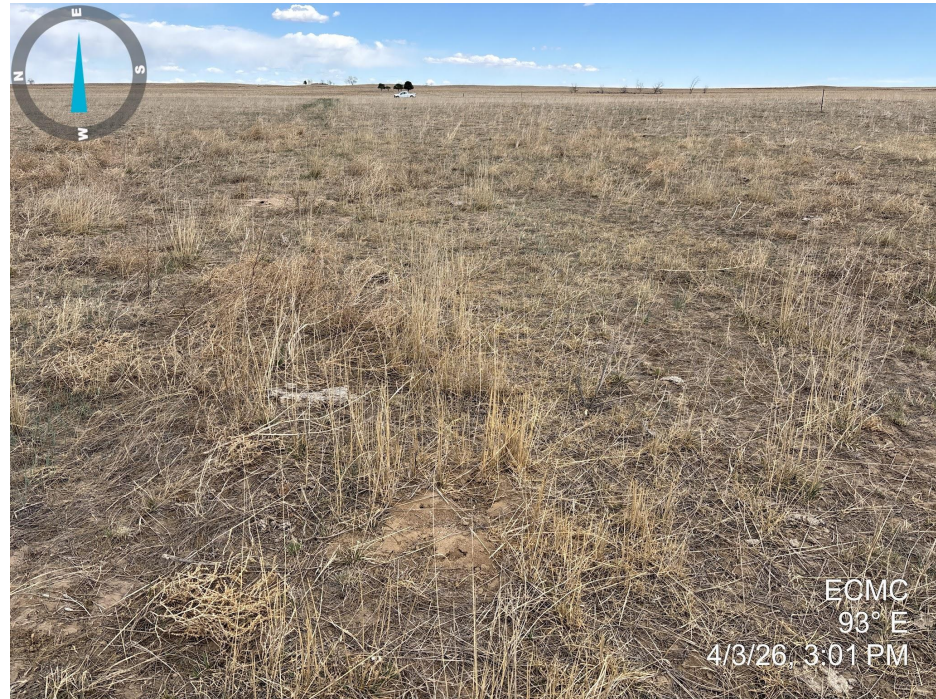
**Photo 2.** Photo taken of the well location, facing east. See comments under Photo 1.
