# Final Reclamation Inspection

Location ID: 330797

Inspection Document #: 718801561

Inspection Photos  
Location Name: BRATTAIN L #12-12Ji  
Location ID: 330797

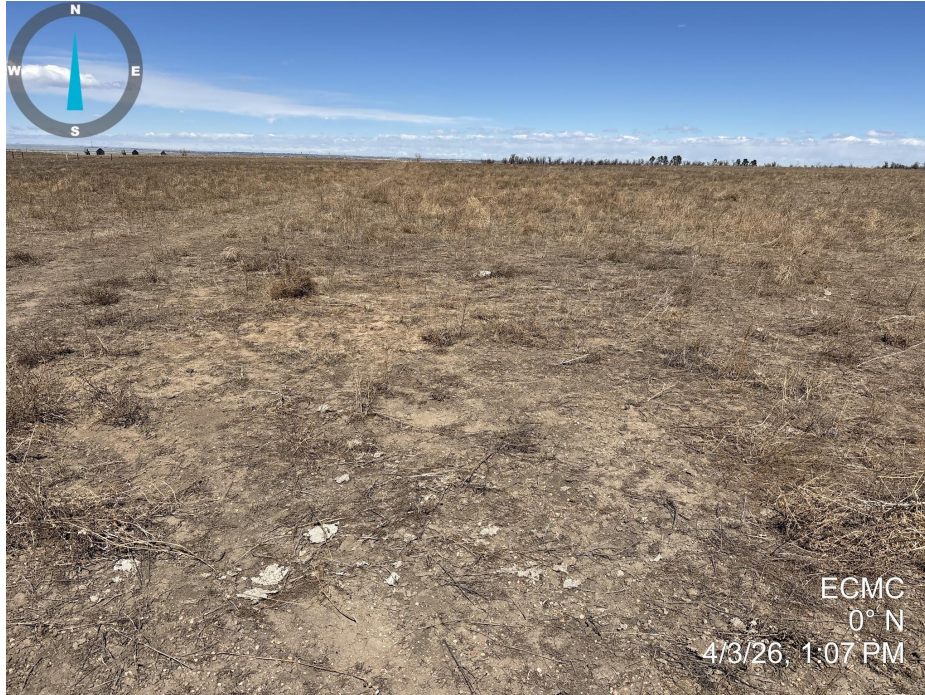
**Photo 1.** Photo taken of the well location, facing north. Photo illustrates that final reclamation activities appear to have taken place at the location, but vegetation establishment does not meet Rule 1004 standards.

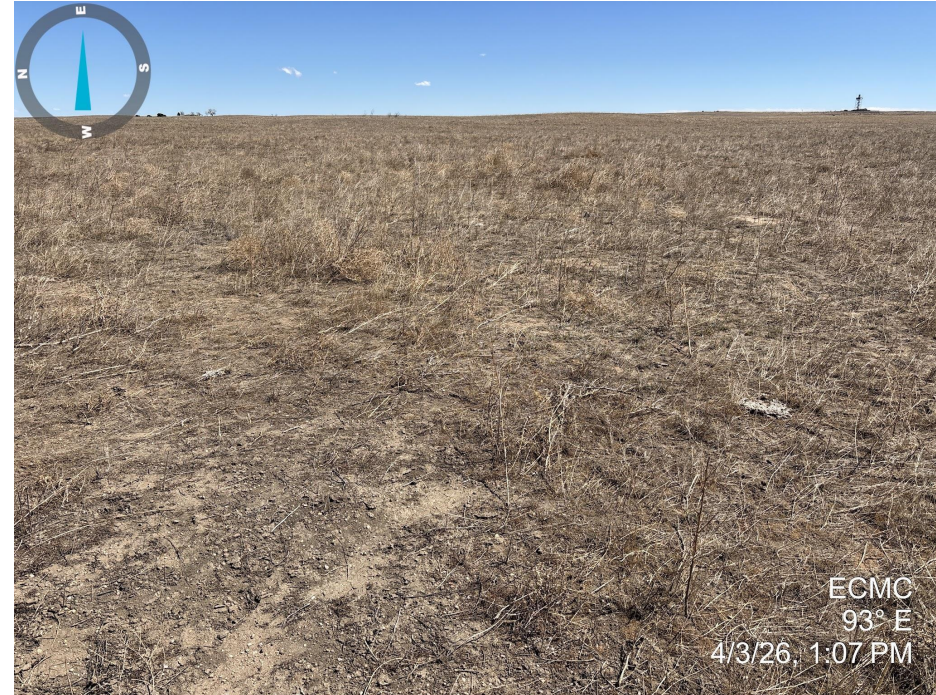
**Photo 2.** Photo taken of the well location, facing east. See comments under Photo 1.

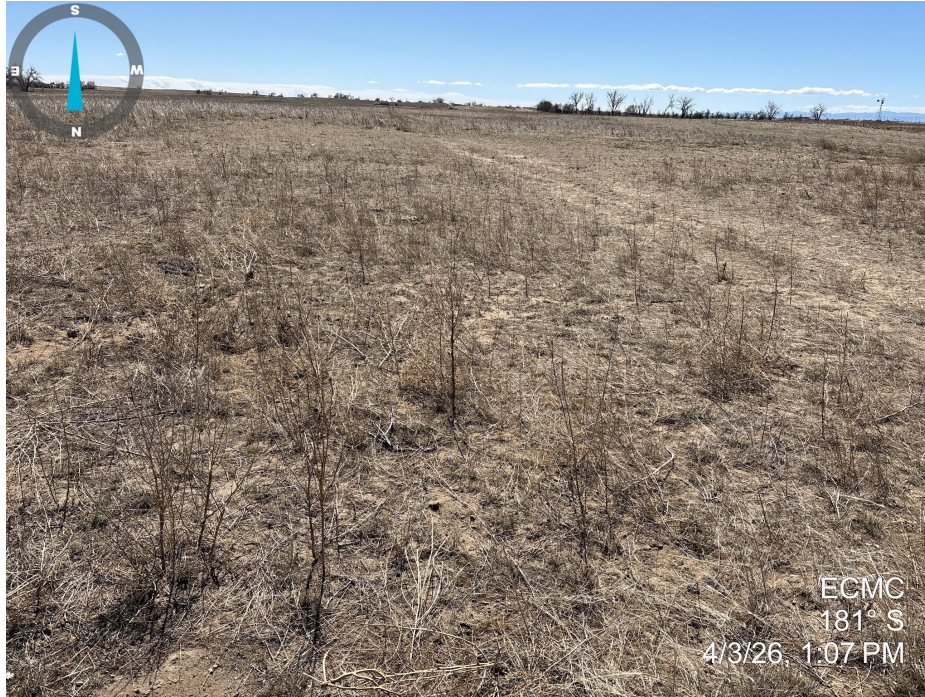
**Photo 3.** Photo taken of the well location, facing south. See comments under Photo 1.

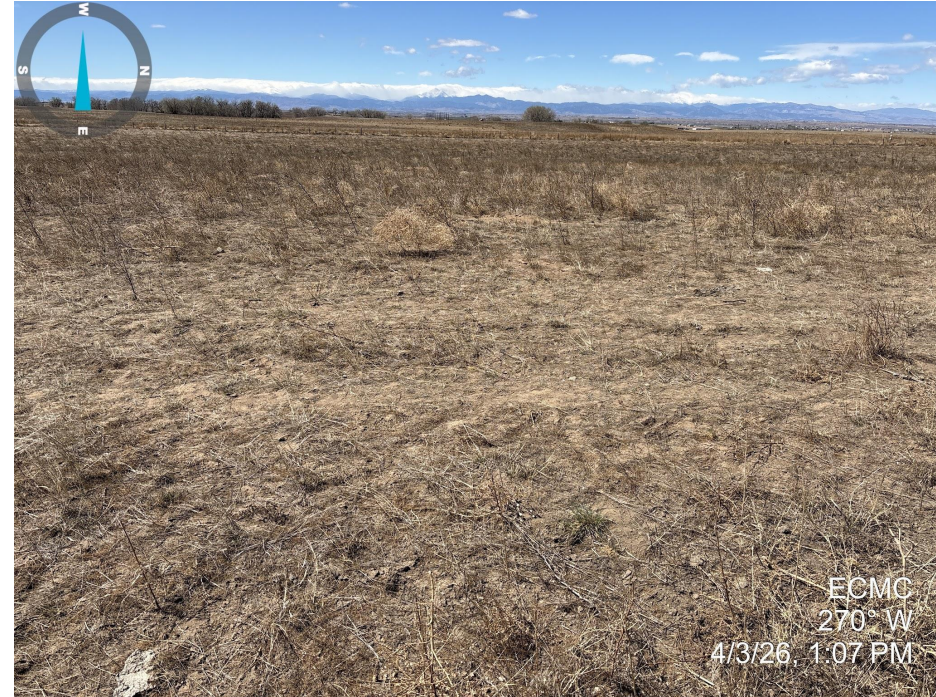
**Photo 4.** Photo taken of the well location, facing west. See comments under Photo 1.

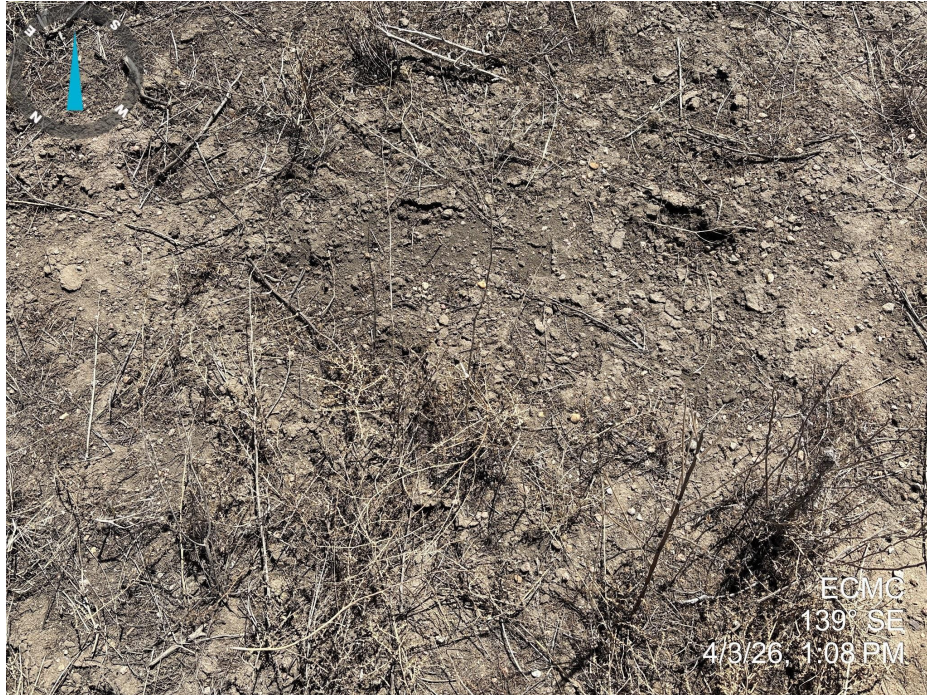
**Photo 5.** Photo taken of ground cover at the location. Photo illustrates perennial grass, bare ground, and weedy annual vegetation including kochia (*Bassia scoparia*) and russian thistle (*Salsola tragus*).

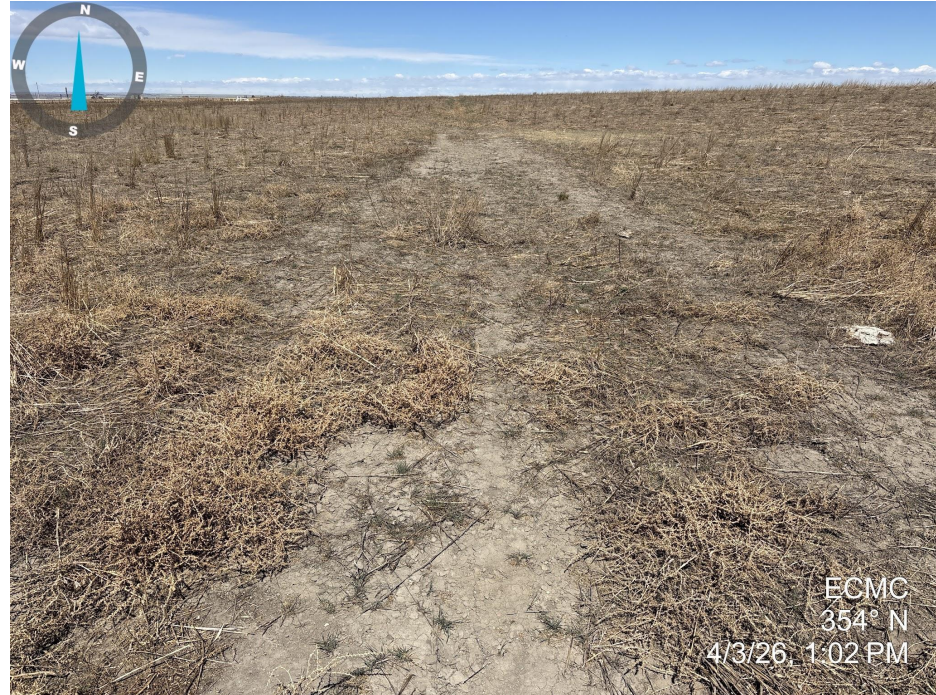
**Photo 6.** Photo taken of the access road to the well location, facing north. Photo illustrates that the access road does not appear to have been recontoured properly and bare ground and weedy annual vegetation including kochia (*Bassia scoparia*) and russian thistle (*Salsola tragus*) were observed.

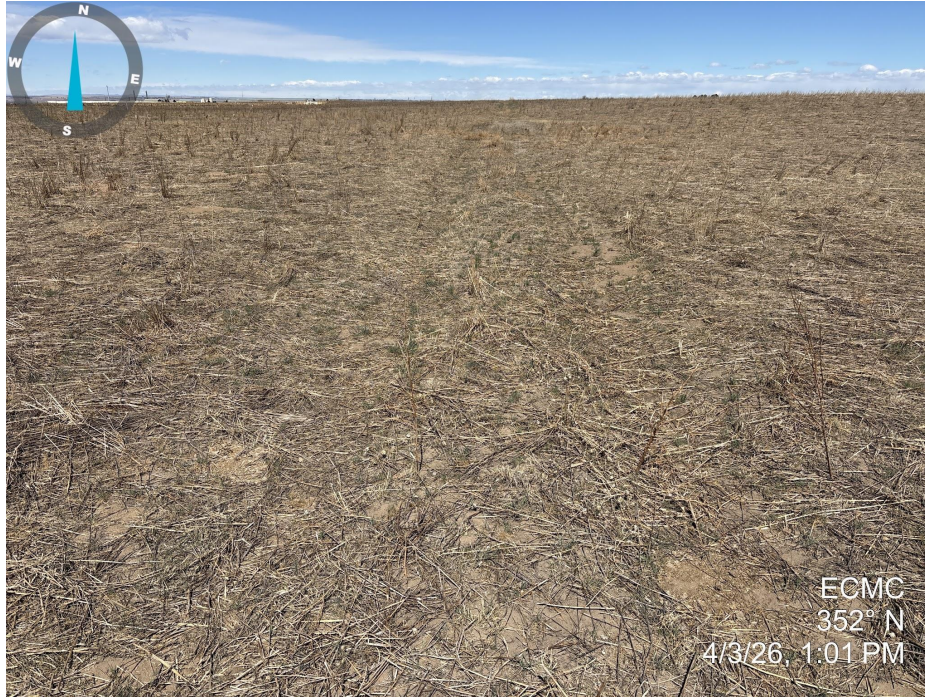
**Photo 7.** Photo taken of the access road to the well location, facing north. See comments under Photo 6.

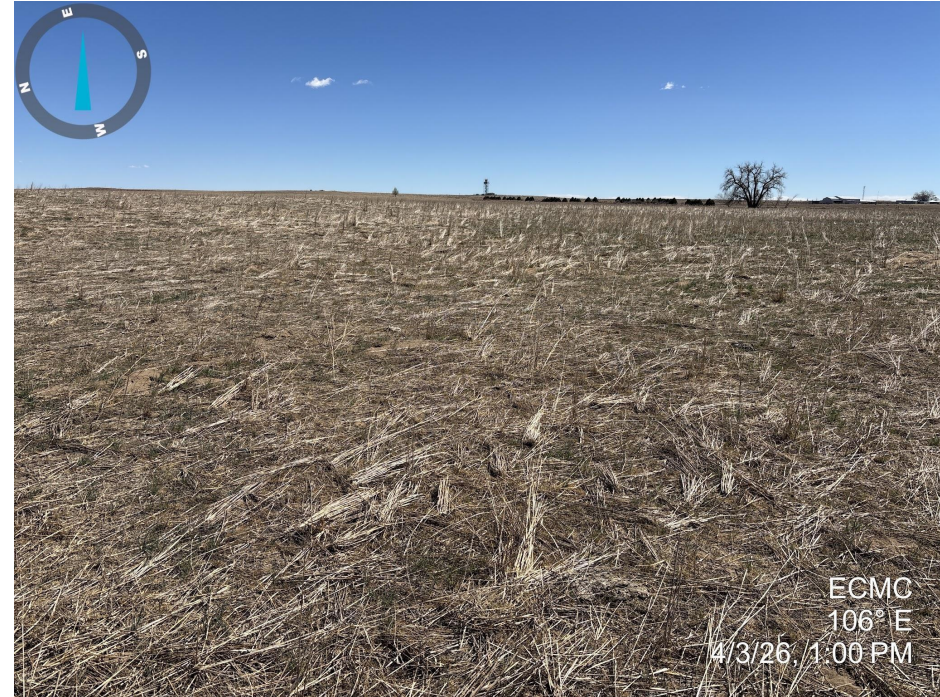
**Photo 8.** Photo taken of the reference area to the location, east of the well location, facing east. Photo illustrates perennial grass.
