Final Reclamation Inspection

Operator: KERR MCGEE OIL & GAS ONSHORE LP - 47120

Location ID: 311469

Inspection Photos
Location Name: BRATTAIN L #12-14JI
Location ID: 311469

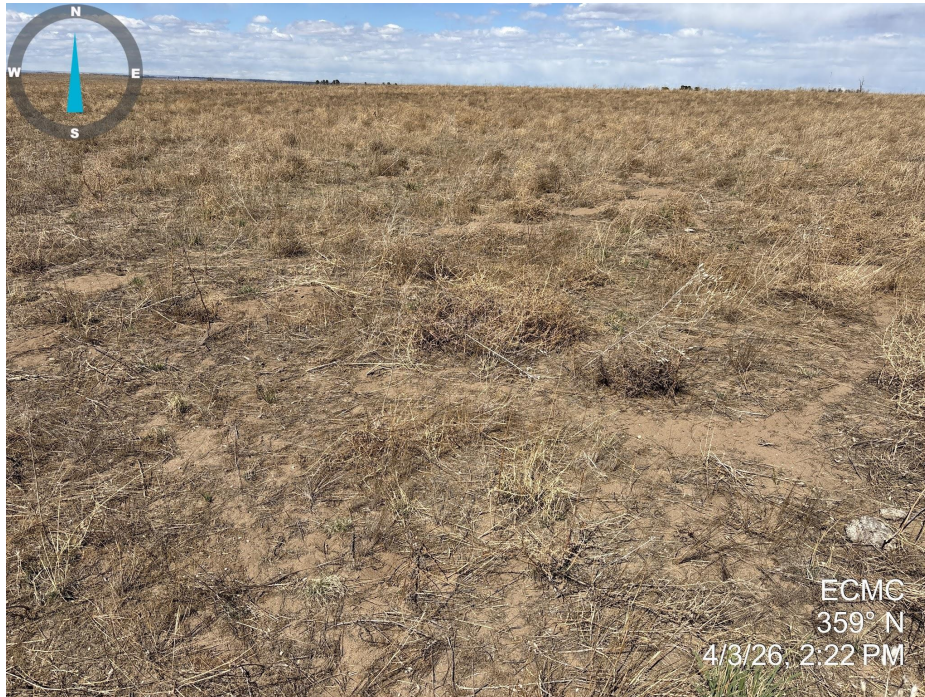
Photo 1. Photo taken of the well location, facing north. Photo illustrates that final reclamation activities appear to have taken place at the location, but vegetation establishment does not meet Rule 1004 standards and weedy annual vegetation including russian thistle (*Salsola tragus*) and cheatgrass (*Bromus tectorum*), a List C Noxious Weed species, was observed at the location.

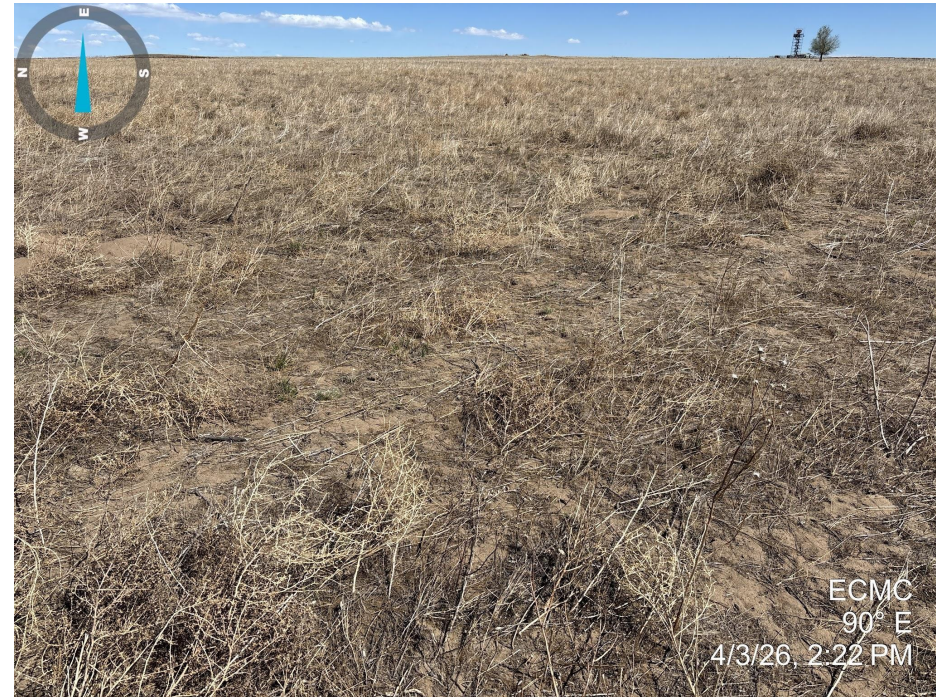
Photo 2. Photo taken of the well location, facing east. See comments under Photo 1.

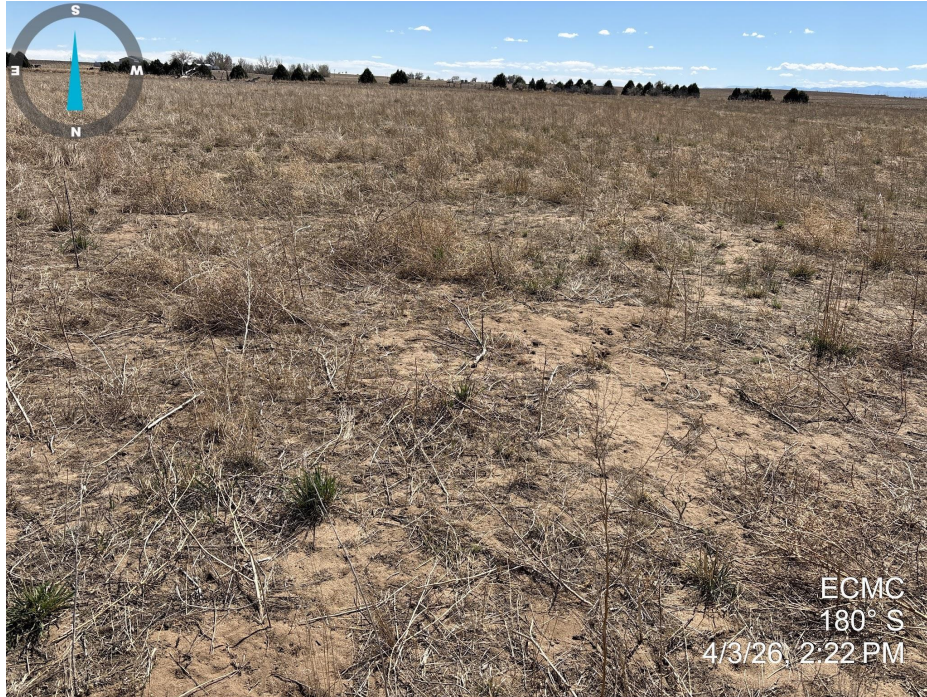
Photo 3. Photo taken of the well location, facing south. See comments under Photo 1.

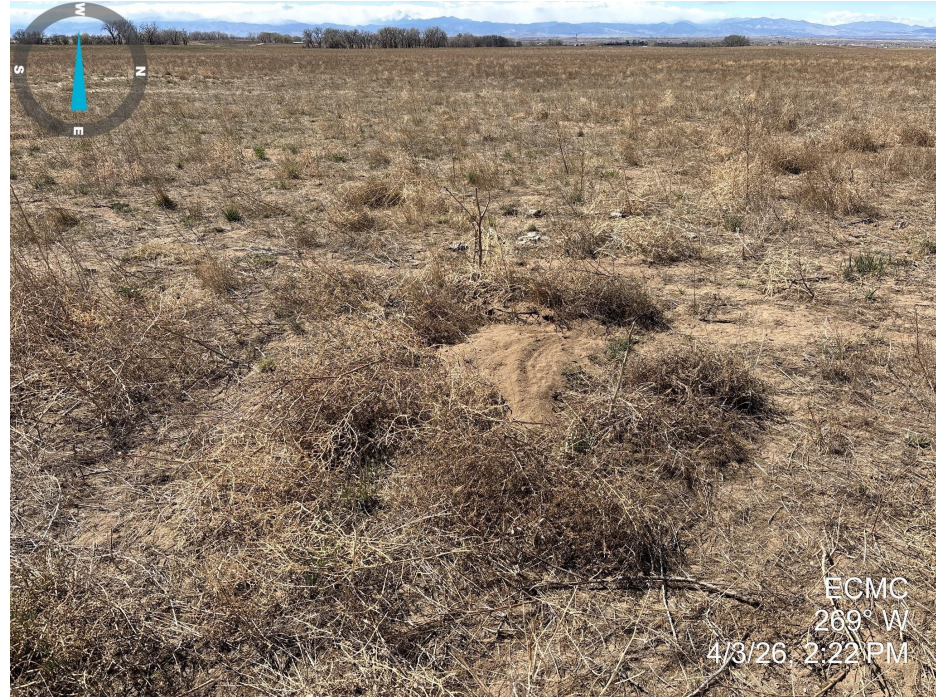
Photo 4. Photo taken of the well location, facing west. See comments under Photo 1.

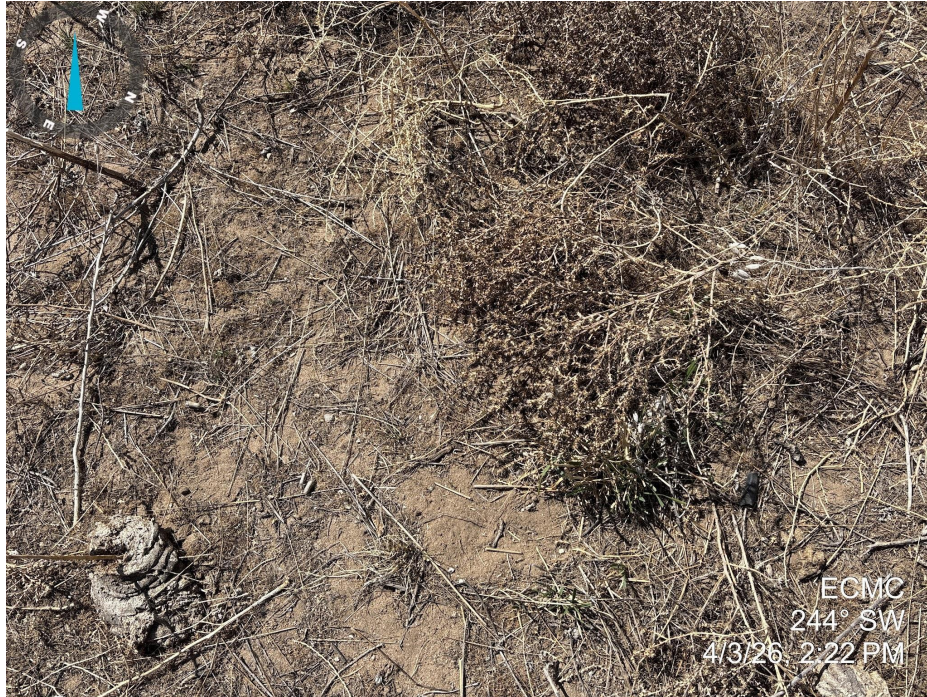
Photo 5. Photo taken of ground cover at the well location. Photo illustrates perennial grass, bare ground, and weedy annual vegetation including russian thistle (*Salsola tragus*) and cheatgrass (*Bromus tectorum*).

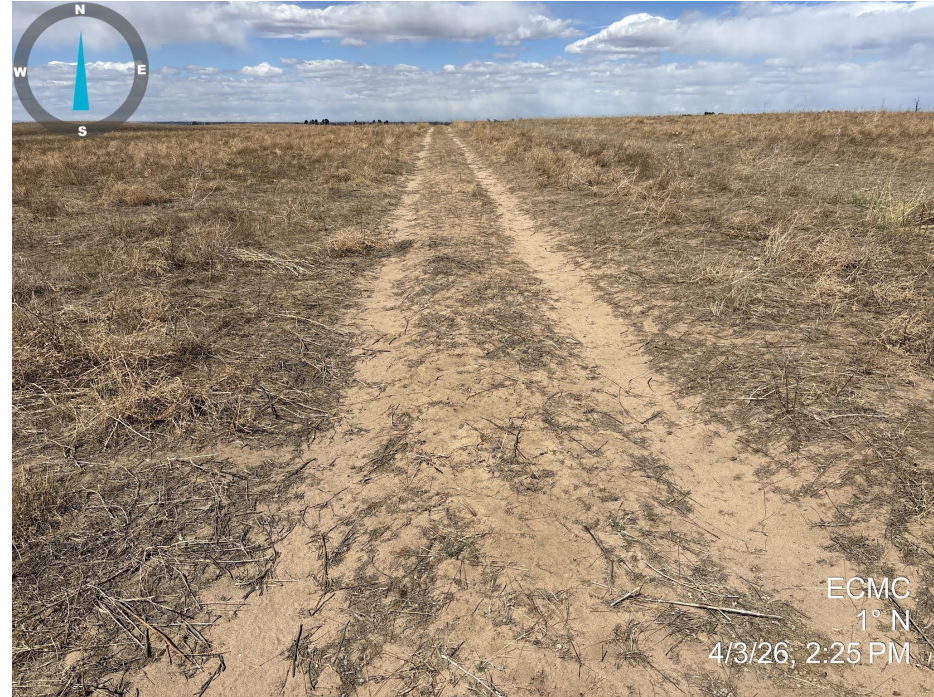
Photo 6. Photo taken of the access road to the location, facing north, away from the location. Photo illustrates that the access road does not meet Rule 1004 standards and bare ground and weedy annual vegetation including cheatgrass (*Bromus tectorum*), a List C Noxious Weed species, were observed.

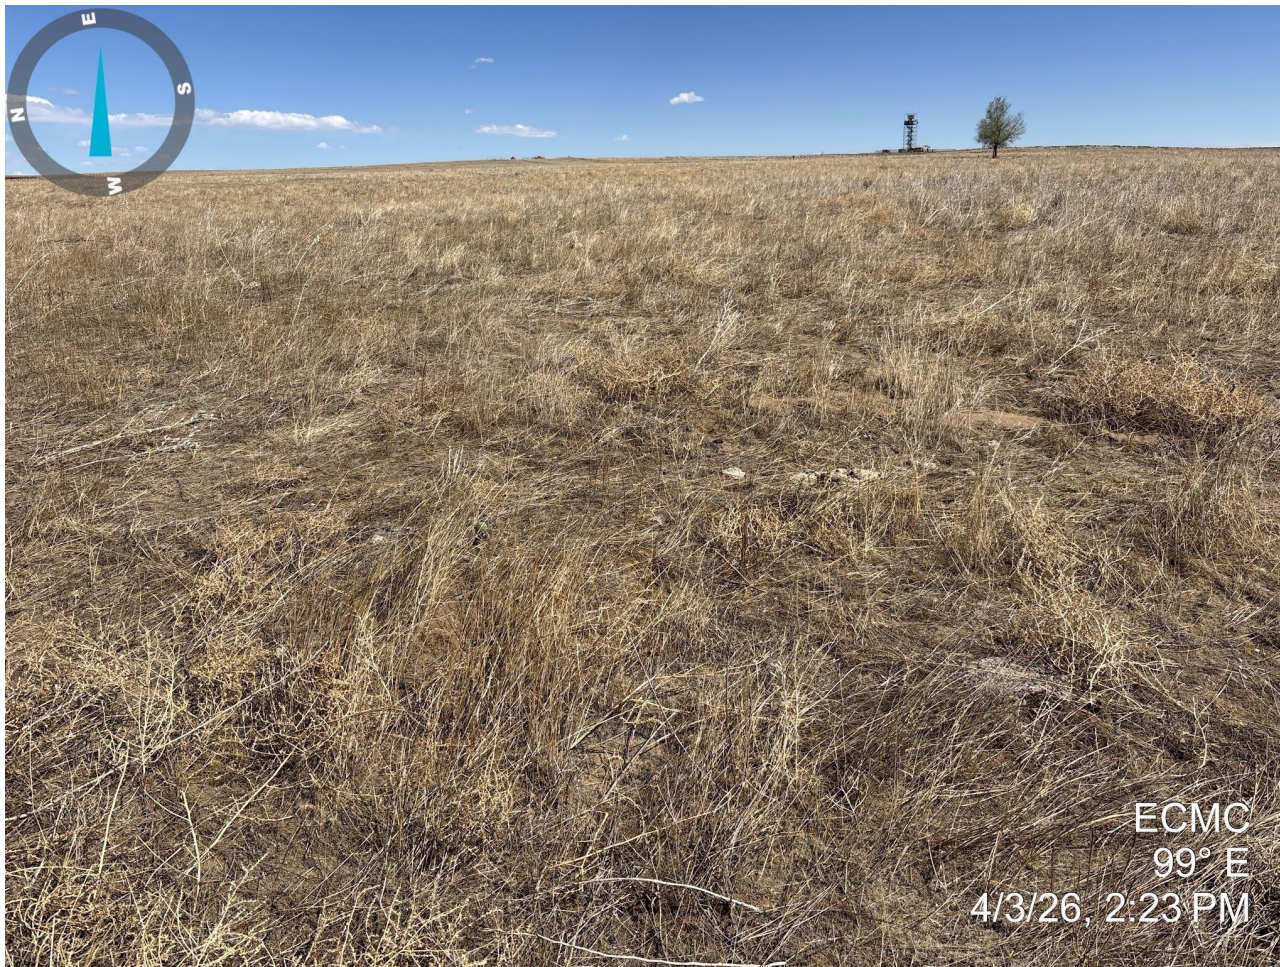
Photo 7. Photo taken of the reference area to the location, east of the well location, facing east. Photo illustrates perennial grass and weedy annual vegetation.
