Final Reclamation Inspection

Operator: KERR MCGEE OIL & GAS ONSHORE LP - 47120

Location ID: 328218

Inspection Photos
Location Name: BELL #L12-13
Location ID: 328218

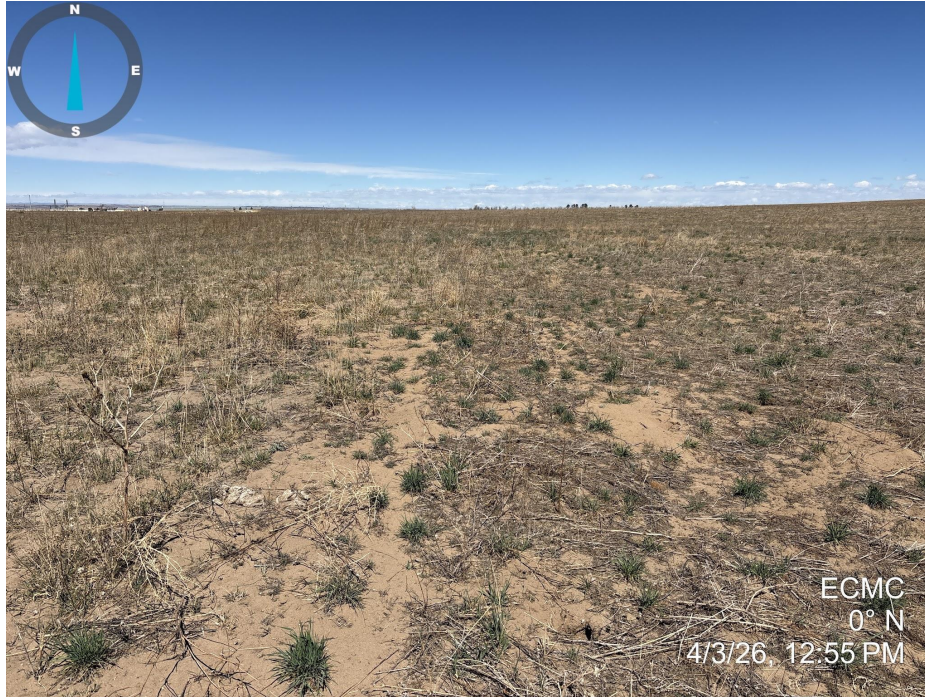
Photo 1. Photo taken of the well location, facing north. Photo illustrates that final reclamation activities appear to have taken place at the location, but vegetation establishment does not meet Rule 1004 standards.

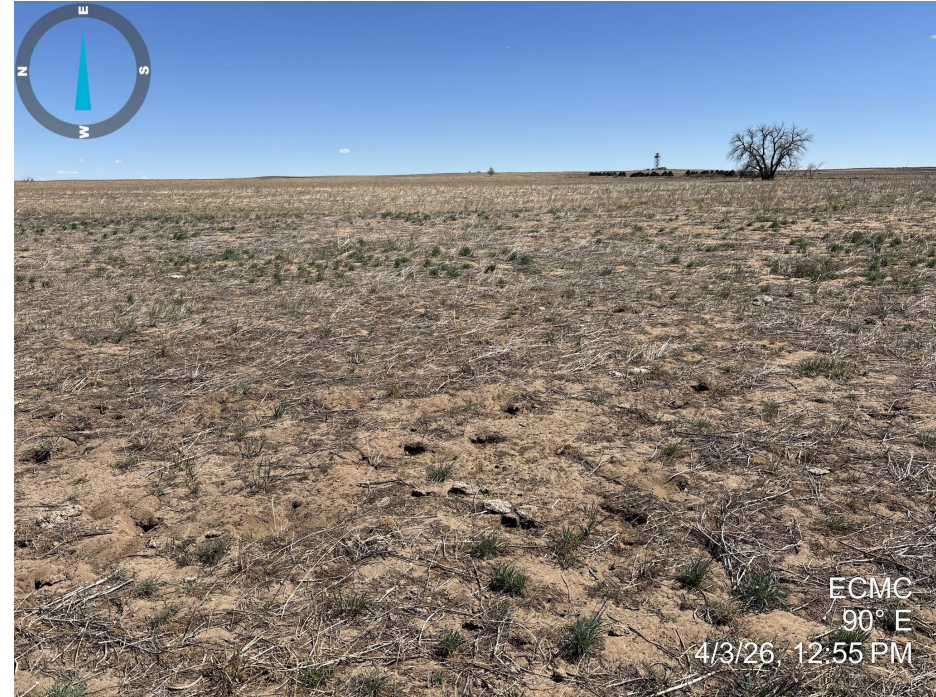
Photo 2. Photo taken of the well location, facing east. See comments under Photo 1.

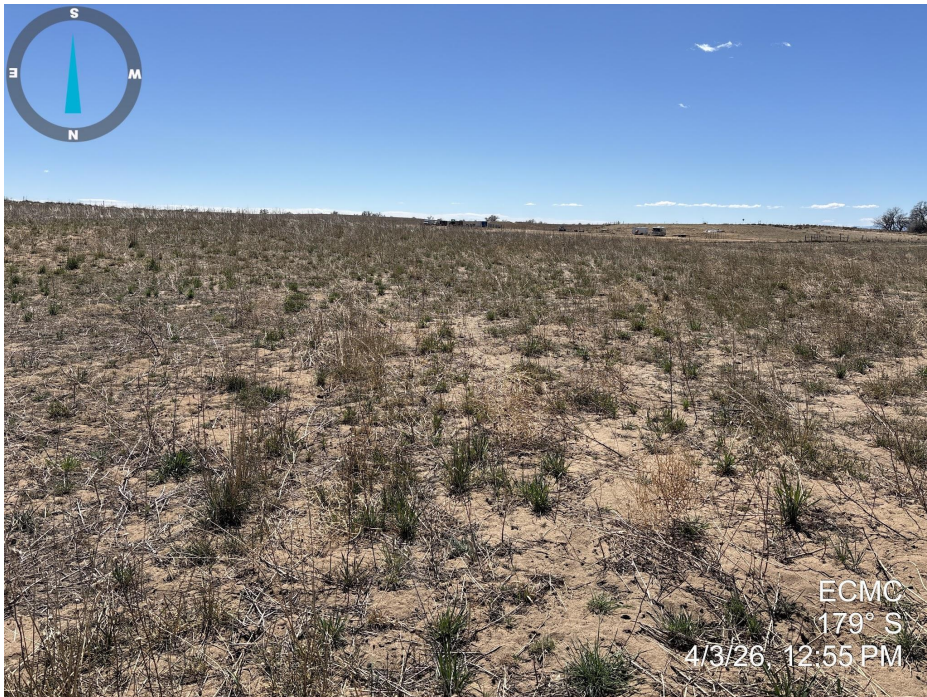
Photo 3. Photo taken of the well location, facing south. See comments under Photo 1.

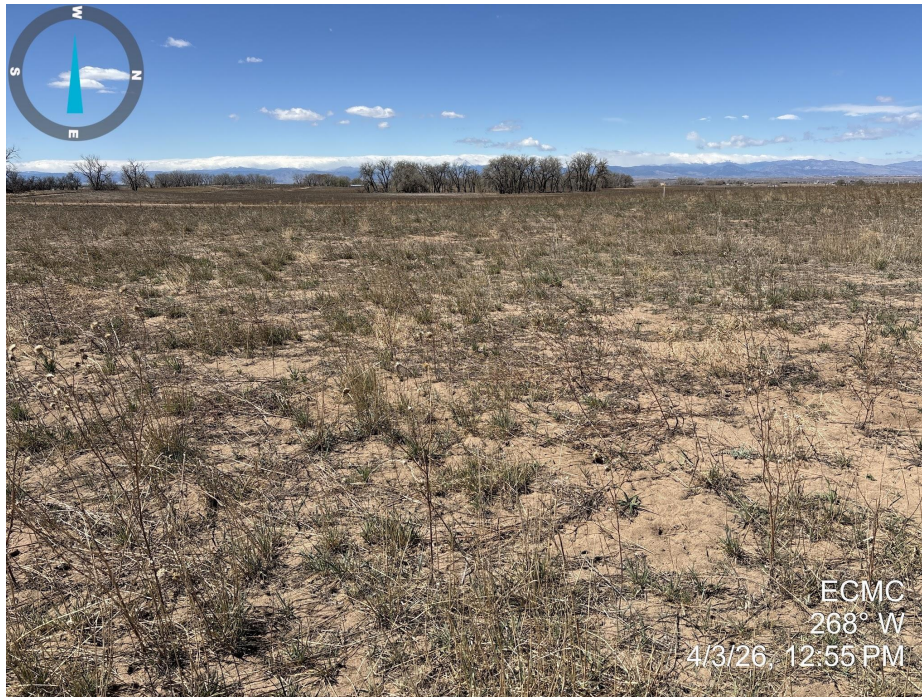
Photo 4. Photo taken of the well location, facing west. See comments under Photo 1.

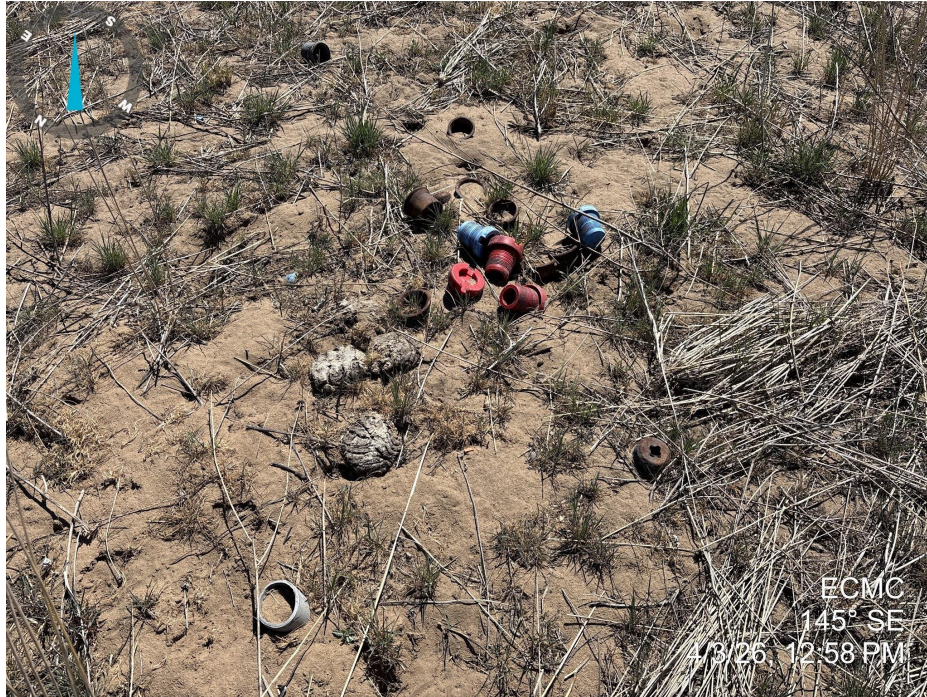
Photo 5. Photo taken of ground cover at the location. Photo illustrates perennial grass, bare ground, and debris that was observed at the location.

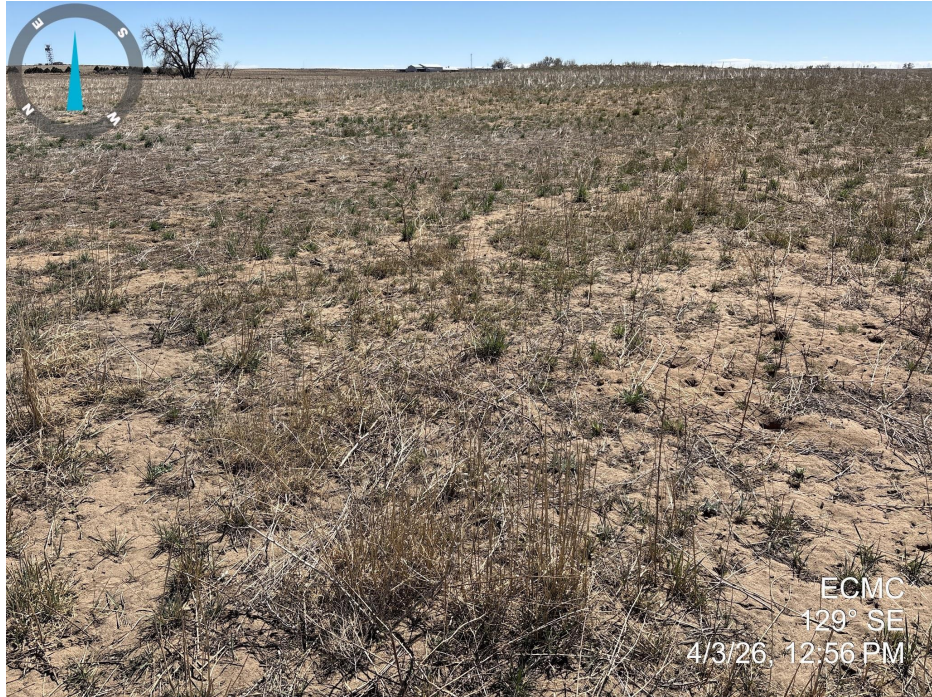
Photo 6. Photo taken of the location, facing southeast. See comments under Photo 1.

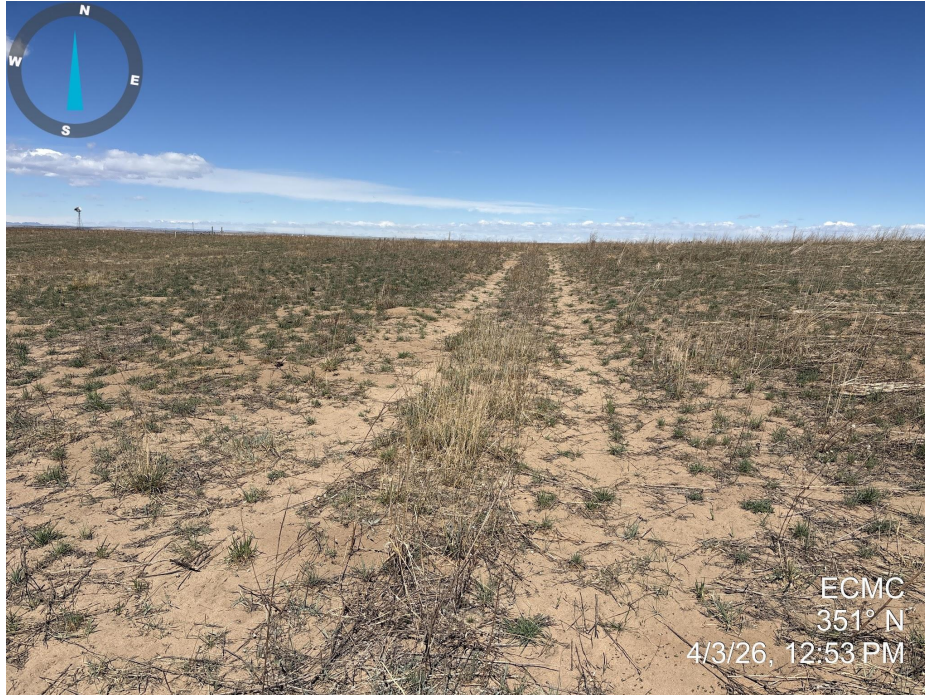
Photo 7. Photo taken of the access road to the well location, facing north. Photo illustrates that reclamation activities appear to have taken place along the road, but vegetation has not established to Rule 1004 standards.

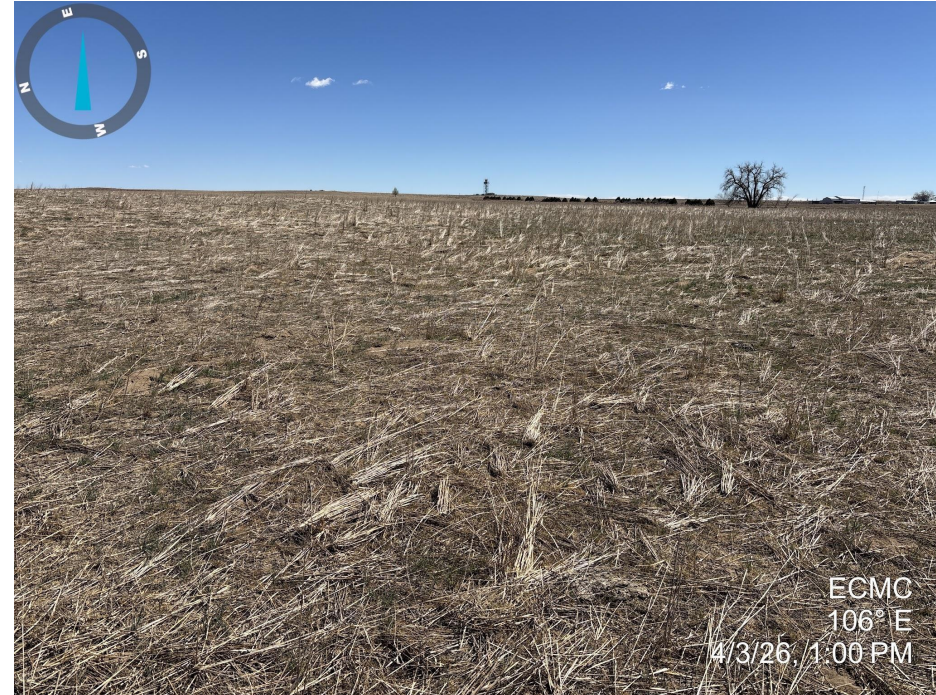
Photo 8. Photo taken of the reference area to the location, east of the well location, facing east. Photo illustrates perennial grass.
