Final Reclamation Inspection

Operator: NOBLE ENERGY INC - 100322

Location ID: 328328

Inspection Photos
Location Name: BELL #L12-24
Location ID: 328328

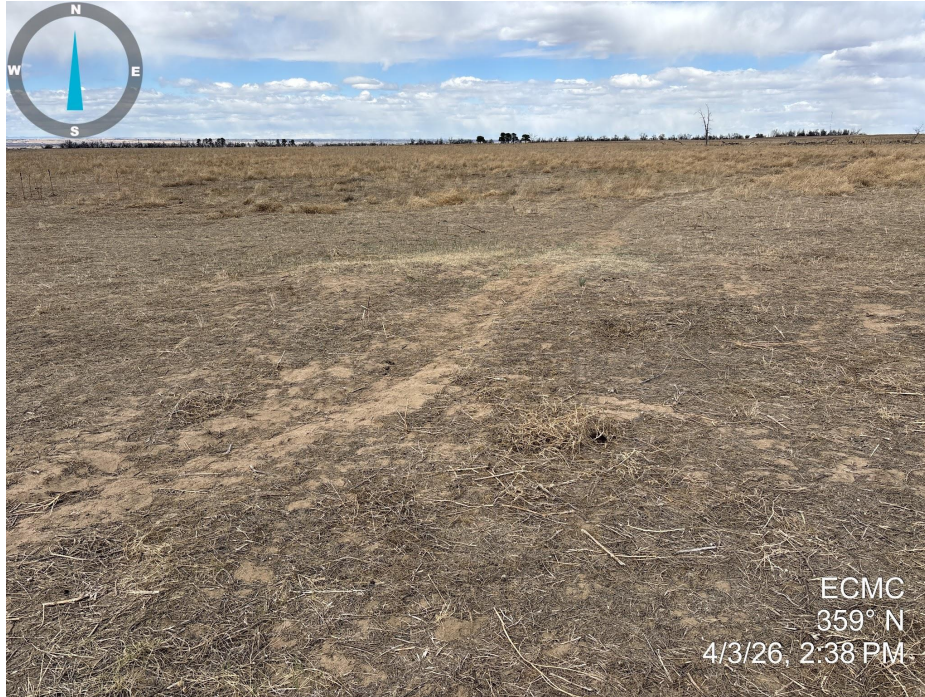
Photo 1. Photo taken of the well location, facing north. Photo illustrates that final reclamation activities appear to have taken place, with evidence of drill row seeding, but vegetation establishment does not meet Rule 1004 standards.

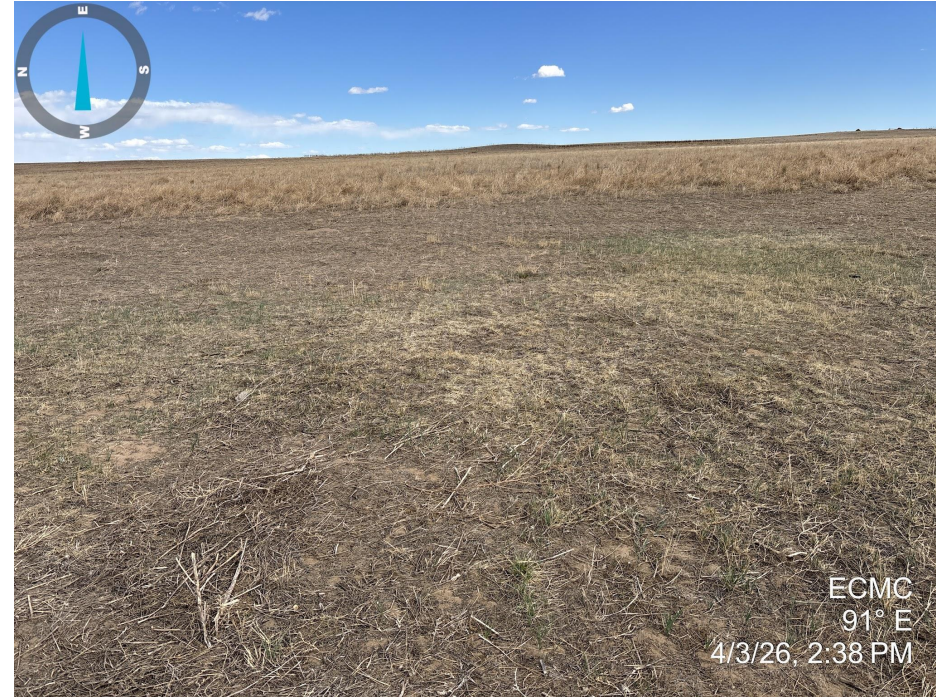
Photo 2. Photo taken of the well location, facing east. See comments under Photo 1.

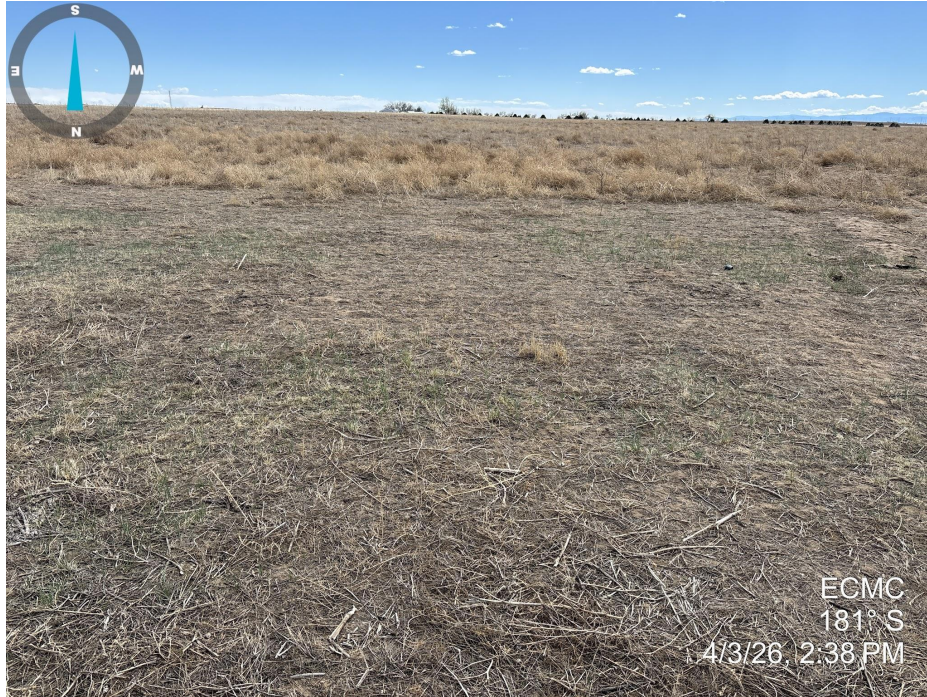
Photo 3. Photo taken of the well location, facing south. See comments under Photo 1.

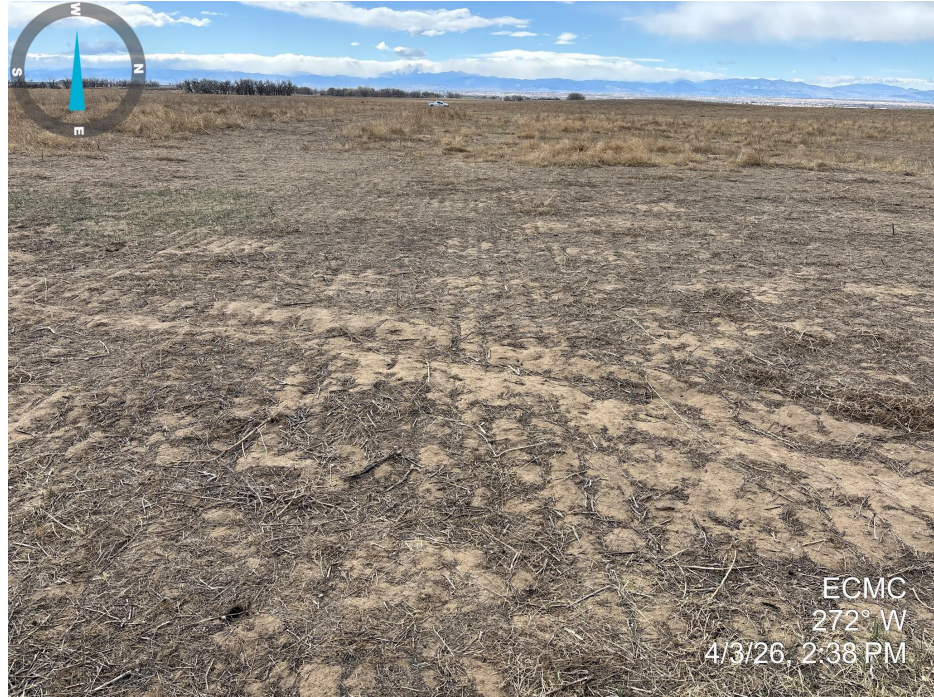
Photo 4. Photo taken of the well location, facing west. See comments under Photo 1.

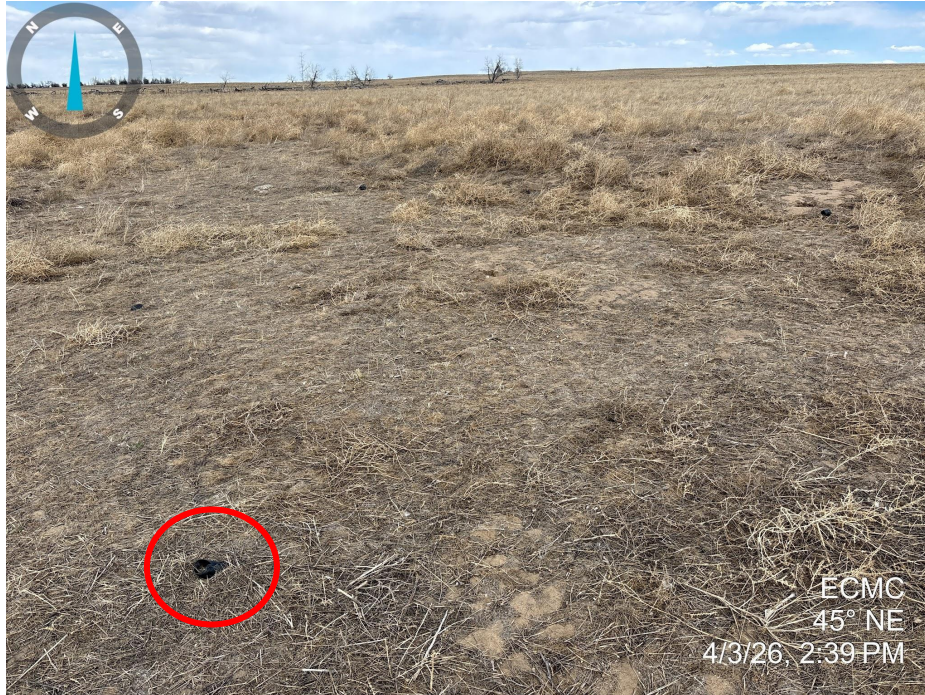
Photo 5. Photo taken of the well location, facing northeast. See comments under Photo 1. Photo illustrates debris was observed across the northeastern portion of the location (circled in red).

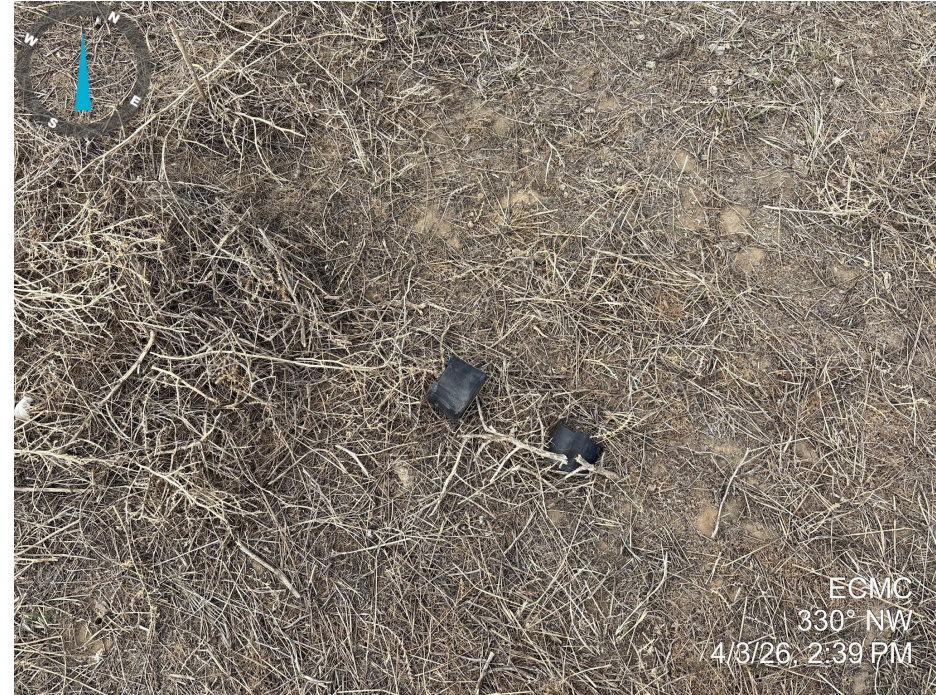
Photo 6. Photo taken of ground cover at the location. Photo illustrates perennial grass, weedy annual vegetation, and debris.

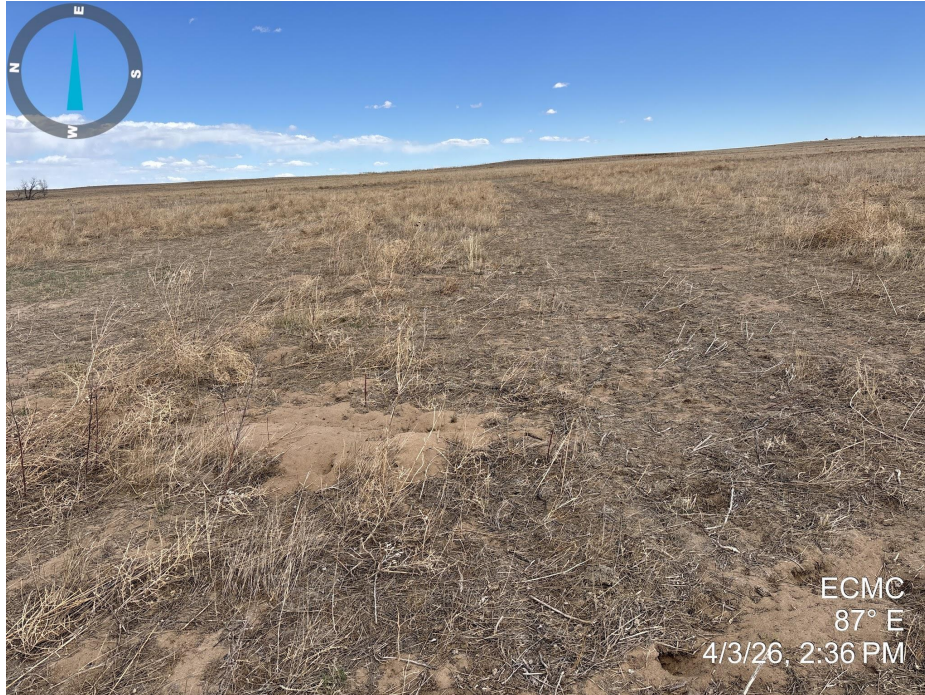
Photo 7. Photo taken of the access road to the well location, facing east, towards the location. Photo illustrates that final reclamation activities appear to have taken place, with evidence of drill rows from seeding, but vegetation establishment does not meet Rule 1004 standards.

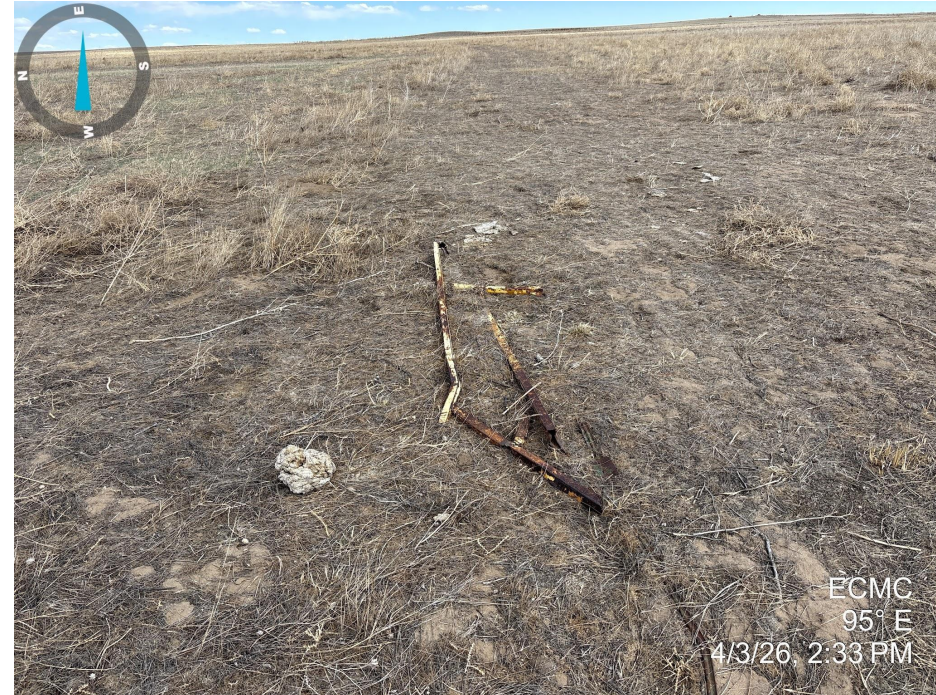
Photo 8. Photo taken of the access road to the well location, facing east. Photo illustrates debris was observed on the road.

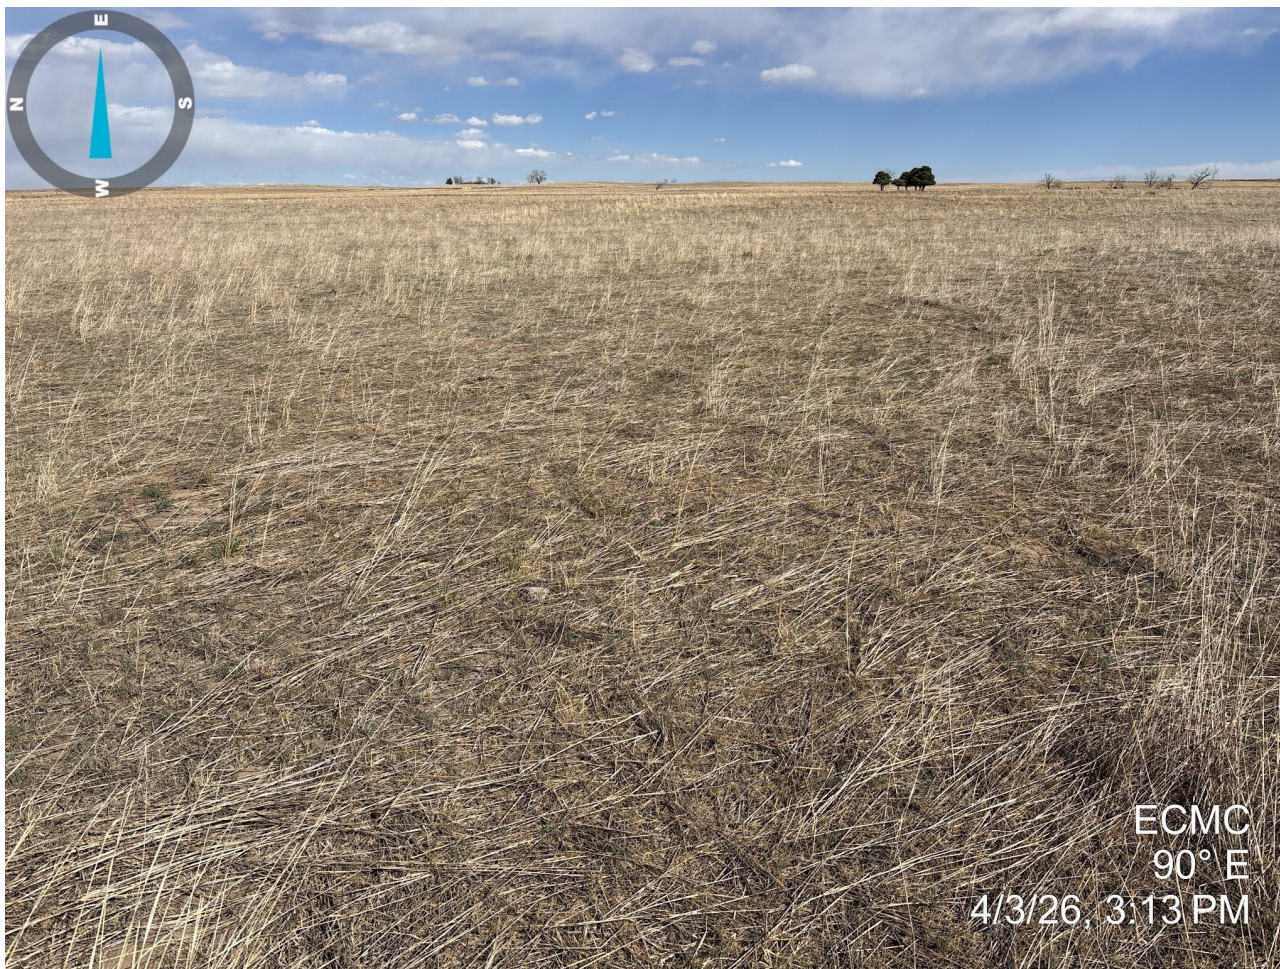
Photo 9. Photo taken of the reference area to the location, north of the location, facing east. Photo illustrates perennial grass and weedy annual vegetation.
