INSPECTION PHOTOS

Well: LPGC 32-32

INSPECTION DOC #: 716302227

Operator: EVERGREEN NATURAL RESOURCES LLC

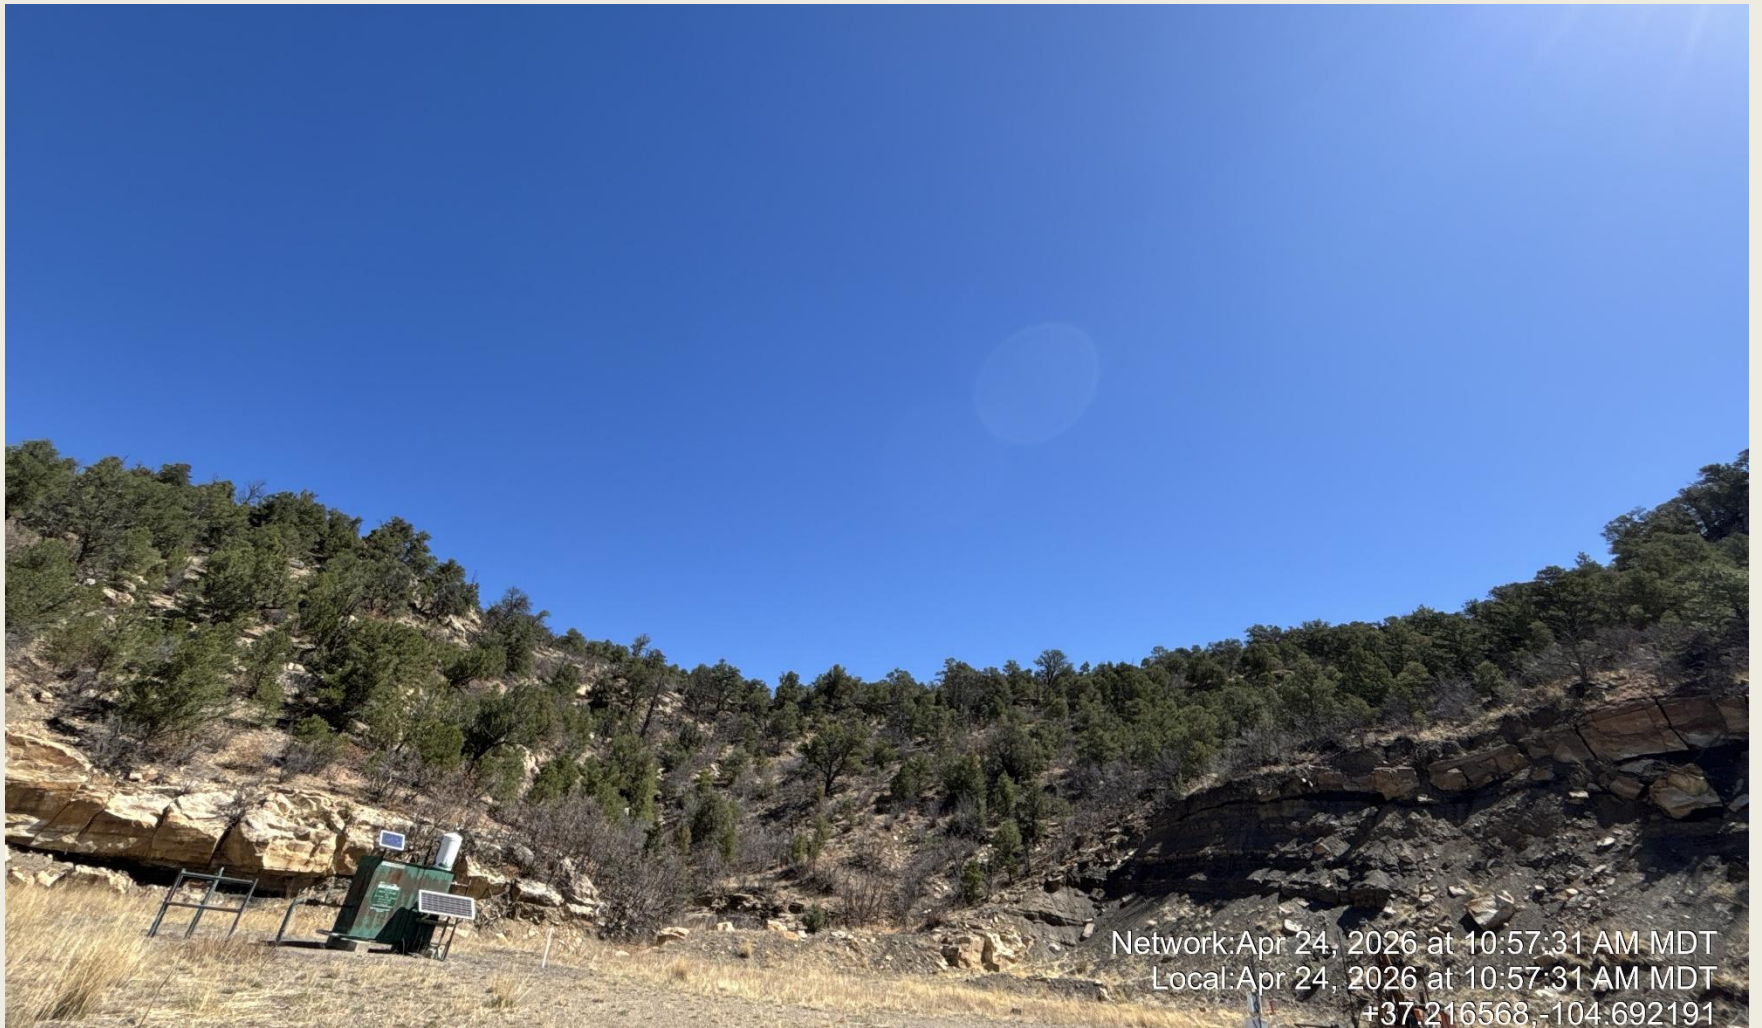
PHOTO 3: LOCATION.

Network: Apr 24, 2026 at 10:57:31 AM MDT
Local: Apr 24, 2026 at 10:57:31 AM MDT
+37.216568, -104.692191

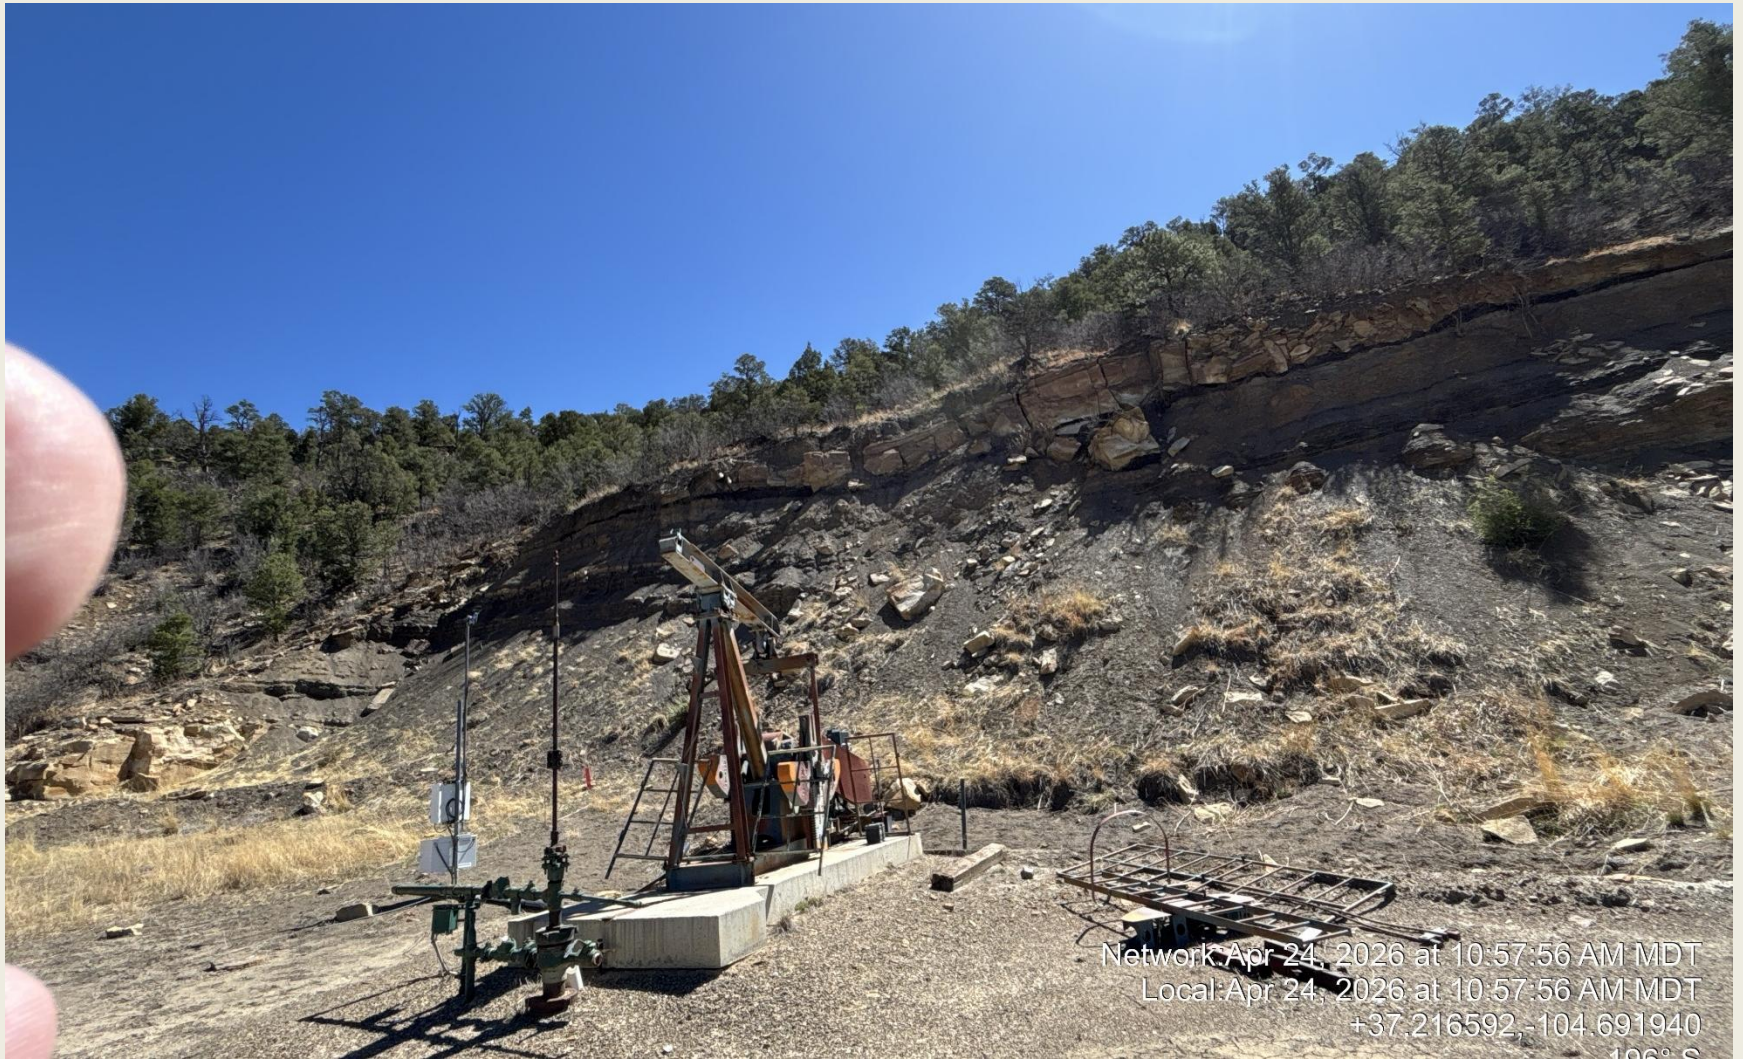
PHOTO 4: WELLHEAD AND EQUIPMENT. UNUSED EQUIPMENT (HEAD FOR PUMPJACK, JUMPJACK FENCING AND WOOD CHOCK ON GROUND NEAR JUMPJACK. **REMOVE OR REINSTALL UNUSED EQUIPMENT PER RULE 606. CA DATE 5/24/2026.**

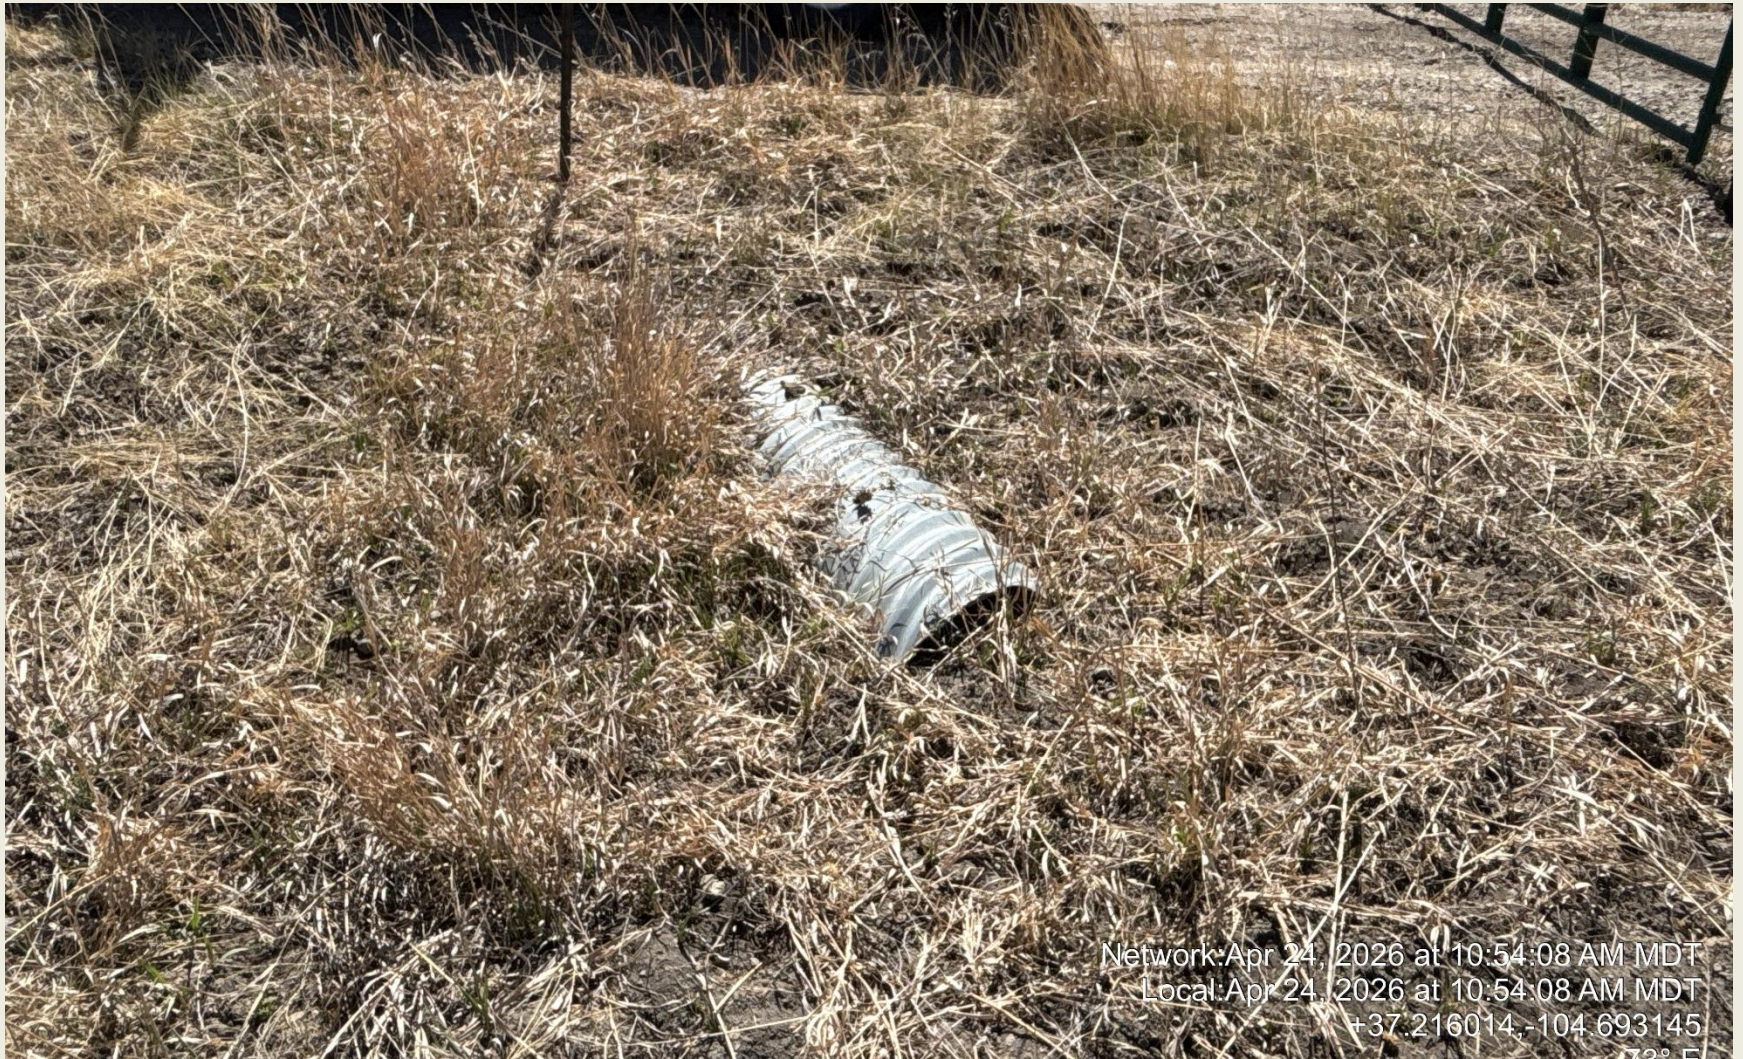
PHOTO 5: CULVERT ON ROW JUST OFF COUNTY ROAD IS PLUGGED. CLEAN AND MAINTAIN CULVERT AND DRAINAGE DITCHES PER RULE 1002.f. CA DATE 5/24/2026.

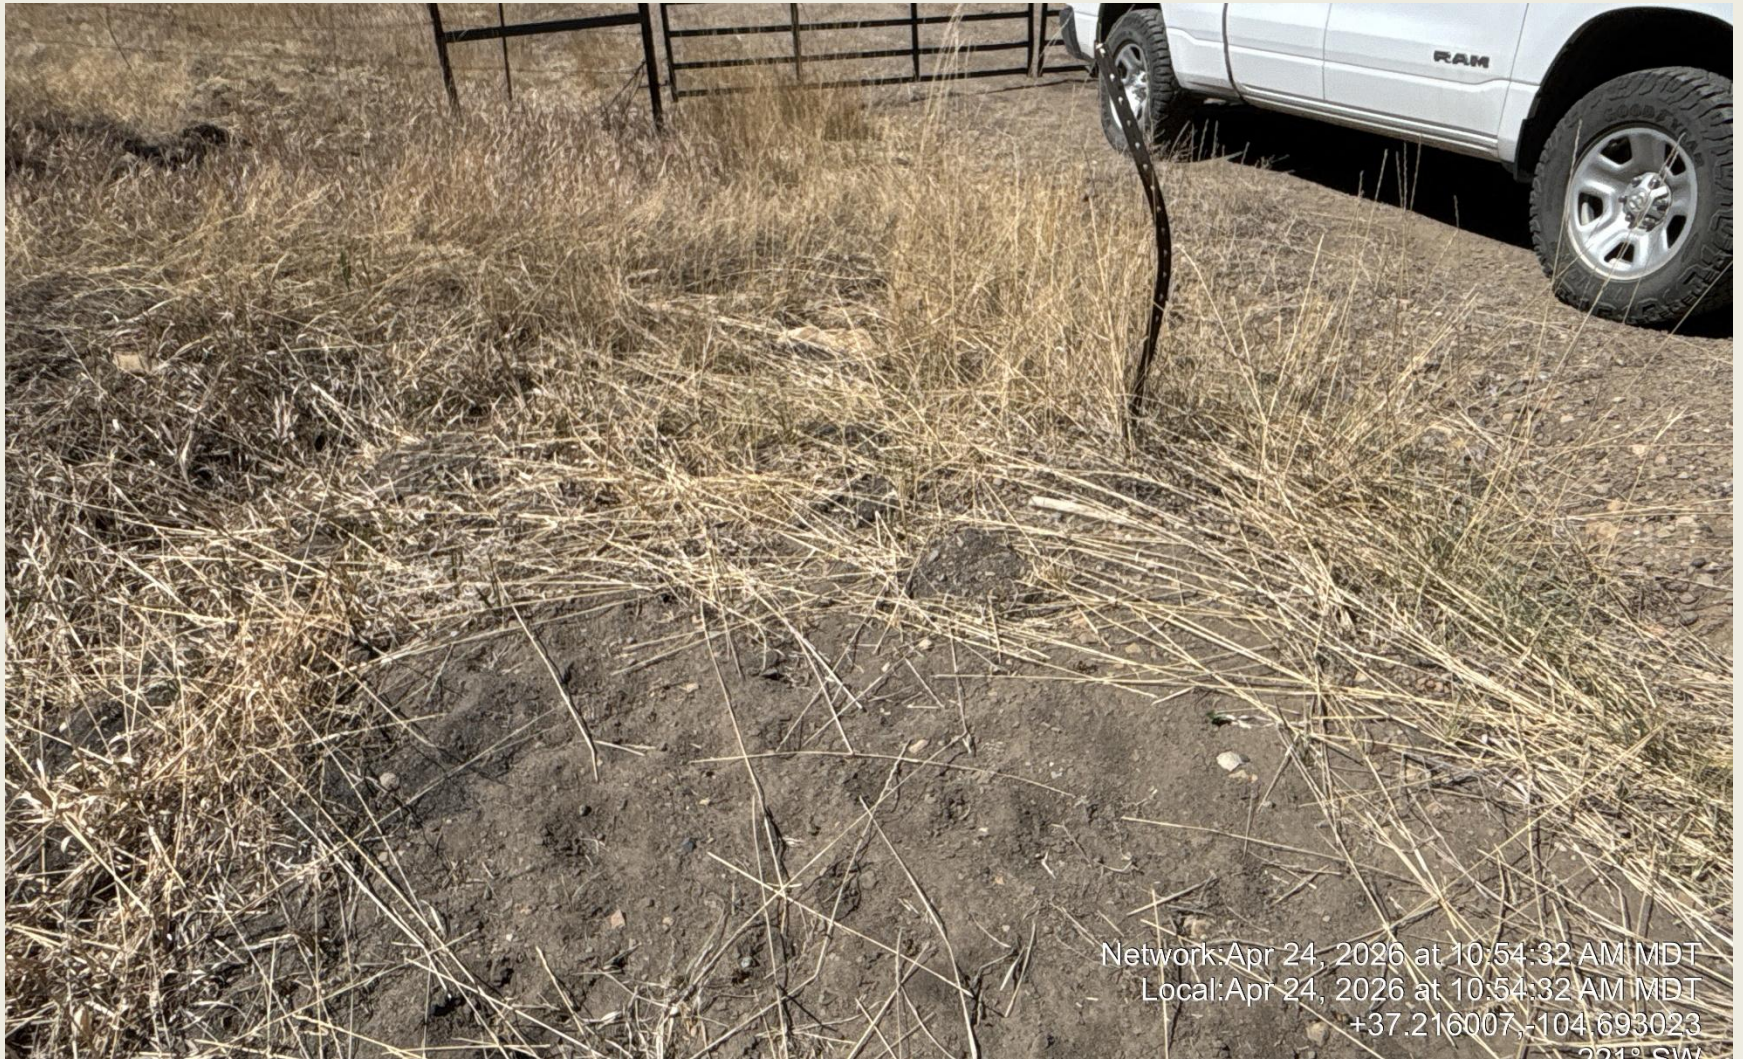
PHOTO 6: CULVERT ON ROW JUST OFF COUNTY ROAD IS PLUGGED. CLEAN AND MAINTAIN CULVERT AND DRAINAGE DITCHES PER RULE 1002.f. CA DATE 5/24/2026.

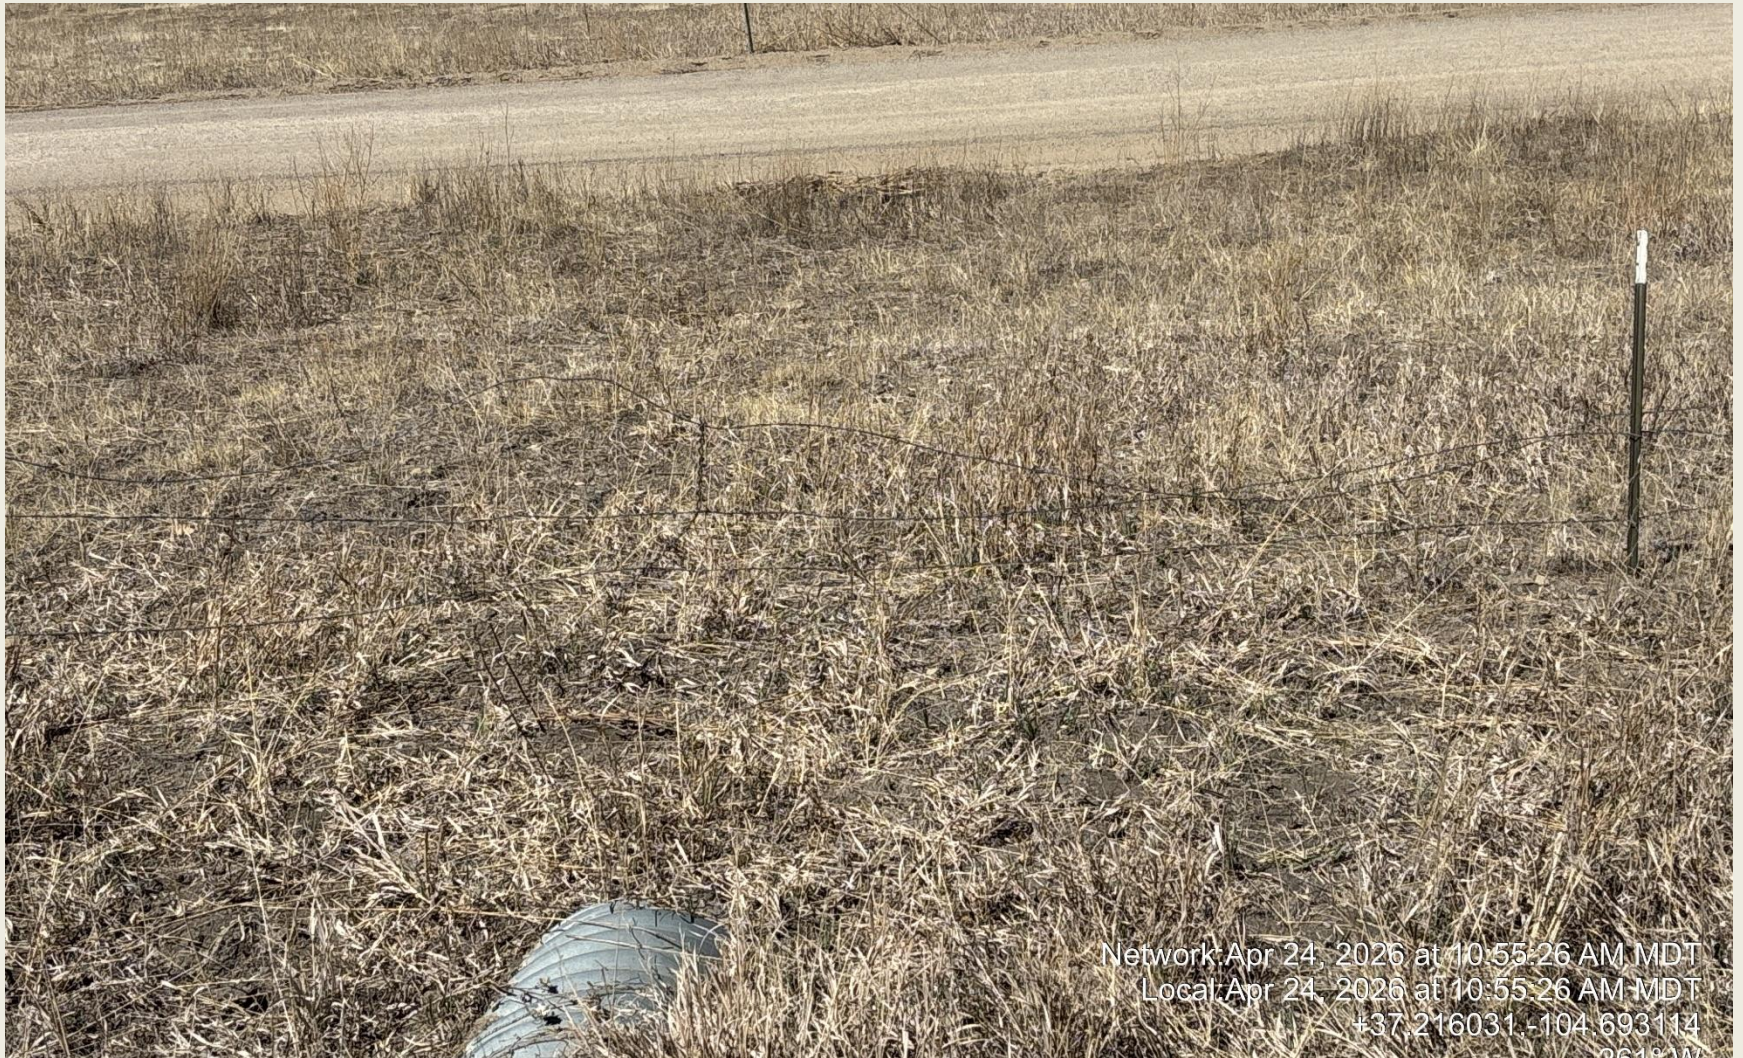
PHOTO 7: DRAINAGE DITCH FROM CULVERT ON ROW TO THE CULVERT THAT CHANELS STORMWATER UNDER COUNTY ROAD IS SILTED IN. CLEAN AND MAINTAIN CULVERT AND DRAINAGE DITCHES PER RULE 1002.f. CA DATE 5/24/2026.
