**Fort Lupton, CO, United States**
Lat 40.049568, Long -104.867246
03/25/2026 12:22 GMT-06:00
ECMC : Environmental Inspection

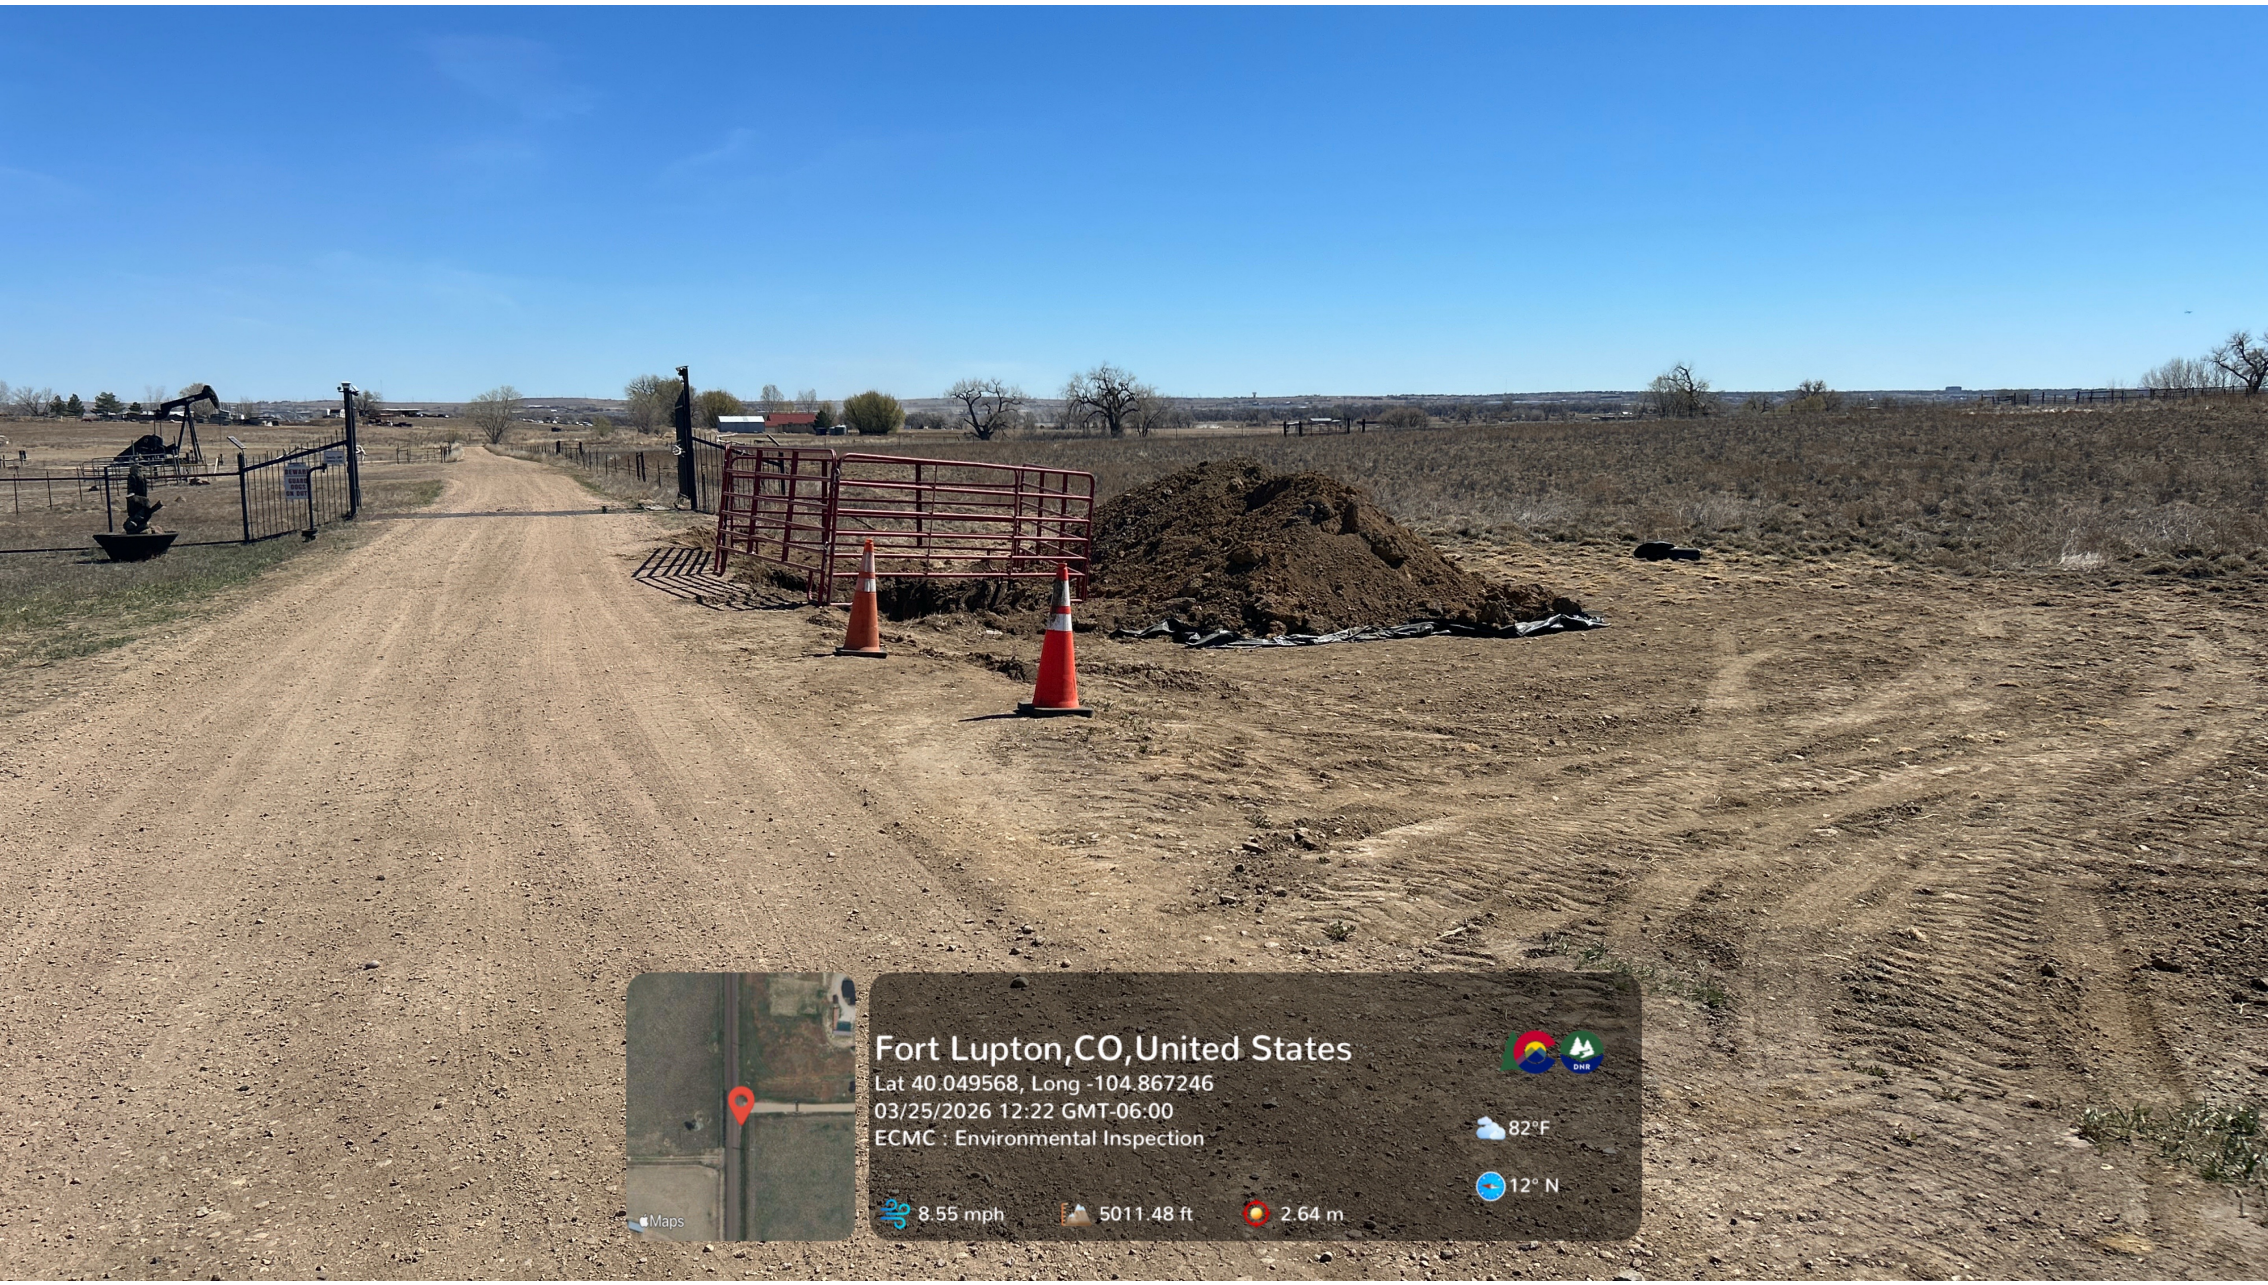
Looking at the spill location. An excavation has been opened. An unmarked soil stockpile is visible.

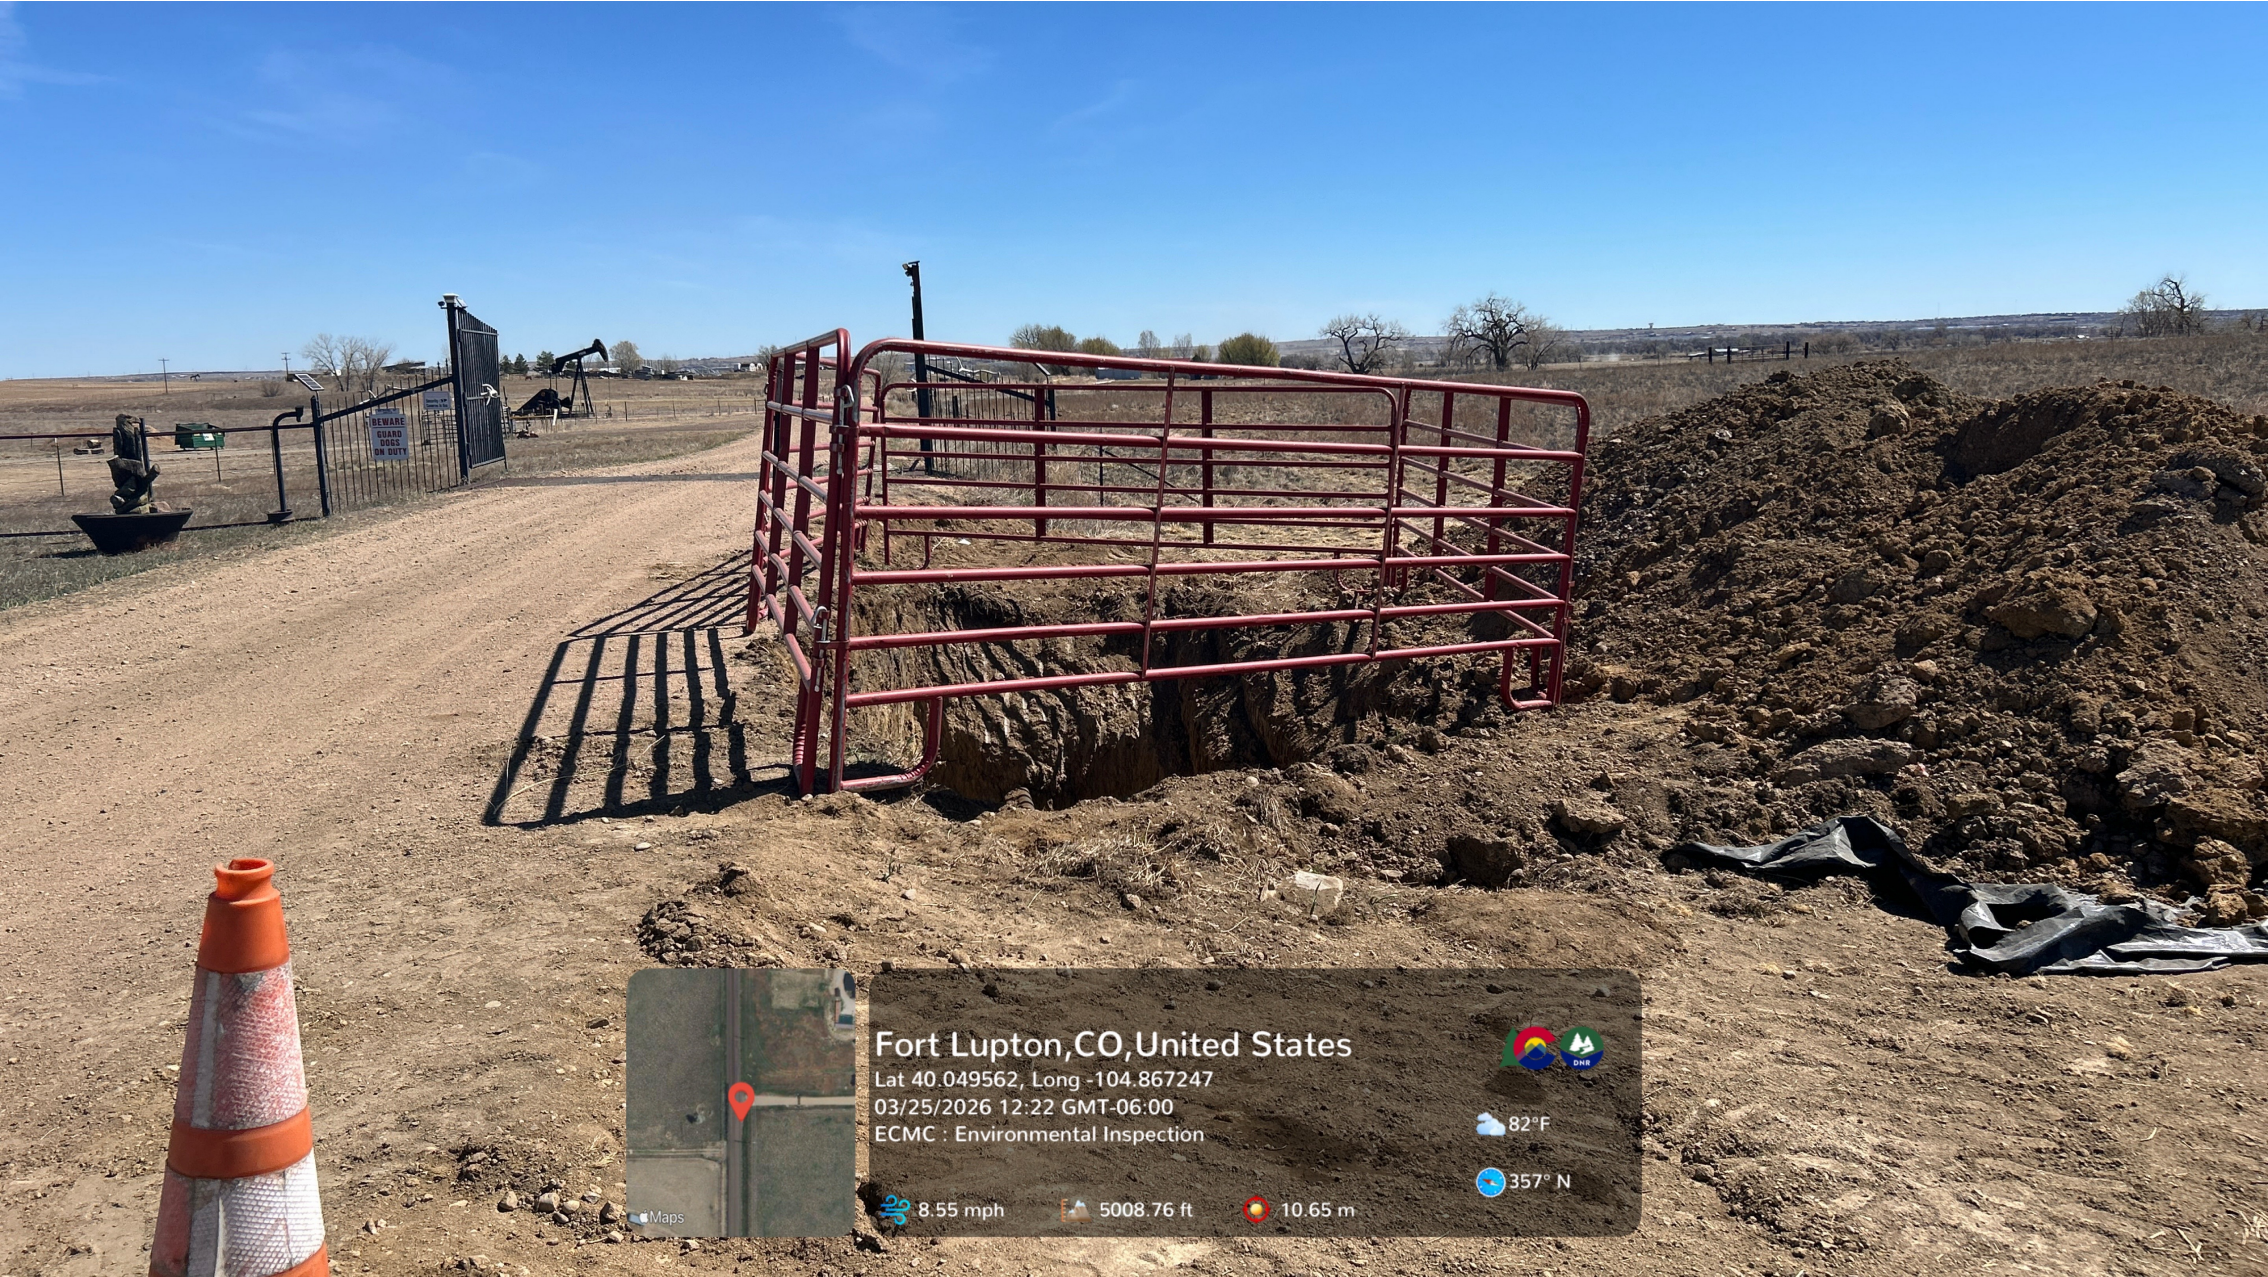
Metal panel fencing surrounds the open excavation. Sign on black metal fence in background reads, "BEWARE GUARD DOGS ON DUTY".

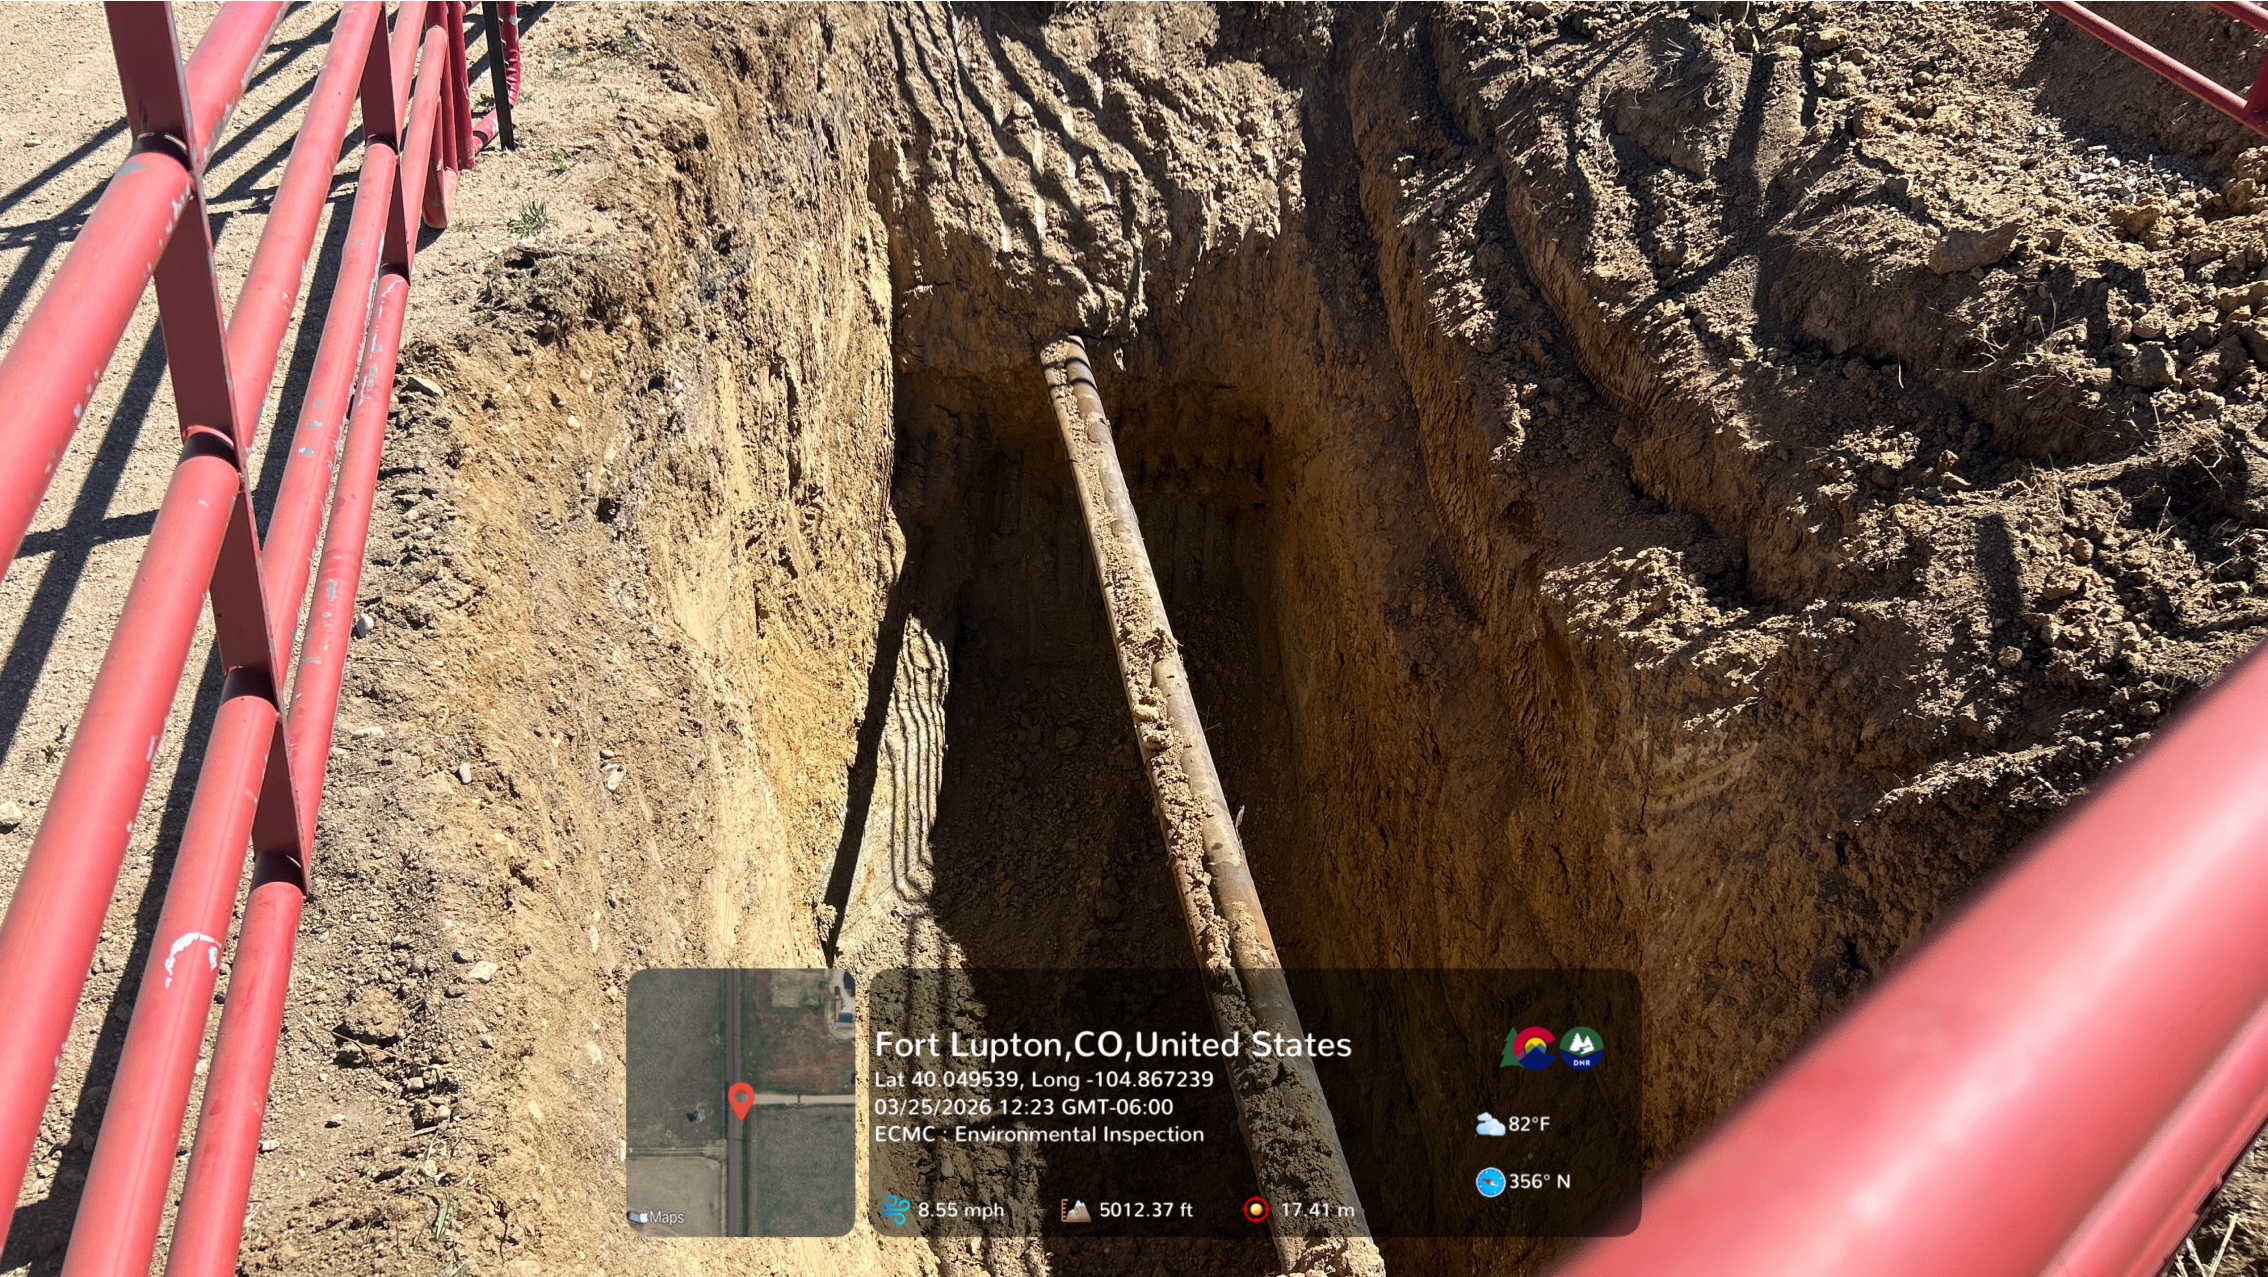
Flowlines are visible in the open excavation.

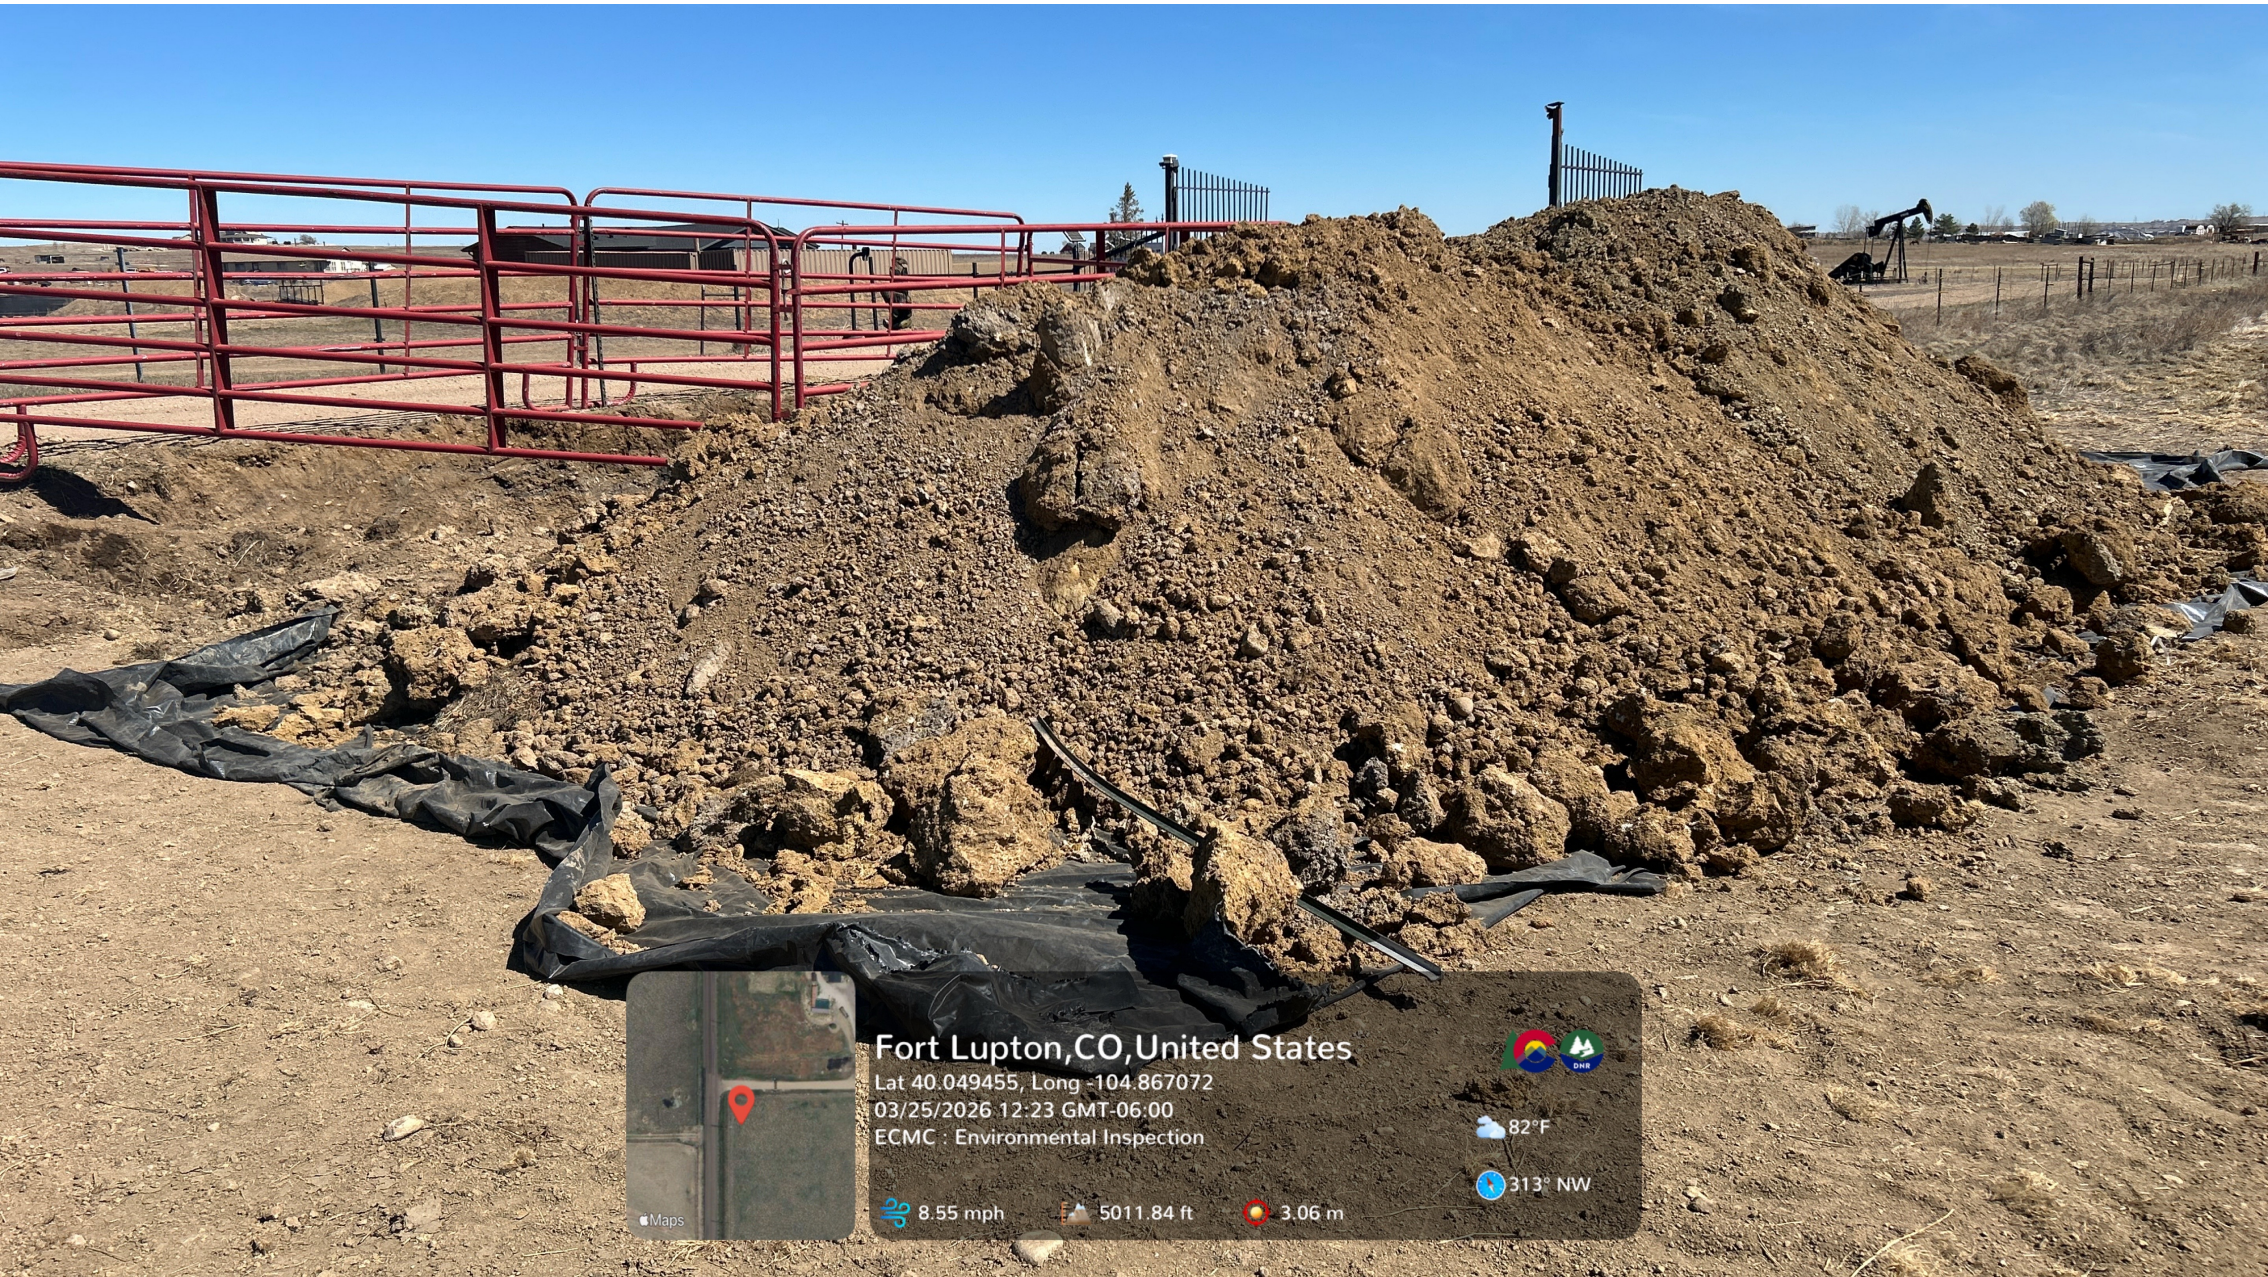
Gray staining is visible in areas of the unmarked soil stockpile. A liner is visible, however, soil has spread outside of the liner.
