# Inspection Photos

**Operator:** Caerus Piceance LLC #10456

**Location ID:** 398469

**Inspection Doc:** 719201067

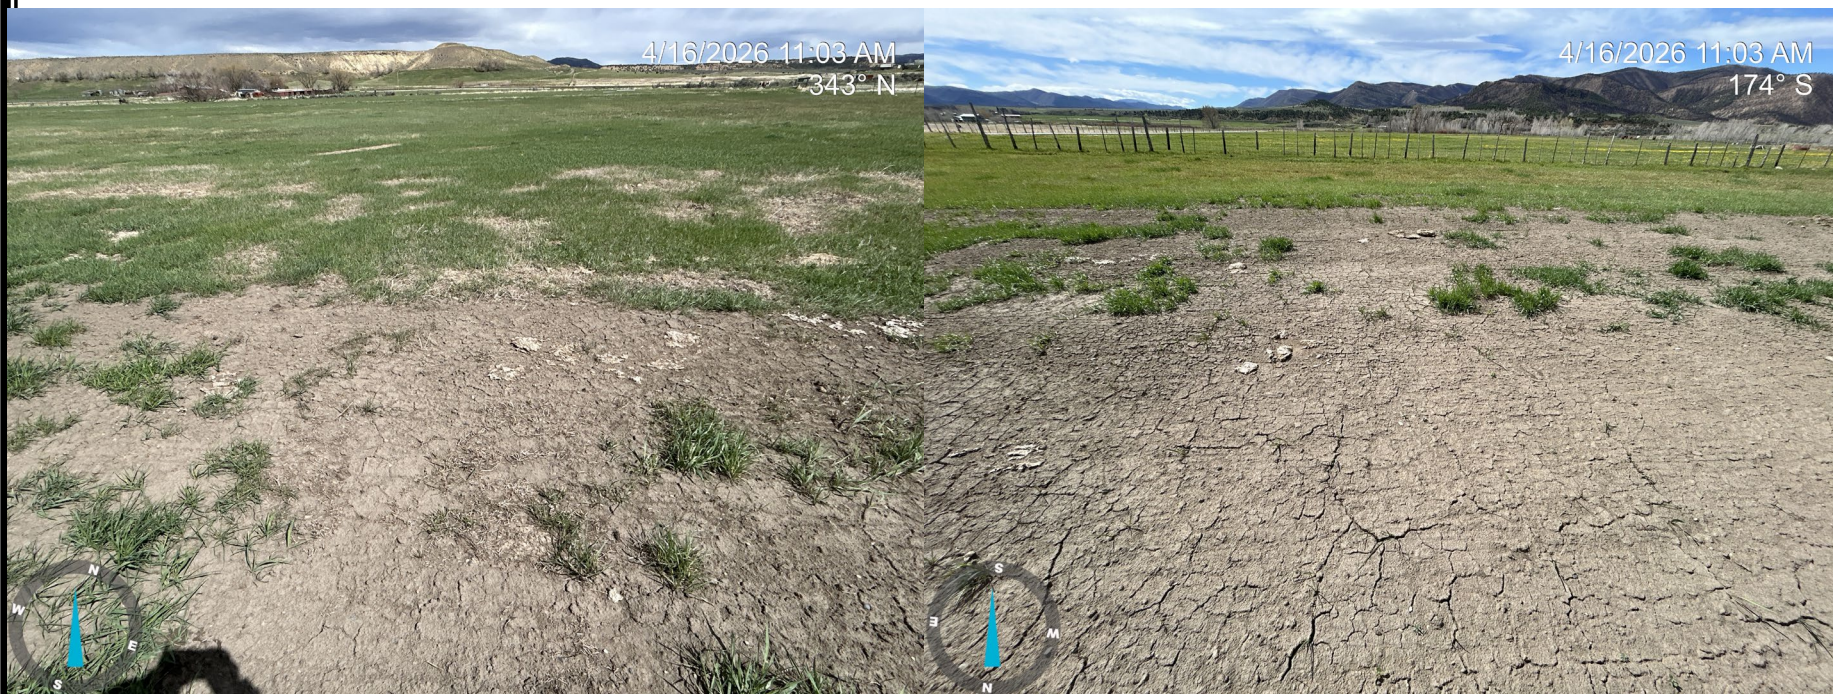
**Photo 1:** Photos showing an overview of the location looking north and south, respectively. Location does not appear to meet 1004 uniformity requirement.

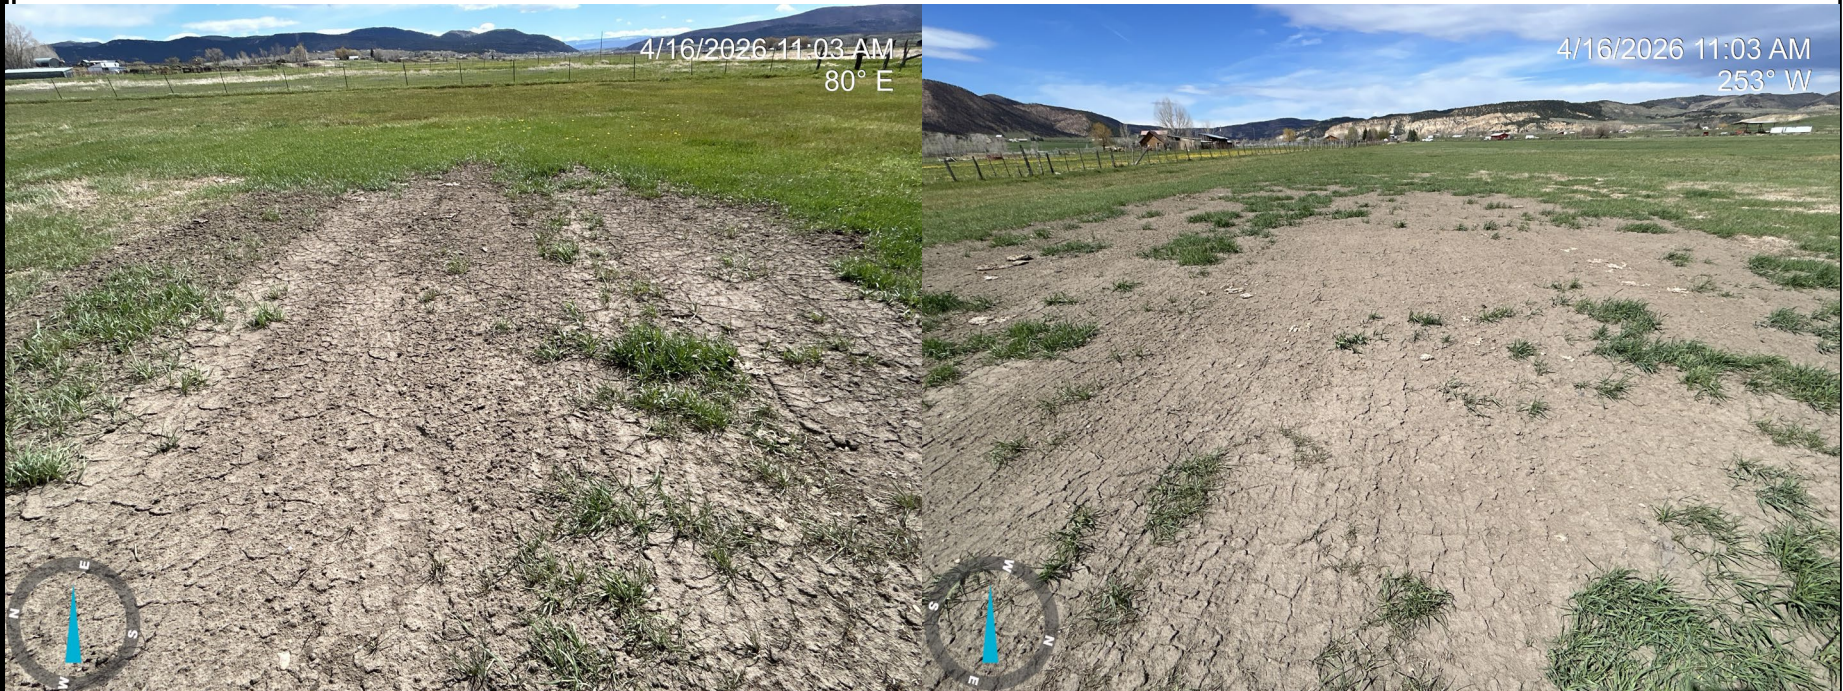
**Photo 2:** Photos showing an overview of the location looking east and west, respectively. Location does not appear to meet 1004 uniformity requirement.

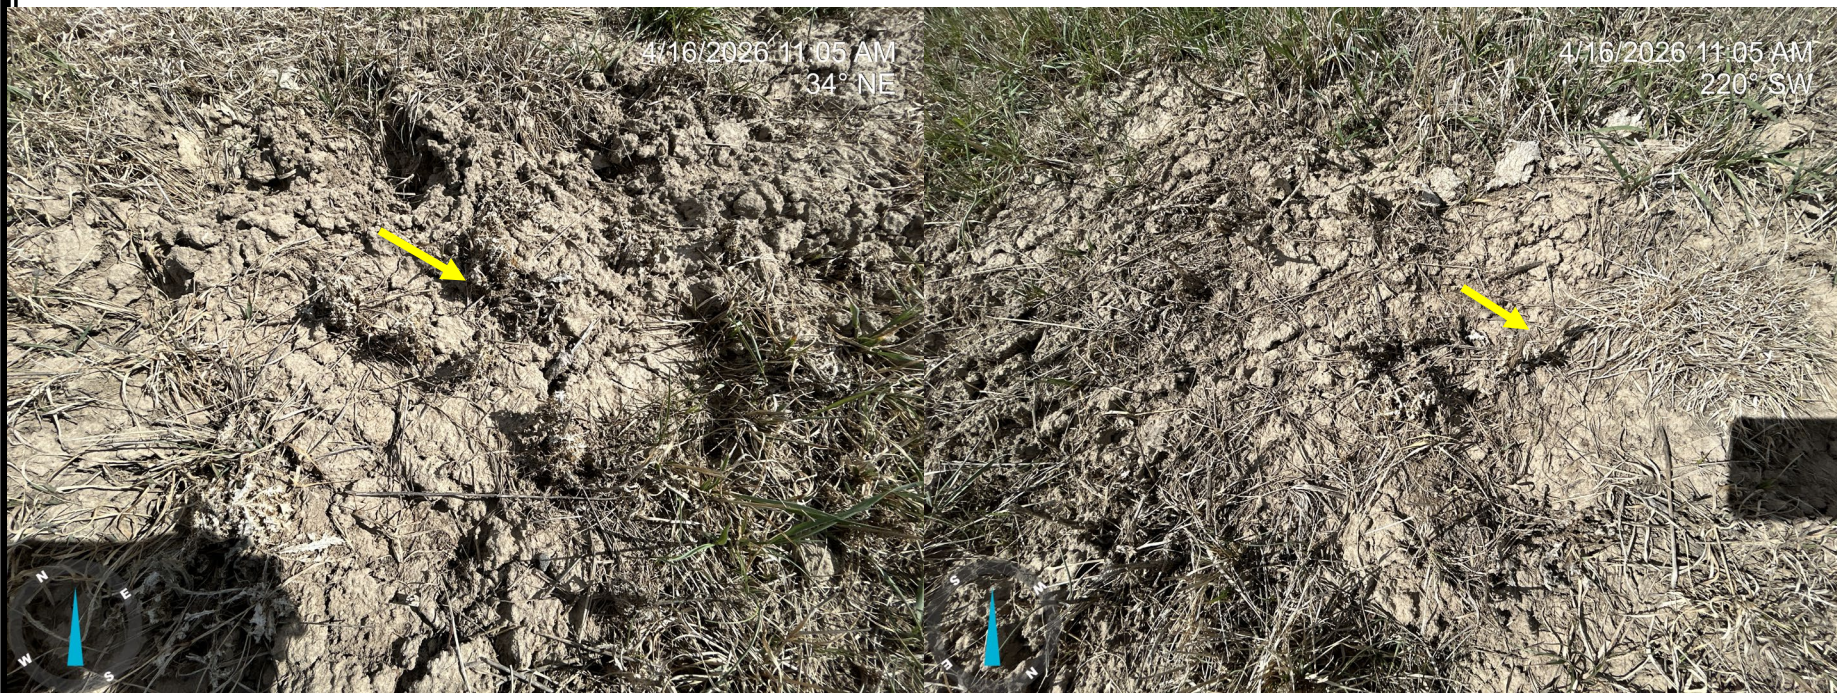
**Photo 3:** Photos showing that Canada thistle at the location has been treated; no new rosettes or weeds were observed.

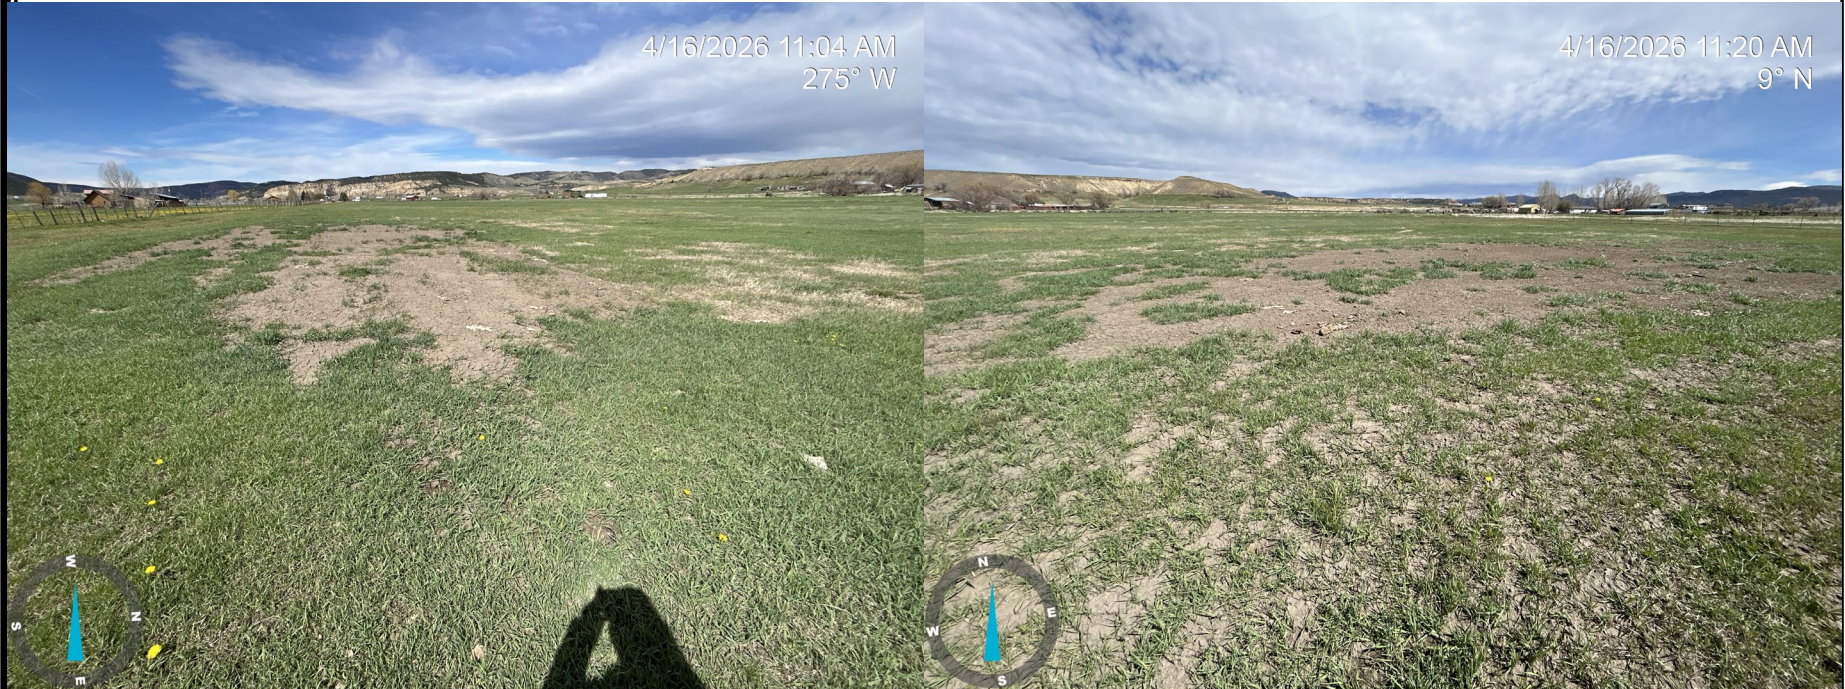
**Photo 4:** Photos showing a general overview of the location looking west and north, respectively.

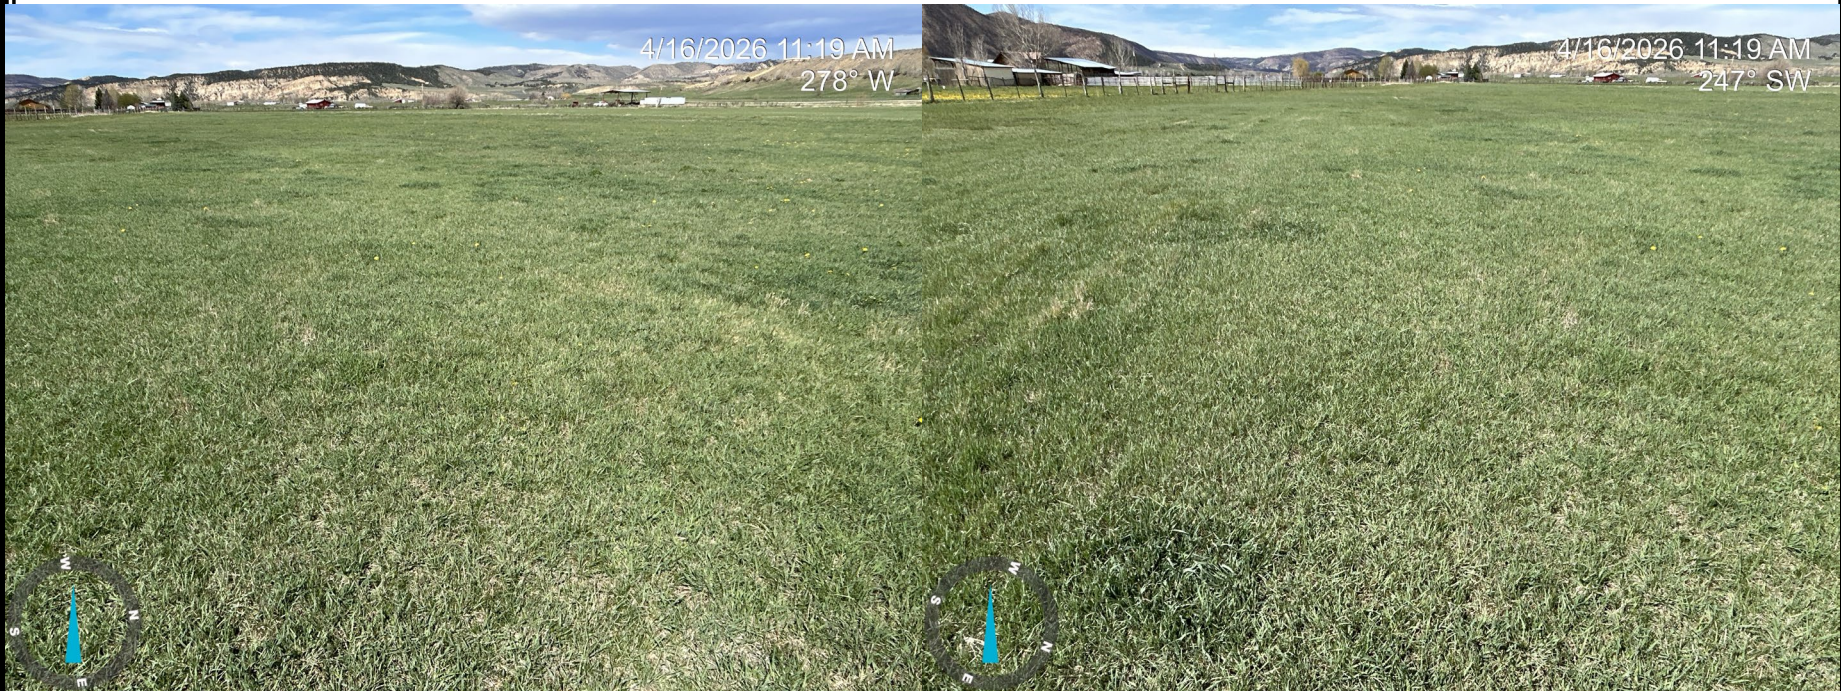
**Photo 5:** Photos showing the nearby reference area, located in the same pasture directly west of the location. The pasture is composed of mixed pasture grasses.
