Inspection Photos

Operator: Robert L. Bayless Producer LLC
#6720

Location ID: 313019

Inspection Doc: 719201078

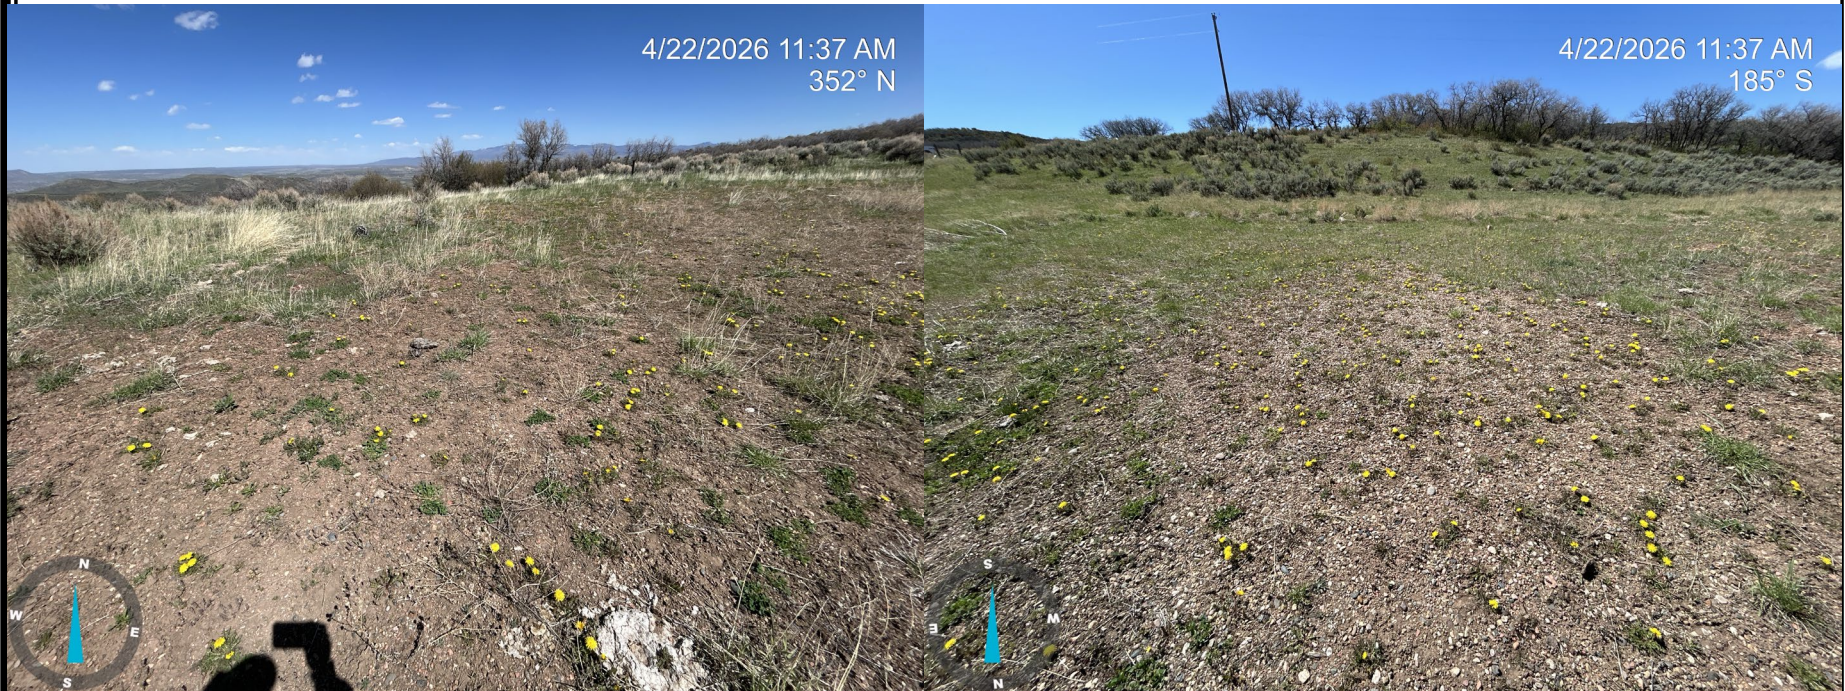
Photo 1: Photos showing an overview of the location looking north and south, respectively.

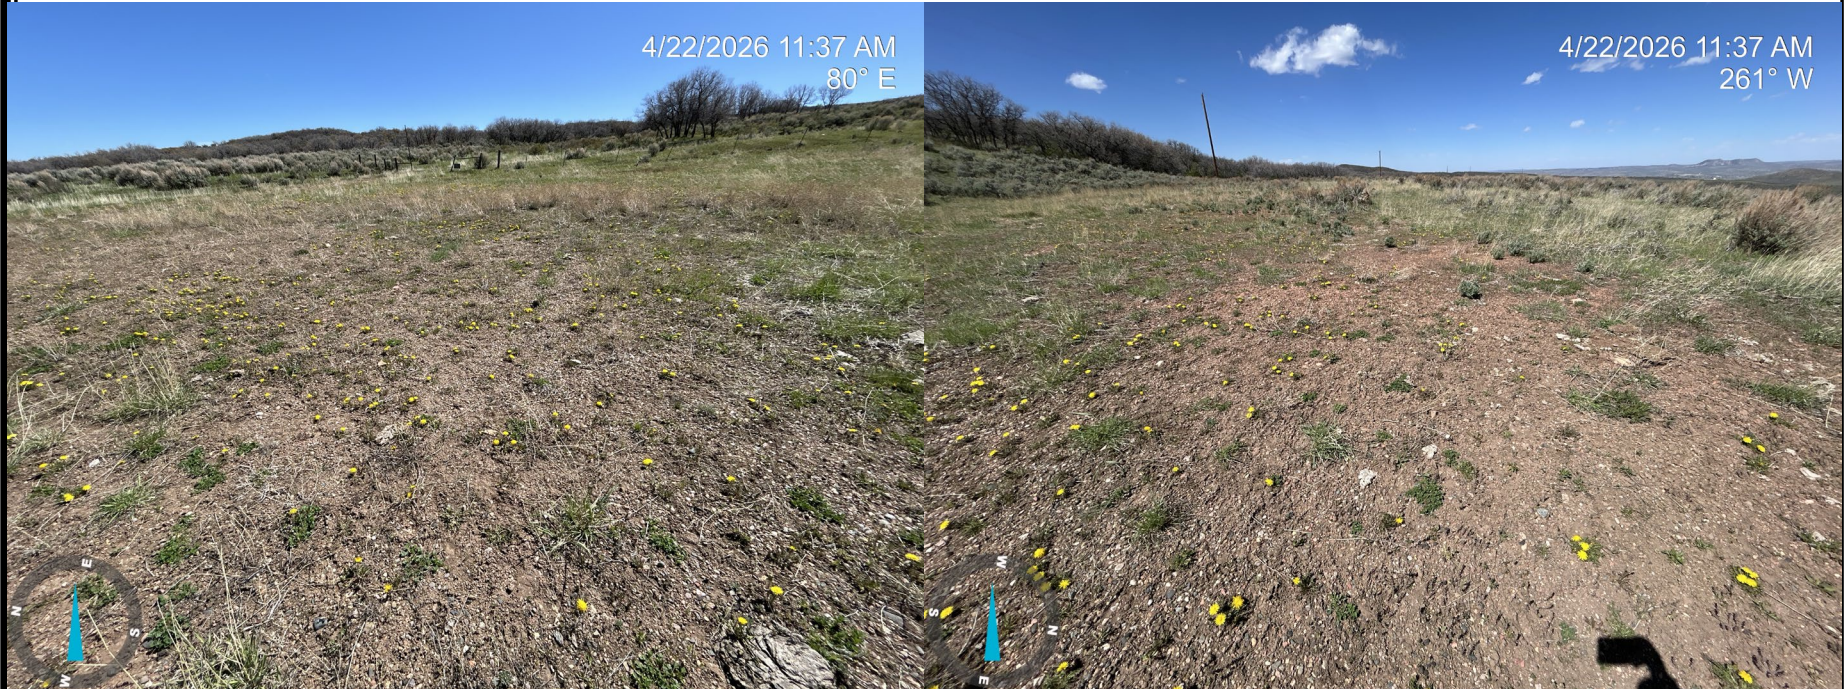
Photo 2: Photos showing an overview of the location looking east and west, respectively. Vegetation at the central portion of the location is not uniform.

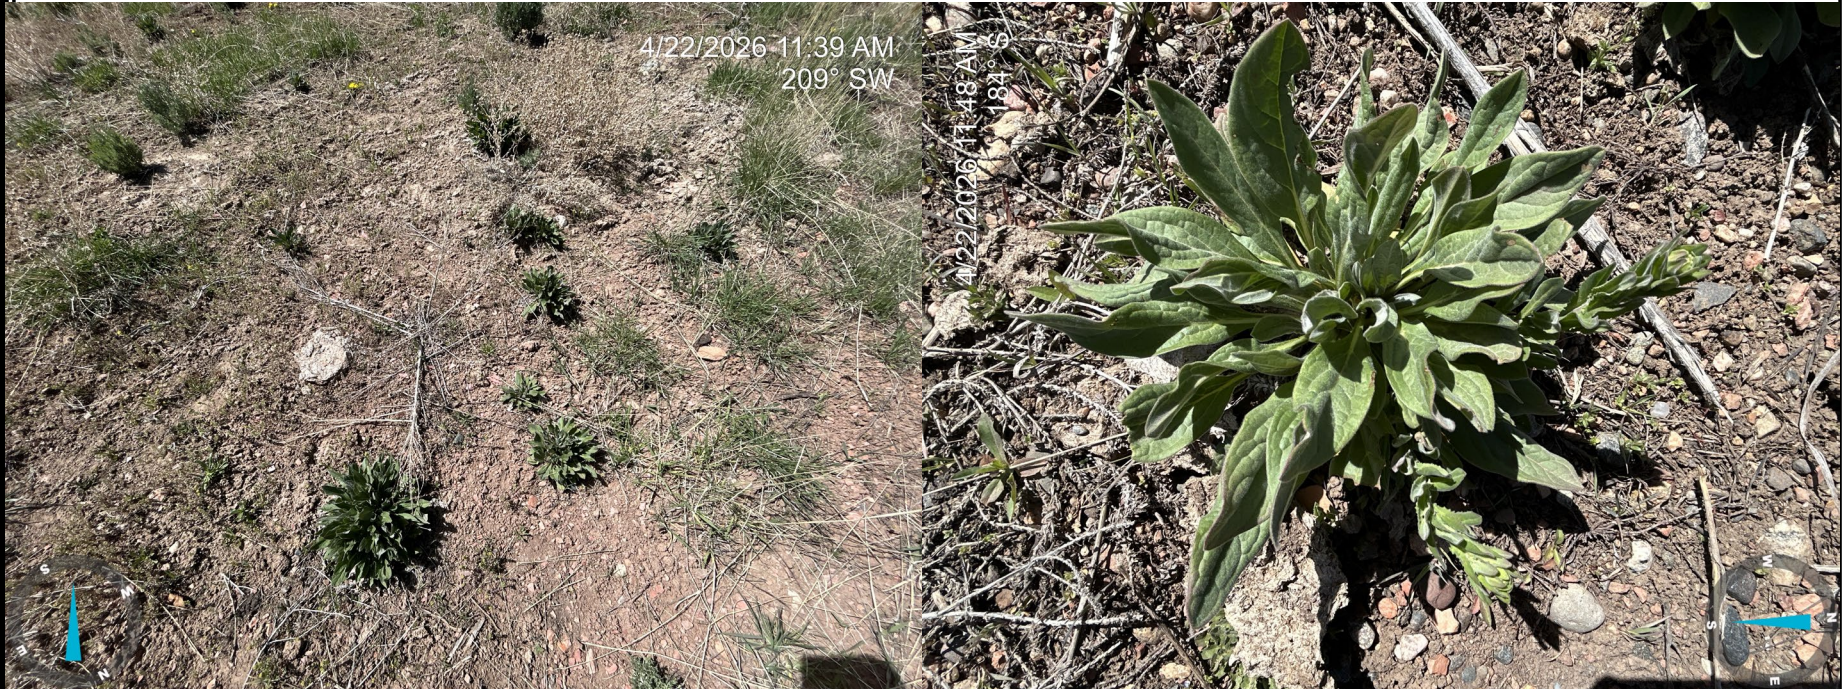
Photo 3: Photos showing an example of houndstongue rosettes, a List B noxious weed, is present throughout the location. Weed maintenance is required.

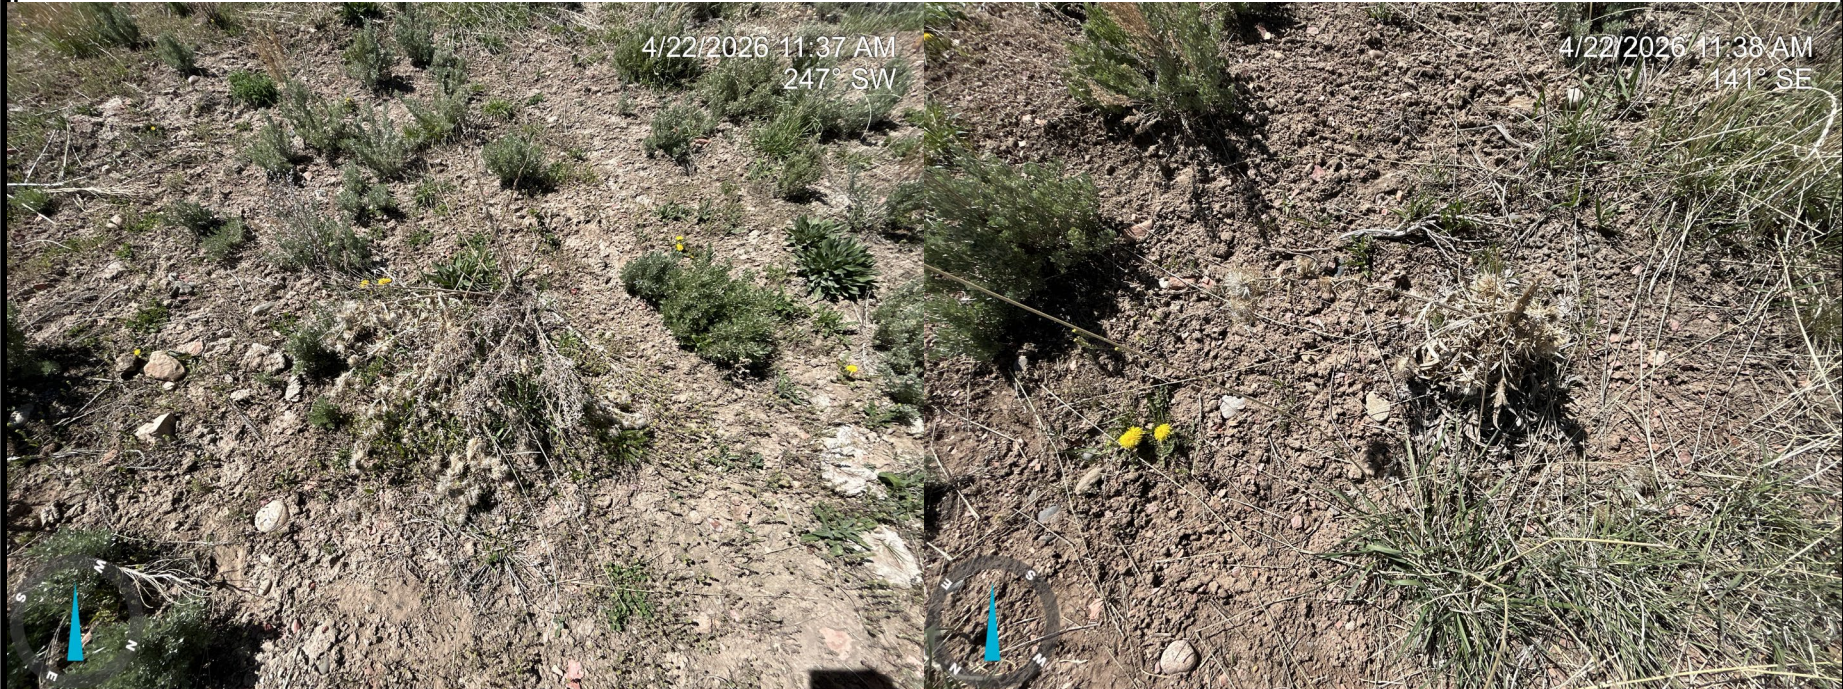
Photo 4: Photos showing an example of thistle skeletons that are present throughout the location. No new thistle growth was observed; however, ongoing weed monitoring and maintenance is required.

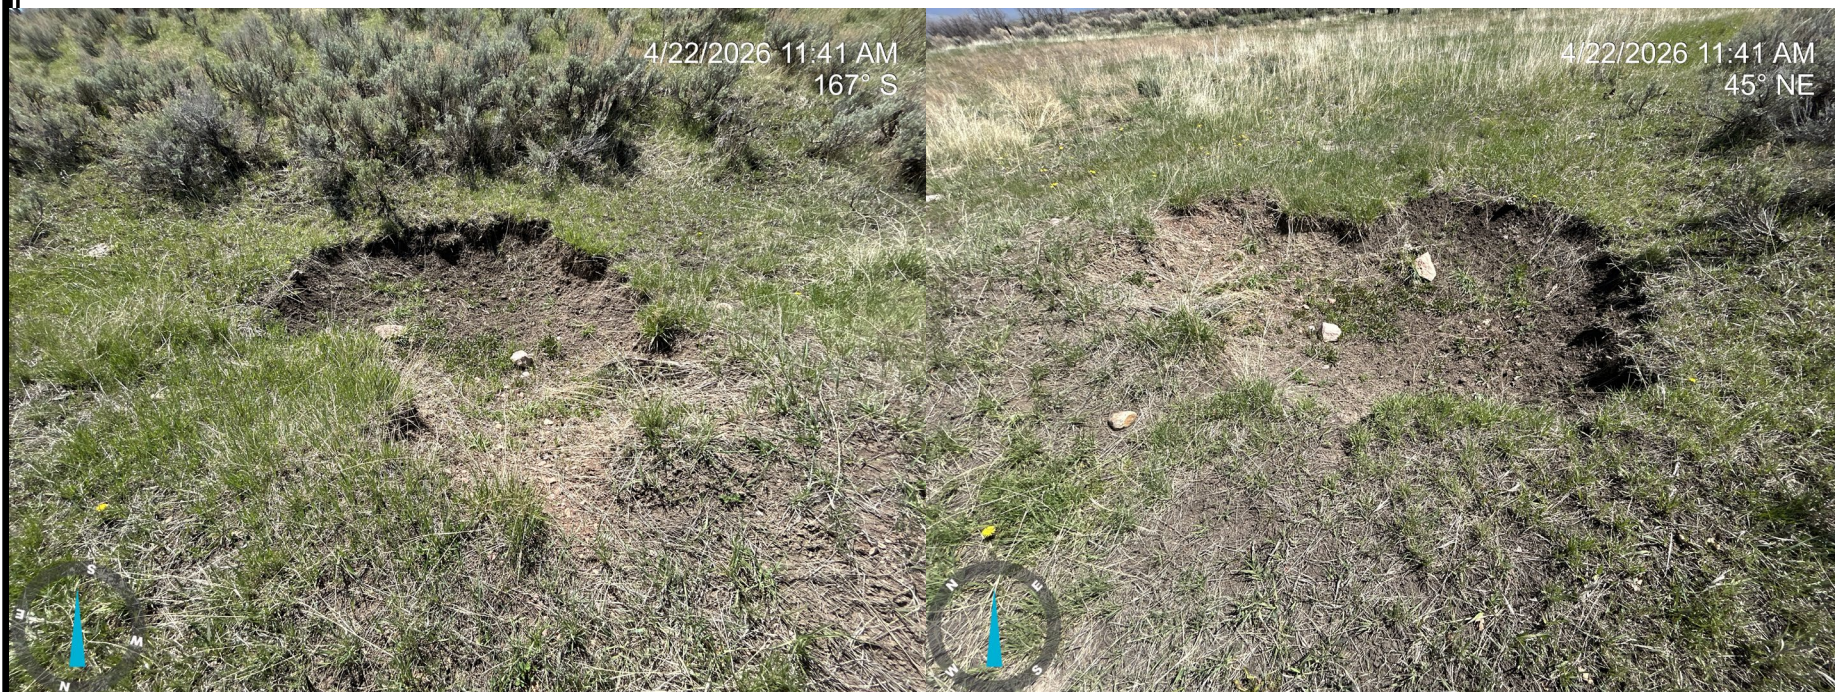
Photo 5: Photos showing a subsidence feature appears to be present at the south-central portion of the location. Maintenance is required to stabilize the area; comply with Rule 1002.f.

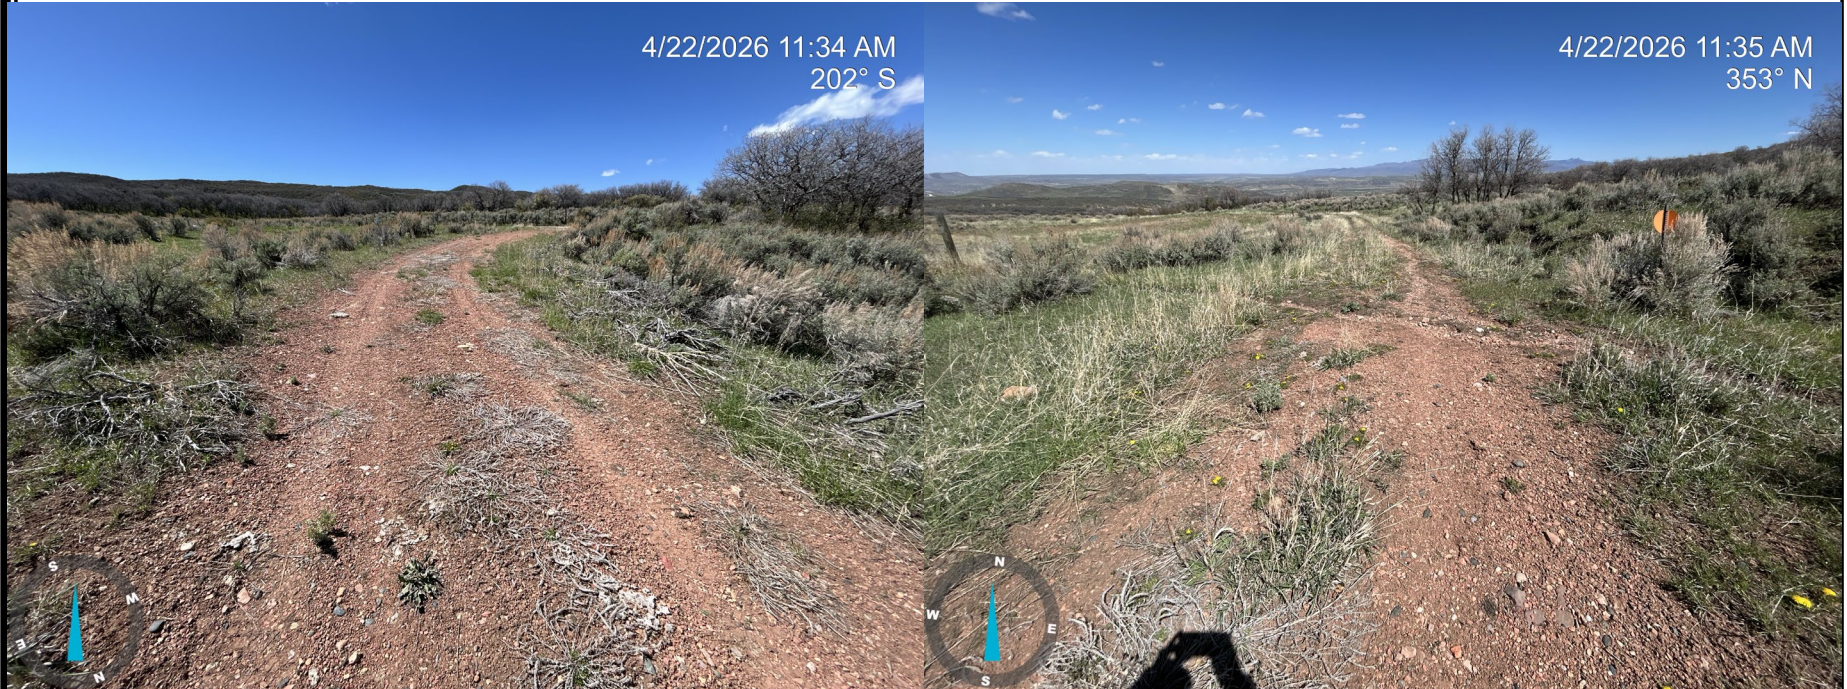
Photo 6: Photos showing the access road leading to the location has not been reclaimed pursuant to 1004 series Rules.

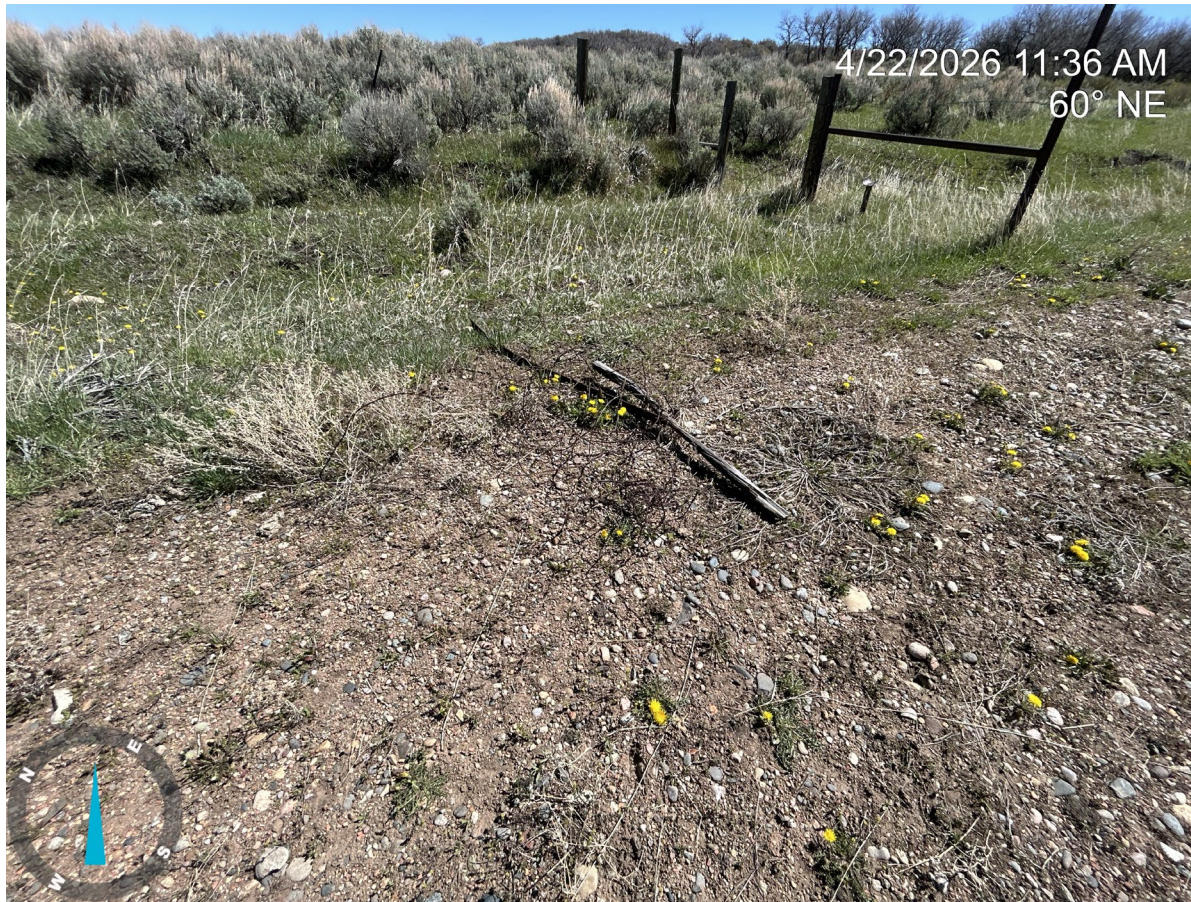
Photo 7: Photo showing fencing trash/debris that requires removal.

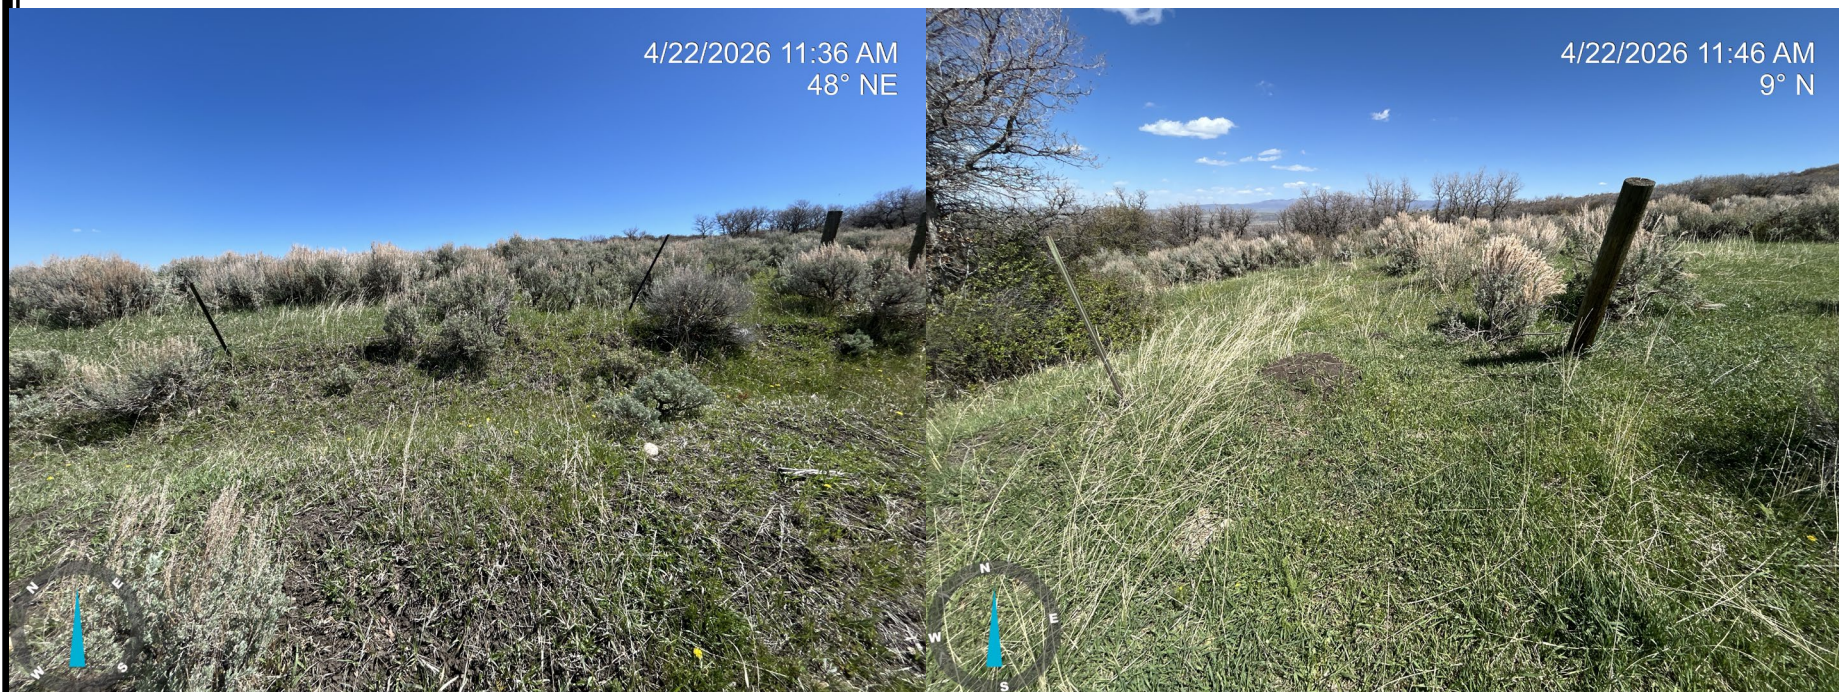
Photo 8: Photos showing portions of downed perimeter fencing around the location. Maintenance is required.

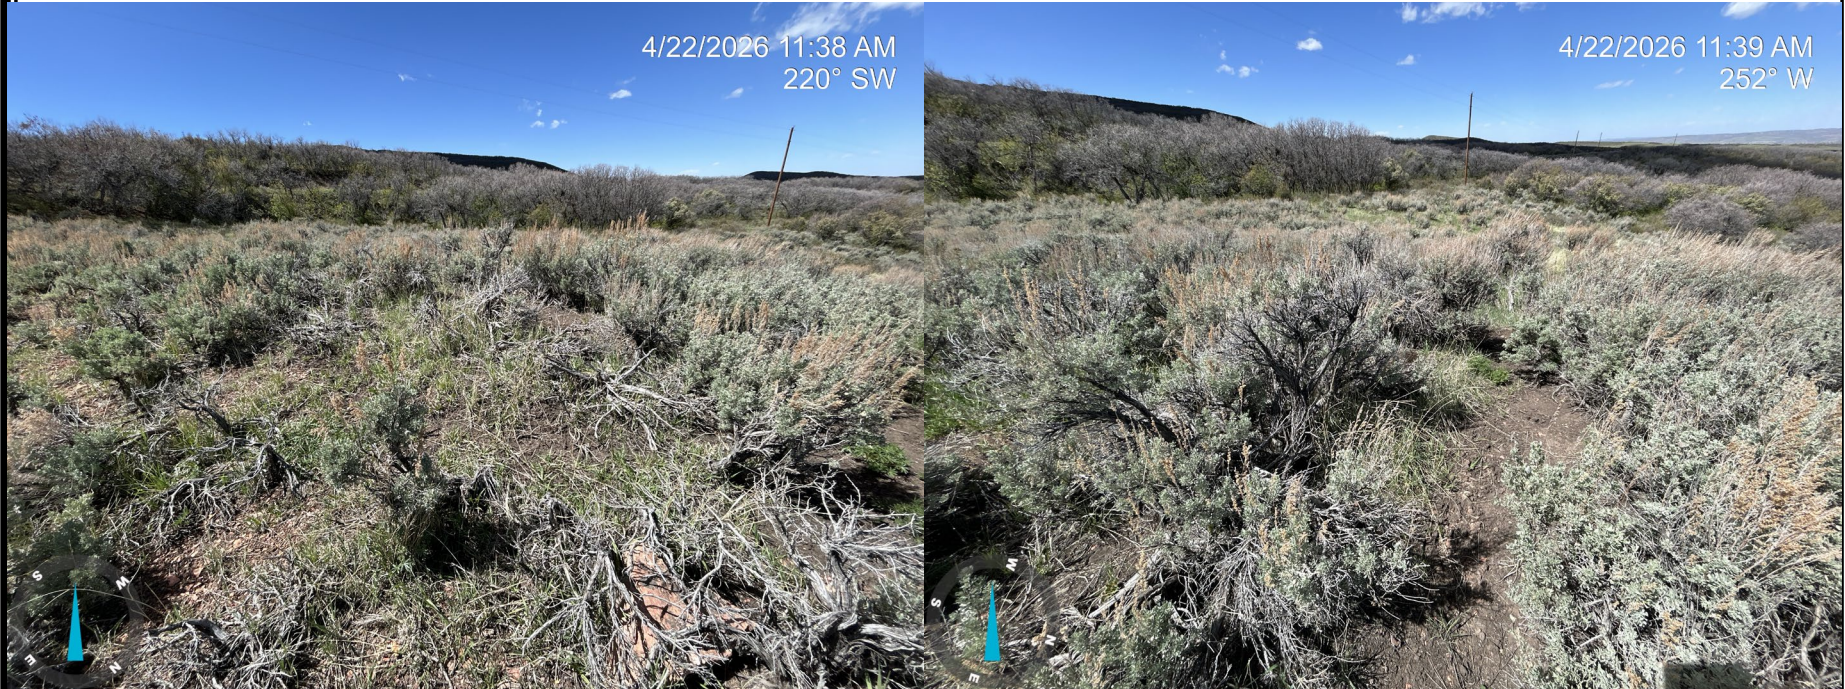
Photo 9: Photos showing the nearby reference area; located directly west of the site. The reference area is a big sagebrush flat near a scrub-oak transition zone.
