INSPECTION PHOTOS

Well: BOWSER 34-21

INSPECTION DOC #: 716302260

Operator: EVERGREEN NATURAL RESOURCES LLC

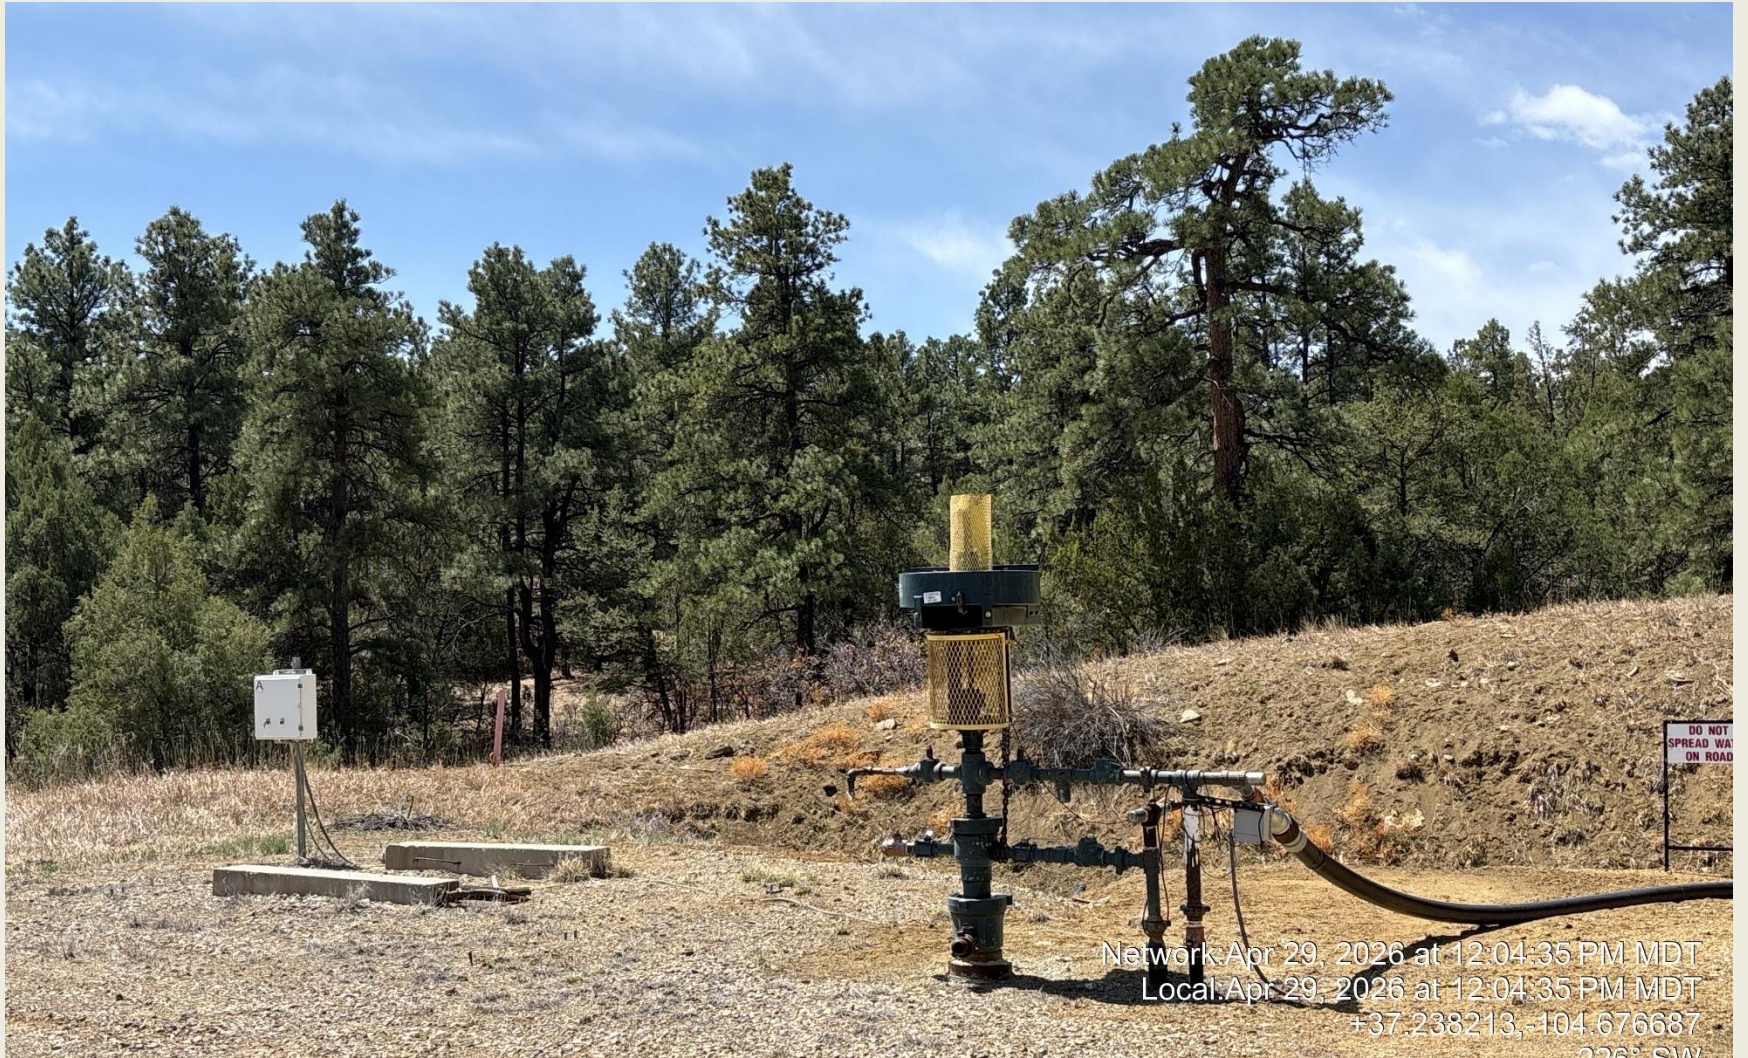
PHOTO 4: WELLHEAD AND EQUIPMENT.

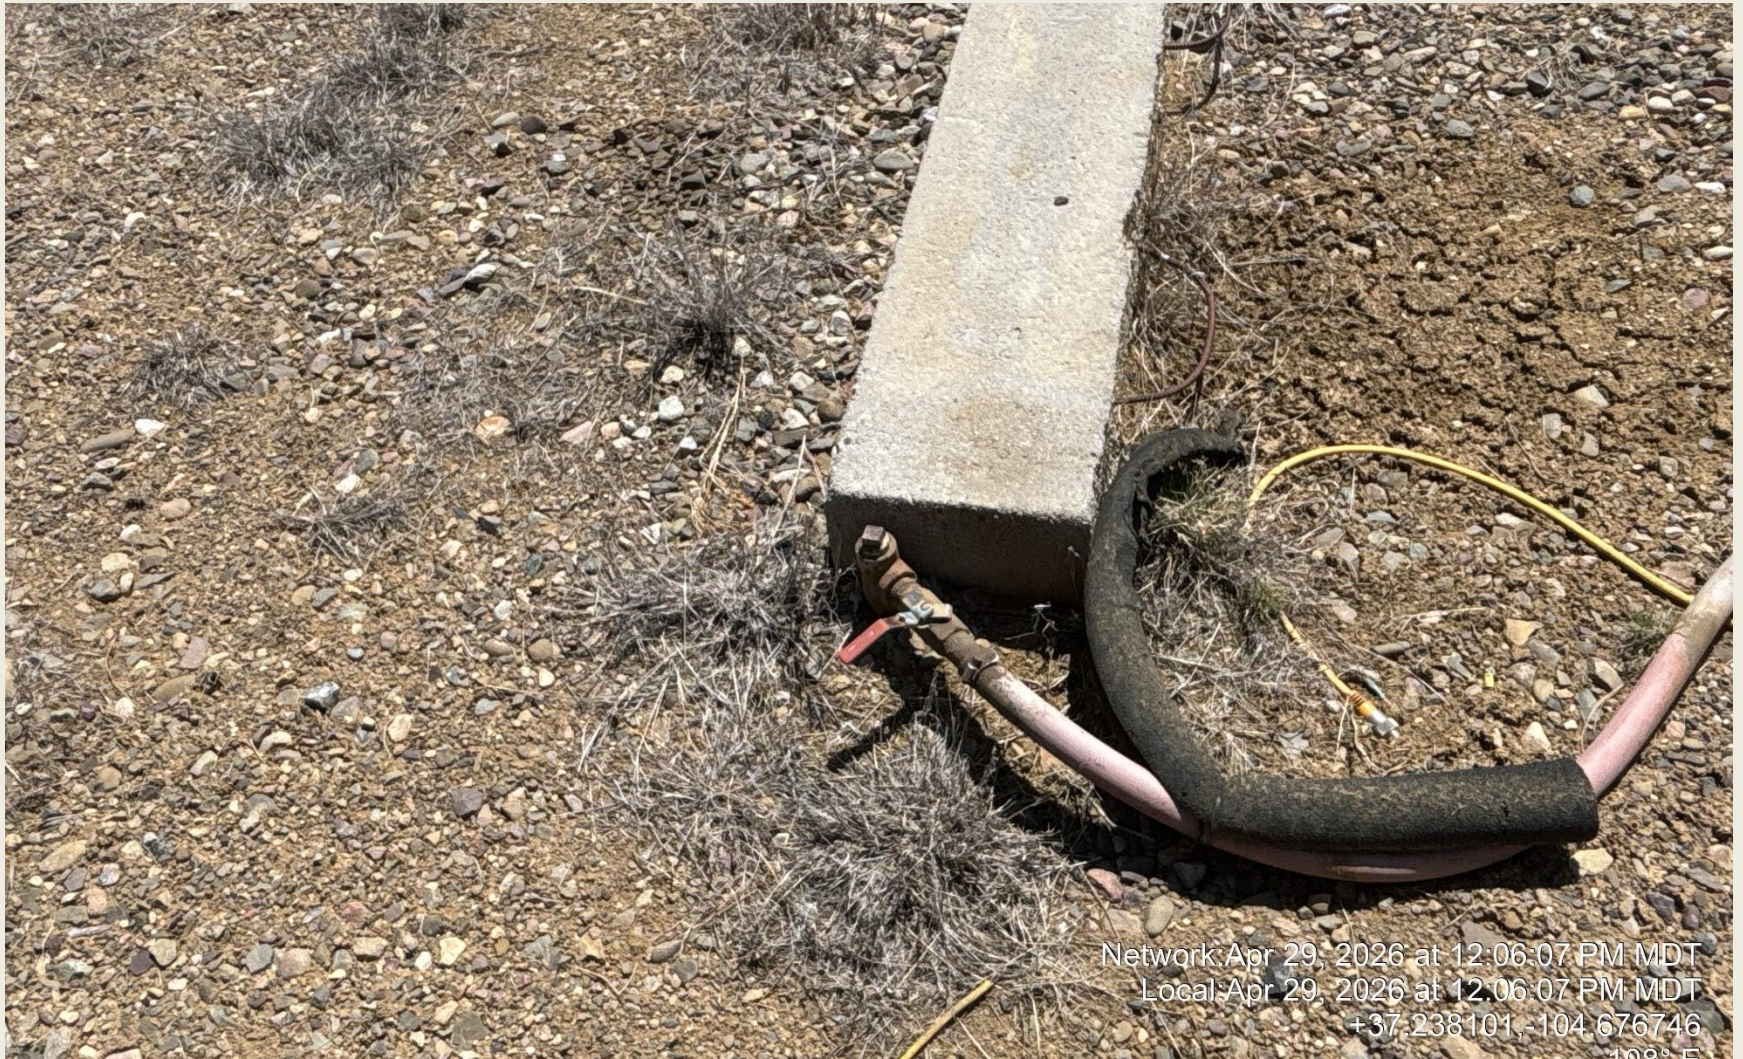
PHOTO 5: UNUSED EQUIPMENT (1" RISER NOT IN USE OR USEFUL). REMOVE OR IDENTIFY THE CONTENTS PER RULE 606. CA DATE 5/29/2026.

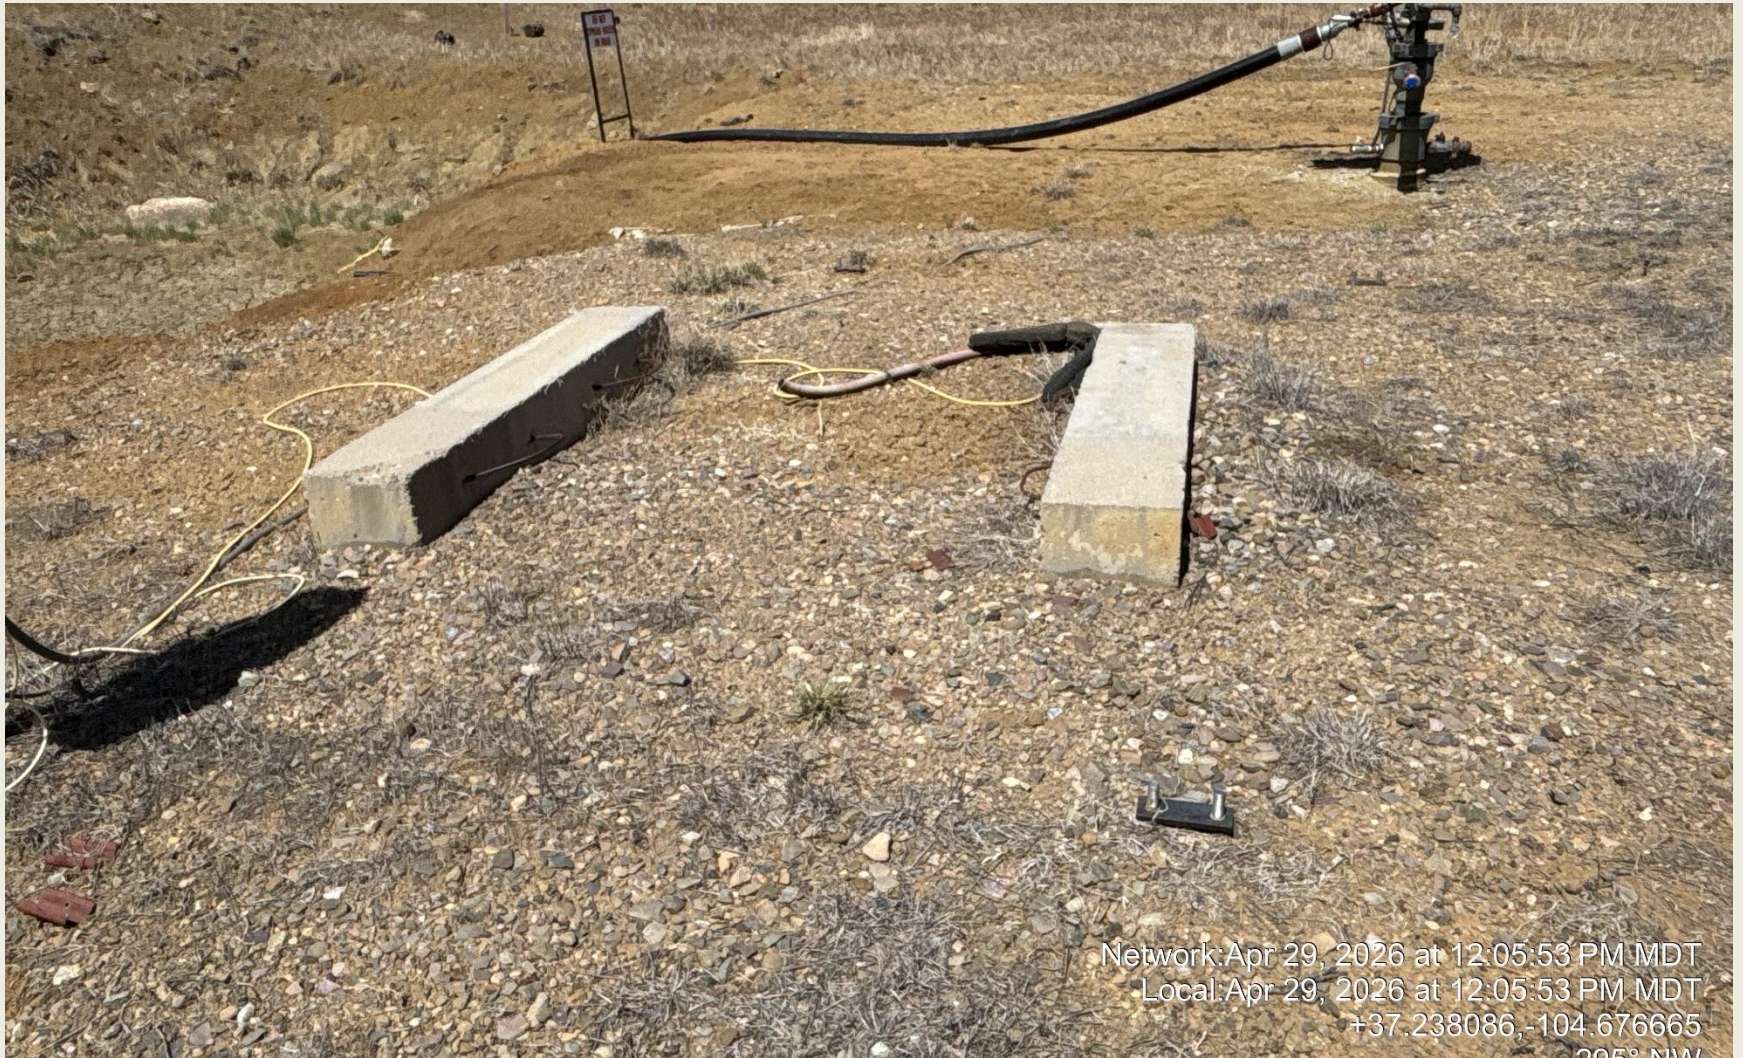
PHOTO 6: UNUSED EQUIPMENT (TWO CONCRETE AND TWO METAL BRACKETS). REMOVE UNUSED EQUIPMENT PER RULE 606. CA DATE 5/29/2026.

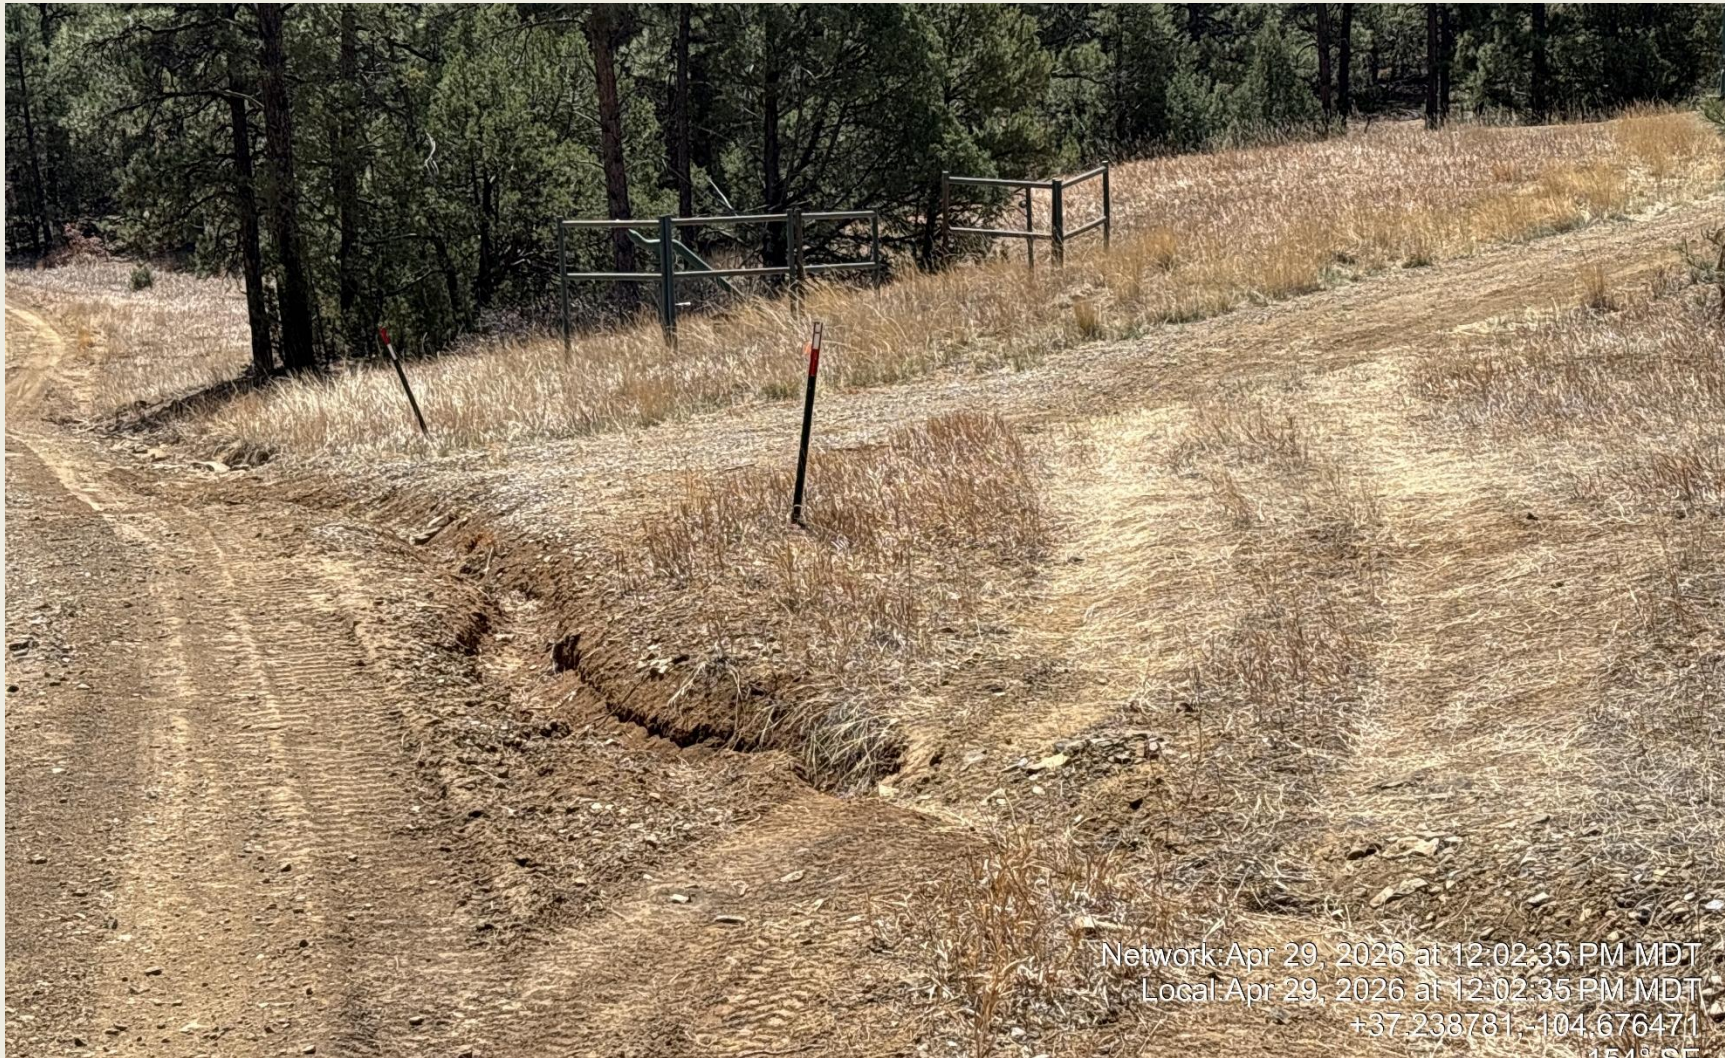
PHOTO 7: STORMWATER EROSION AT ENTRANCE OF LOCATION VEHICLES ARE DRIVING OFF OF THE ROW TO BYPASS THE EROSION. IMMEDIATELY STOP ALL VEHICLES FROM DRIVING OFF OF THE ROW AND INSTALL BMP'S TO PREVENT STORMWATER EROSION FROM DAMAGING THE ROW PER RULE 1002. CA DATE 5/5/2026.
