Inspection Photos

Operator: BONANZA CREEK ENERGY OPERATING
LLC- #8960

Location ID: 324729

Inspection Photos
Location Name: McCallum Unit #165 Pad
Location ID: 324729

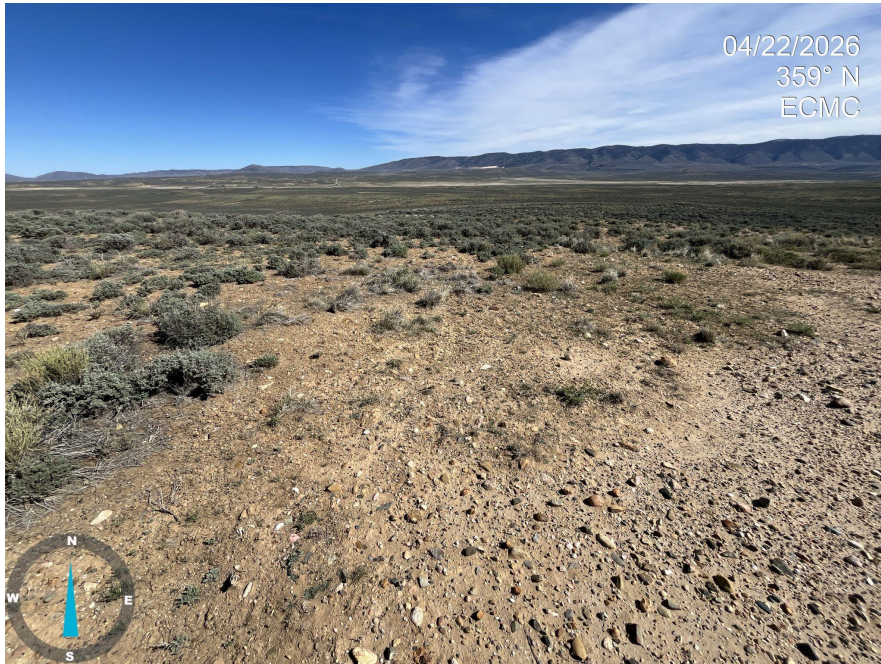
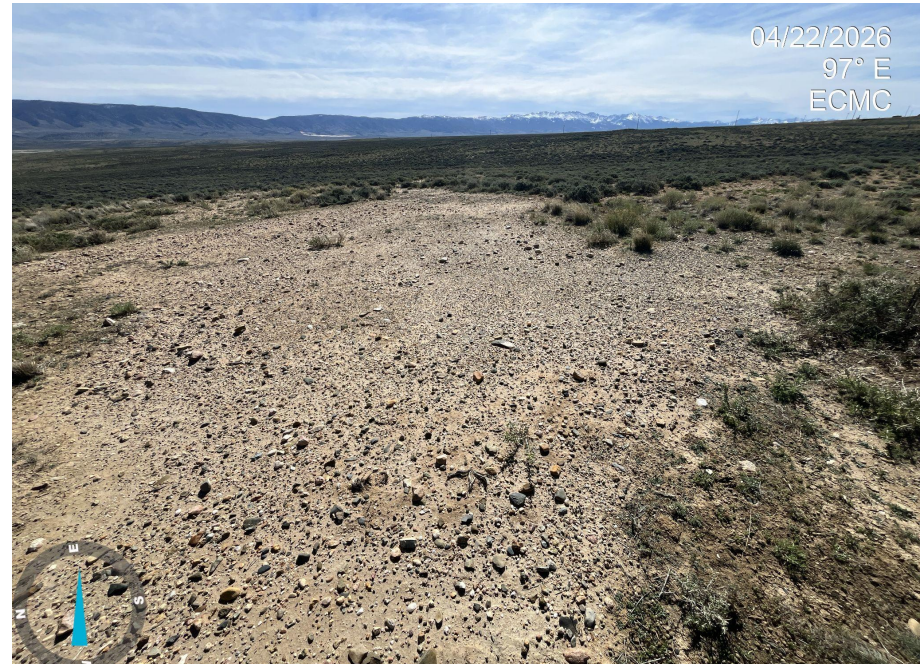
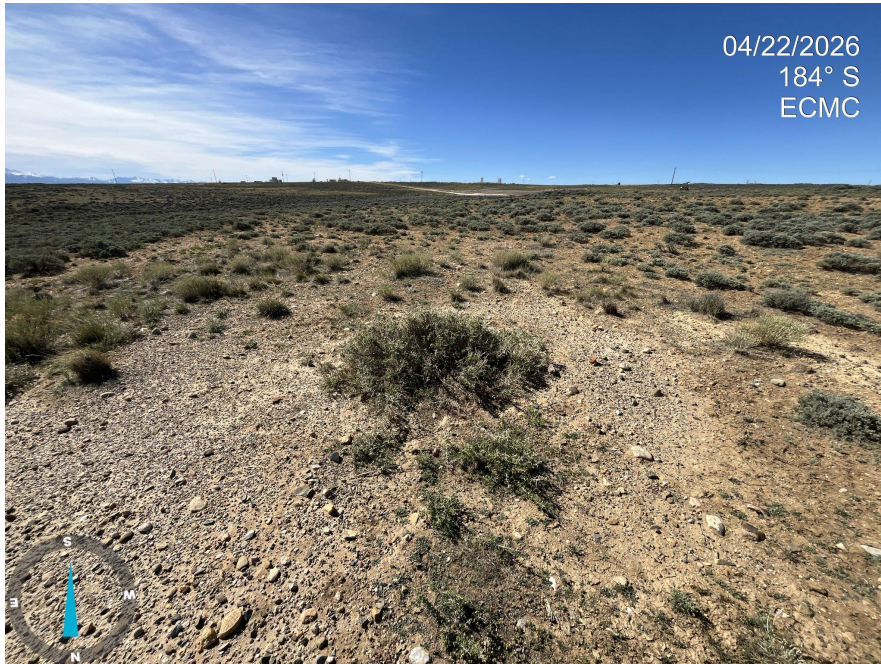
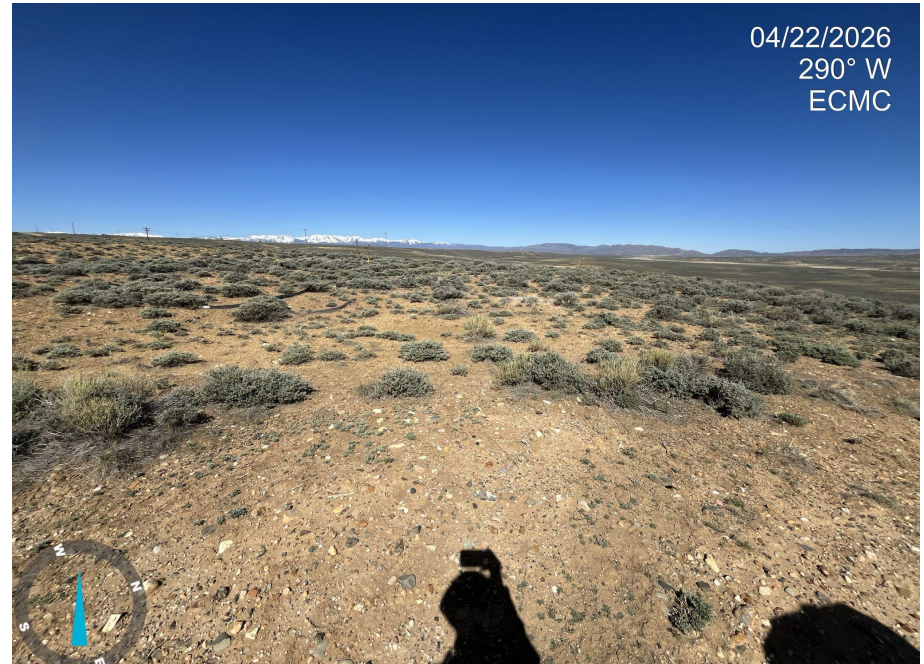
Photo 2. See comments under Photo 1.

Photo 1. Photos 1-4 taken from the center of the pad disturbance, facing north, east, south, and west, illustrating the Location overview.

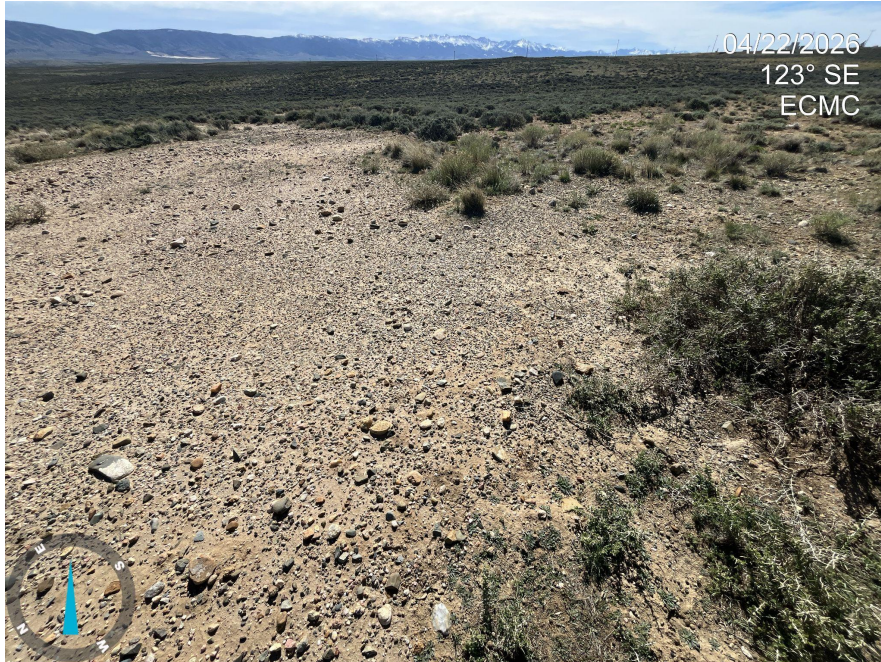
Photo 5. Photo taken of the center of the well pad. The area where the well head was previously is not progressing towards 1004 vegetation standards.

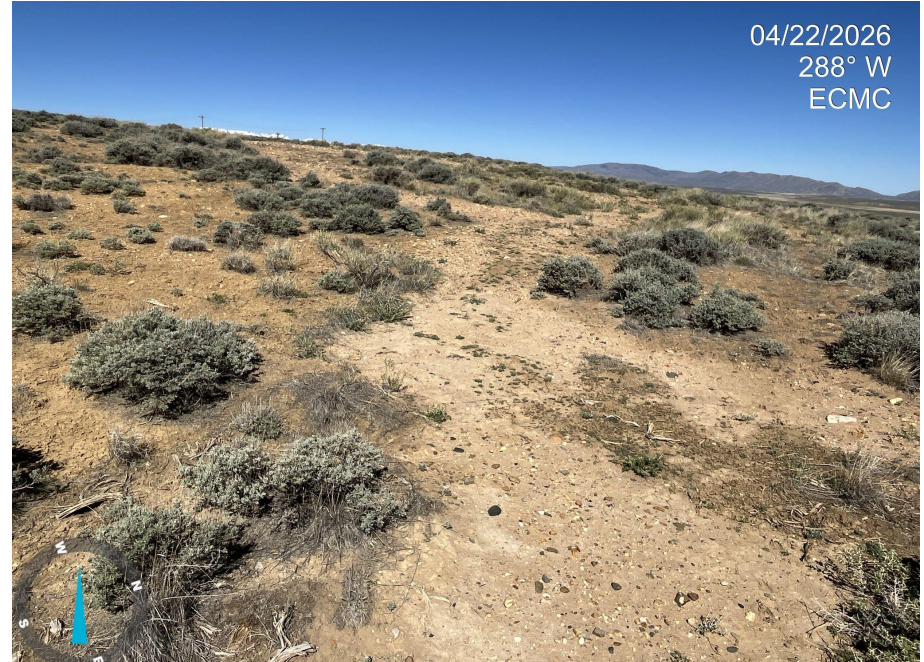
Photo 6. Photo taken east of the well pad center facing west; photo illustrates that areas downhill of the pad center have not established vegetation.

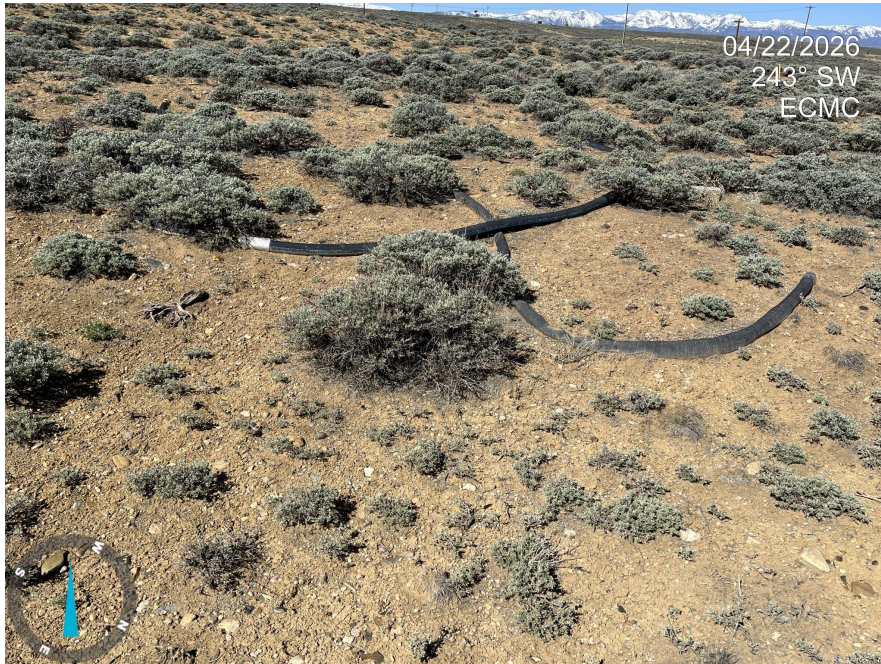
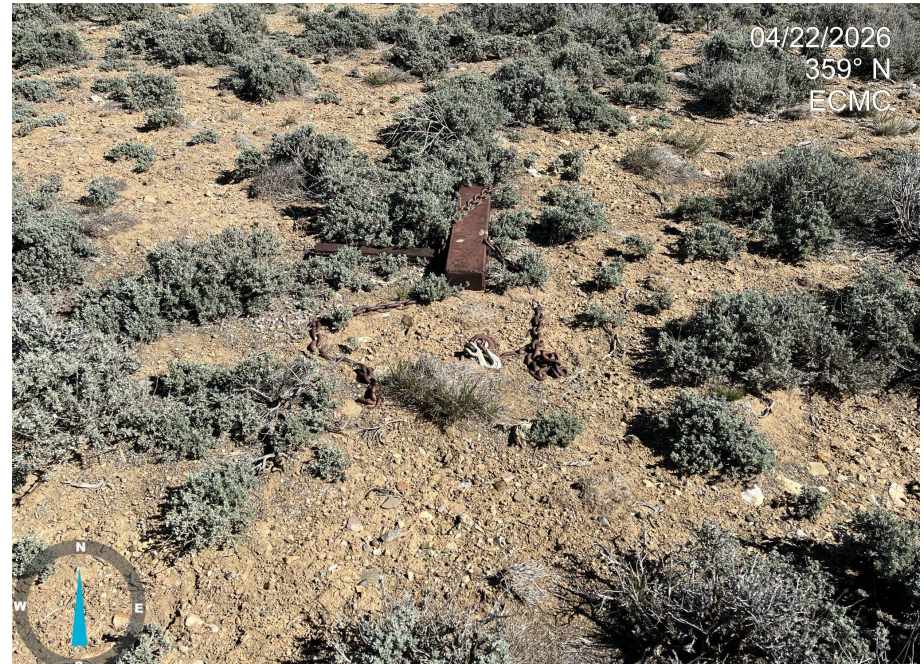
Photo 8. See comments under Photo 7.

Photo 7. Photos 7-8 illustrate examples of trash/debris left on the Location.

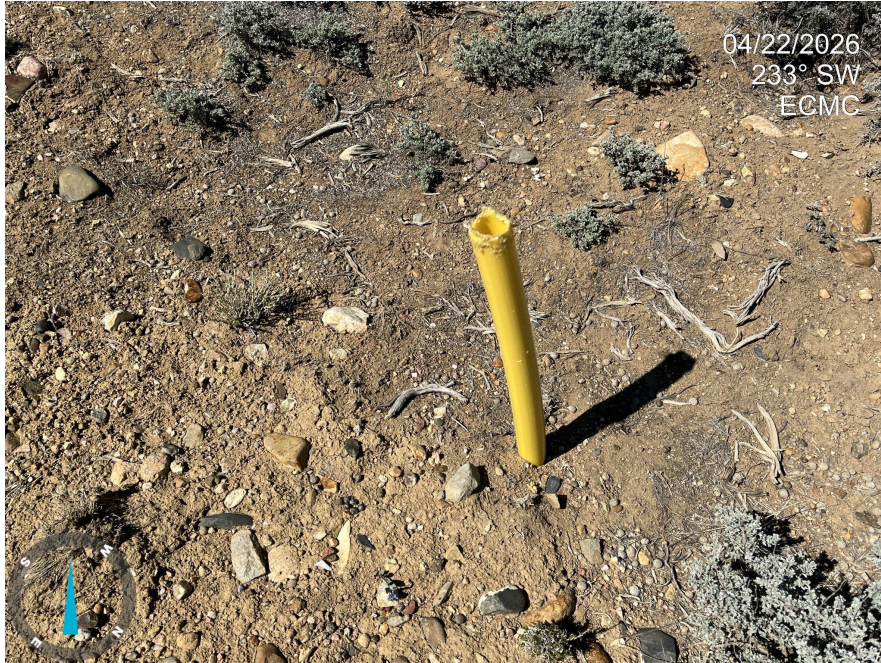
Photo 9. Photo illustrates that the anchor marker has been left on Location. It was unclear if the anchors were left on the Location, but have since been buried.

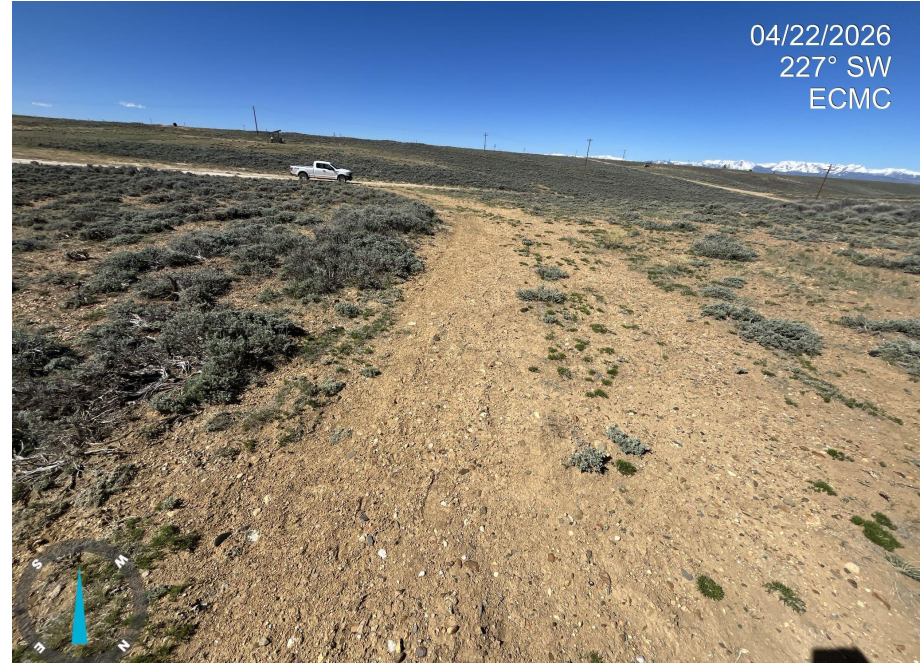
Photo 10. Photo illustrates that the access road has not been reclaimed.

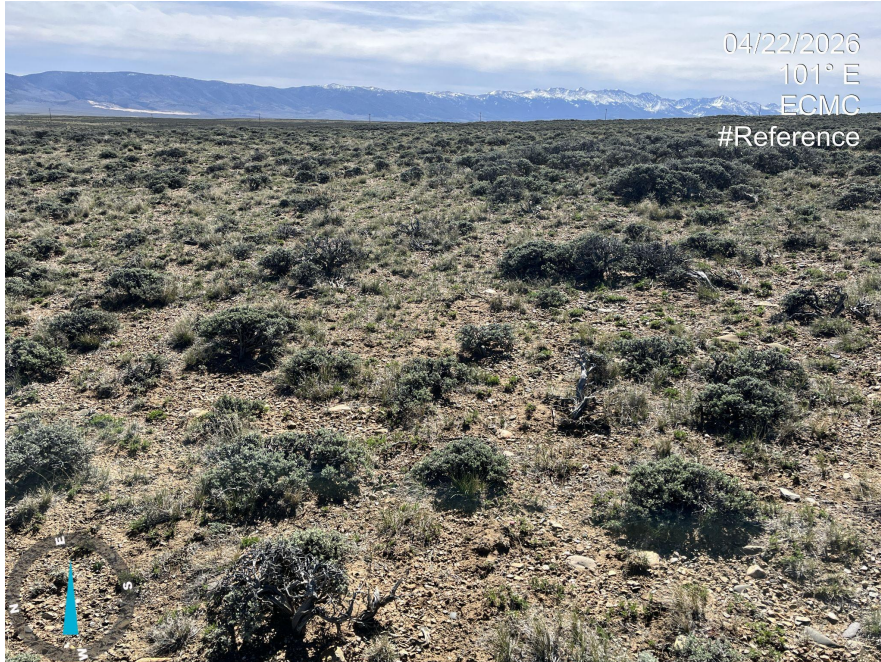
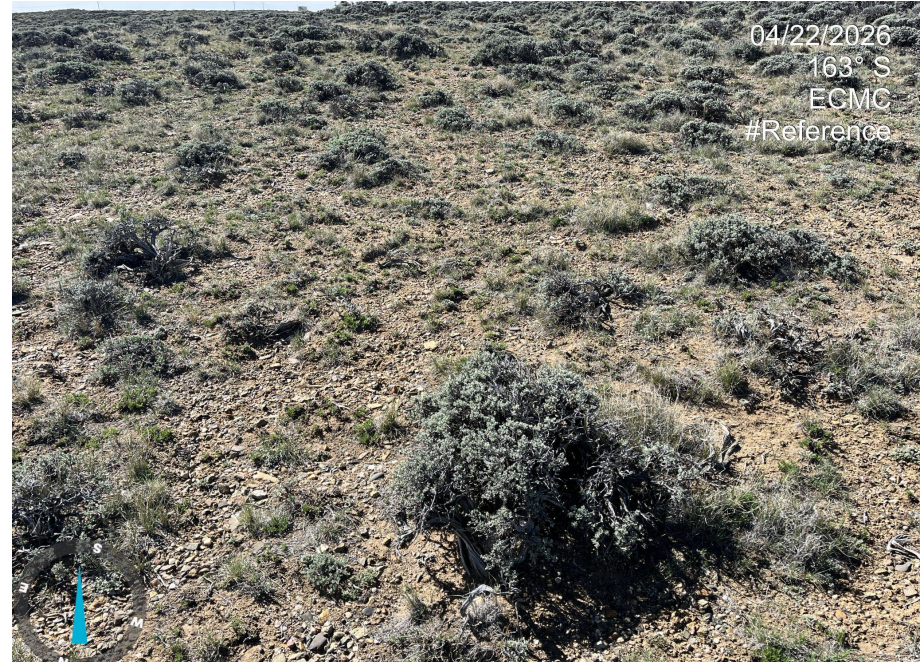
Photo 12. See comment under Photo 11.

Photo 11. Photos 11-12 taken east of the Location, facing east and south, illustrating reference area vegetation. This includes primarily Wyoming sagebrush, Sandburg bluegrass, and phlox.
