INSPECTION PHOTOS

Well: CULVER 14-12

INSPECTION DOC #: 716302283

Operator: EVERGREEN NATURAL RESOURCES LLC

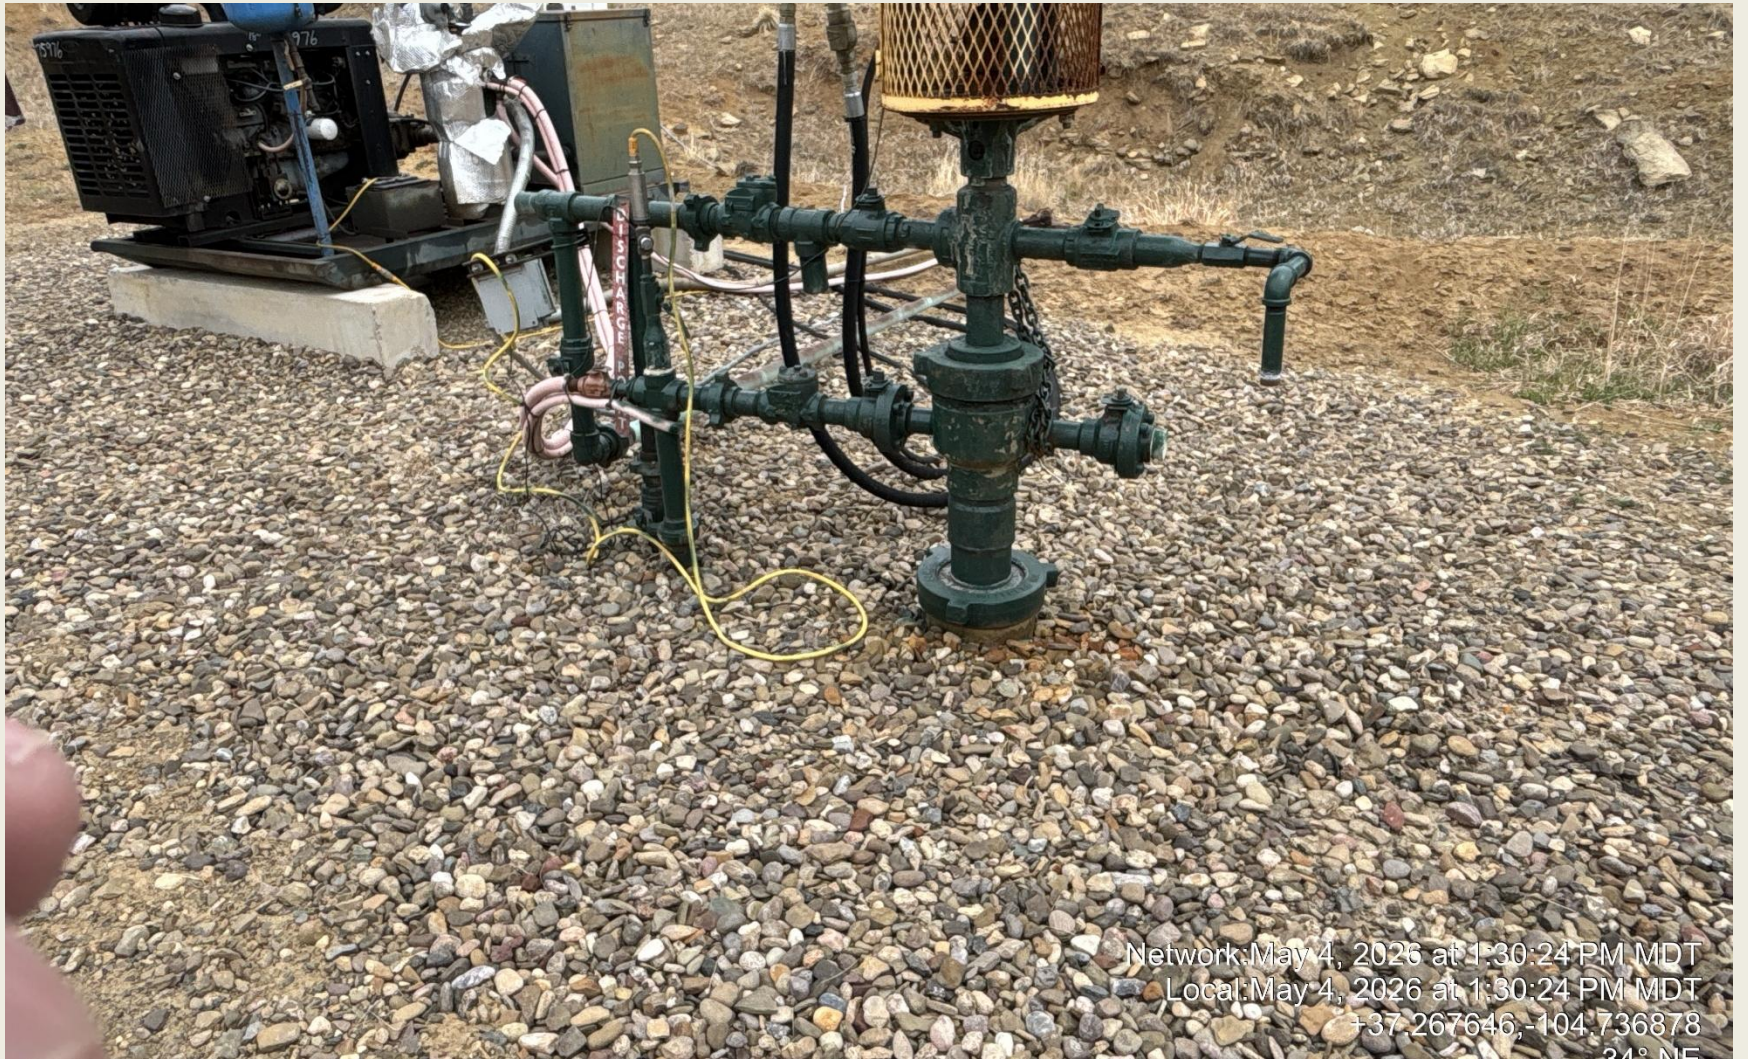
PHOTO 5: IMPACTED SOIL HAS BEEN REMOVED.

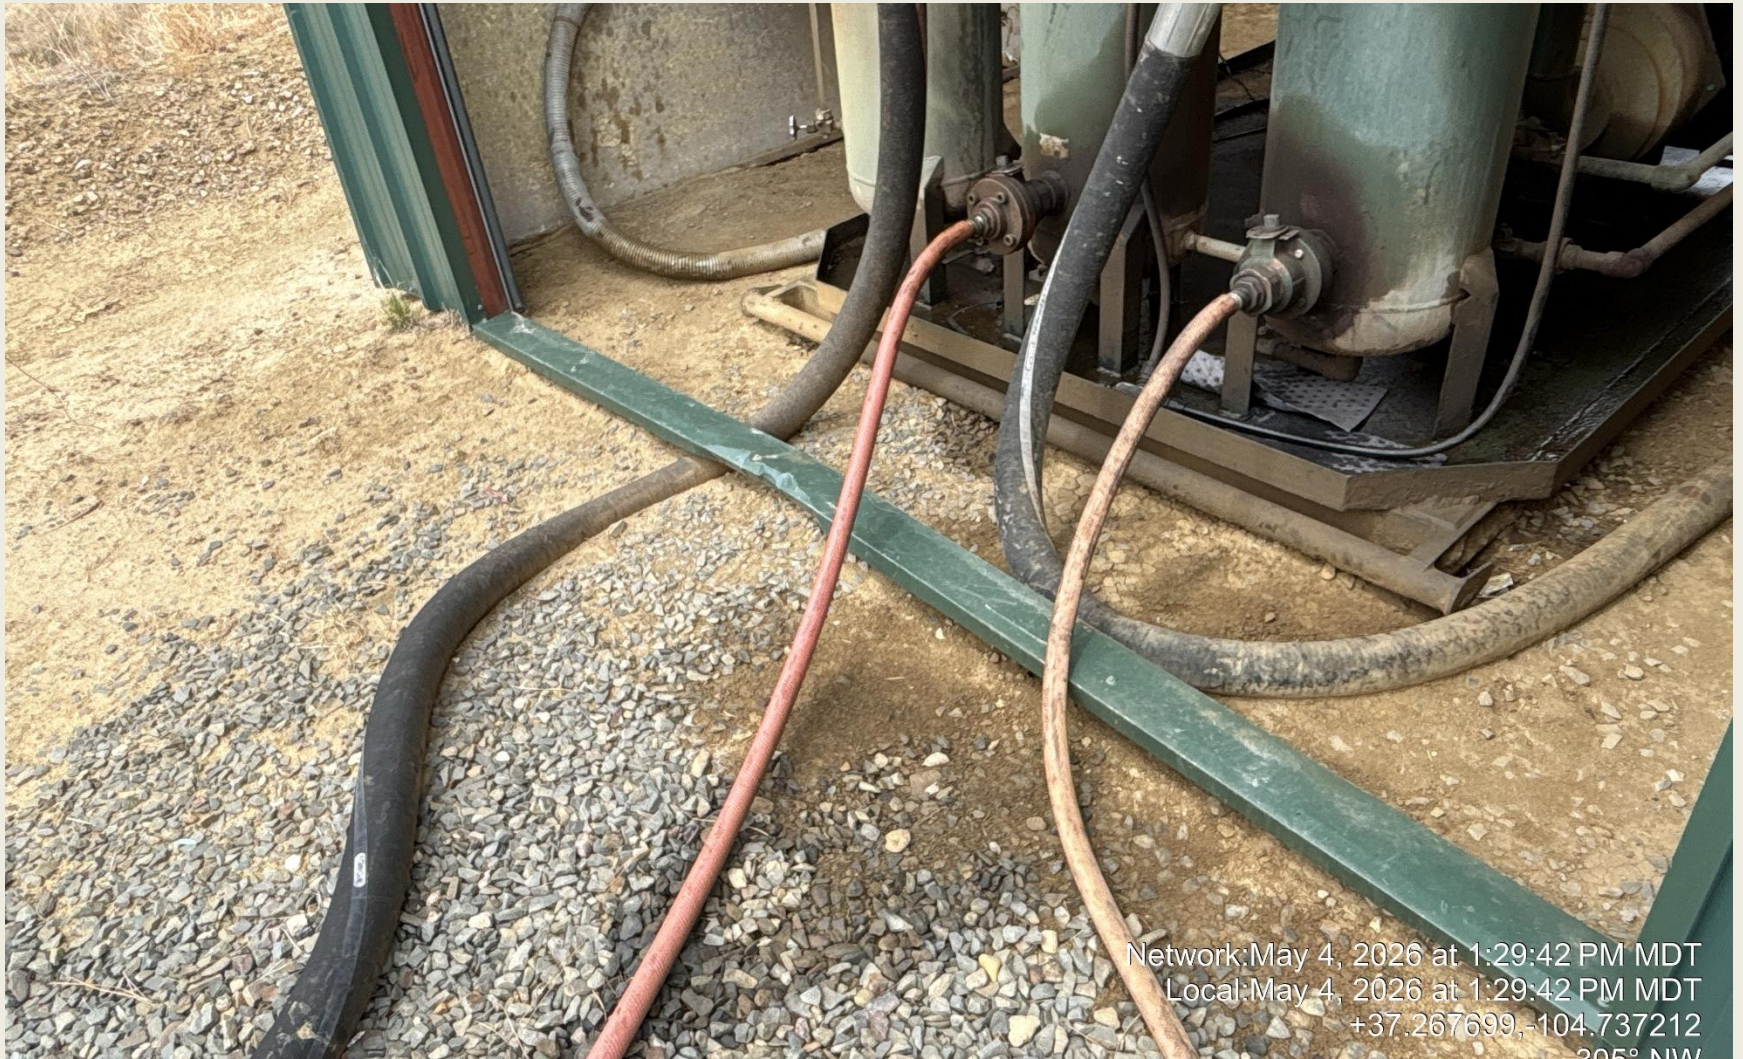
PHOTO 7: AREA OF IMPACTED SOIL NEAR TR WELL COMPRESSOR. Conduct maintenance on equipment, cleanup stained material and review self inspection processes. COMPLY WITH RULE 1002,(2).D. CA DATE 6/4/2026.
