Inspection Photos

Operator: KP KAUFFMAN COMPANY INC - #46290

Location ID: 450391

Inspection Photos
Location Name: Make up water Tank Battery
Location ID: 450391

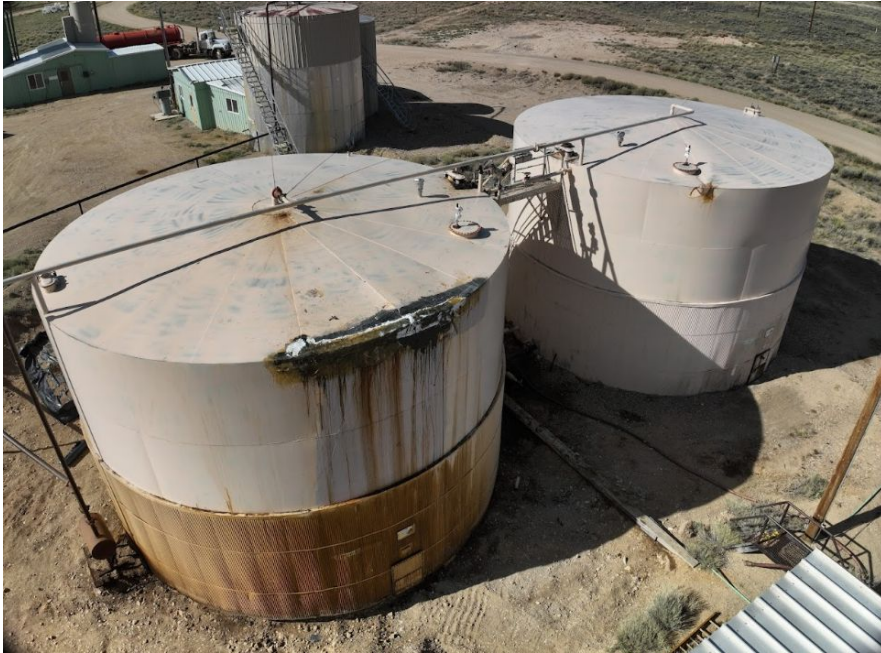
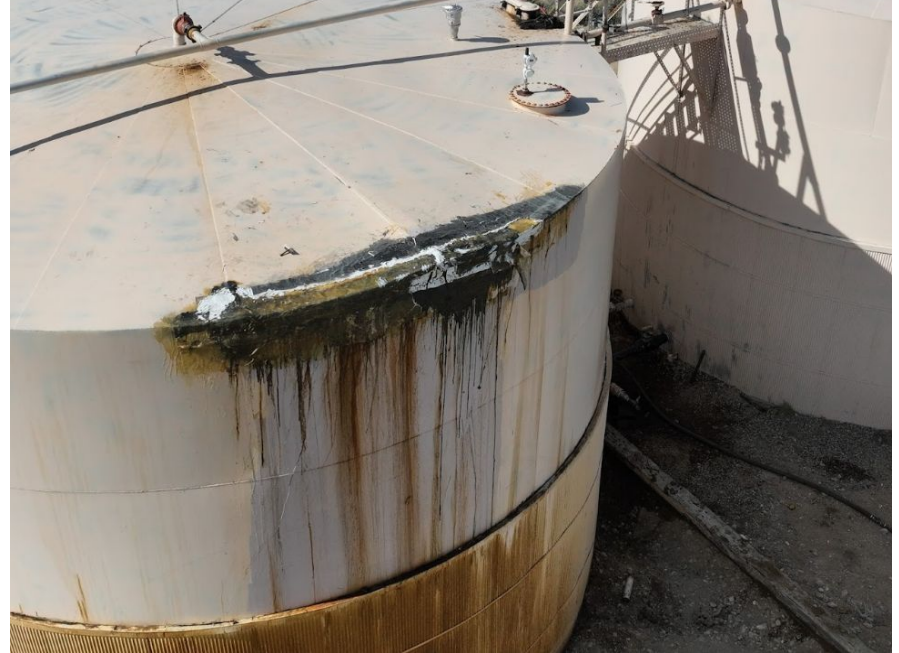
Photo 1. Photos 1-2 taken of the tank battery with drone imagery, illustrating the fiberglass patch.

Photo 2. See comments under photo 1.

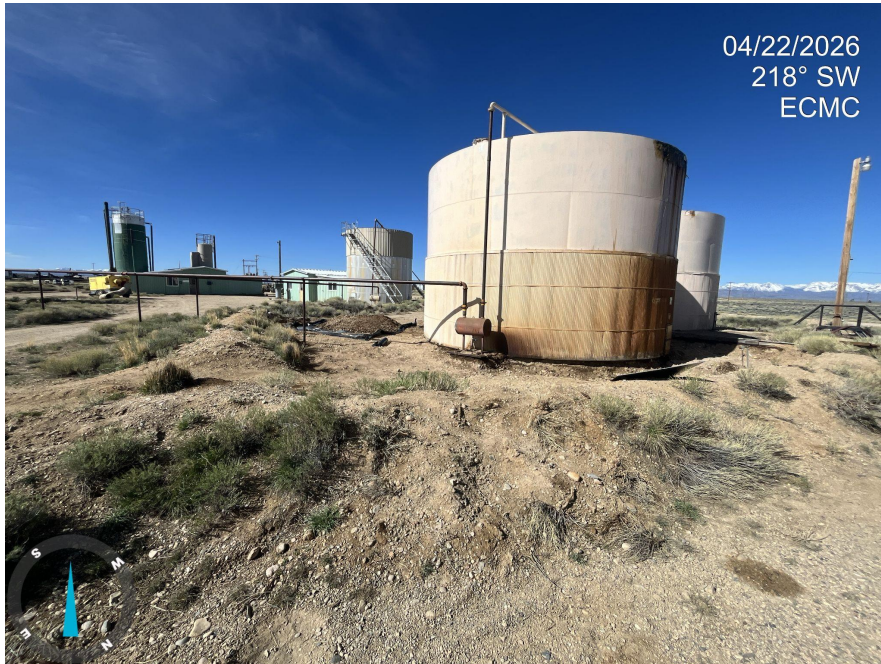
Photo 3. Photo taken from the northeastern portion of the tank battery, facing southwest, illustrating overview.

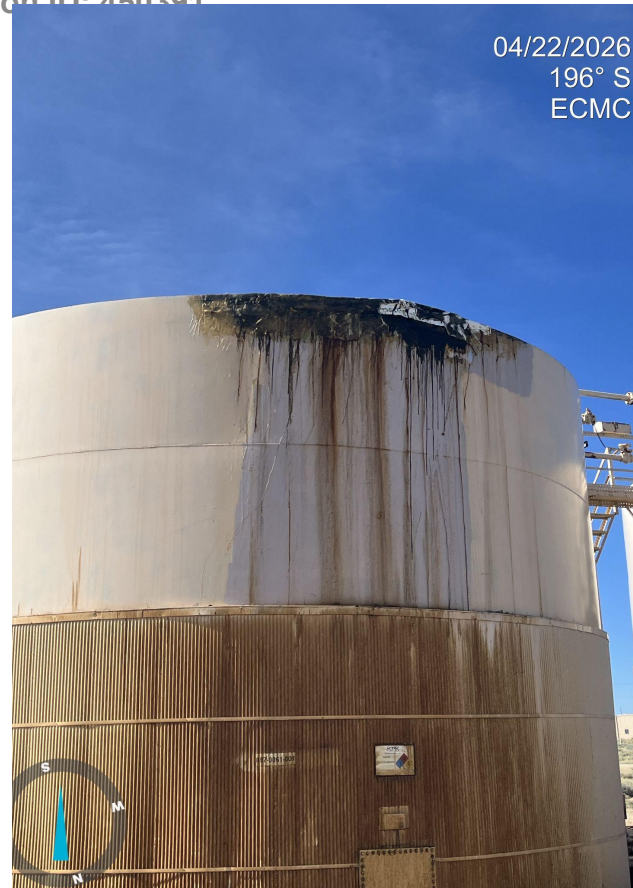
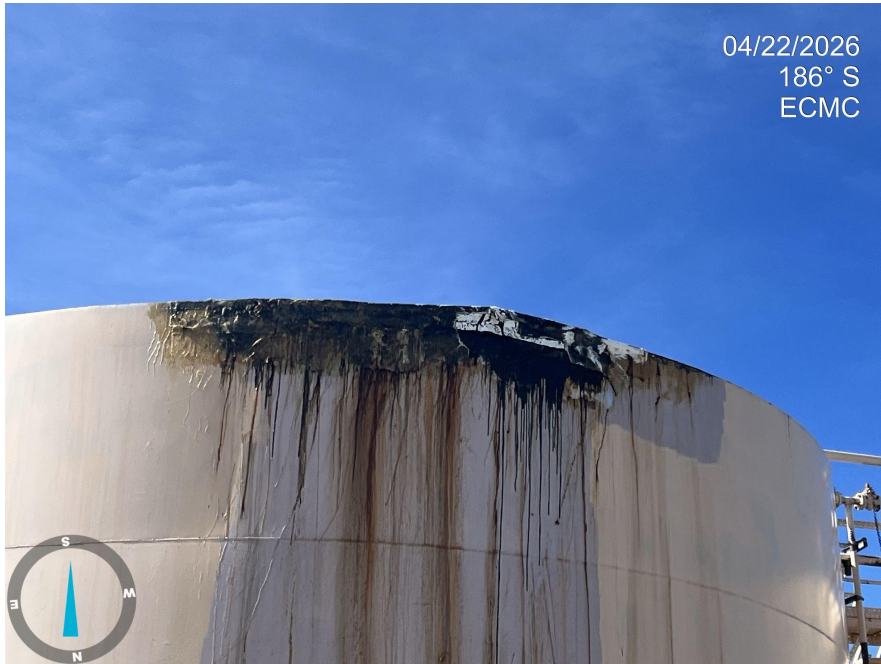
Photo 4. Photos 4-5 taken of the fiberglass patch on the tank.

Photo 5. See comment under Photo 4.

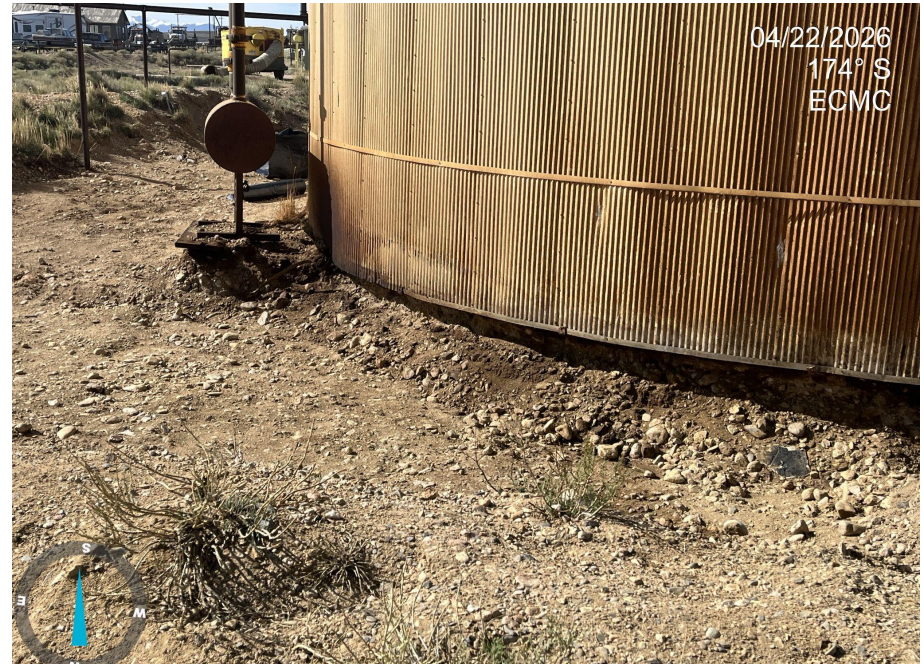
Photo 6. Photo taken from the northeastern portion of the tank battery, facing south, illustrating some of the contaminated soil has been excavated underneath the tank battery.

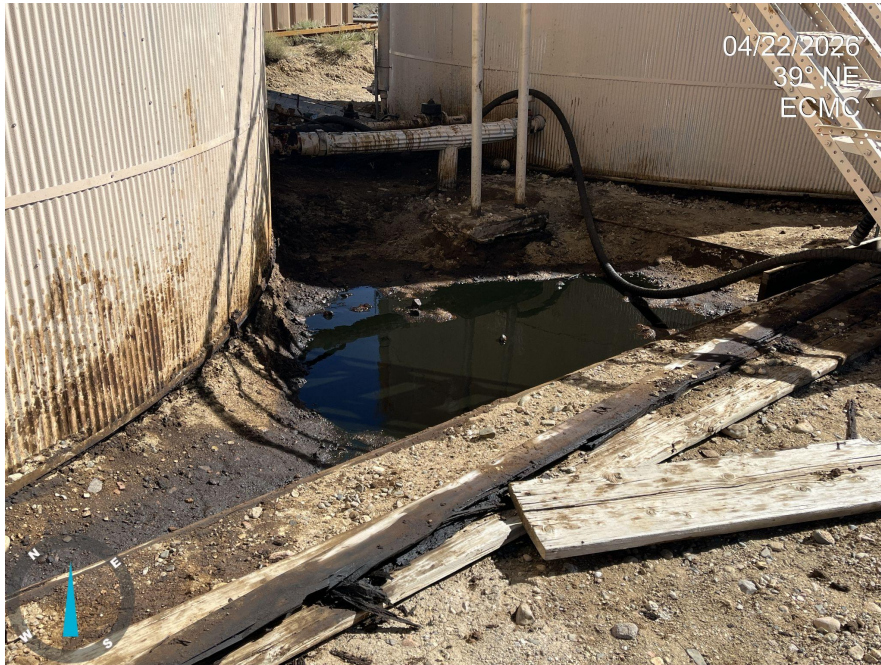
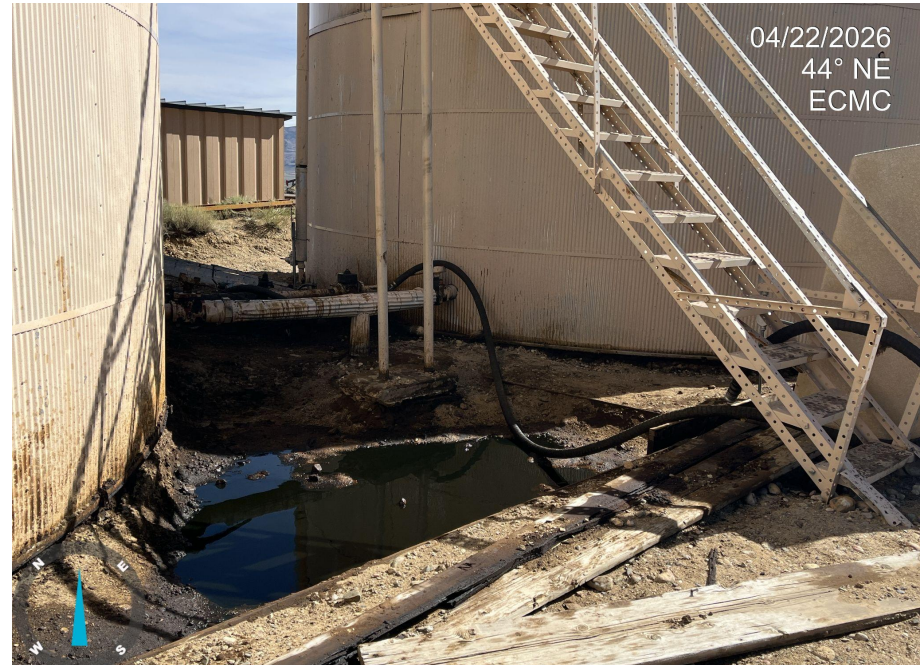
Photo 7. Photos 7-8 taken on the south of the tank batteries, facing northeast. Photos illustrate the free-standing fluids between the two tanks.

Photo 8. See comments under photo 7.

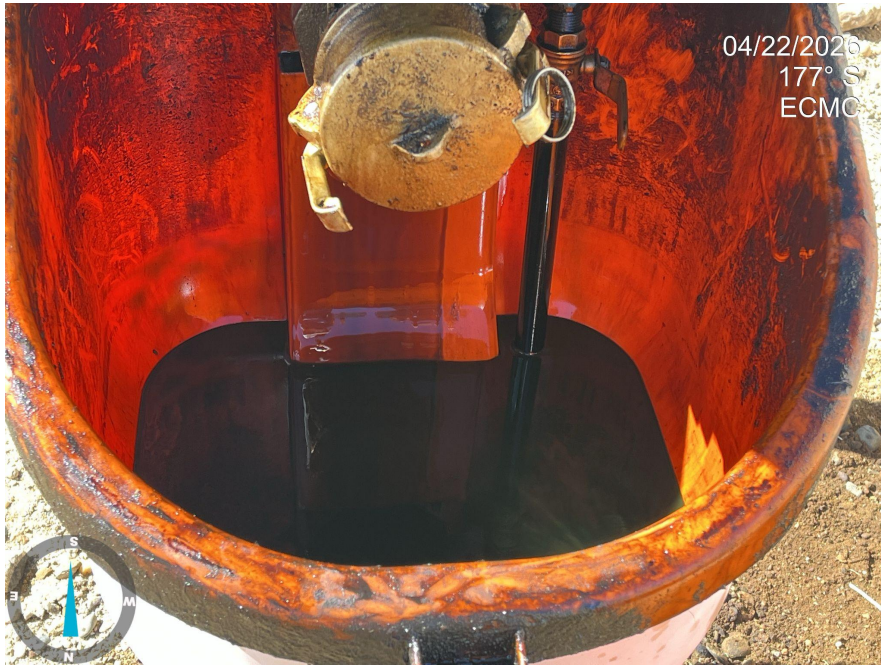
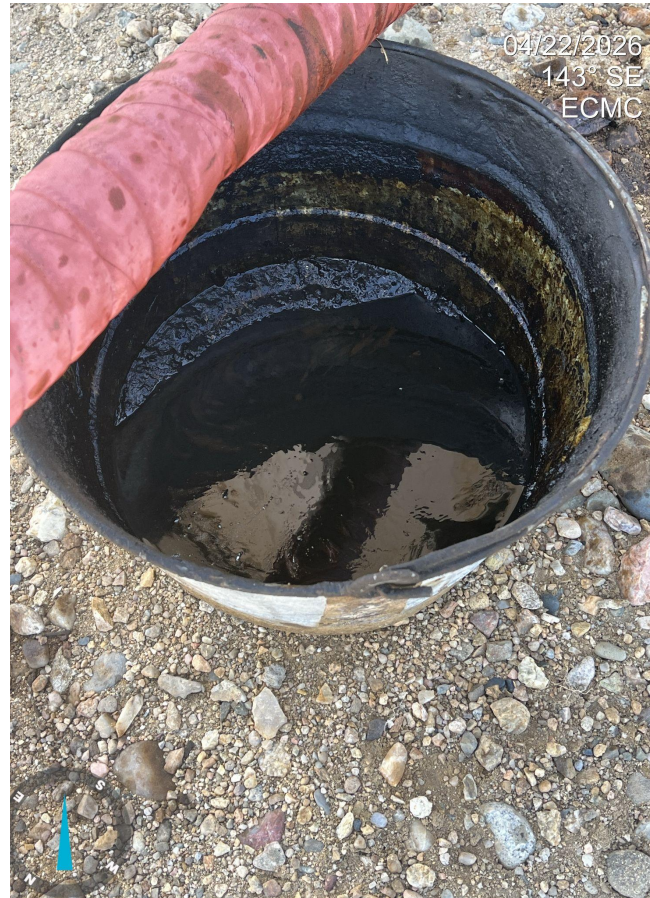
Photo 9. Photos 9-10 taken of the honey pot and uncovered container on the northern side of the tanks, outside the berm. Both have fluids; the container in photo 10 had no protective covers.

Photo 10. See comments under photo 9.

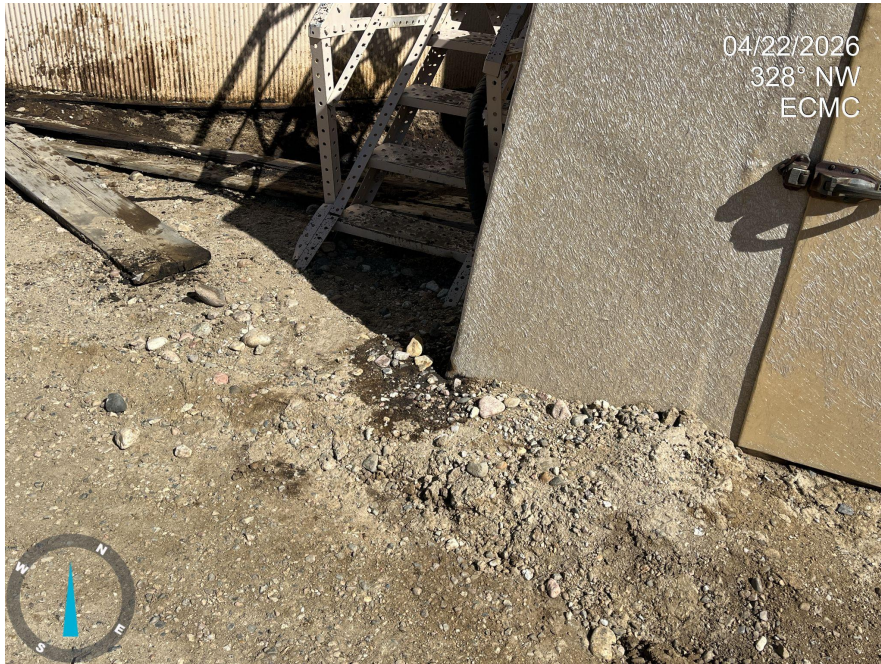
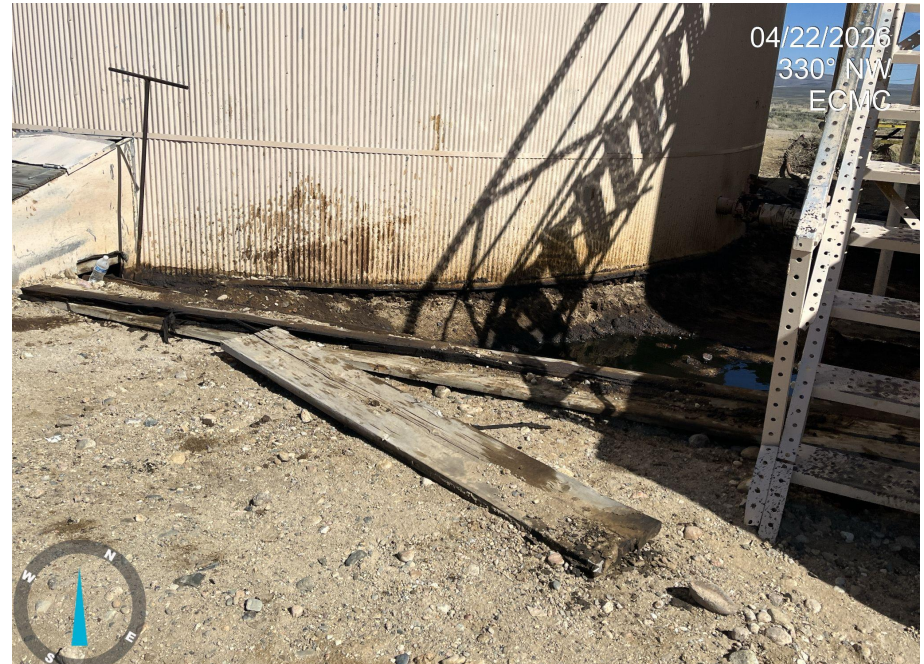
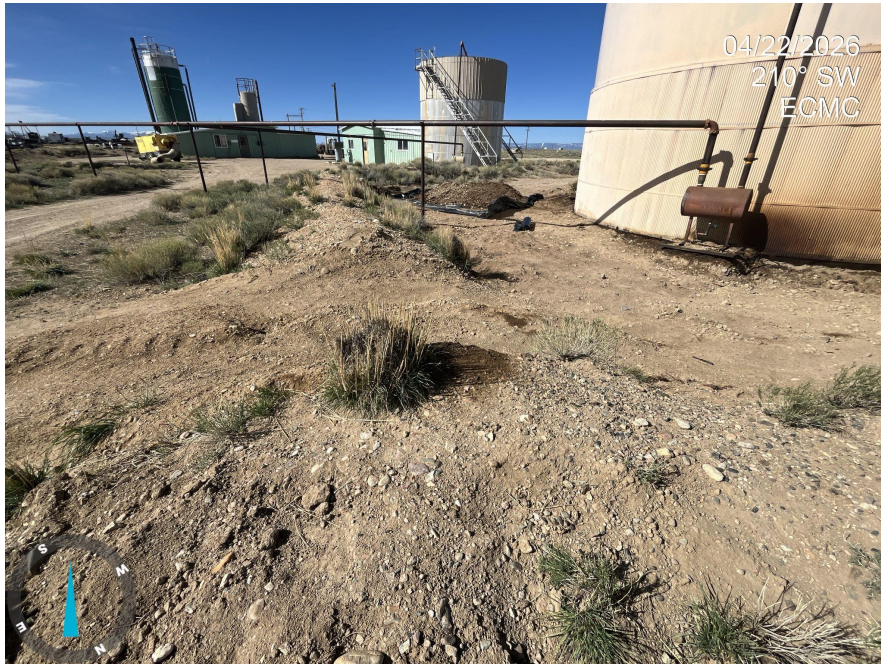
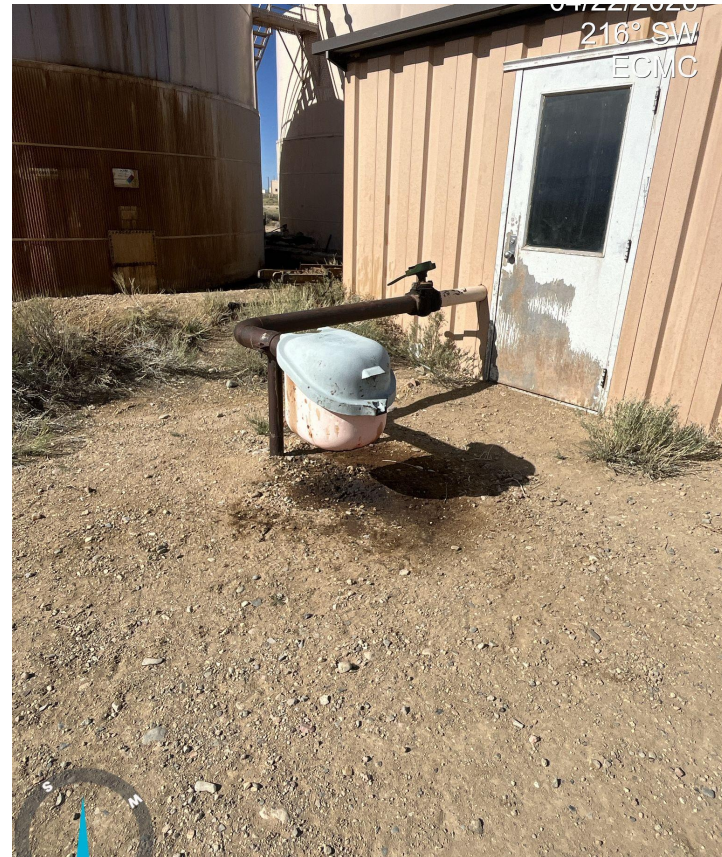
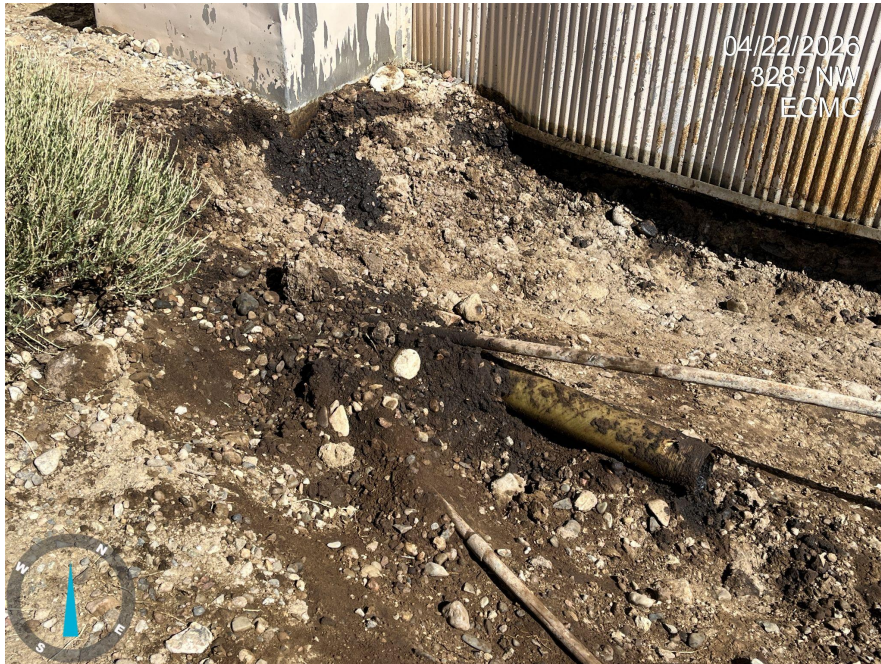
Photo 11. Photos 11-15 taken throughout the Location, illustrating stained and contaminated soils.

Photo 12. See comments under photo 11.

Photo 13. See comments under photo 11.

Photo 14. See comments under photo 11.

Photo 15. See comments under photo 11.

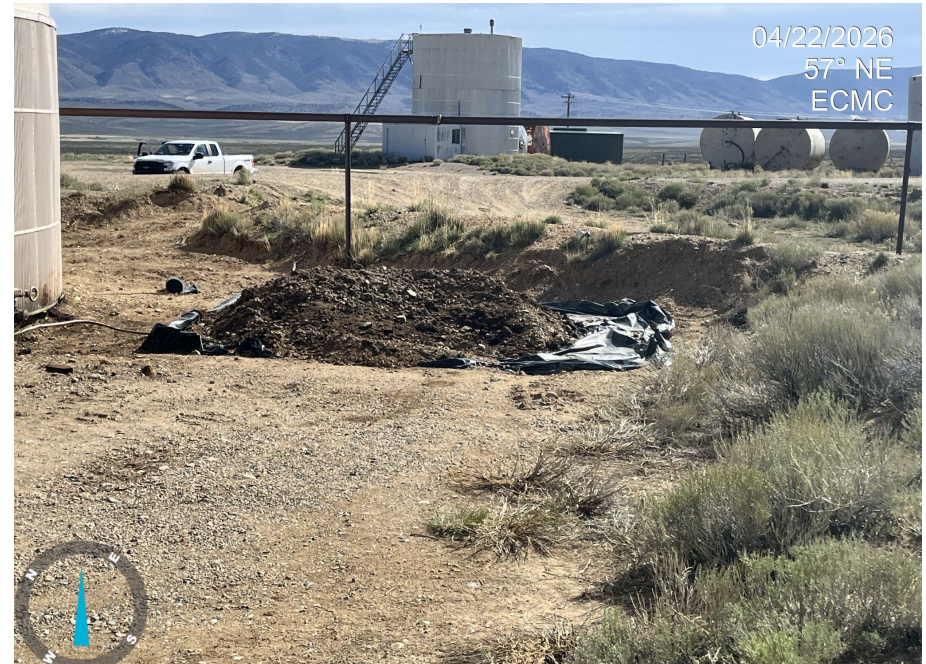
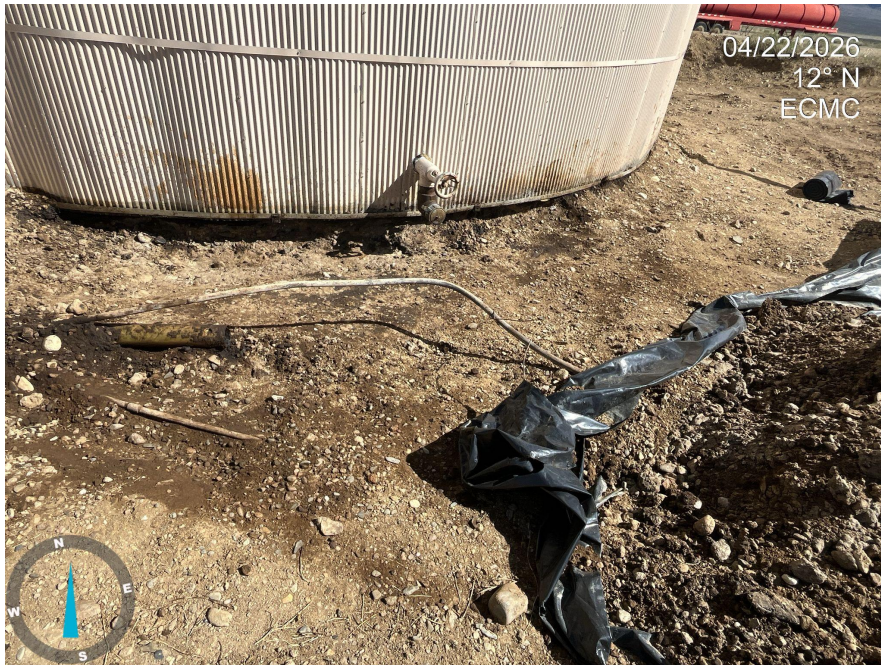
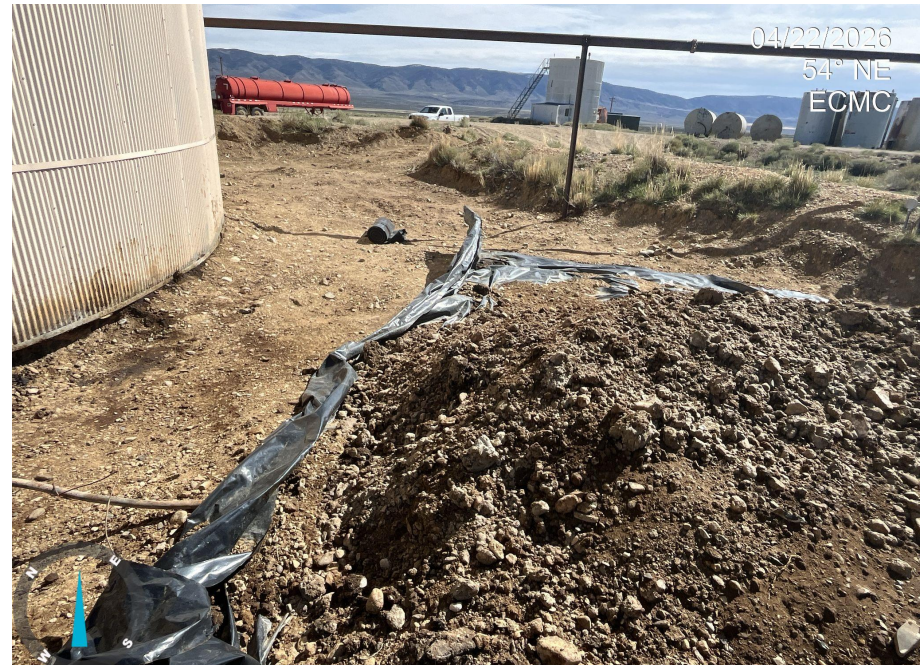
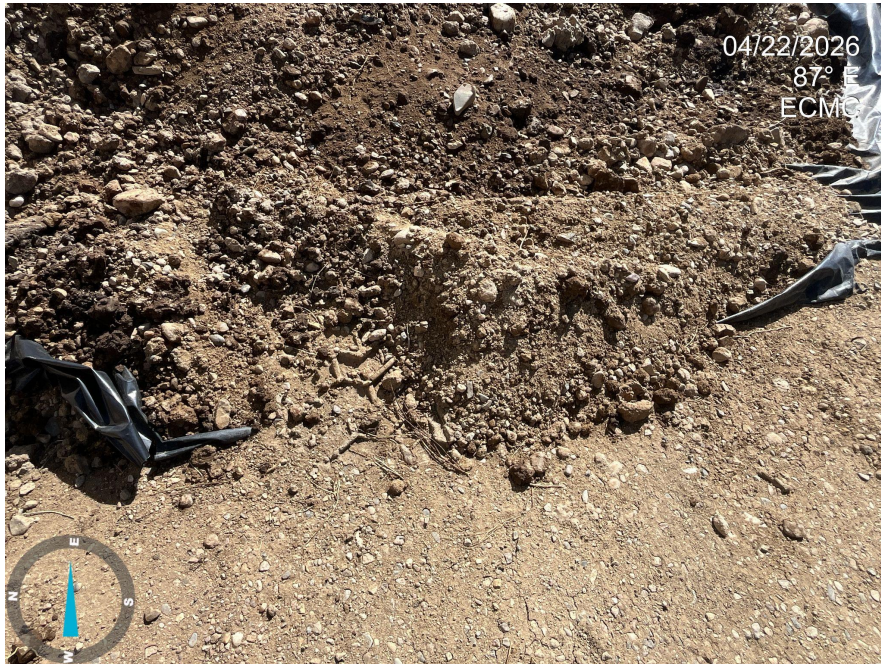
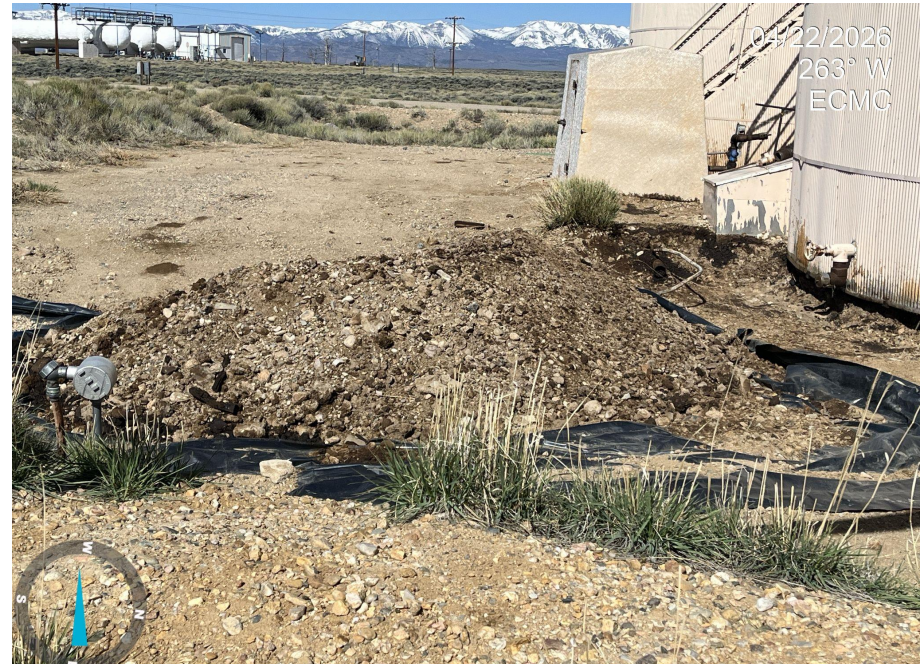
Photo 16. Photos 16-20 illustrated what appears to be the excavated contaminated soil from within the berm during the first spill. The soil is not stored adequately on the additional liner.

Photo 17. See comments under photo 16.

Photo 18. See comments under photo 16.

Photo 19. See comments under photo 16.

Photo 20. See comments under photo 16.

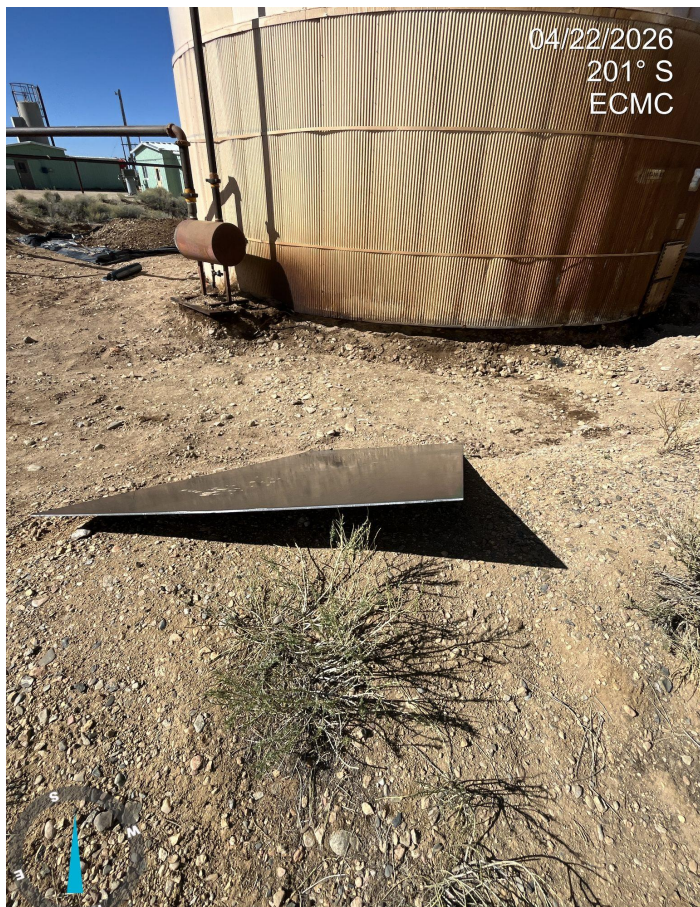
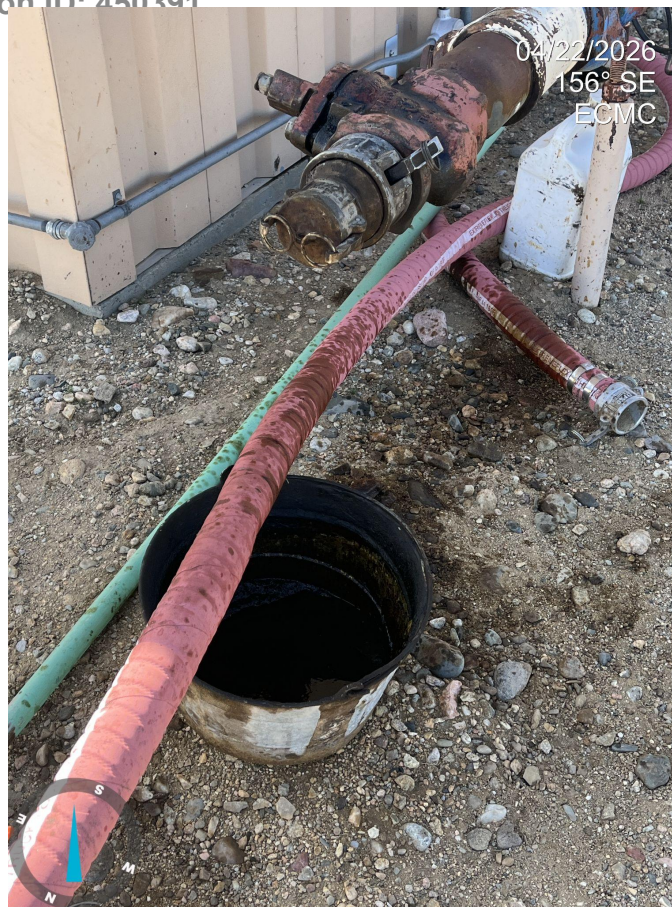
Photo 21. Photos 21-22 illustrate that trash/debris/unused equipment was observed on the Location.

Photo 22. See comments under photo 21.

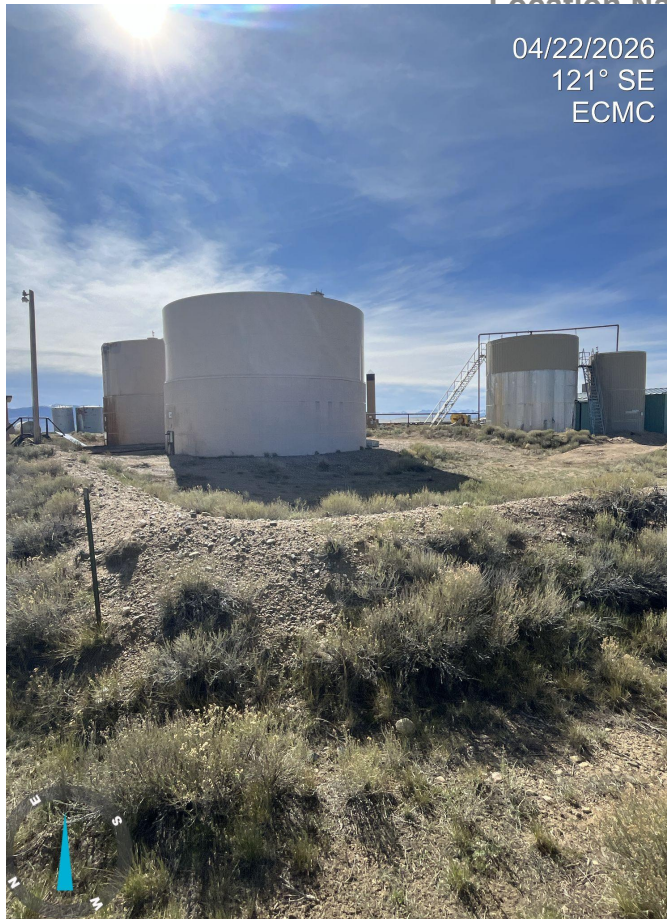
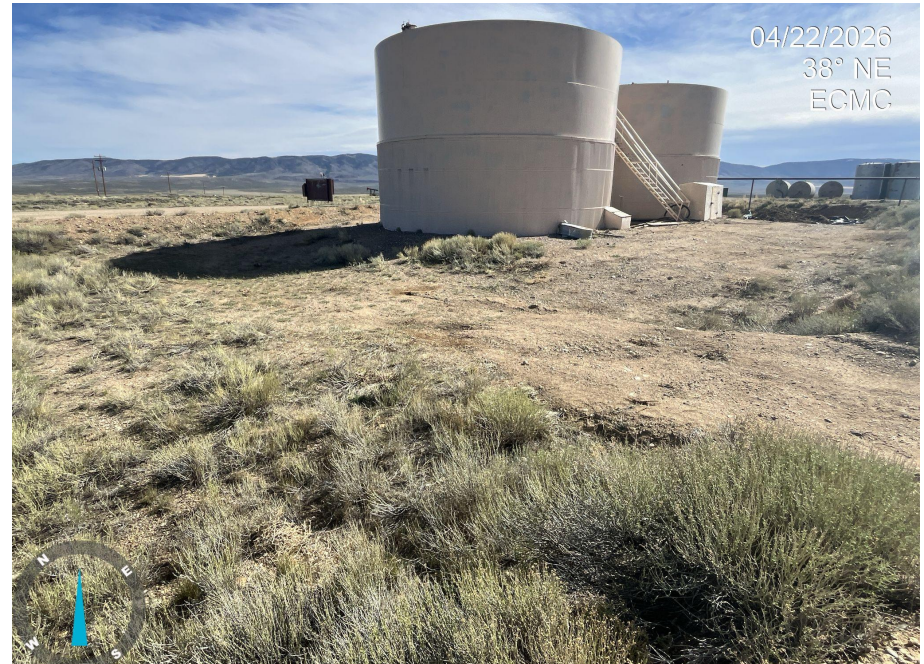
Photo 24. See comments under photo 23.

Photo 23. Photos 23-24 taken on the northwestern and southwestern portions of the tank batteries, facing southeast and northeast, respectively. Photos illustrate the berm size and vegetation growth within the secondary containment.

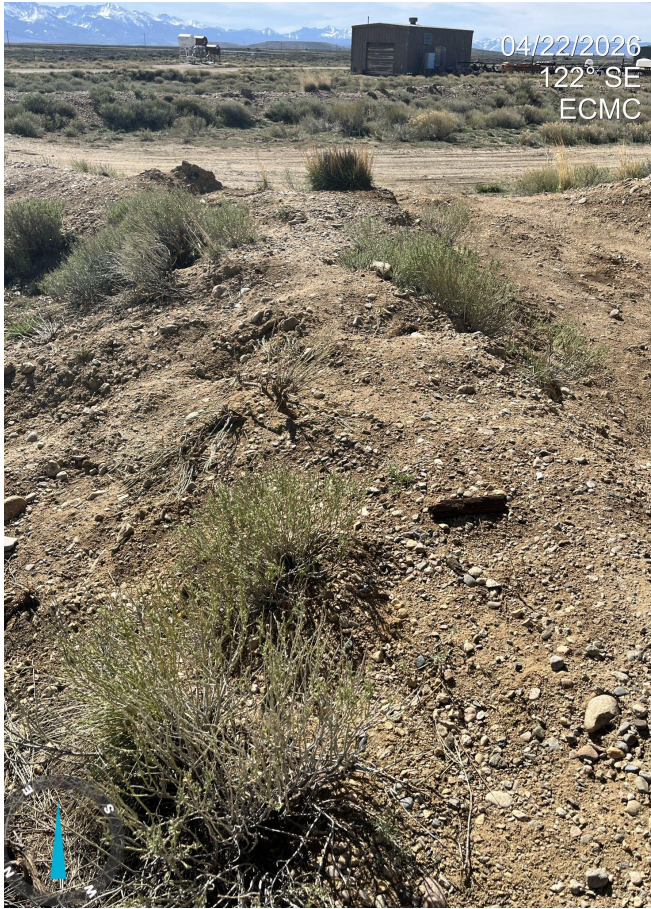
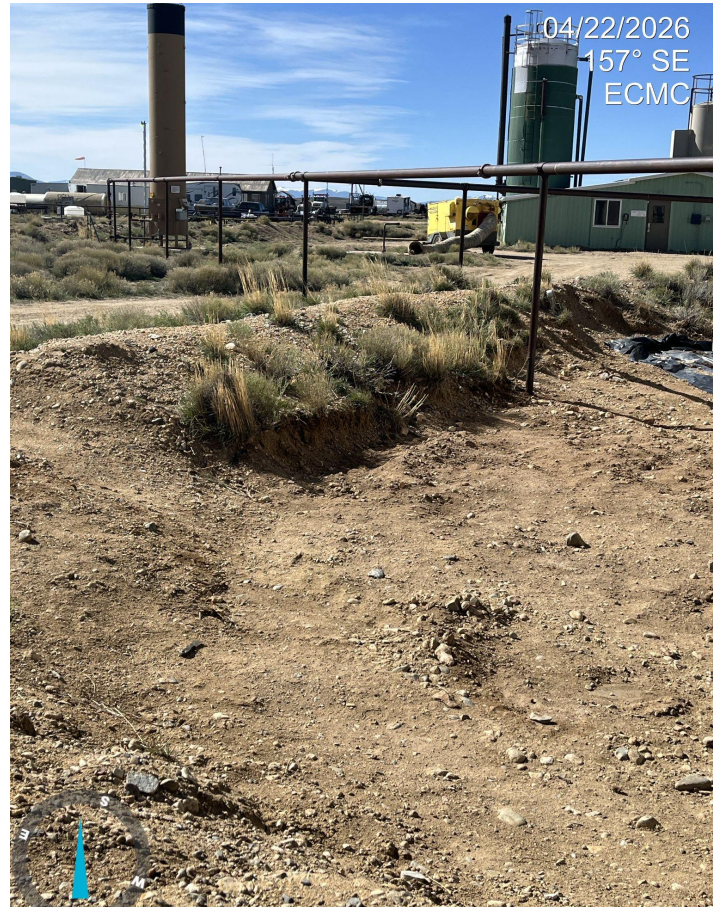
Photo 25. Photos 25-26 illustrate examples of vegetative growth on the earthen berms, illustrating the berms are not impervious to spills.

Photo 26. See comments under photo 25.
