INSPECTION PHOTOS

Well: GILA MONSTER FEDERAL 42-21

API #: 05-071-06605

Operator: EVERGREEN NATURAL RESOURCES LLC

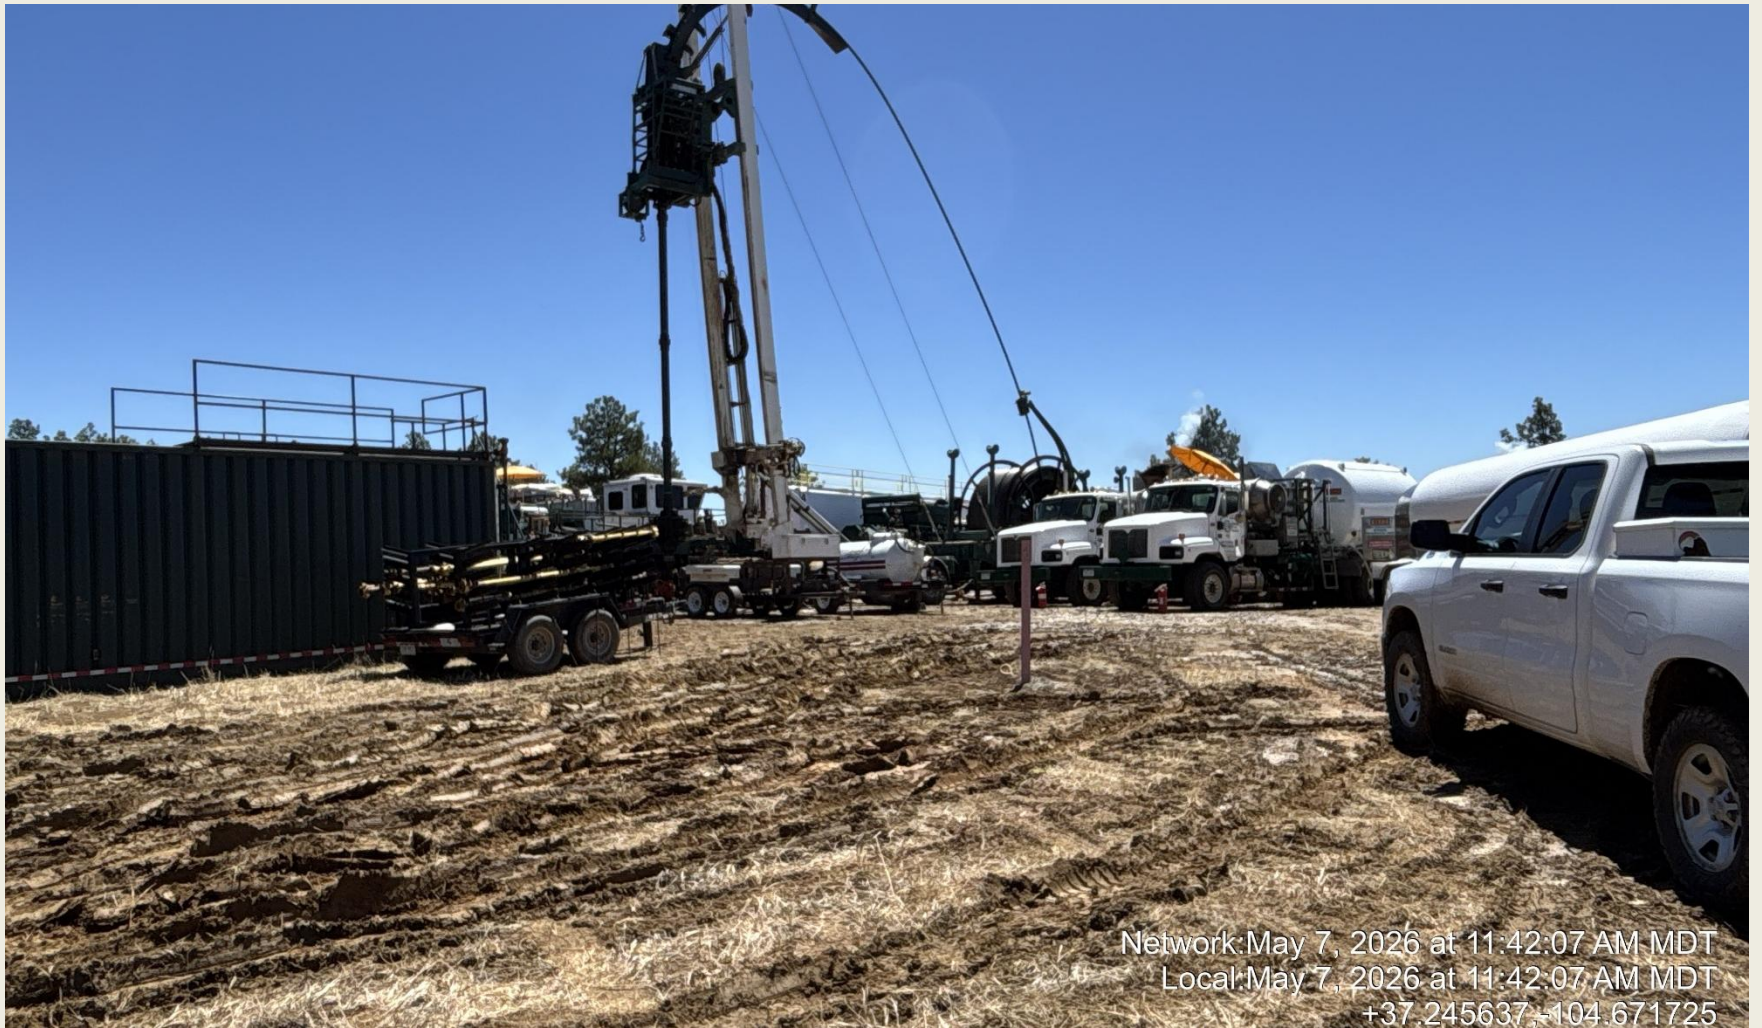
PHOTO 3: LOCATION.

Network: May 7, 2026 at 11:42:07 AM MDT
Local: May 7, 2026 at 11:42:07 AM MDT
+37.245637,-104.671725

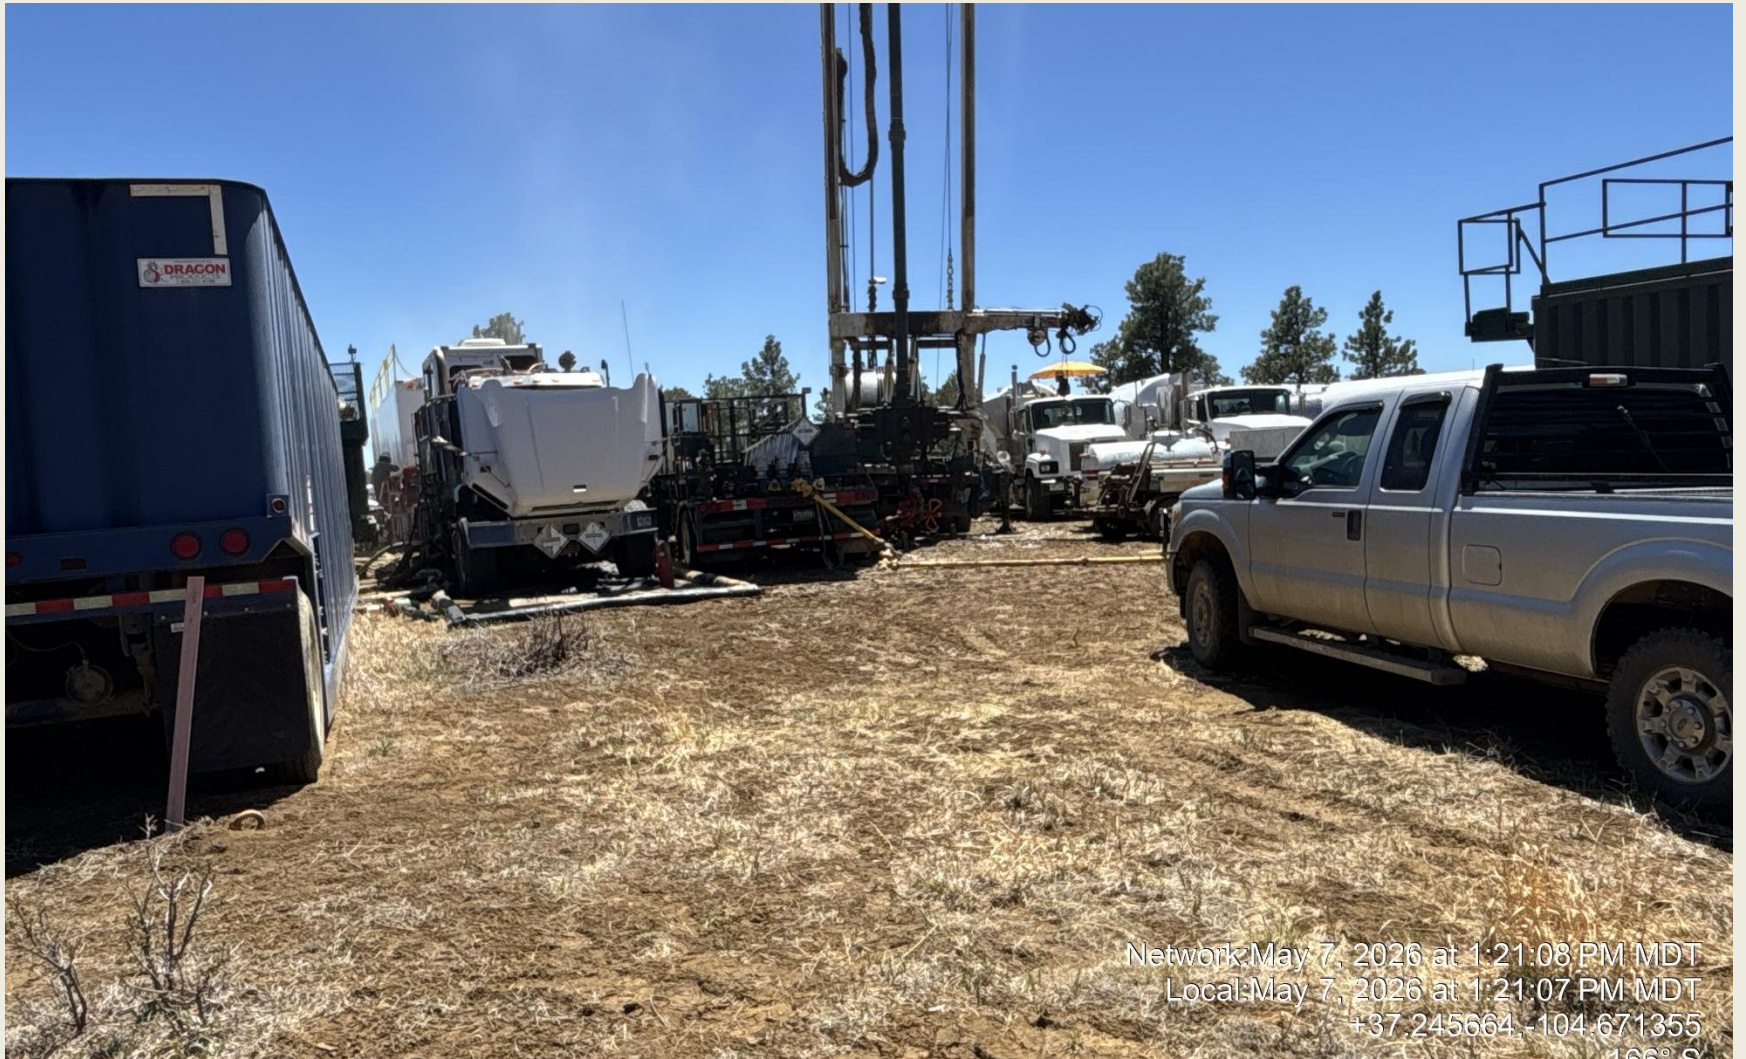
PHOTO 4: WELLHEAD AND EQUIPMENT.

Network: May 7, 2026 at 1:21:08 PM MDT
Local: May 7, 2026 at 1:21:07 PM MDT
+37.245664, -104.671355
106° S

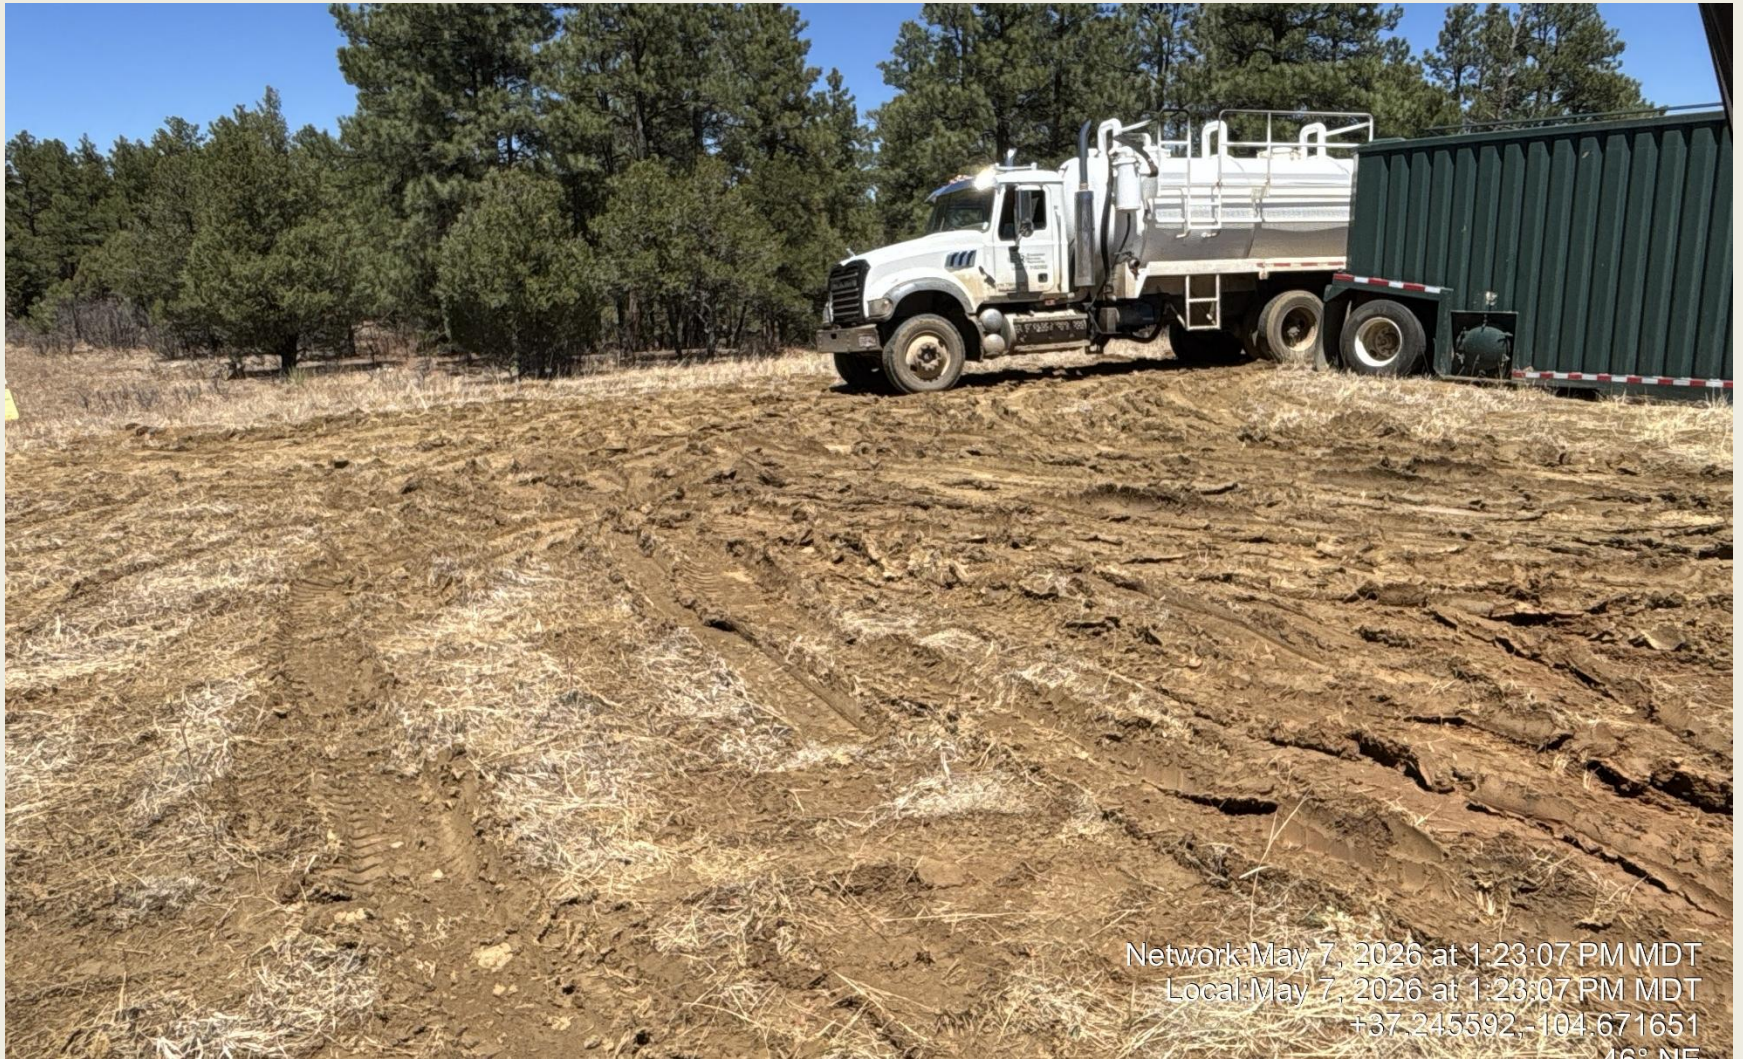
Network May 7, 2026 at 1:23:07 PM MDT
Local May 7, 2026 at 1:23:07 PM MDT
+37.245592, -104.671651
16° NE

PHOTO 5: INTERIM RECLIMATION AREA WEST OF WELLHEAD WILL NEED RE-SEEDED. RE-SEED ALL DISTURBED INTERIM RECLIMATION AREAS PER RULE 1003. CA DATE 7/15/2026.

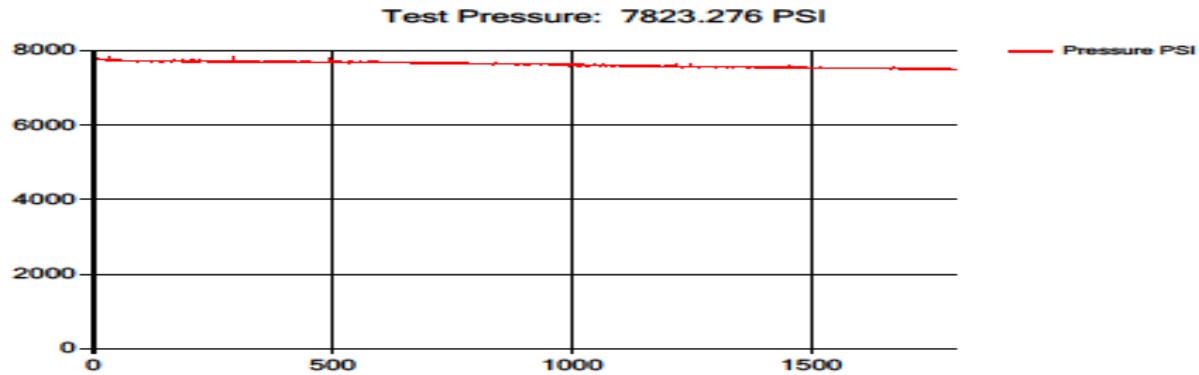
BOP Test

Pressure Test Date: 4/29/2026 8:16:36 AM

BOP Serial Number: 0507-027

Set Pressure Target: 150

Test Pressure: **7823.276**

Pressure Drop: **323.2759**

Side Tested: pipe rams

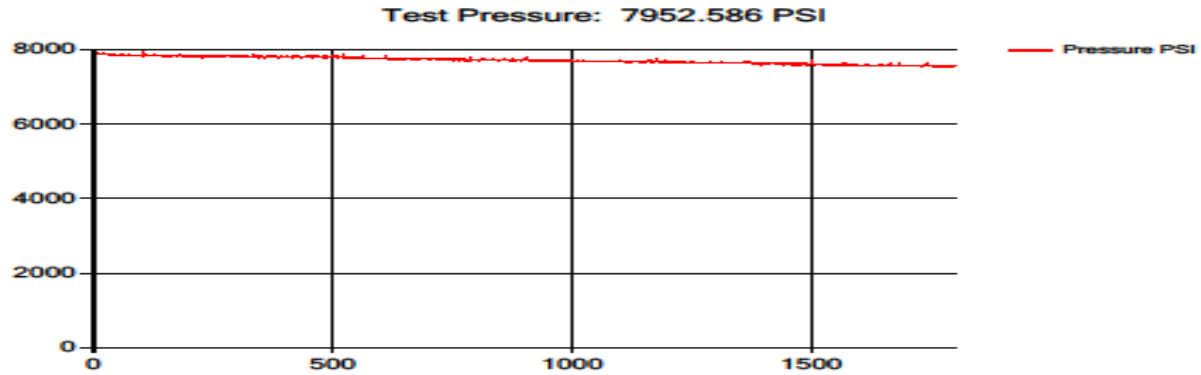
BOP Test

Pressure Test Date: 4/29/2026 8:16:36 AM
Test Performed By: KR
BOP Serial Number: 0507-027
Set Pressure Target: 150
Test Pressure: 7952.586
Pressure Drop: 387.9312
Side Tested: housing test

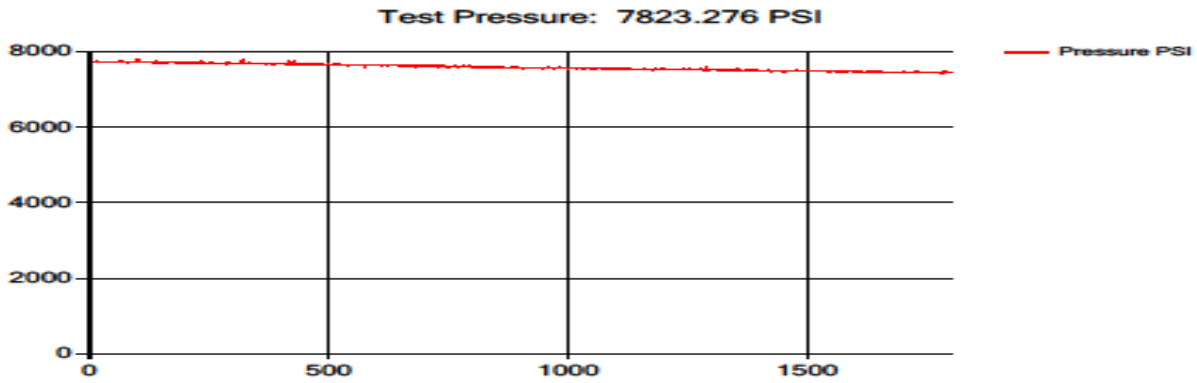
BOP Test

Pressure Test Date: 4/29/2026 8:16:36 AM
Test Performed By: KR
BOP Serial Number: 0507-027
Set Pressure Target: 150
Test Pressure: 7823.276
Pressure Drop: 387.9312
Side Tested: Blinds
