Final Reclamation Inspection

Operator: NOBLE ENERGY INC - 100322

Location ID: 450378

Inspection Photos
Location Name: Muirhead 1-1
Location ID: 450378

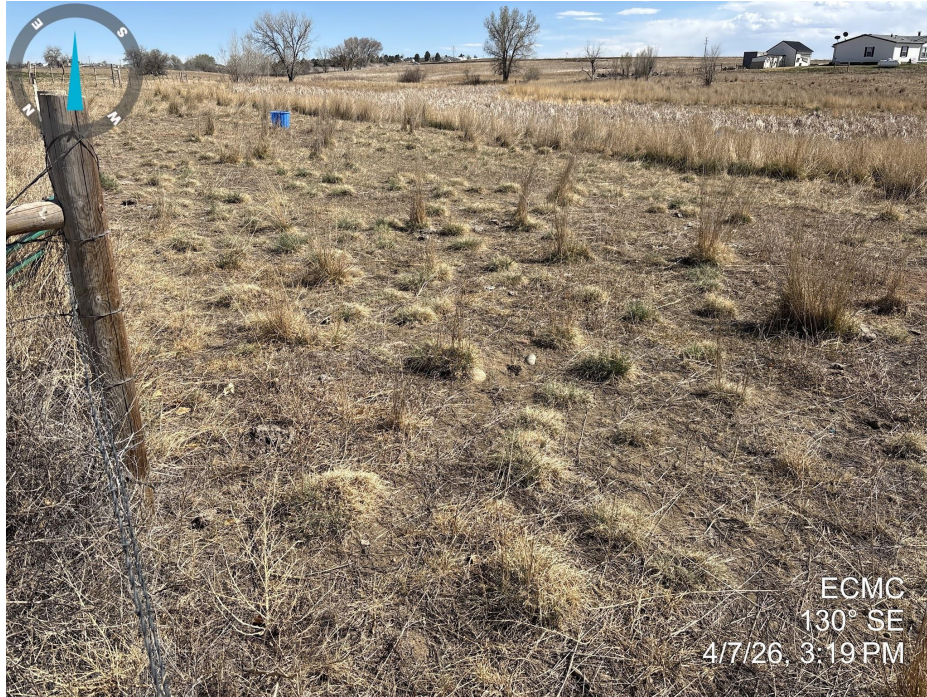
Photo 1. Photo taken of the tank battery location, facing southeast. Photo illustrates that final reclamation activities appear to have taken place at the location and perennial grass is establishing, but vegetation does not meet Rule 1004 standards.

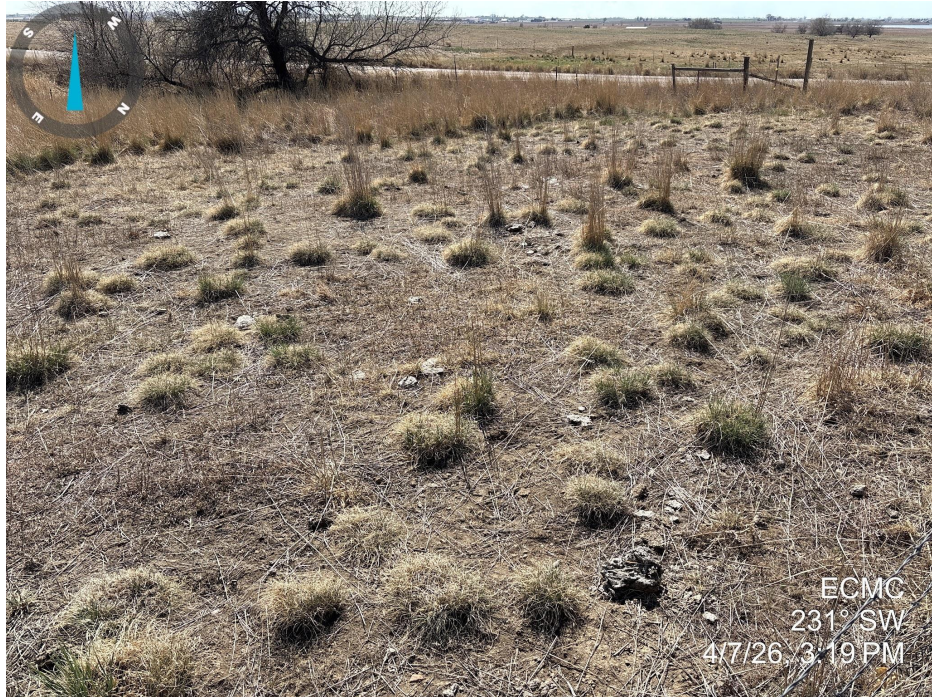
Photo 2. Photo taken of the tank battery location, facing southwest. See comments under Photo 1.

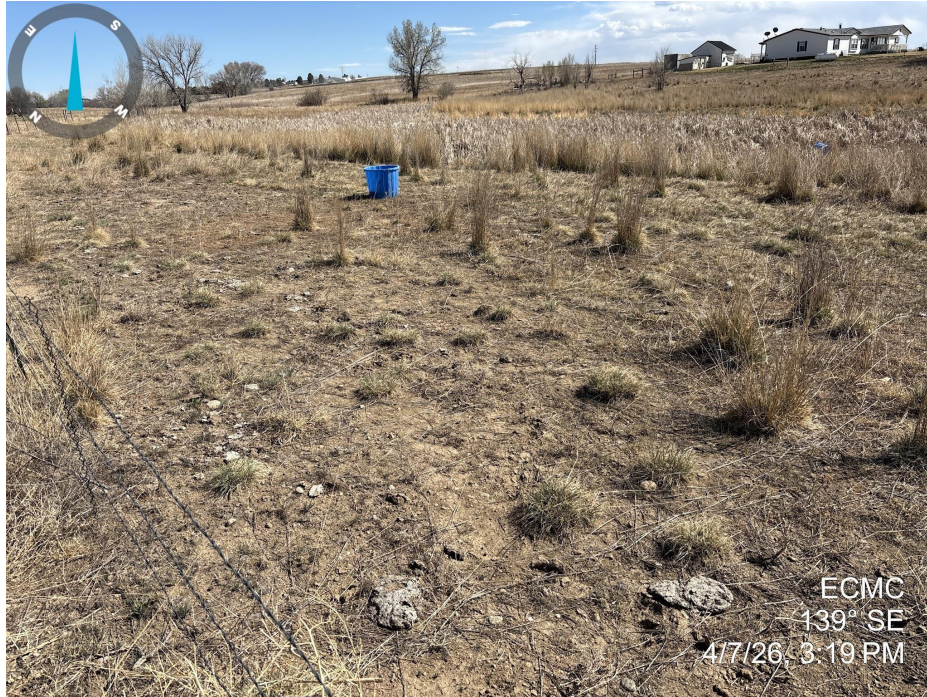
Photo 3. Photo taken of the tank battery location, facing southeast. See comments under Photo 1.

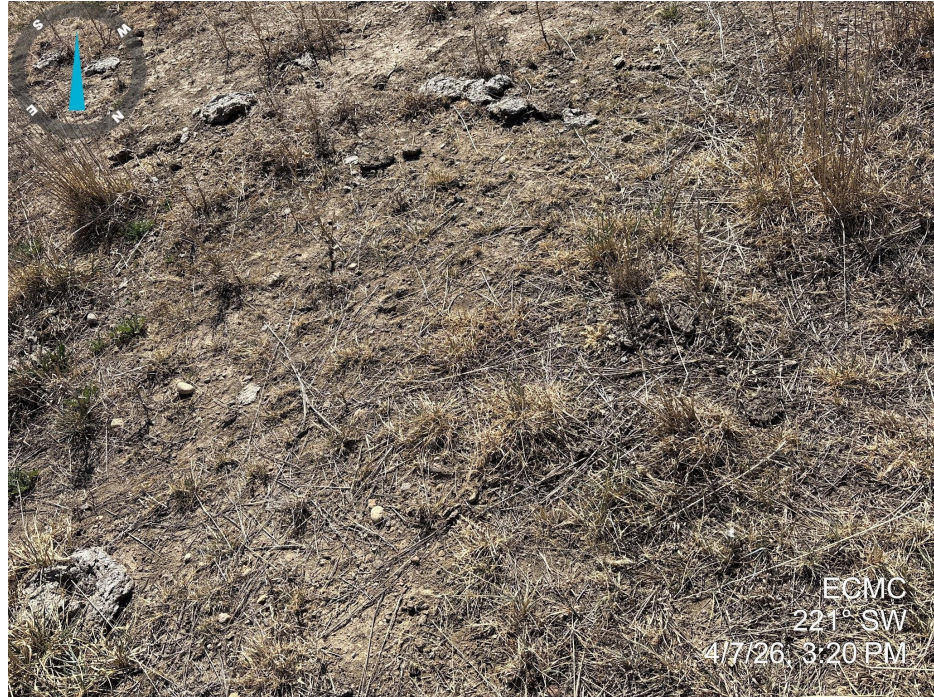
Photo 4. Photo taken of ground cover at the tank battery location, facing southwest. Photo illustrates bare ground and perennial grass.

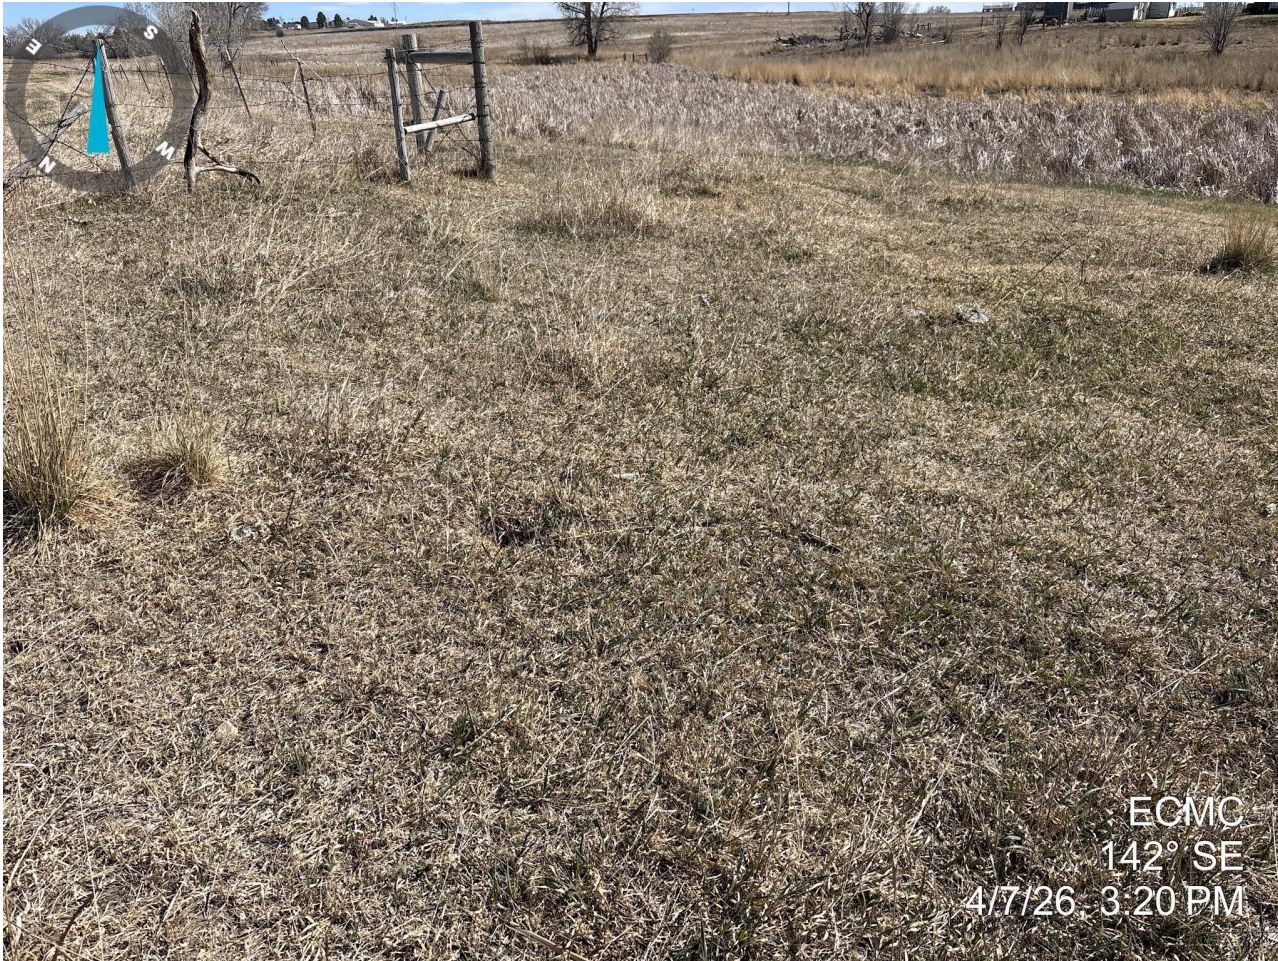
Photo 5. Photo taken of the reference area to the location, east of the location, facing southeast. Photo illustrates perennial grass vegetation.
