Final Reclamation Inspection

Location ID: 328215

Inspection Document #: 718801650

Inspection Photos
Location Name: BELL #L12-7
Location ID: 328215

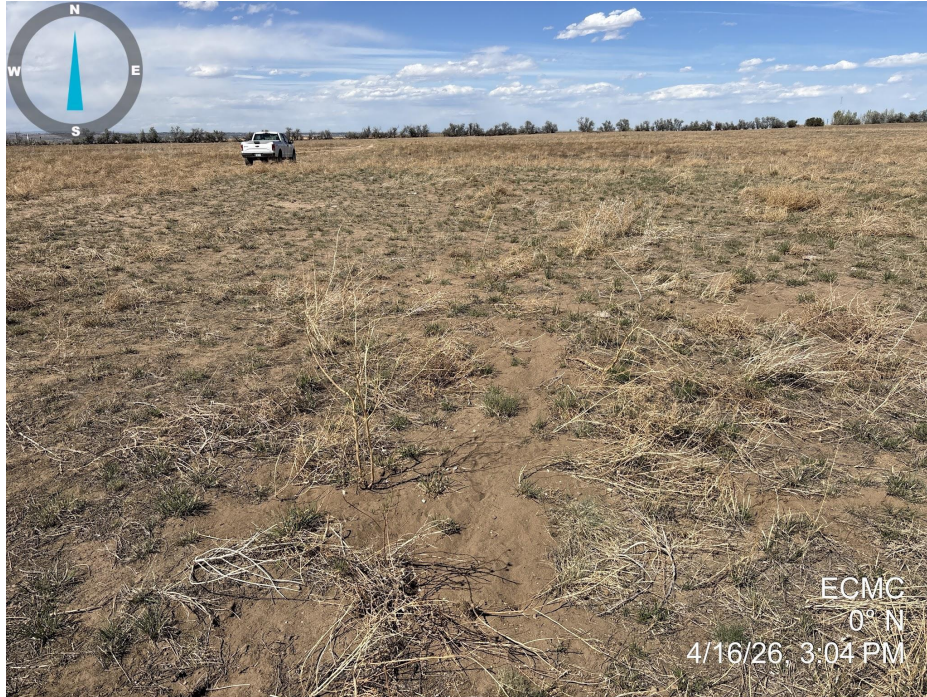
Photo 1. Photo taken of the well location, facing north. Photo illustrates that final reclamation activities appear to have taken place, but vegetation establishment does not meet Rule 1004 standards.

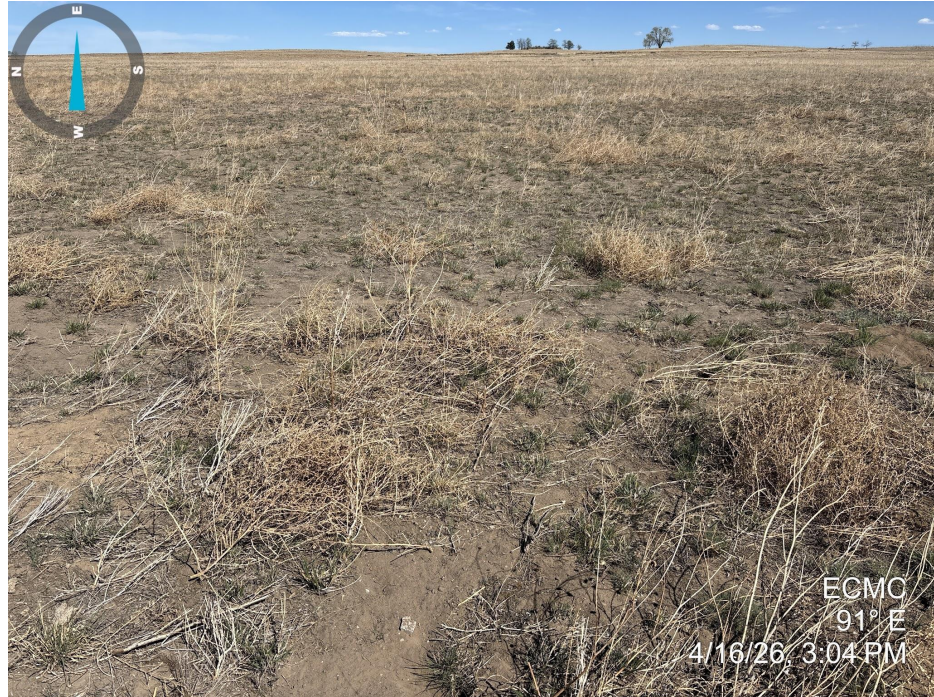
Photo 2. Photo taken of the well location, facing east. See comments under Photo 1.

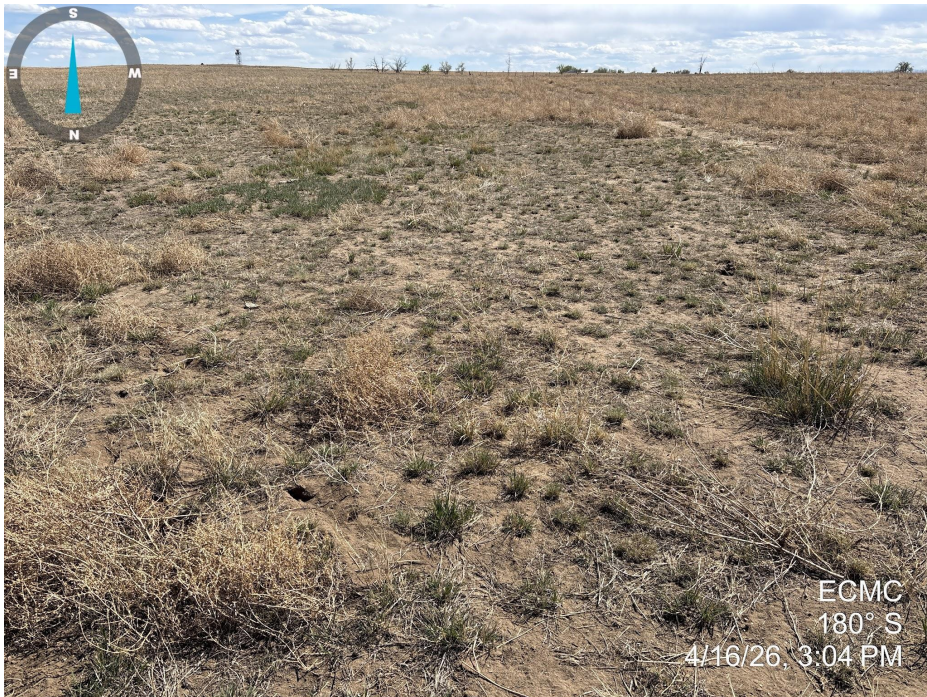
Photo 3. Photo taken of the well location, facing south. See comments under Photo 1.

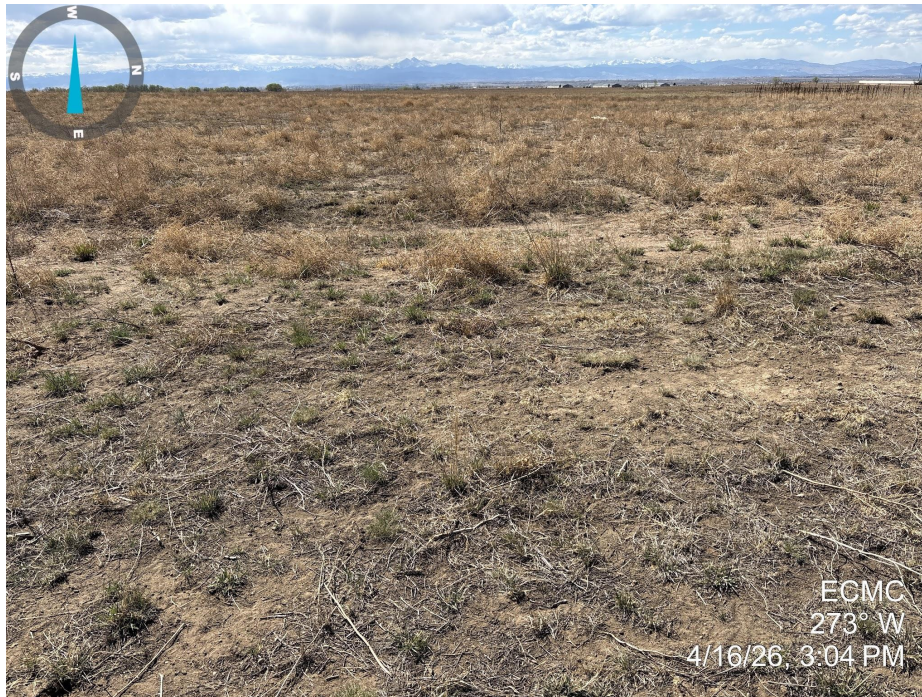
Photo 4. Photo taken of the well location, facing west. See comments under Photo 1.

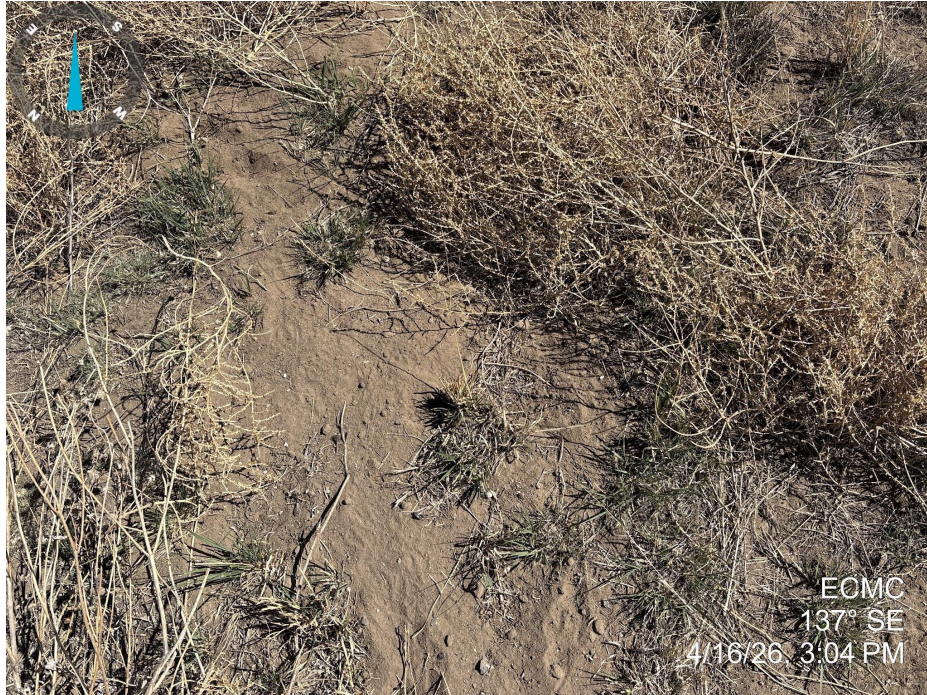
Photo 5. Photo taken of ground cover at the well location. Photo illustrates perennial grass, bare ground, and weedy annual vegetation including russian thistle (*Salsola tragus*).

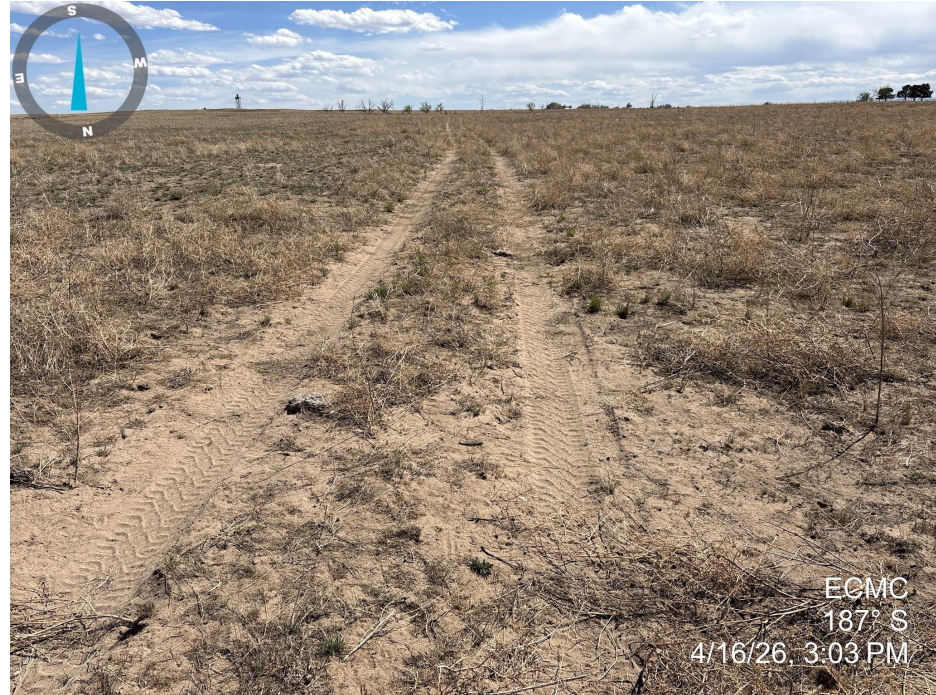
Photo 6. Photo taken of the access road to the well location, facing south, towards the location. Photo illustrates that final reclamation does not meet Rule 1004 standards along the access road and bare ground and weedy annual vegetation including russian thistle (*Salsola tragus*) were observed.

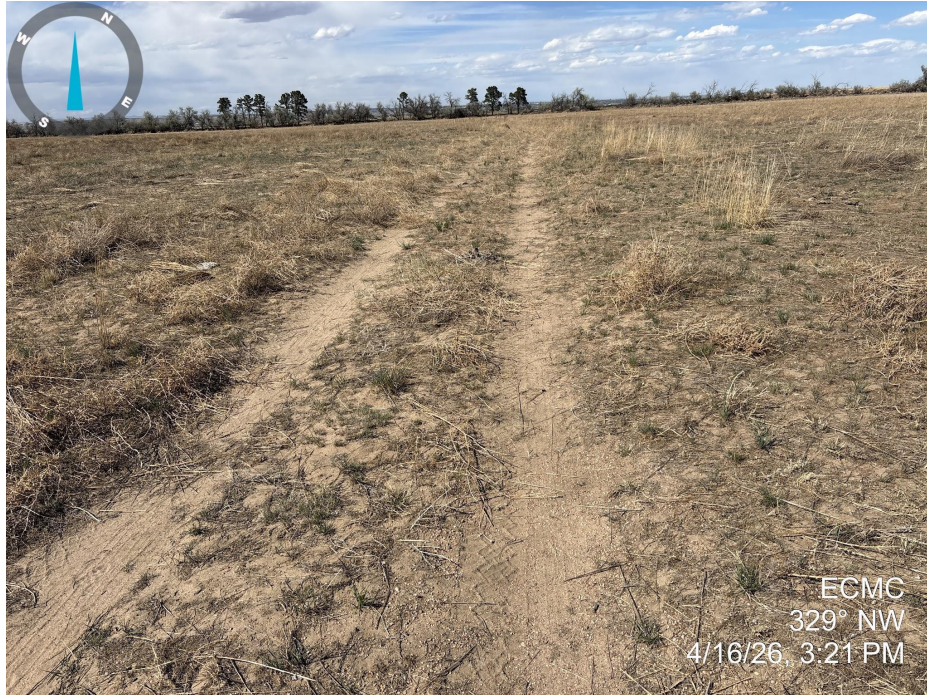
Photo 7. Photo taken of the access road to the well location, facing northwest, away from the location. See comments under Photo 6.

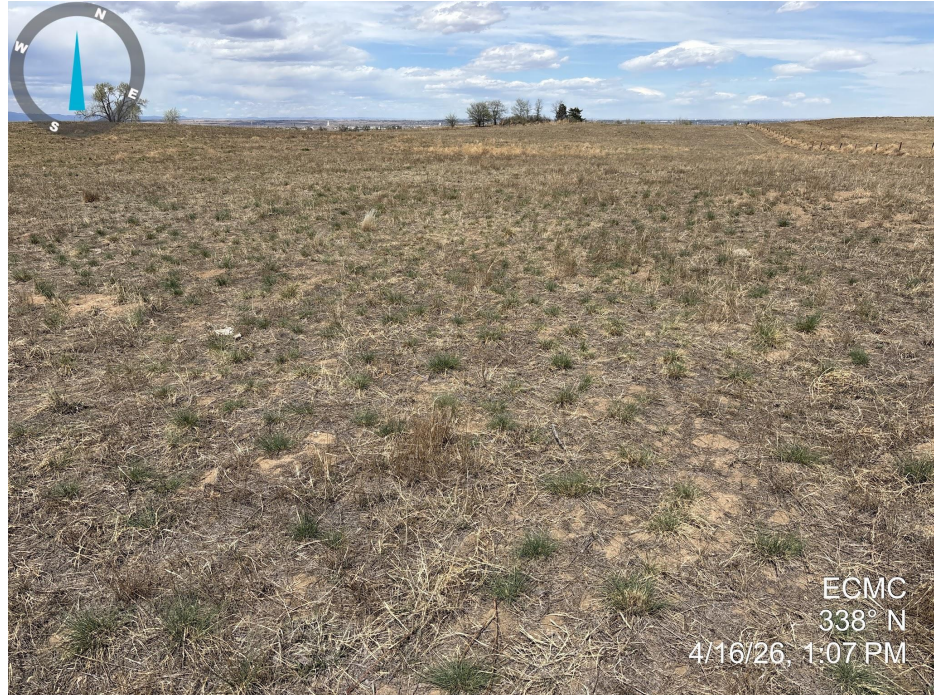
Photo 8. Photo taken of the reference area to the location, east of the location, facing north. Photo illustrates perennial grass and weedy annual vegetation.
