Final Reclamation Inspection

Operator: KERR MCGEE OIL & GAS ONSHORE LP - 47120

Location ID: 327703

Inspection Photos
Location Name: BRATTAIN #2
Location ID: 327703

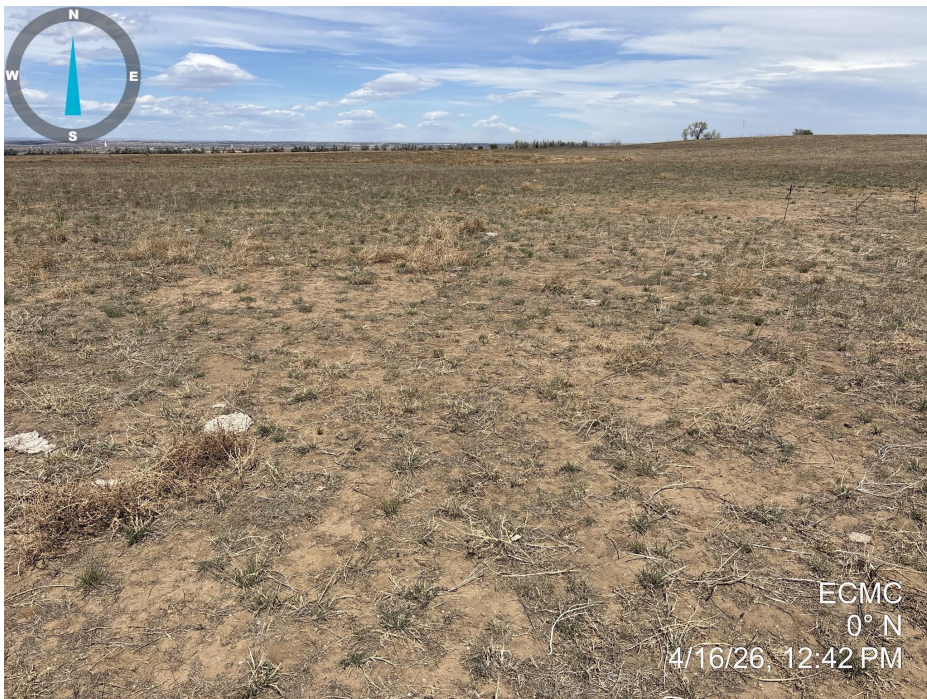
Photo 1. Photo taken of the well location, facing north. Photo illustrates that final reclamation activities appear to have taken place, but vegetation establishment does not meet Rule 1004 standards. Weedy annual vegetation including russian thistle (*Salsola tragus*) and cheatgrass (*Bromus tectorum*) were observed at the location.

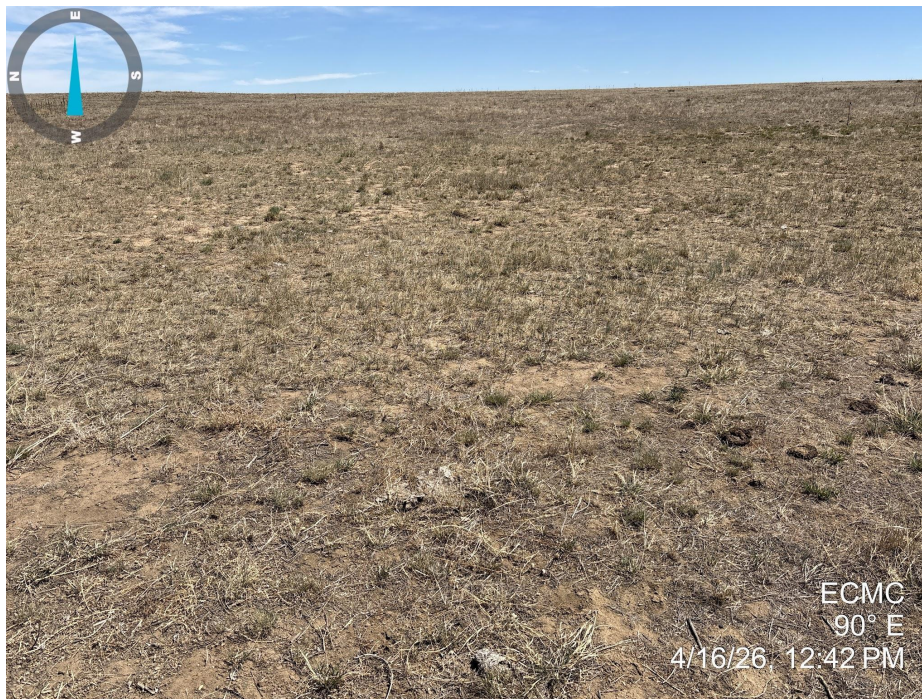
Photo 2. Photo taken of the well location, facing east. See comments under Photo 1.

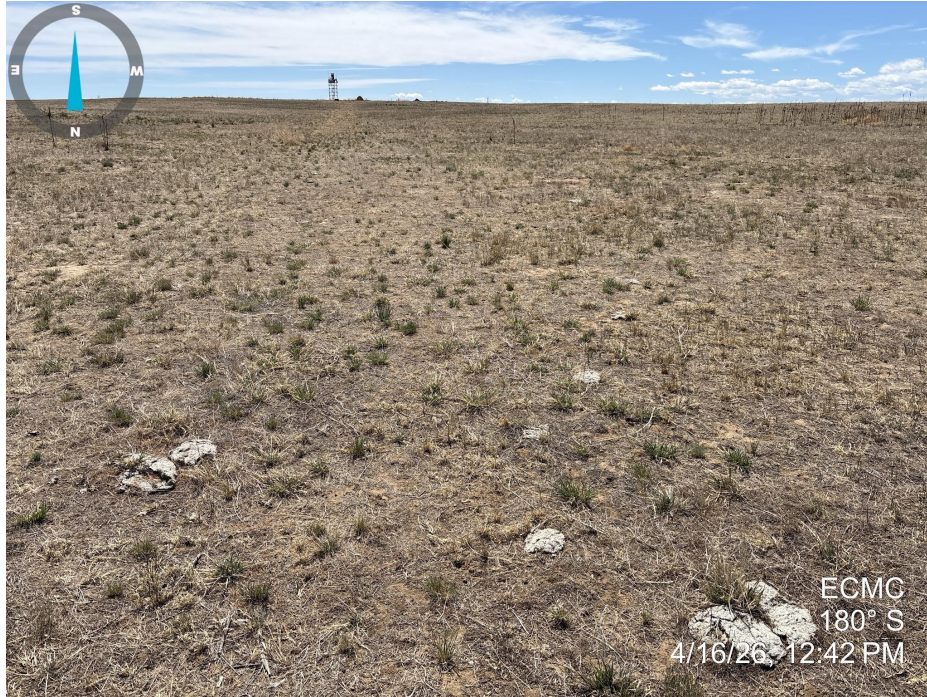
Photo 3. Photo taken of the well location, facing south. See comments under Photo 1.

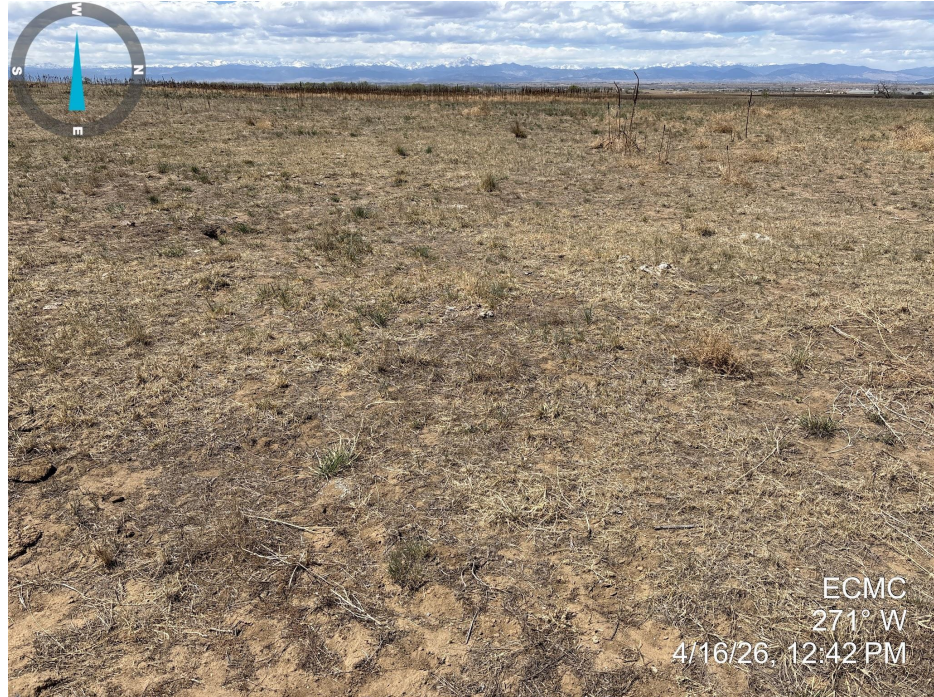
Photo 4. Photo taken of the well location, facing west. See comments under Photo 1.

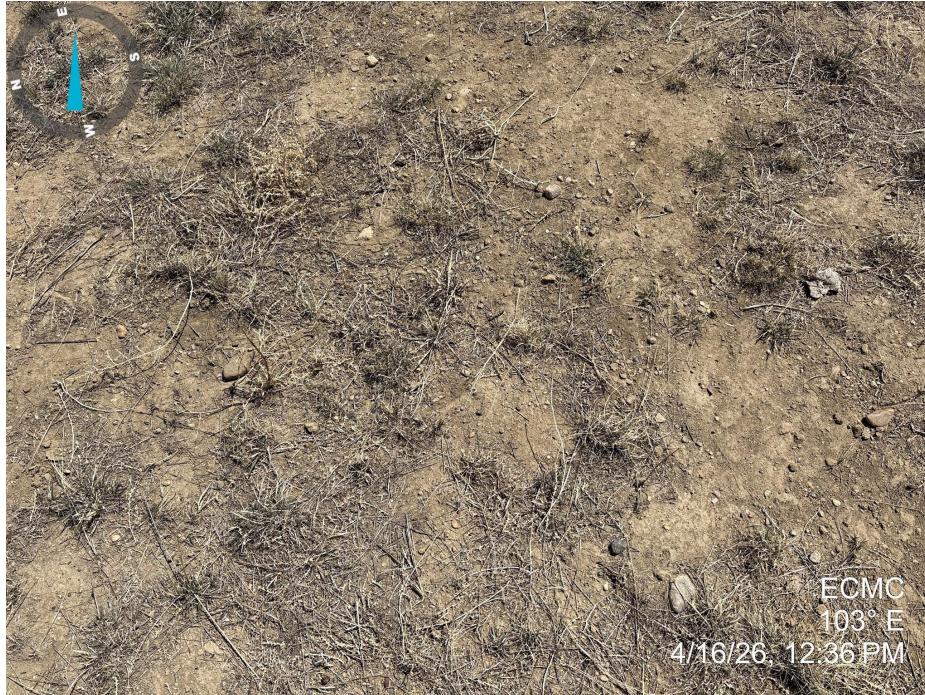
Photo 5. Photo taken of ground cover at the well location. Photo illustrates bare ground, perennial grass, and russian thistle (*Salsola tragus*).

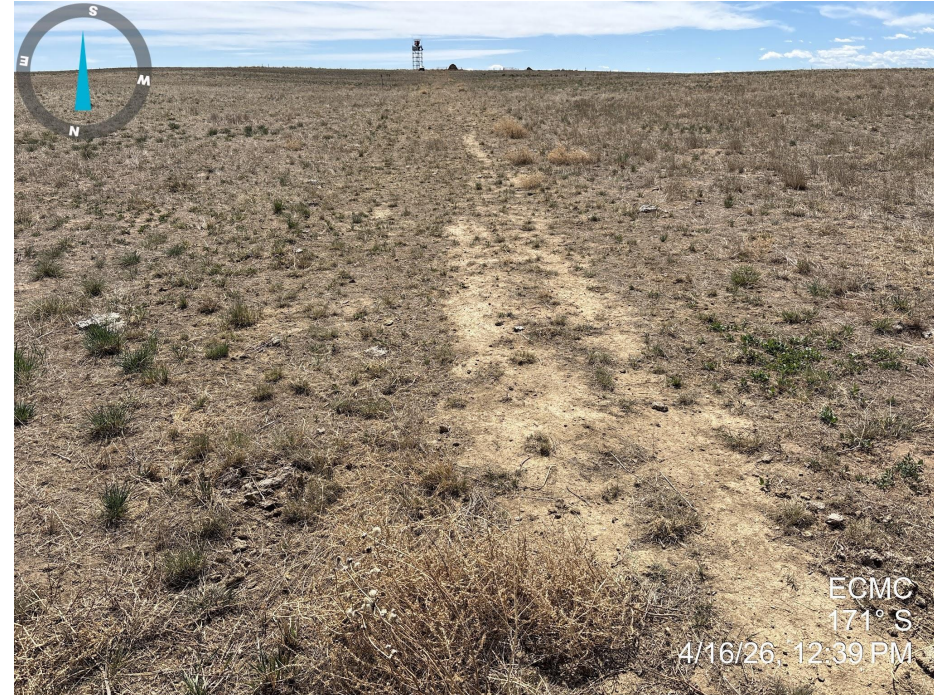
Photo 6. Photo taken of the access road to the well location, facing south. Photo illustrates that final reclamation activities have taken place along the access road, but vegetation has not established to Rule 1004 standards. Bare ground and weedy annual vegetation including russian thistle (*Salsola tragus*) and cheatgrass (*Bromus tectorum*) were observed along the road.

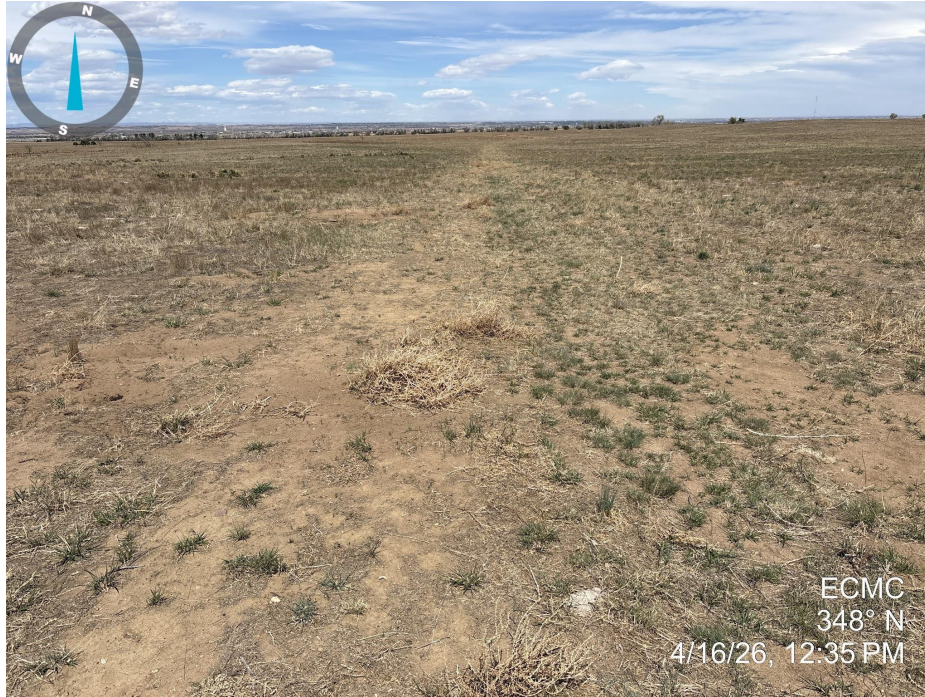
Photo 7. Photo taken of the access road to the well location, facing north. See comments under Photo 6.

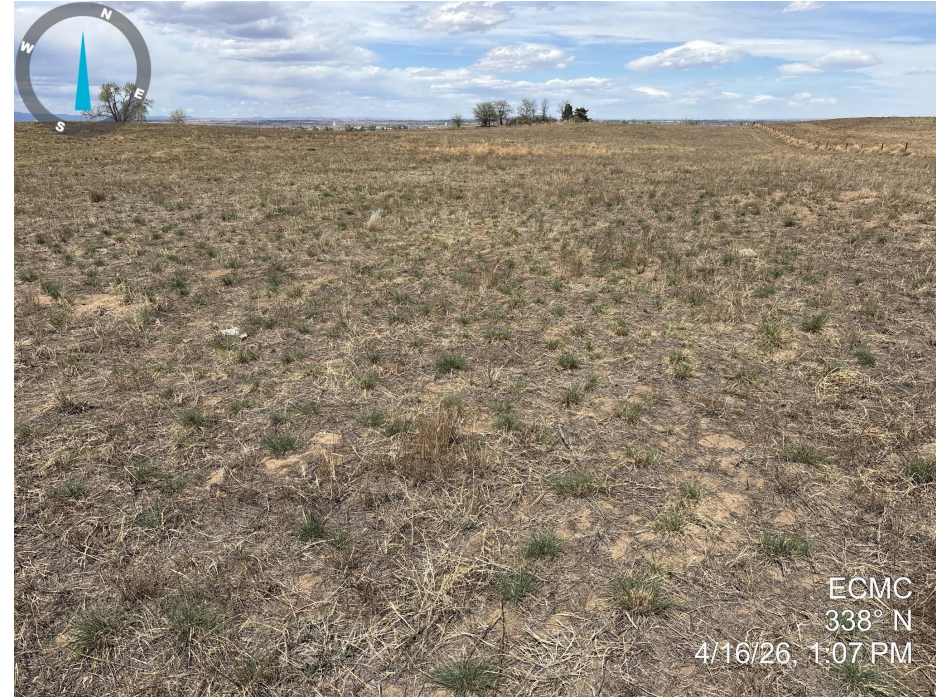
Photo 8. Photo taken of the reference area to the location, north of the location, facing north. Photo illustrates perennial grass and weedy annual vegetation.
