# Final Reclamation Inspection

Operator: KERR MCGEE OIL & GAS ONSHORE LP - 47120

Location ID: 328325

Inspection Photos  
Location Name: BELL #L12-18  
Location ID: 328325

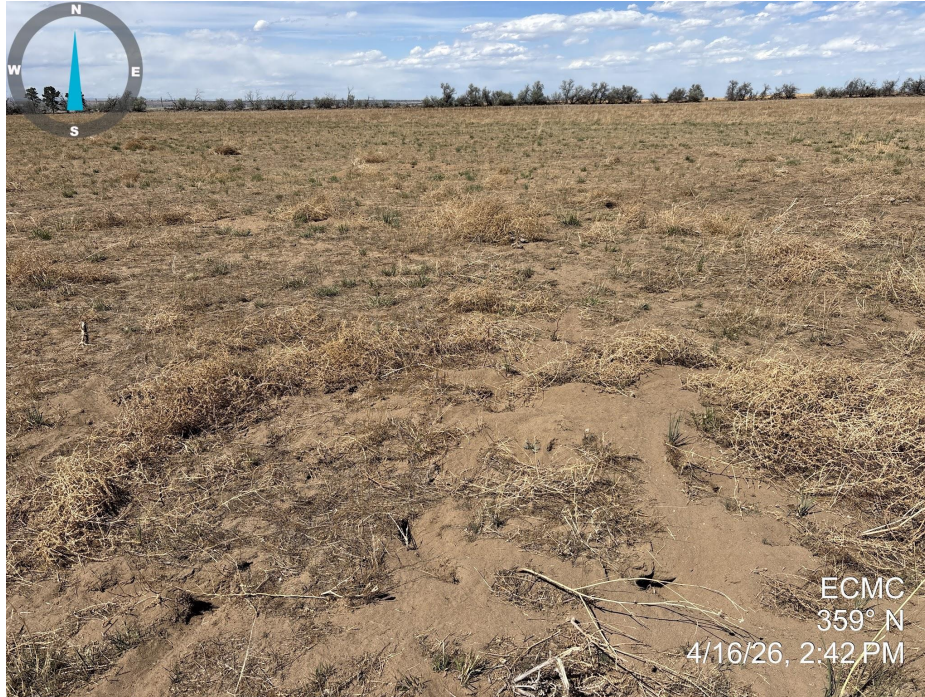
**Photo 1.** Photo taken of the well location, facing north. Photo illustrates that final reclamation activities appear to have taken place, but vegetation establishment does not meet Rule 1004 standards. Weedy annual vegetation including russian thistle (*Salsola tragus*) and cheatgrass (*Bromus tectorum*) was observed at the location.

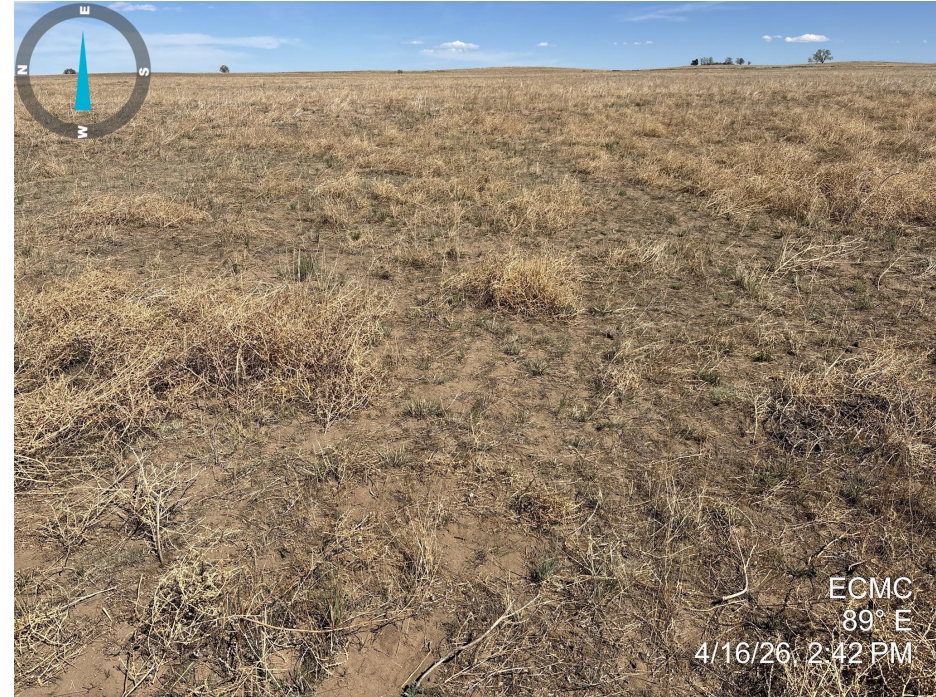
**Photo 2.** Photo taken of the well location, facing east. See comments under Photo 1.

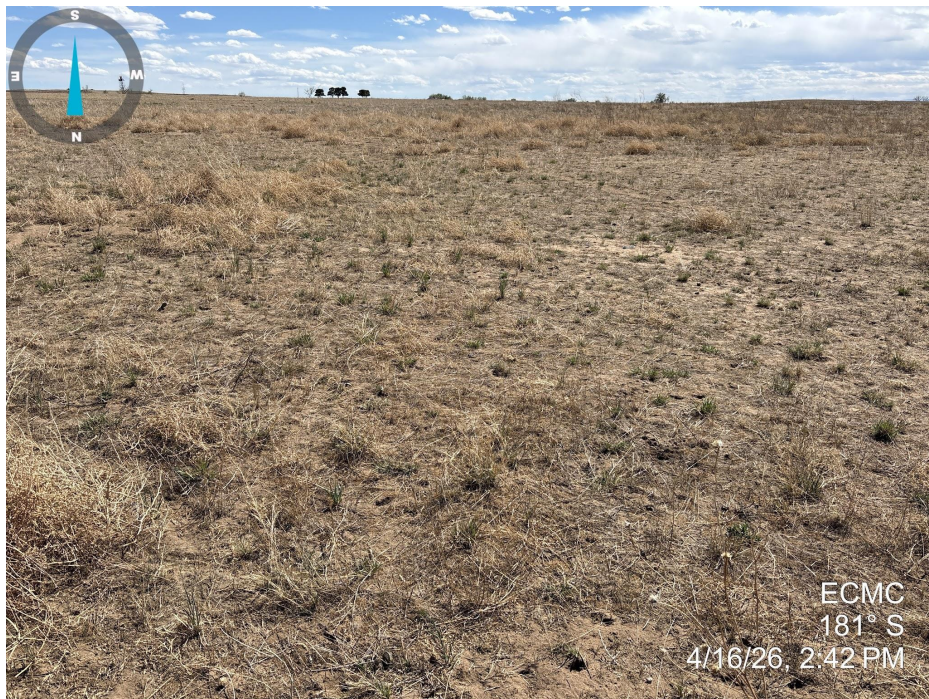
**Photo 3.** Photo taken of the well location, facing south. See comments under Photo 1.

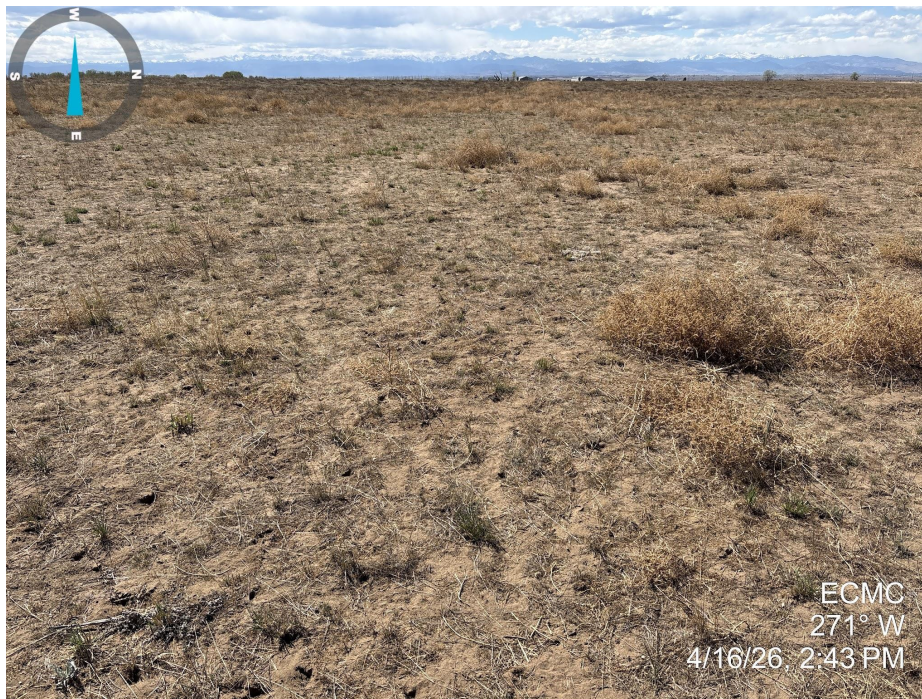
**Photo 4.** Photo taken of the well location, facing west. See comments under Photo 1.

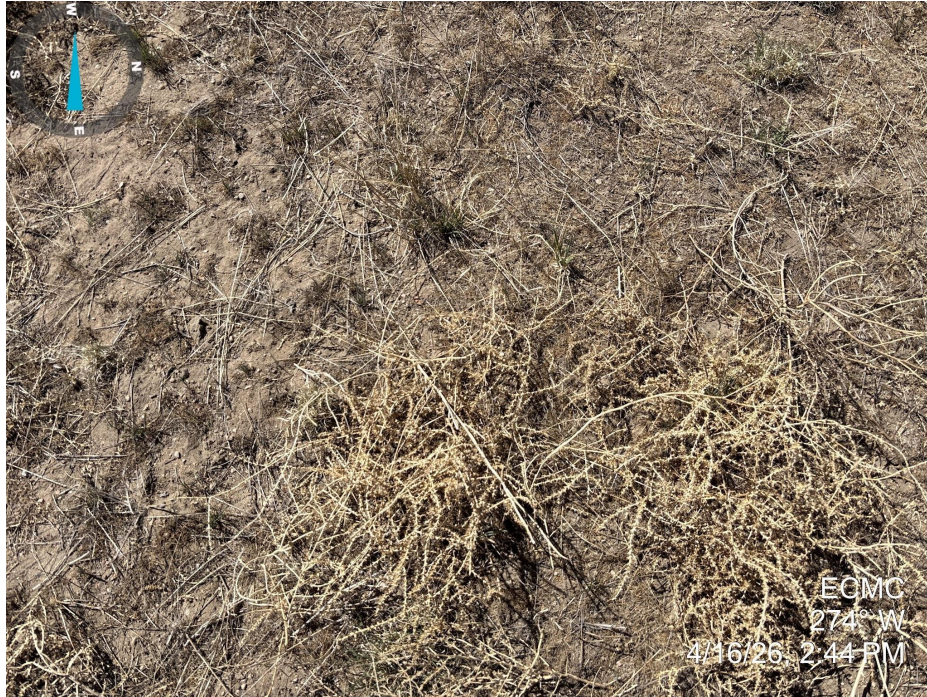
**Photo 5.** Photo taken of ground cover at the well location. Photo illustrates perennial grass, bare ground, and weedy annual vegetation including russian thistle (*Salsola tragus*).

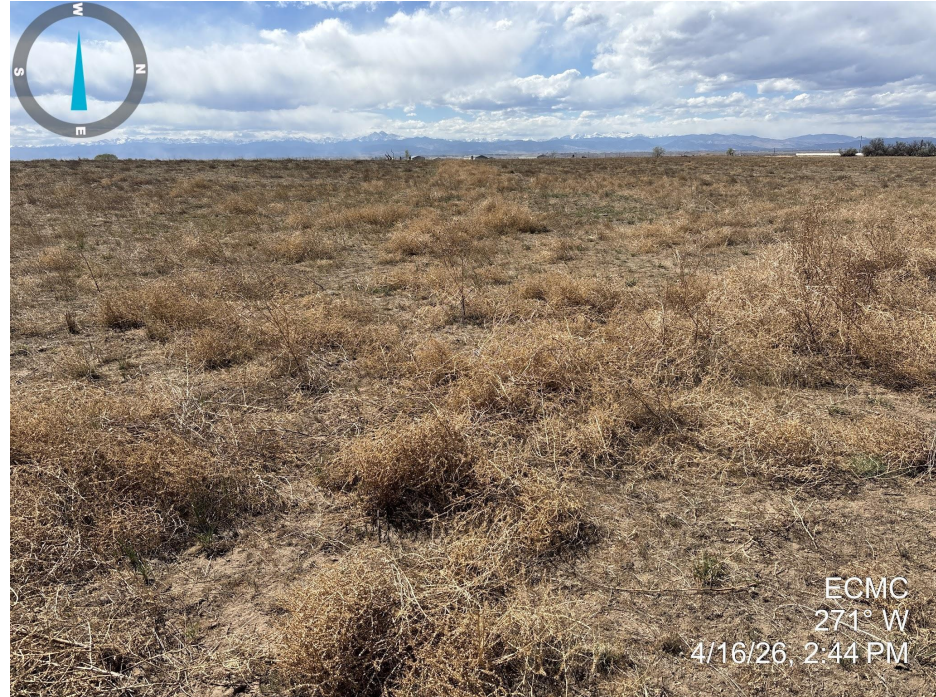
**Photo 6.** Photo taken of the access road to the well location, facing west, away from the location. Photo illustrates that final reclamation activities have taken place, but vegetation establishment does not meet Rule 1004 standards. Weedy annual vegetation including russian thistle (*Salsola tragus*) was observed across the access road.

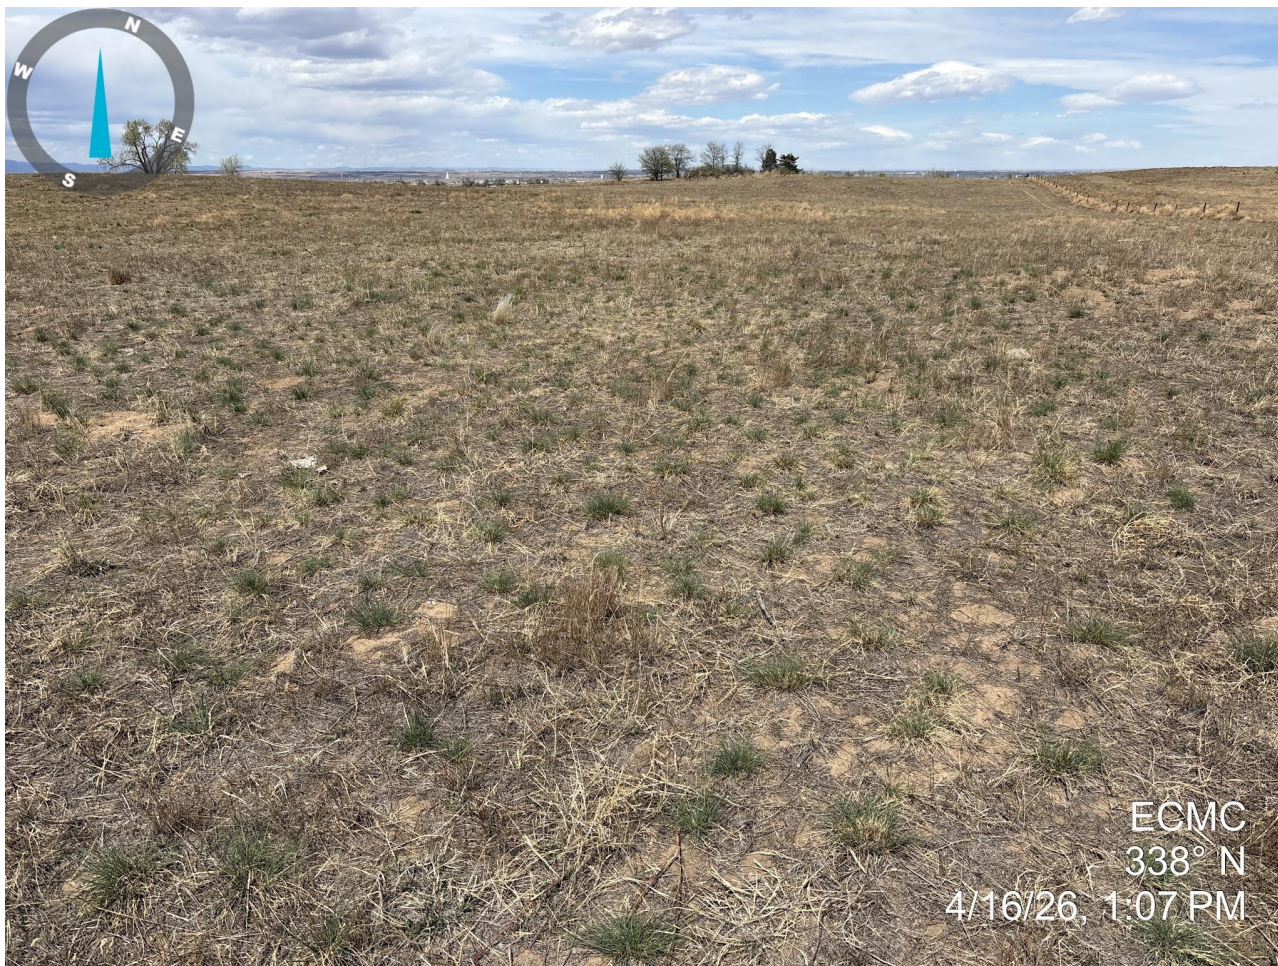
**Photo 7.** Photo taken of the reference area to the location, northeast of the location, facing north. Photo illustrates perennial grass and weedy annual vegetation.
