Final Reclamation Inspection

Operator: KERR MCGEE OIL & GAS ONSHORE LP - 47120

Location ID: 331907

Inspection Photos
Location Name: BRATTAIN L #12-3JI
Location ID: 331907

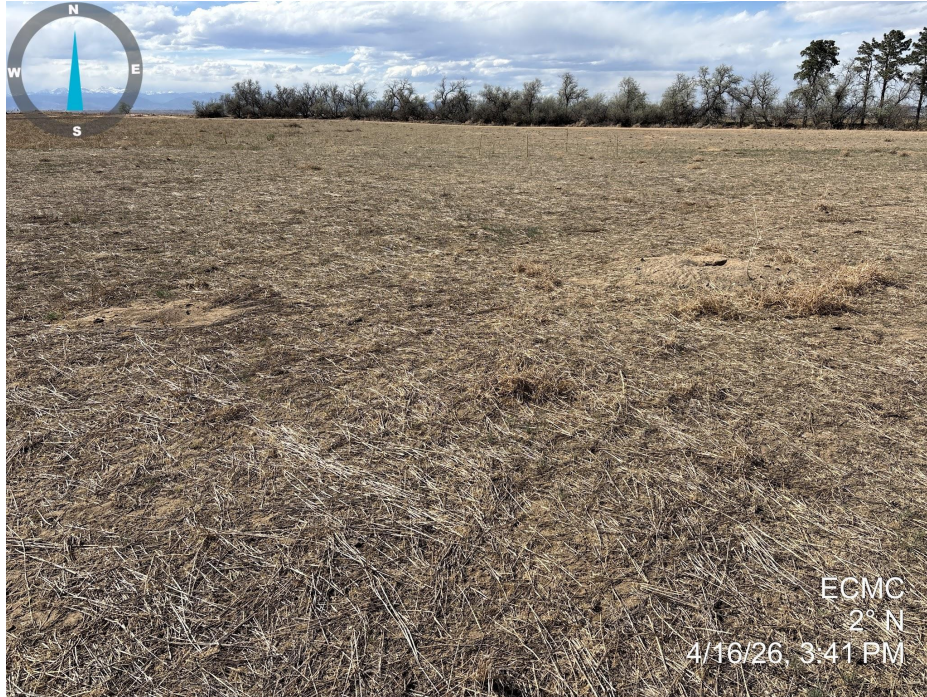
Photo 1. Photo taken of the well location, facing north. Photo illustrates that final reclamation activities appear to have taken place, but vegetation establishment does not meet Rule 1004 standards. The location appears to have been mowed.

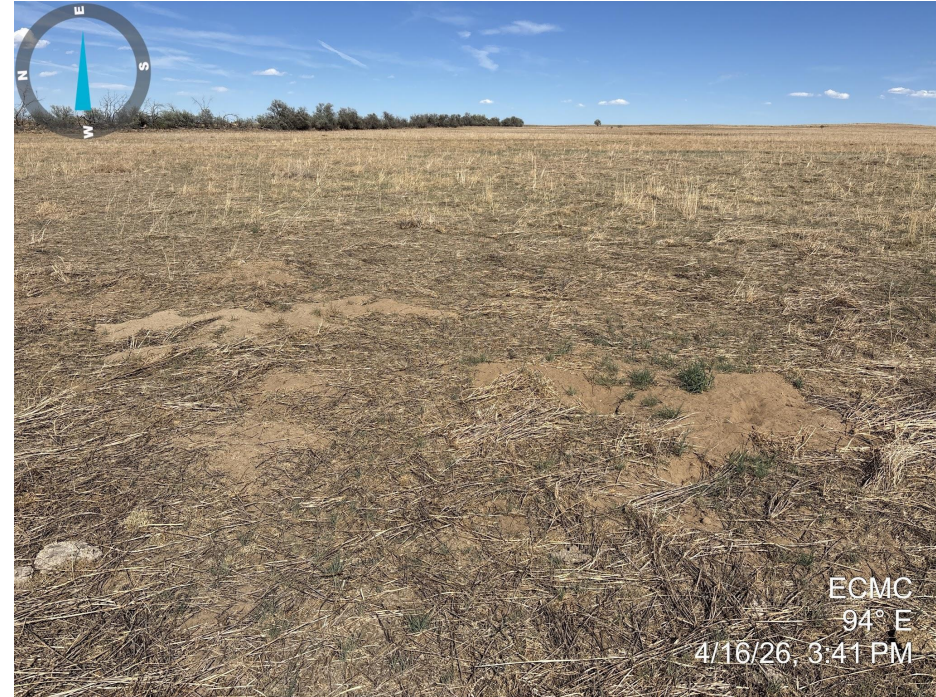
Photo 2. Photo taken of the well location, facing east. See comments under Photo 1.

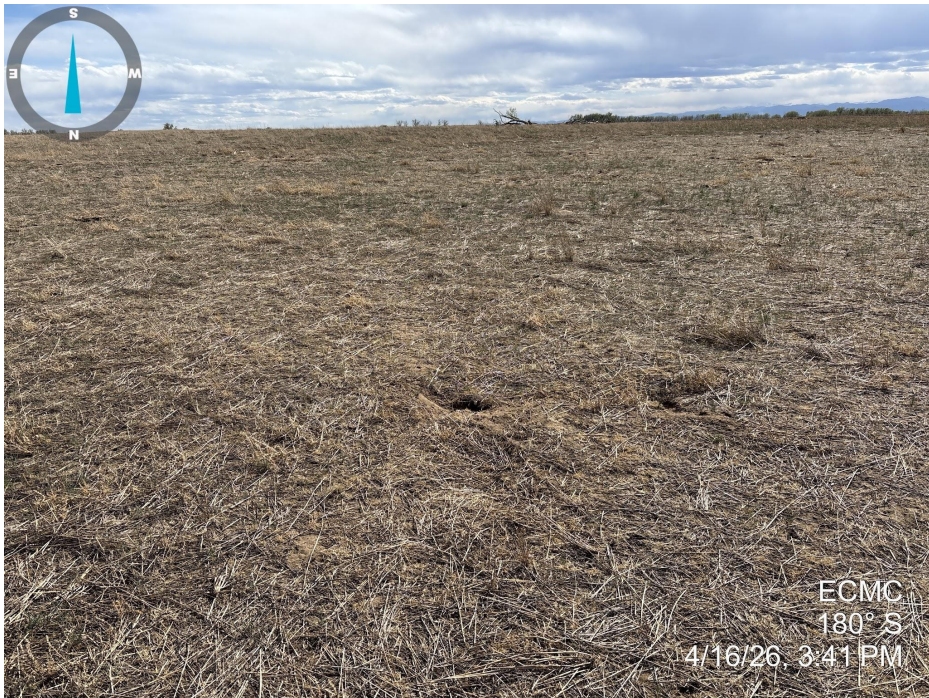
Photo 3. Photo taken of the well location, facing south. See comments under Photo 1.

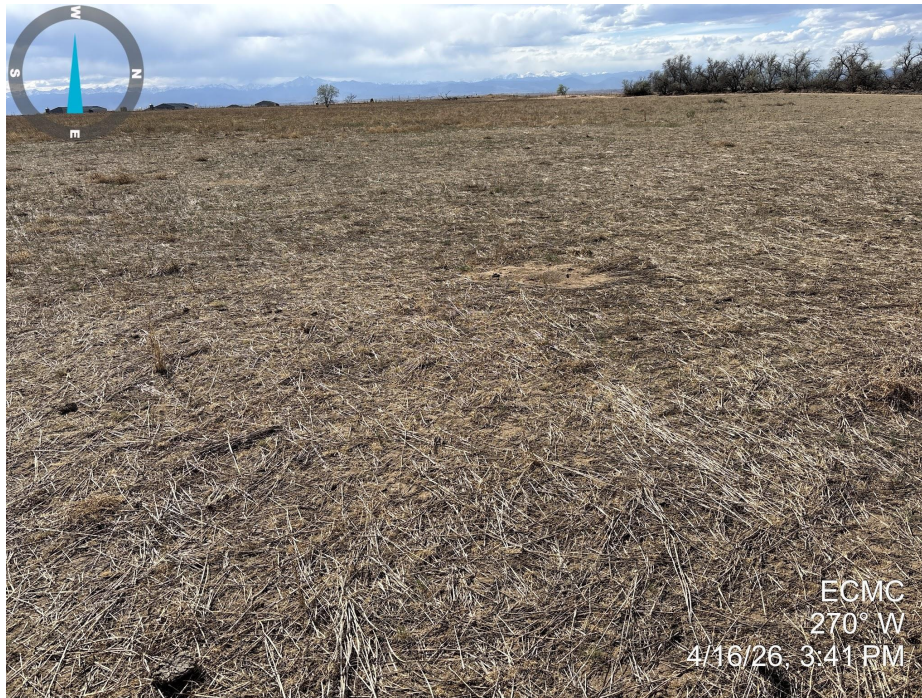
Photo 4. Photo taken of the well location, facing west. See comments under Photo 1.

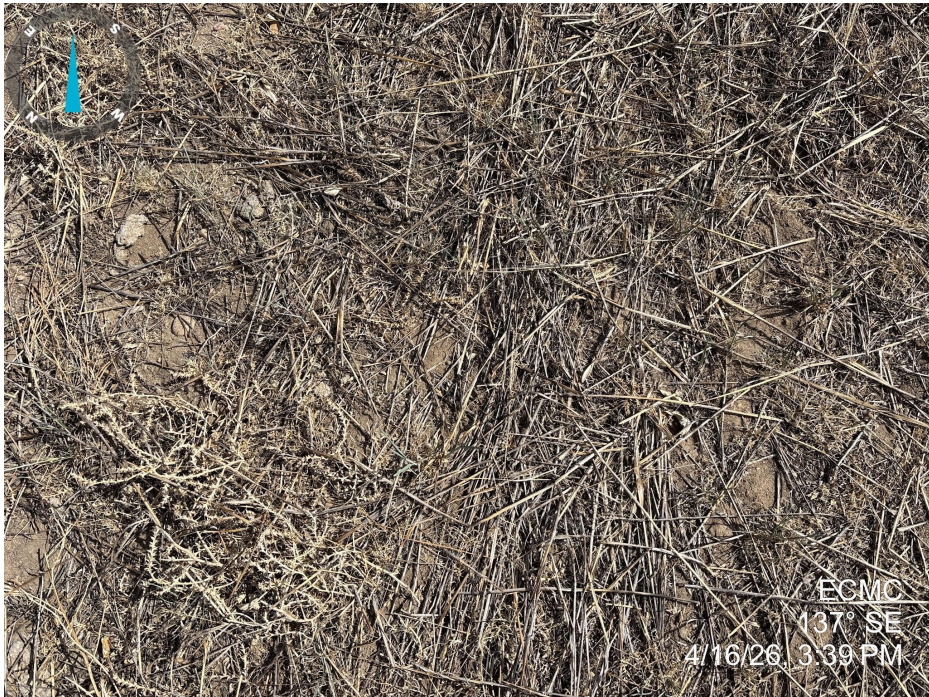
Photo 5. Photo taken of ground cover at the well location. Photo illustrates bare ground, perennial grass, and weedy annual vegetation including russian thistle (*Salsola tragus*).

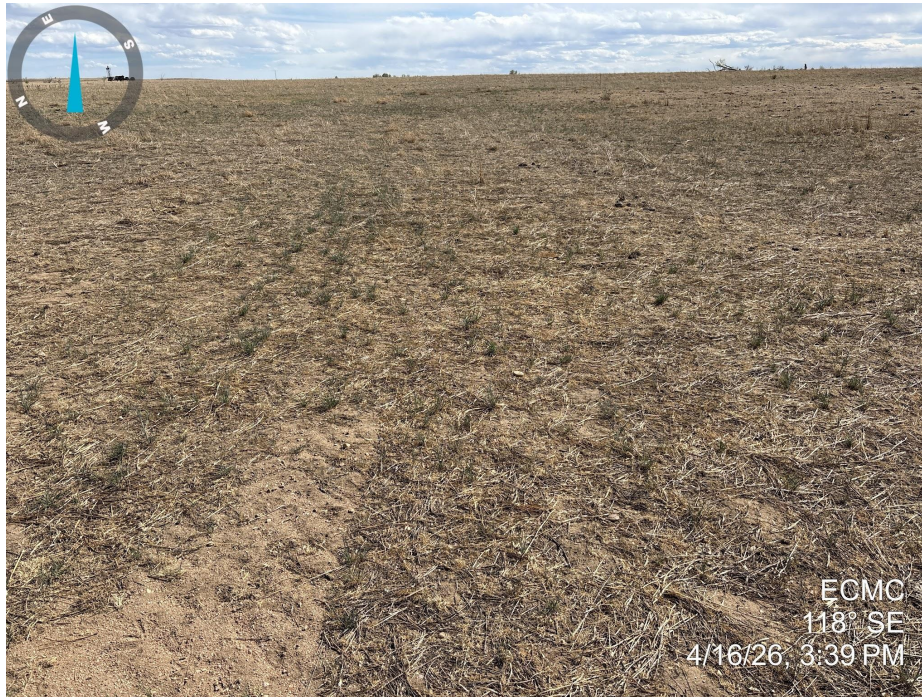
Photo 6. Photo taken of the access road to the well location, facing southeast, towards the location. Photo illustrates that final reclamation activities have taken place along the access road and perennial grass appears to be establishing.

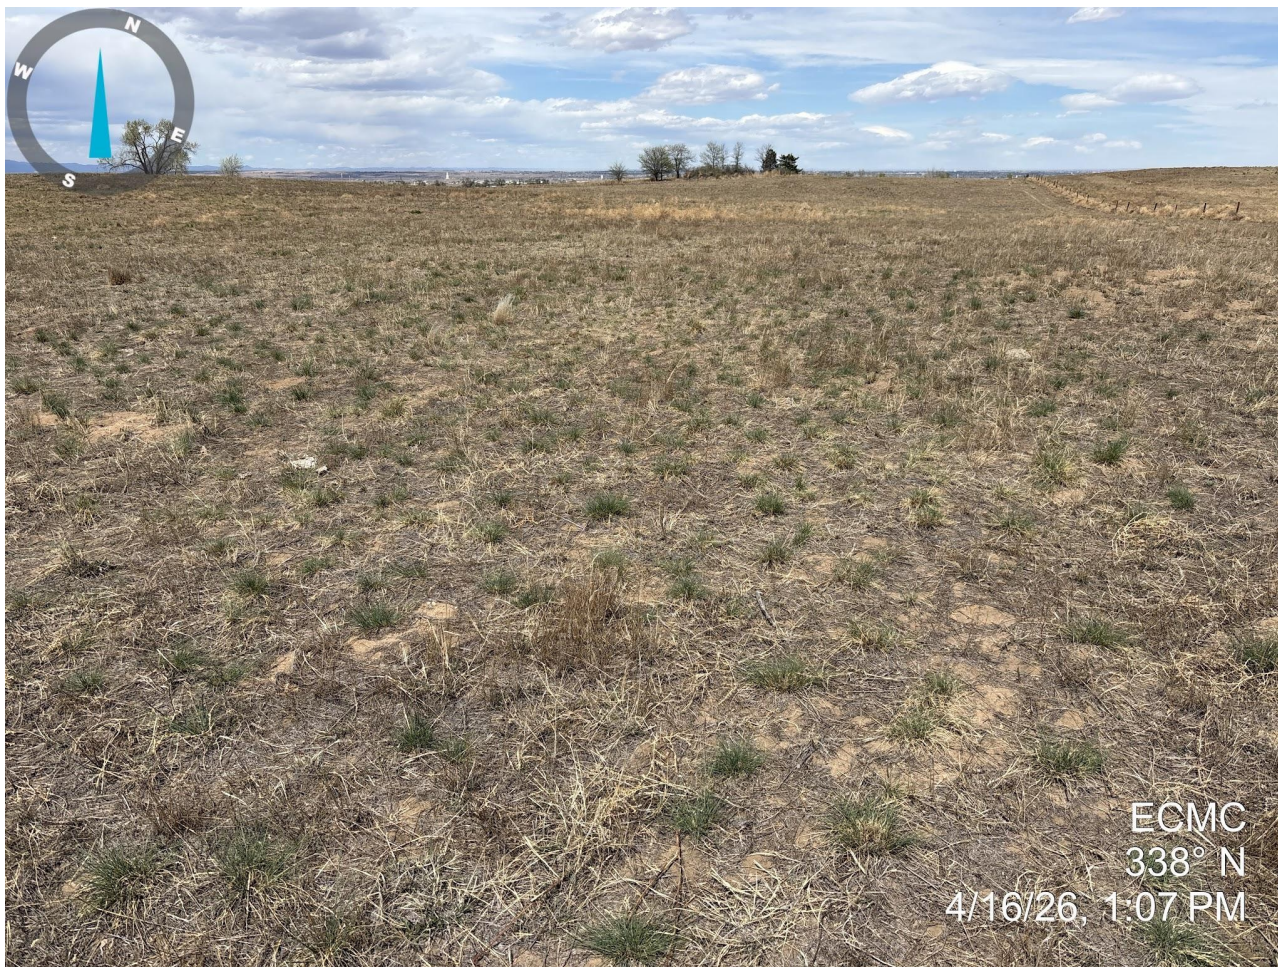
Photo 7. Photo taken of the reference area to the location, east of the location, facing north. Photo illustrates perennial grass and weedy annual vegetation.
