Final Reclamation Inspection

Operator: KERR MCGEE OIL & GAS ONSHORE LP - 47120

Location ID: 328221

Inspection Document #: 718801638

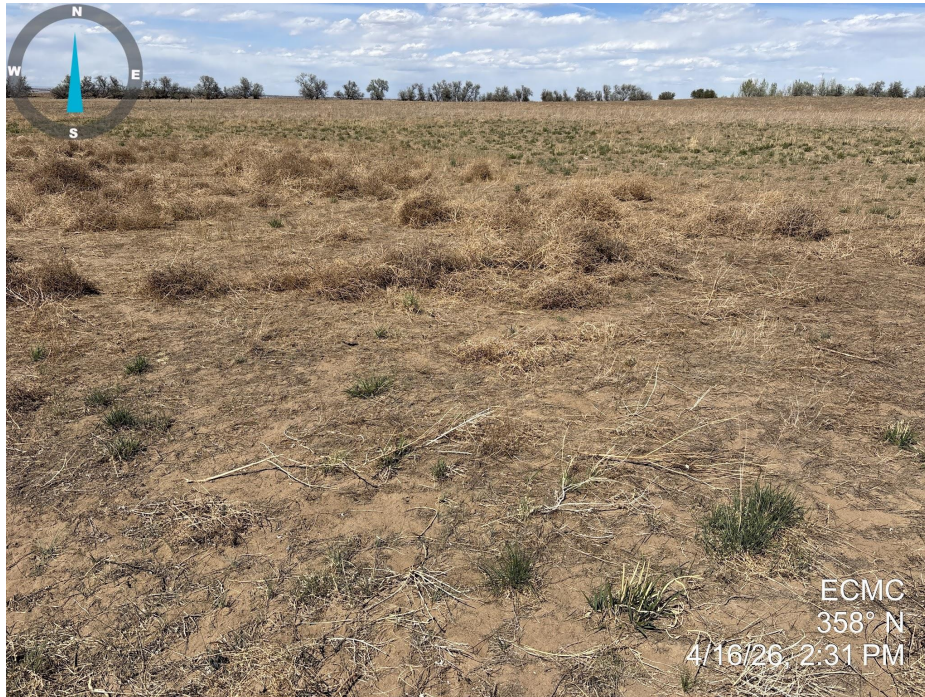
Photo 1. Photo taken of the well location, facing north. Photo illustrates that final reclamation activities appear to have taken place, but vegetation establishment does not meet Rule 1004 standards. Weedy annual vegetation including russian thistle (*Salsola tragus*) and cheatgrass (*Bromus tectorum*) was observed at the location.

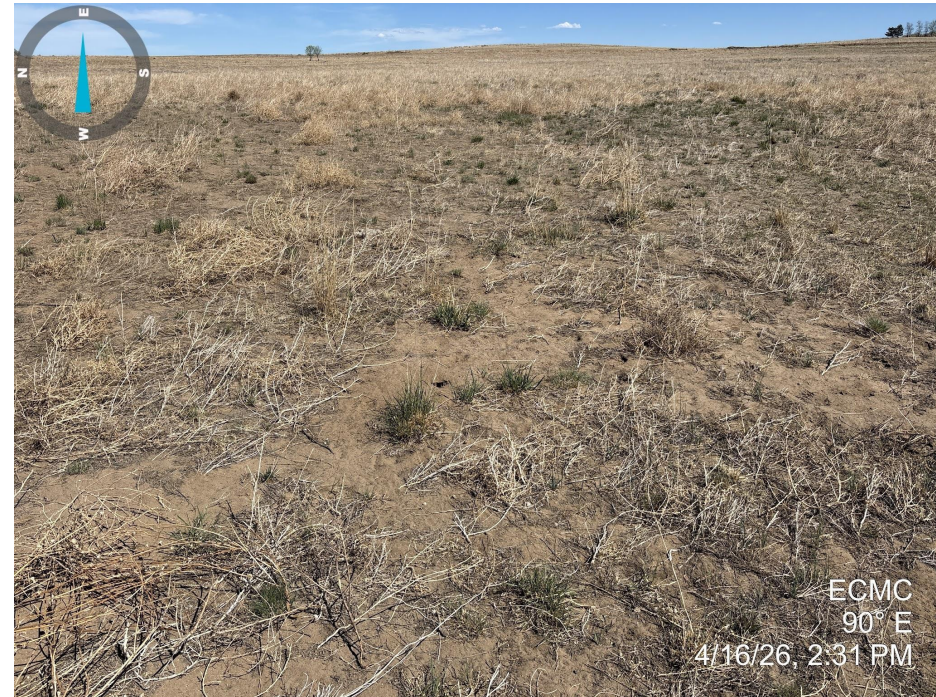
Photo 2. Photo taken of the well location, facing east. See comments under Photo 1.

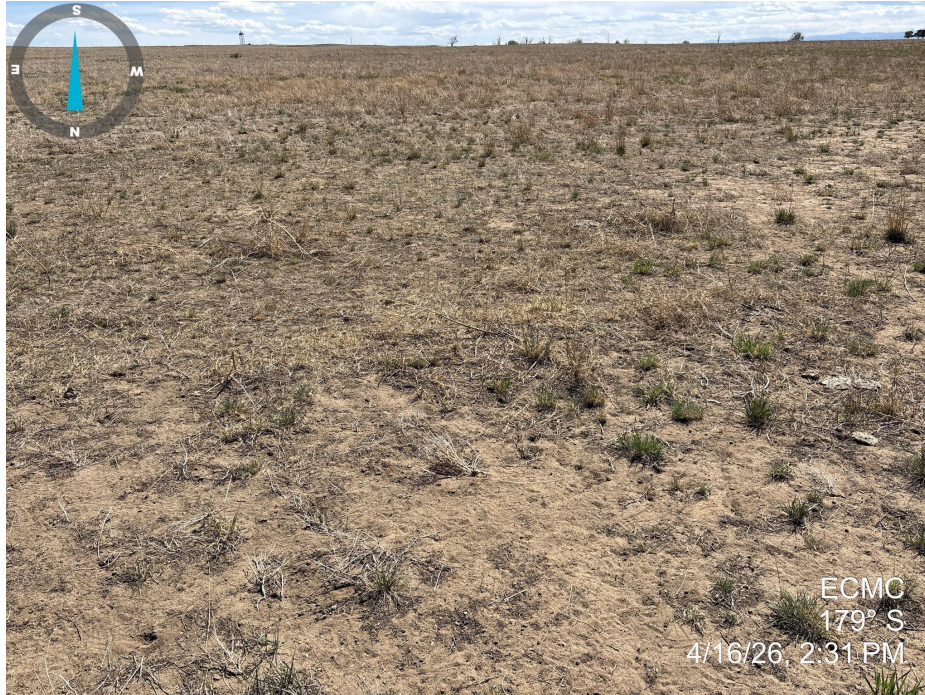
Photo 3. Photo taken of the well location, facing south. See comments under Photo 1.

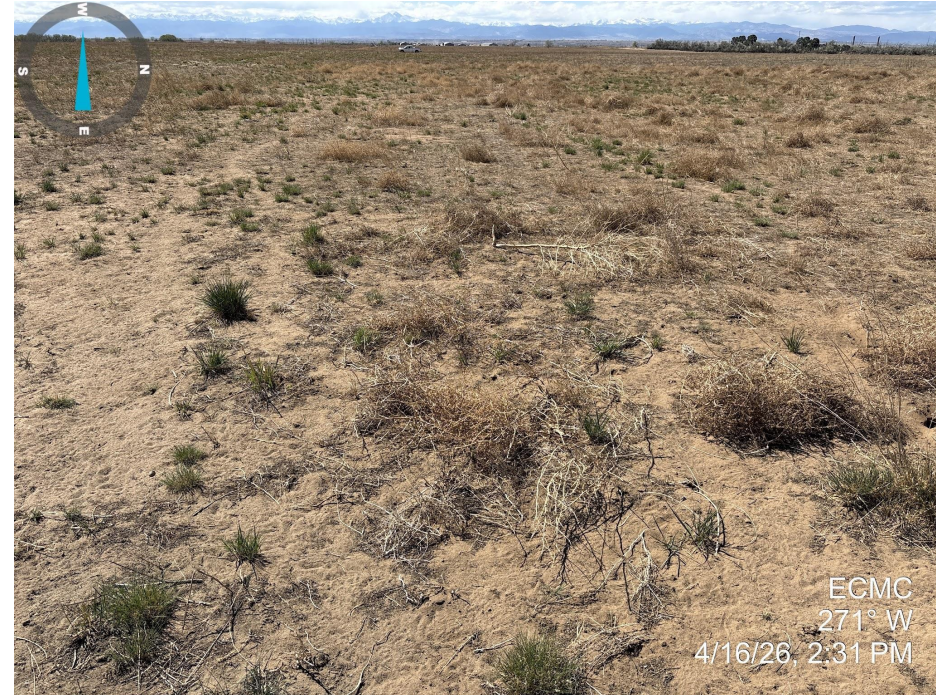
Photo 4. Photo taken of the well location, facing west. See comments under Photo 1.

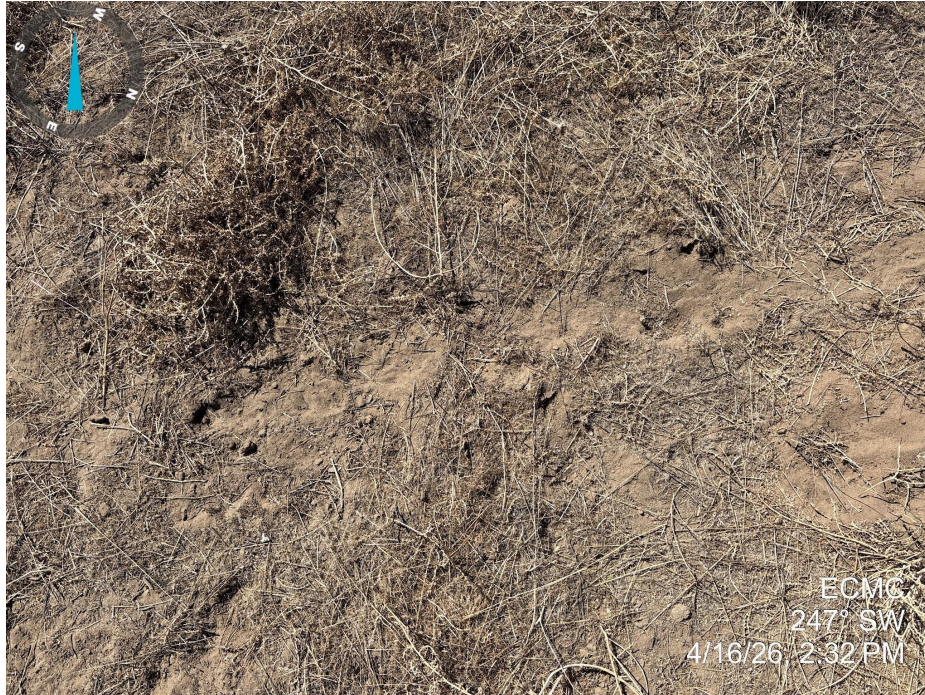
Photo 5. Photo taken of ground cover at the well location. Photo illustrates perennial grass, bare ground, and weedy annual vegetation including russian thistle (*Salsola tragus*).

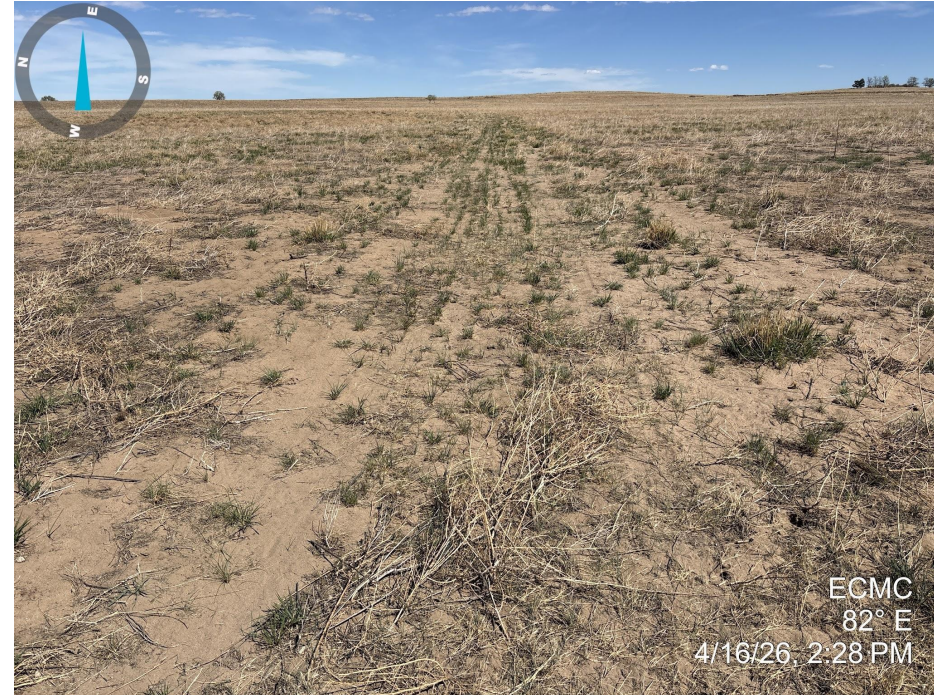
Photo 6. Photo taken of the access road to the well location, facing east, towards the location. Photo illustrates that final reclamation activities have taken place, with evidence of drill row seeding, but vegetation establishment does not meet Rule 1004 standards.

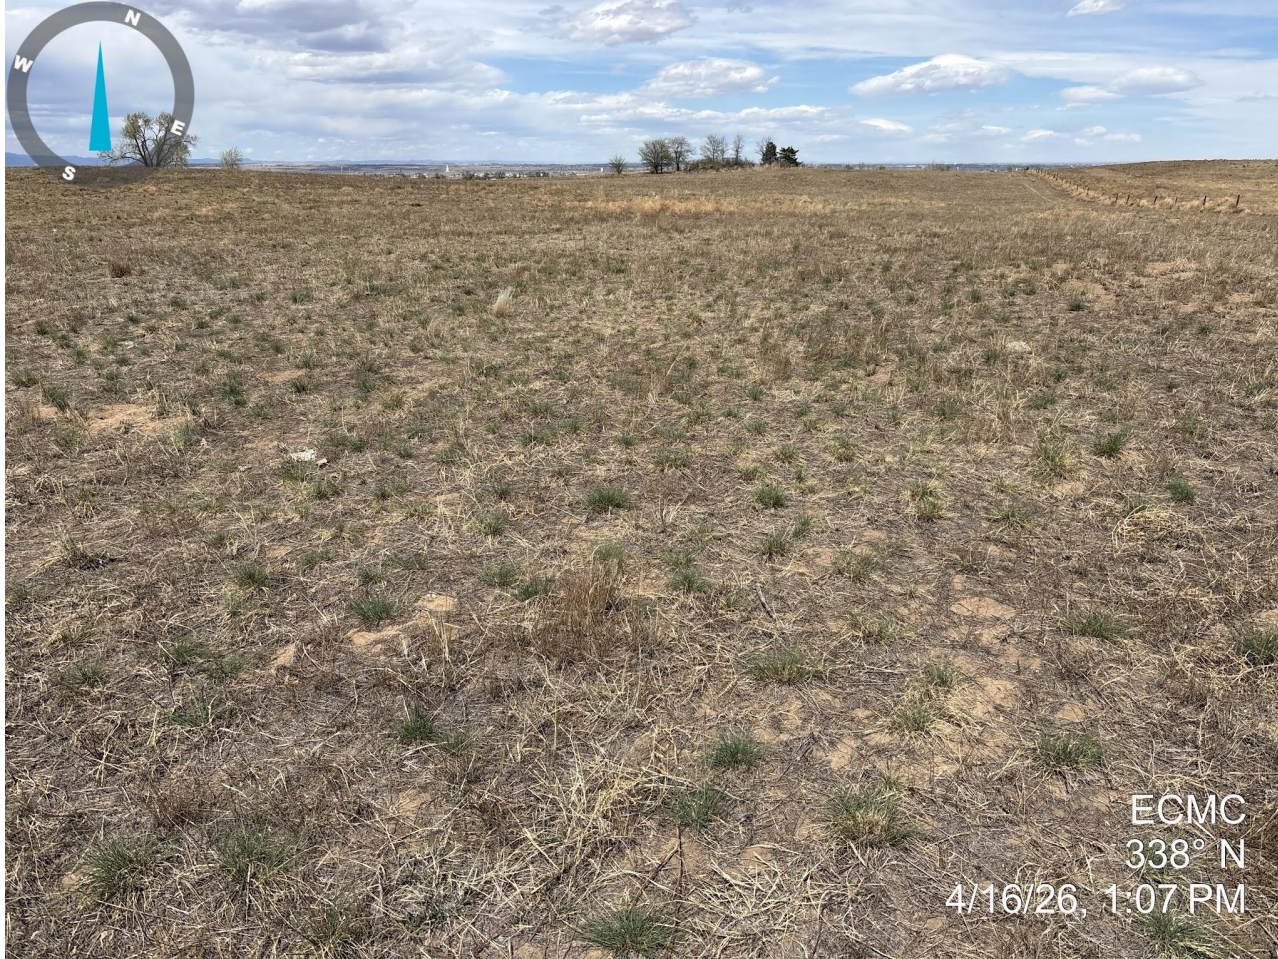
Photo 7. Photo taken of the reference area to the location, northeast of the location, facing north. Photo illustrates perennial grass and weedy annual vegetation.
