# Inspection Photos

Operator: TEP Rocky Mountain LLC #96850

Location ID: 335570

Inspection Doc: 719201115

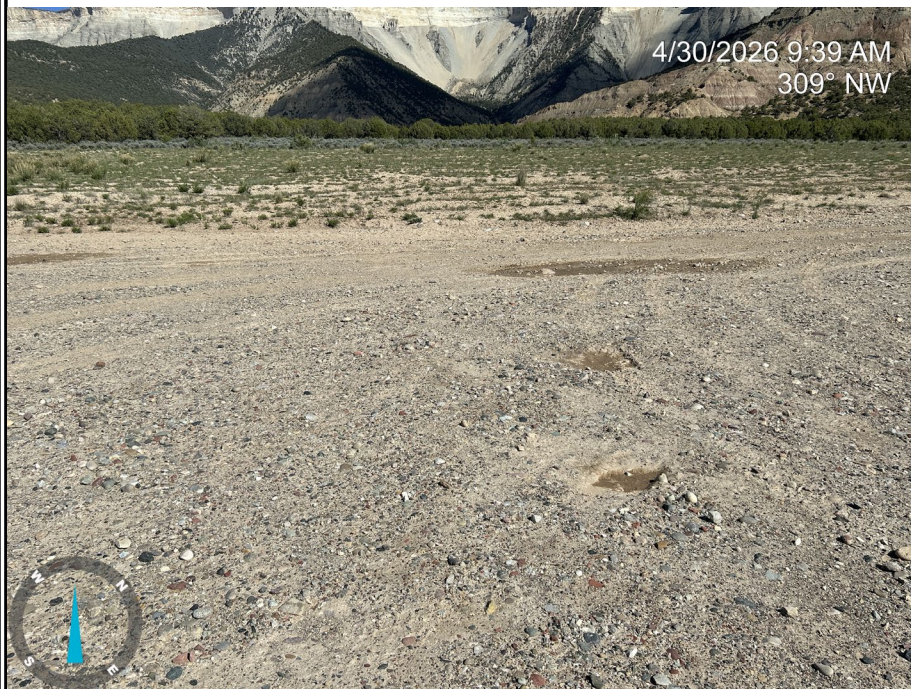
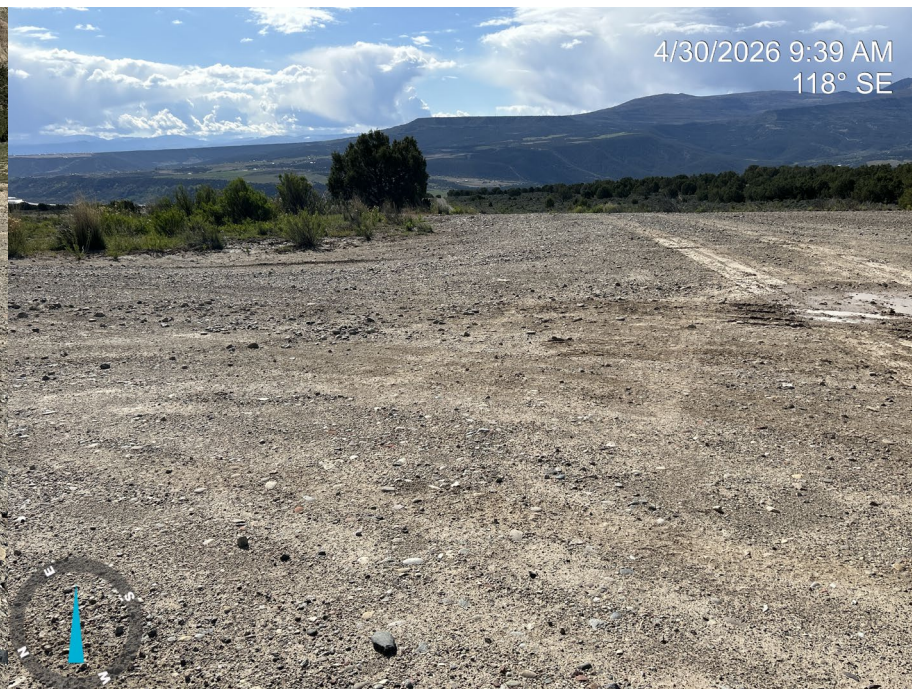
**Photo 1:** Photos showing an overview of the location looking northwest and southeast, respectively.

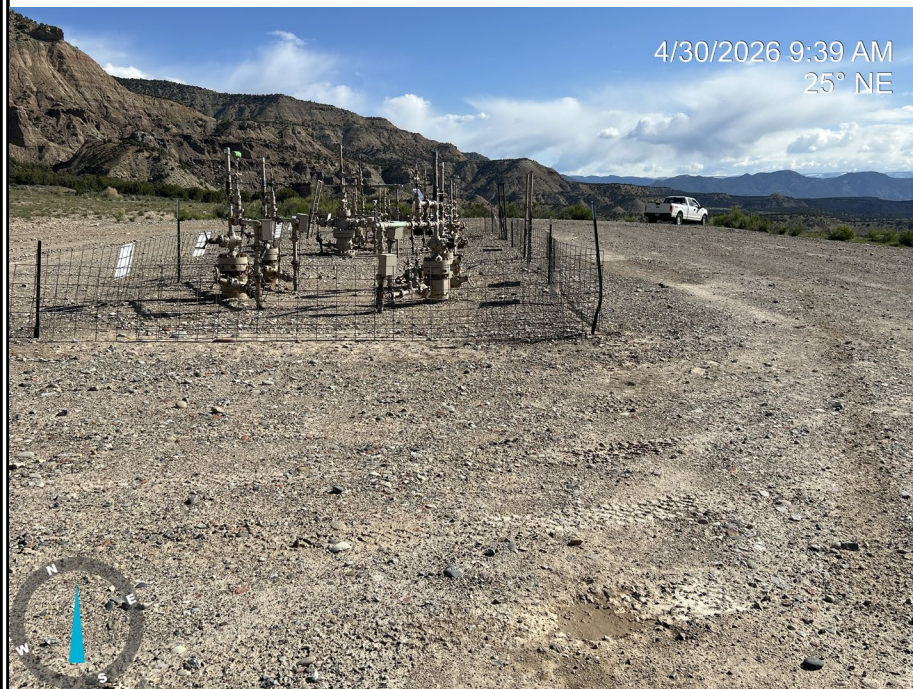
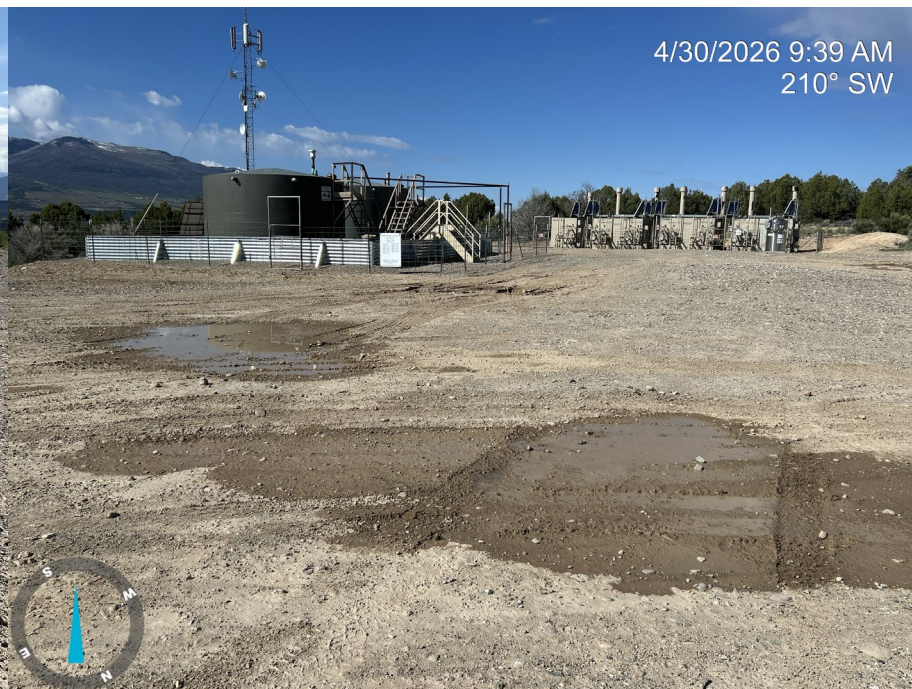
**Photo 2:** Photos showing an overview of the location looking northeast and southwest, respectively.

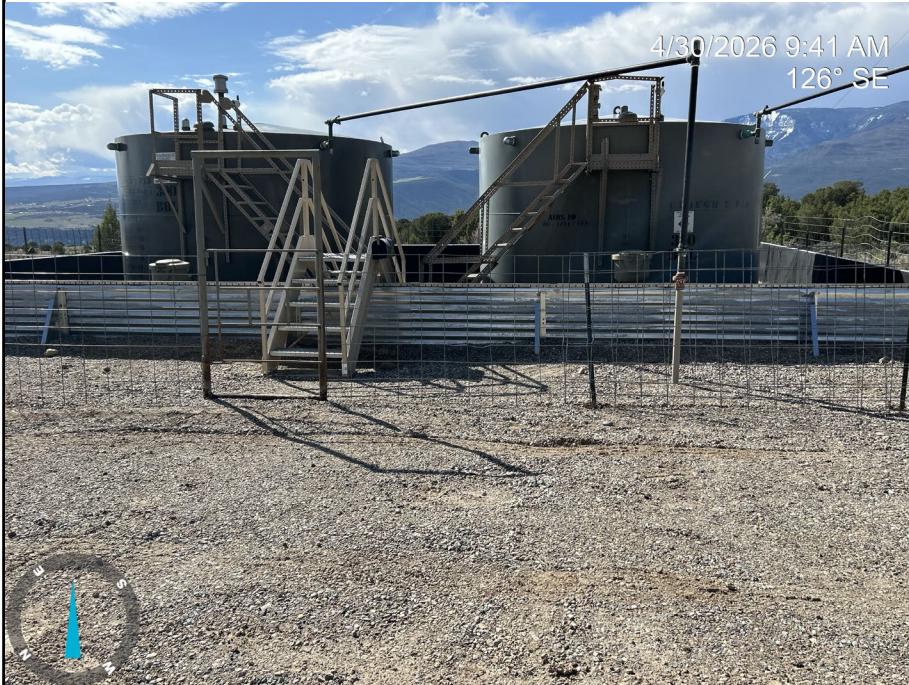
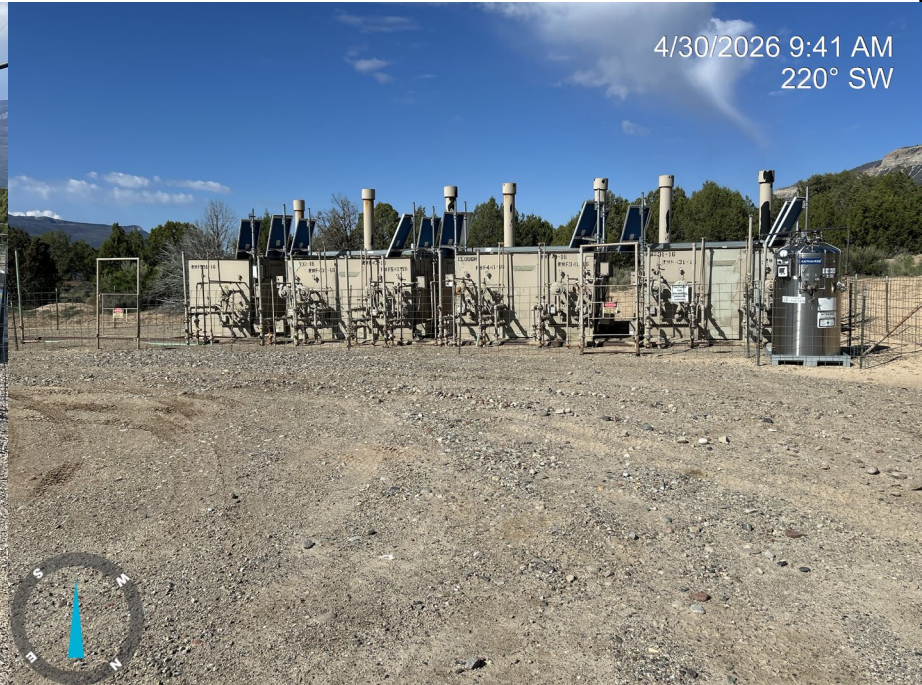
**Photo 3:** Photos showing an overview of tank and separator equipment.

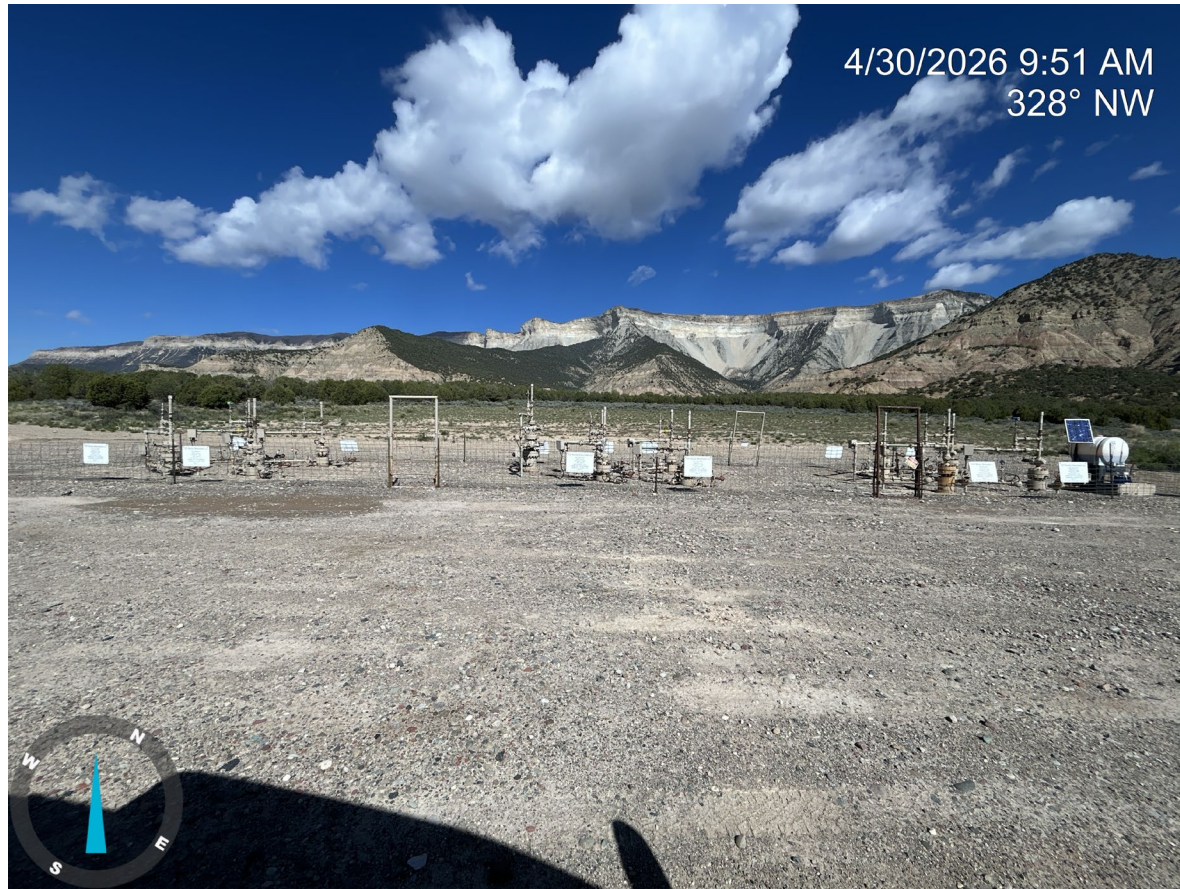
**Photo 4:** Photo showing an overview of the wellhead area.

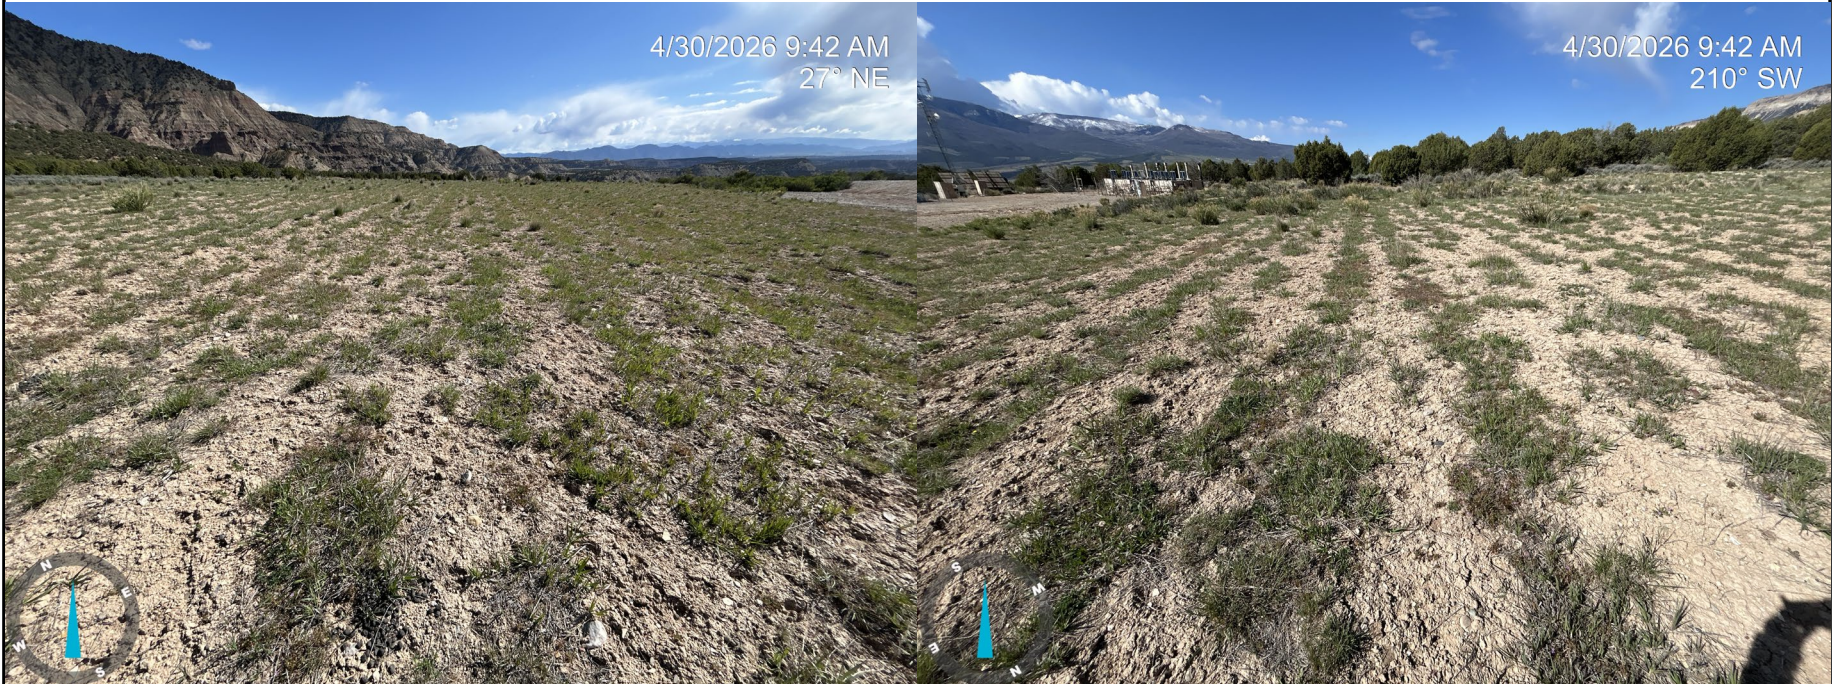
**Photo 5:** Photos showing an overview of the northern interim area. Desirable, perennial grasses are present; overall, interim areas are progressing towards 1003 reclamation requirements.

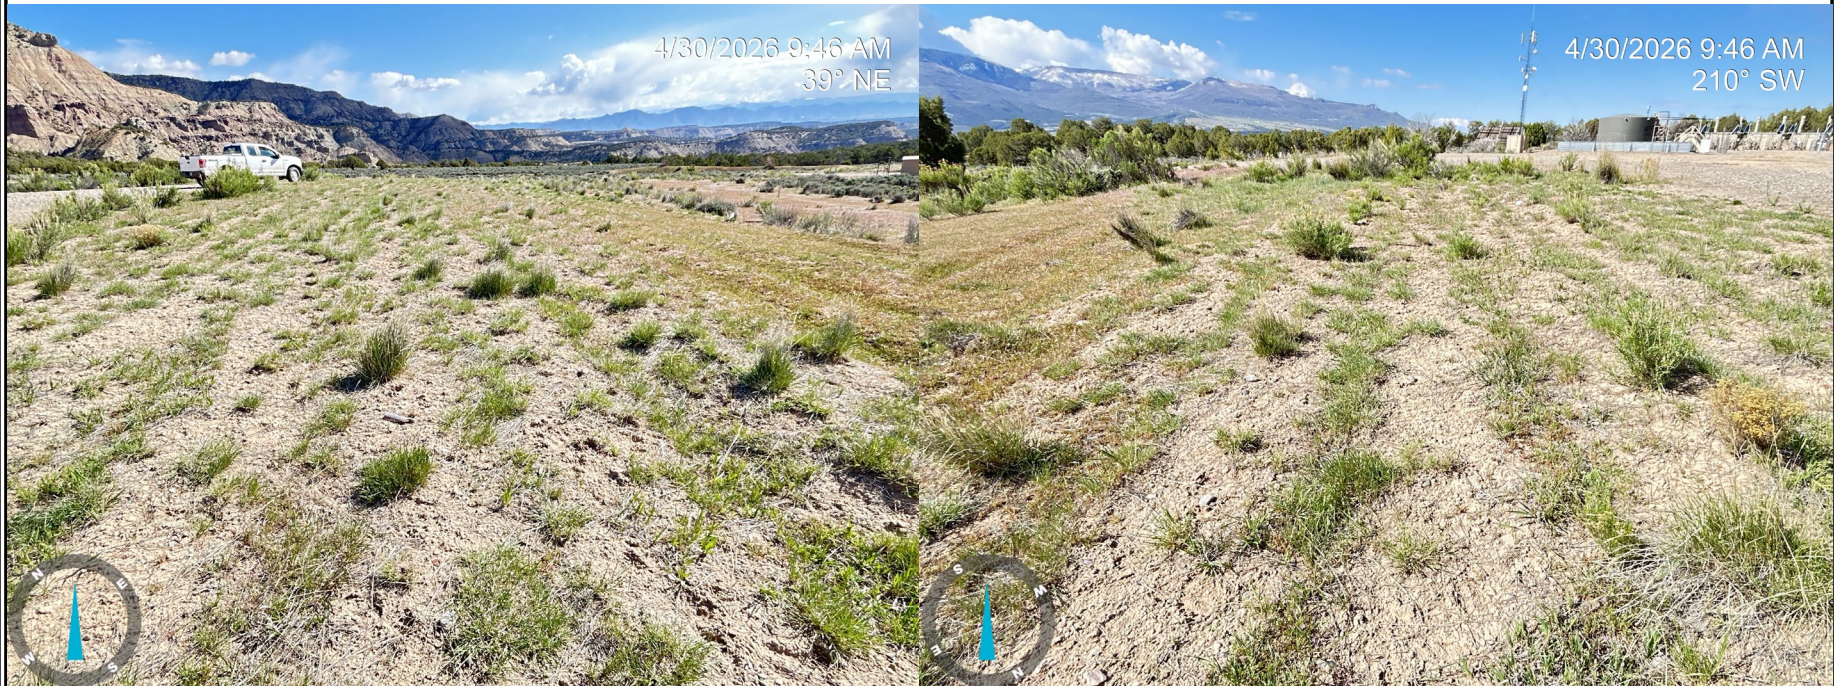
**Photo 6:** Photos showing an overview of the southern interim area. Desirable, perennial grasses are present; overall, interim areas are progressing towards 1003 reclamation requirements.

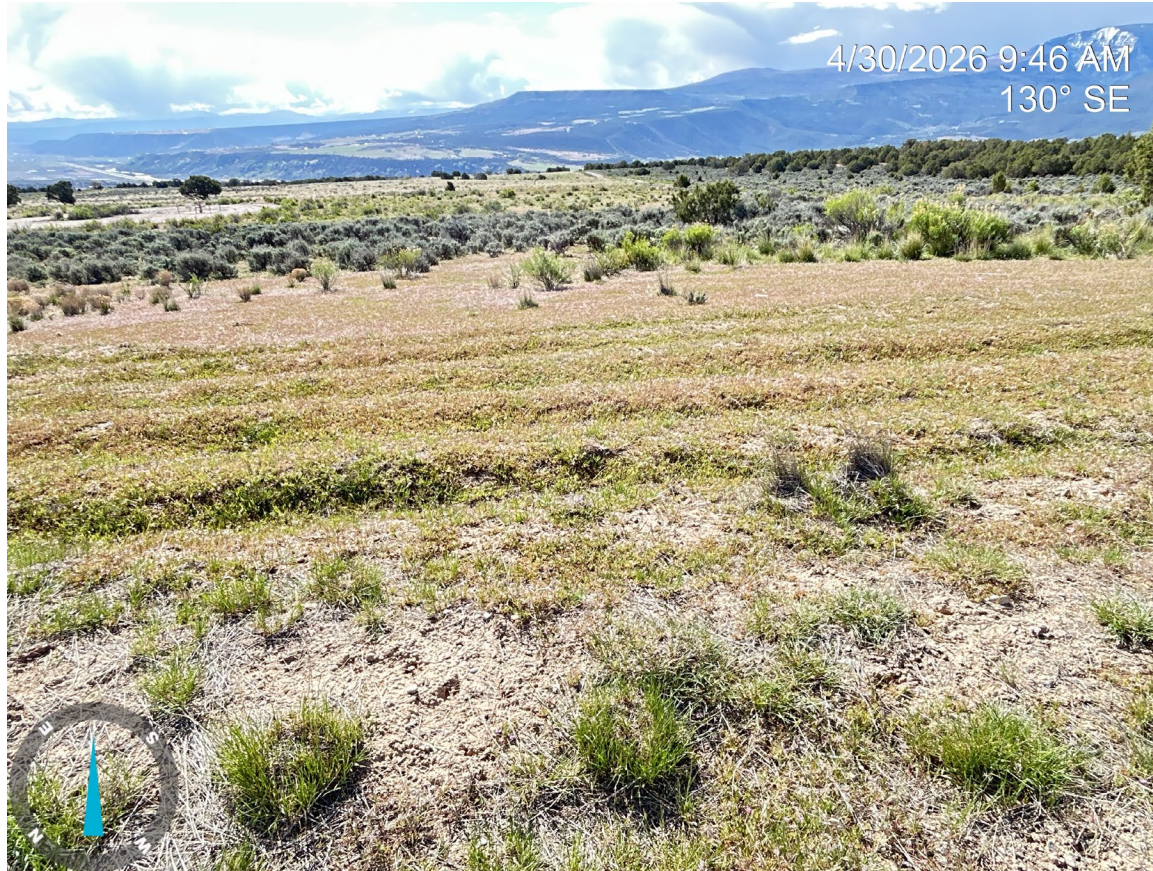
**Photo 7:** Photos showing an example of the southern interim area; cheatgrass is encroaching. Weed maintenance is required. Comply with Rule 606.c. and 1003.f.

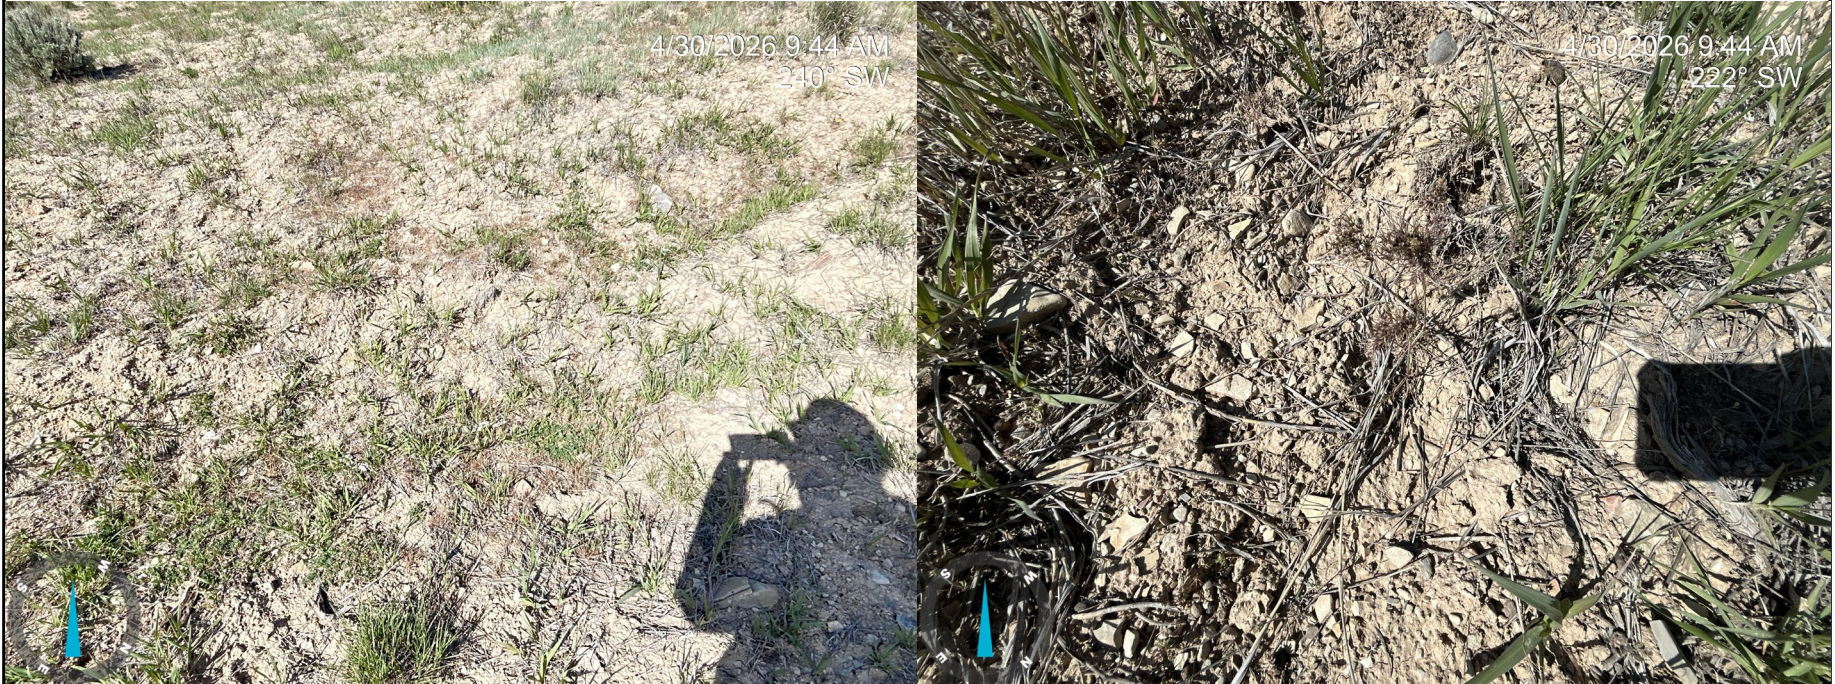
**Photo 8:** Photos showing a patch of bulbous bluegrass, a List C noxious weed, is present in the northeastern interim area.

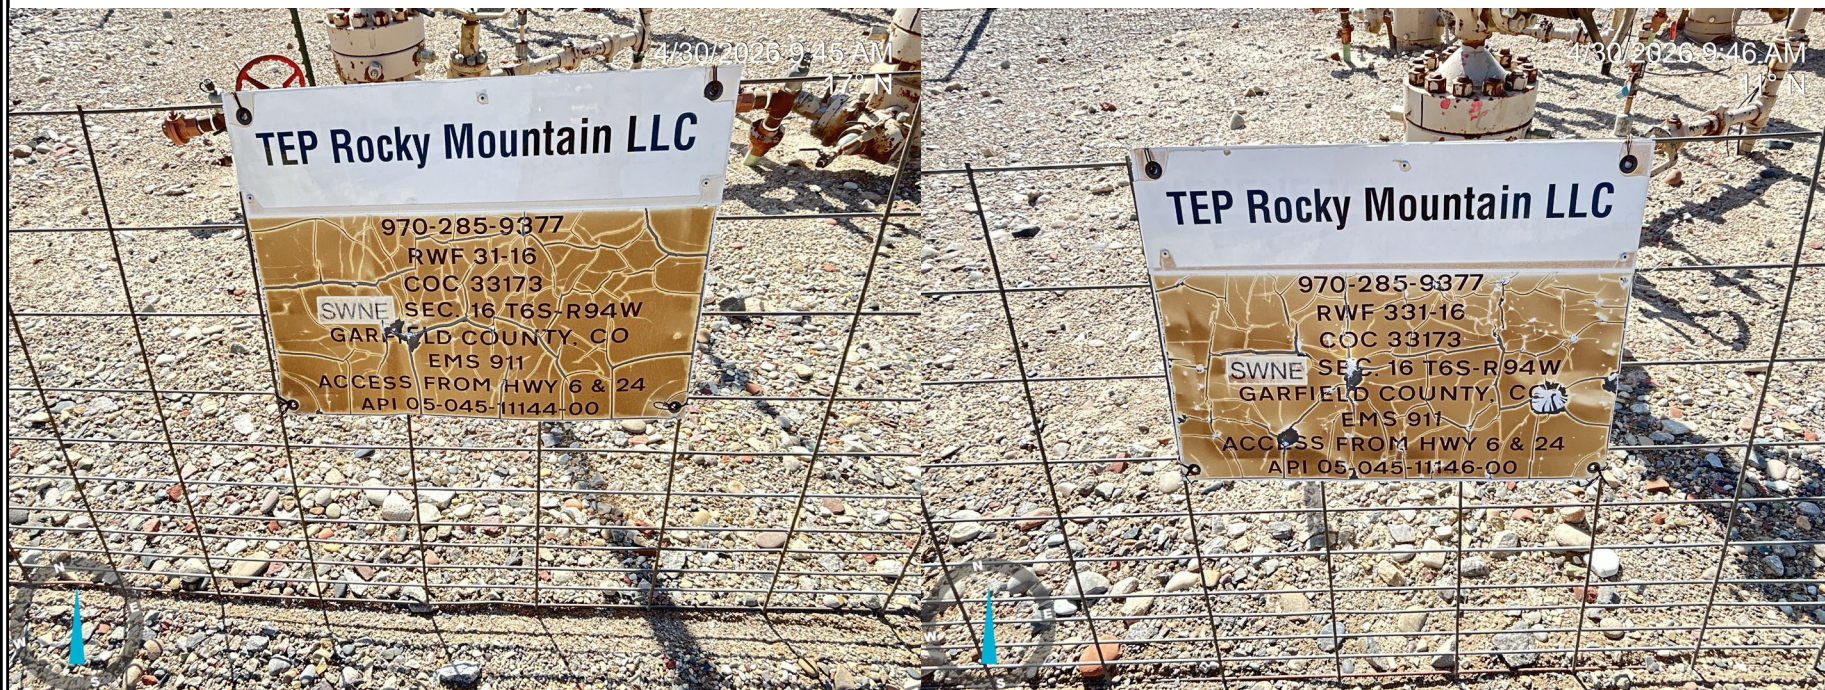
**Photo 9:** Photos showing some wellhead signage is cracked and discolored, becoming difficult to read. Maintenance is recommended.
