Inspection Photos

Operator: TEP Rocky Mountain LLC #96850

Location ID: 335572

Inspection Doc: 719201121

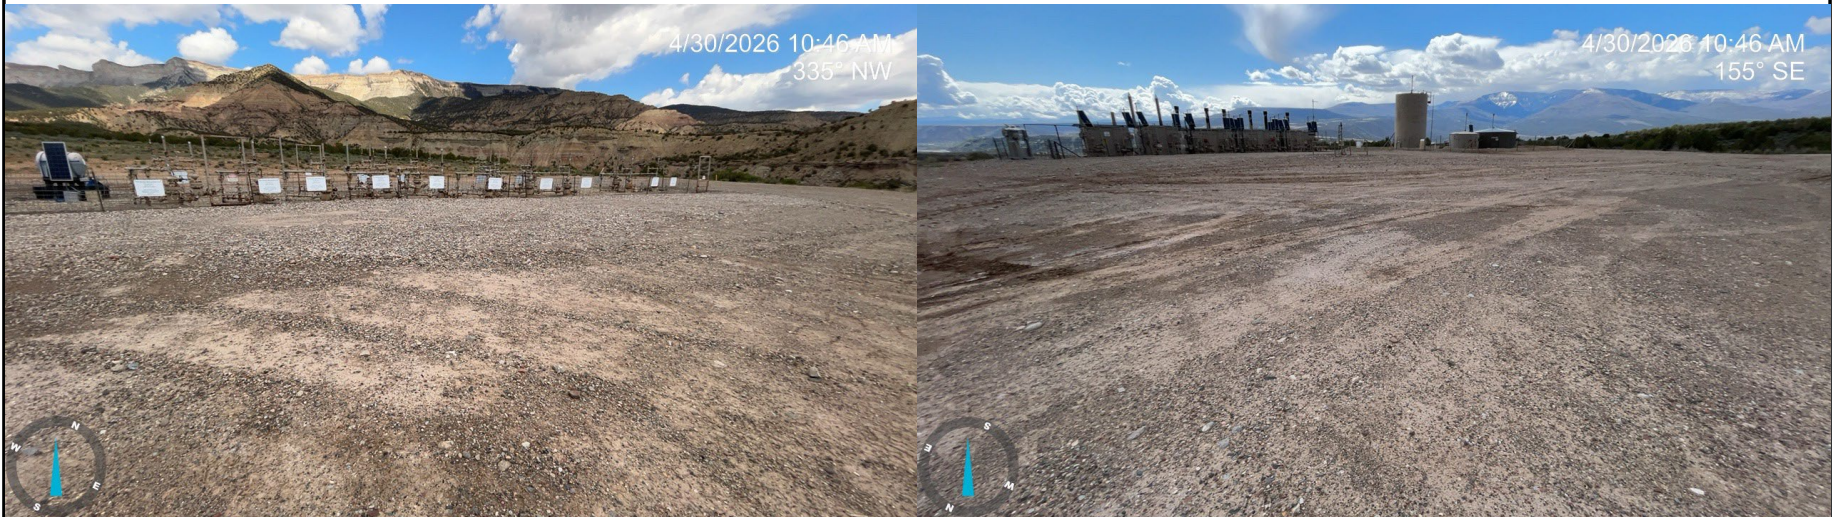
Photo 1: Photos showing and overview of the location looking northwest and southeast, respectively.

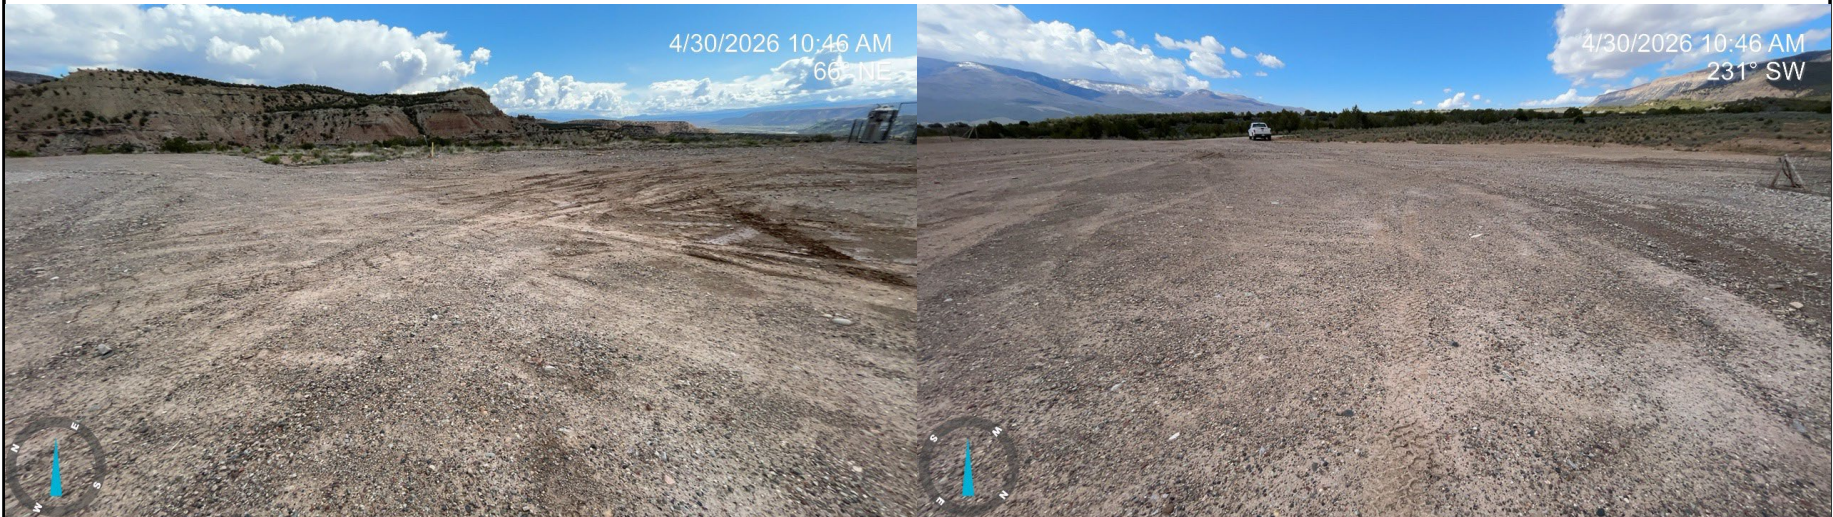
Photo 2: Photos showing and overview of the location looking northeast and southwest, respectively.

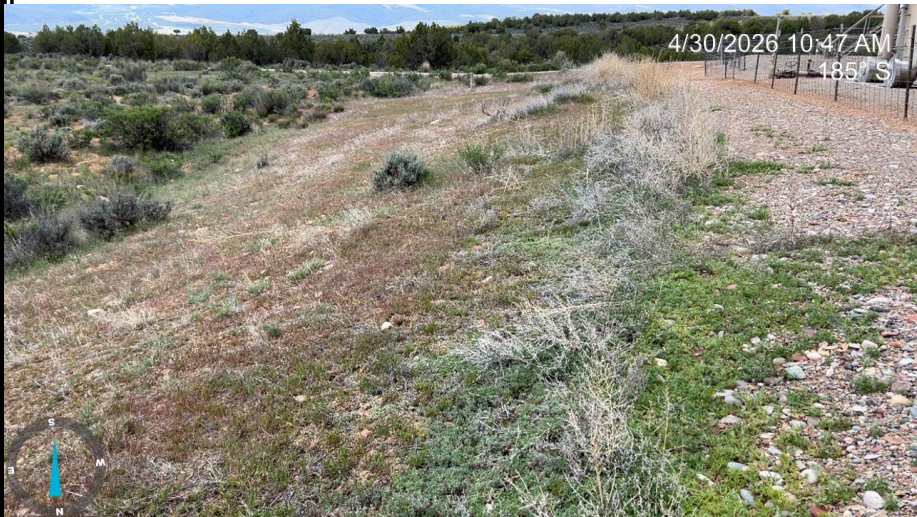
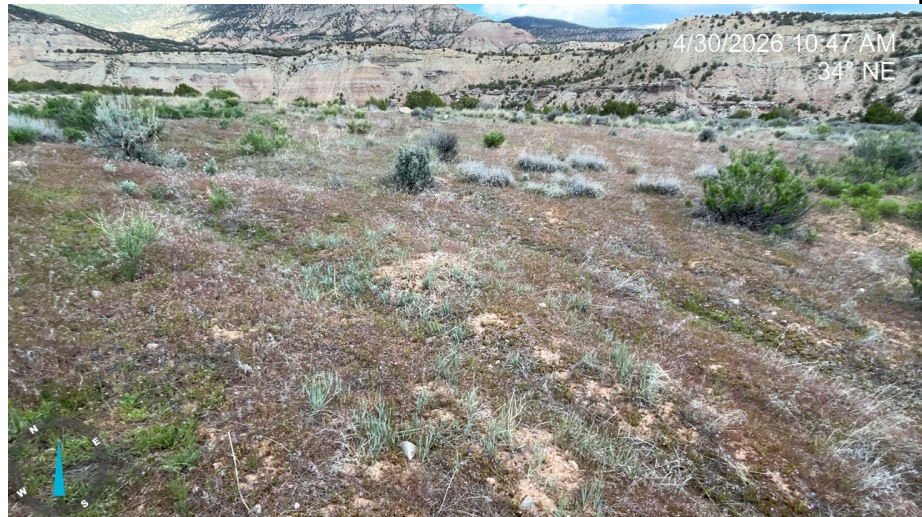
Photo 3: Photos showing the eastern fill slopes are dominated by cheatgrass and redstem fillaree, both a List C noxious weed. Desirable, perennial plants are scattered throughout in secondary to tertiary amounts. Weed maintenance is required; comply with Rules 606.c. and 1003.f.

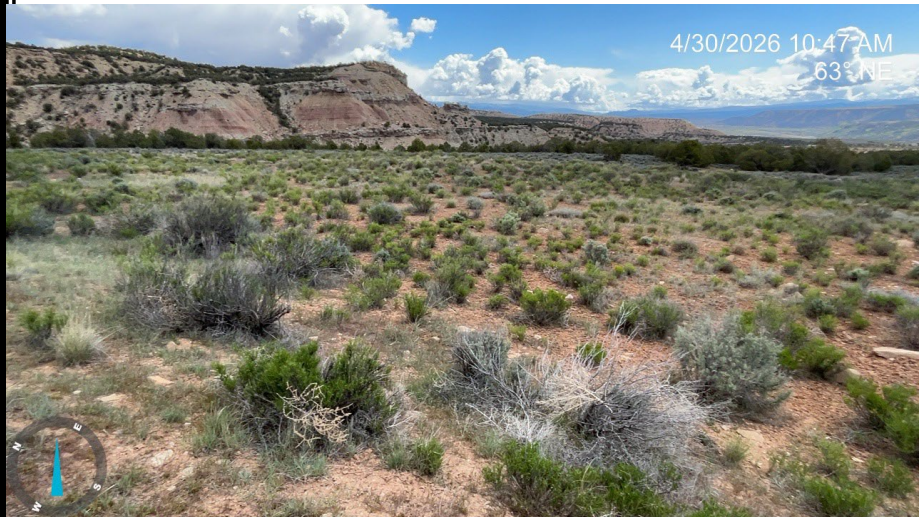
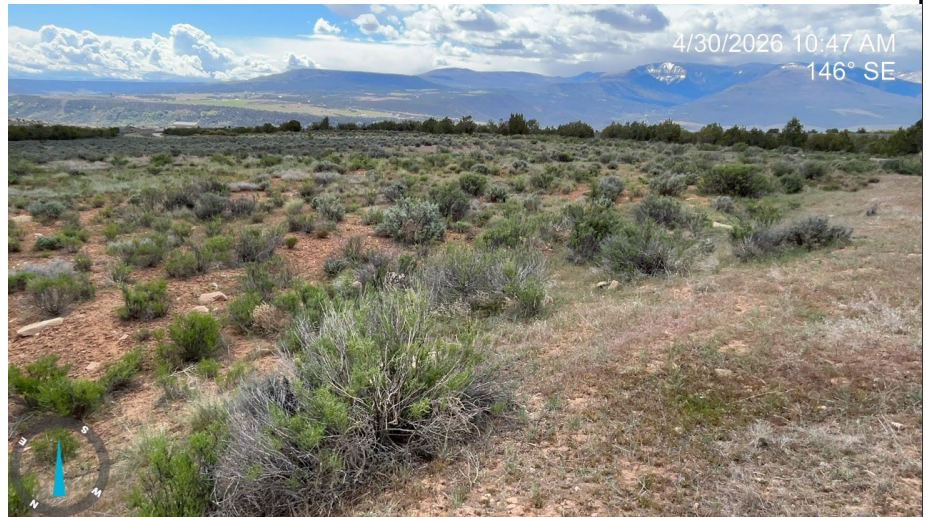
Photo 4: Photos showing the pit to the east of the location is well vegetated.

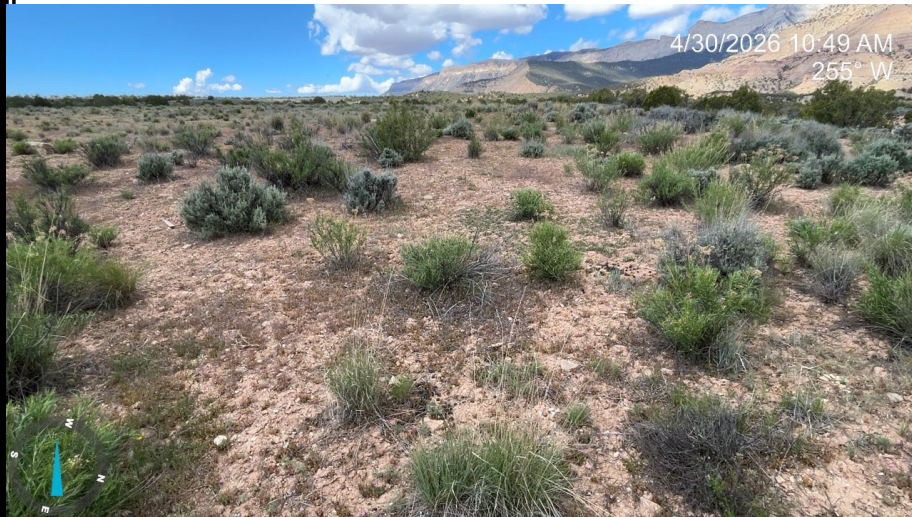
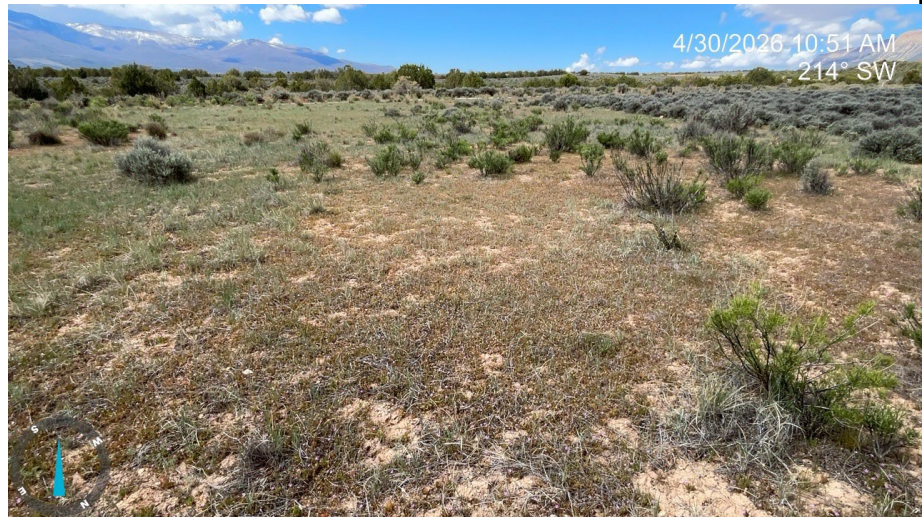
Photo 5: Photos showing the northern and northeastern interim areas are dominated by cheatgrass and redstem fillaree in the understory, both a List C noxious weed. Desirable, perennial plants are present throughout in secondary to tertiary amounts. Weed maintenance is required; comply with Rules 606.c. and 1003.f.

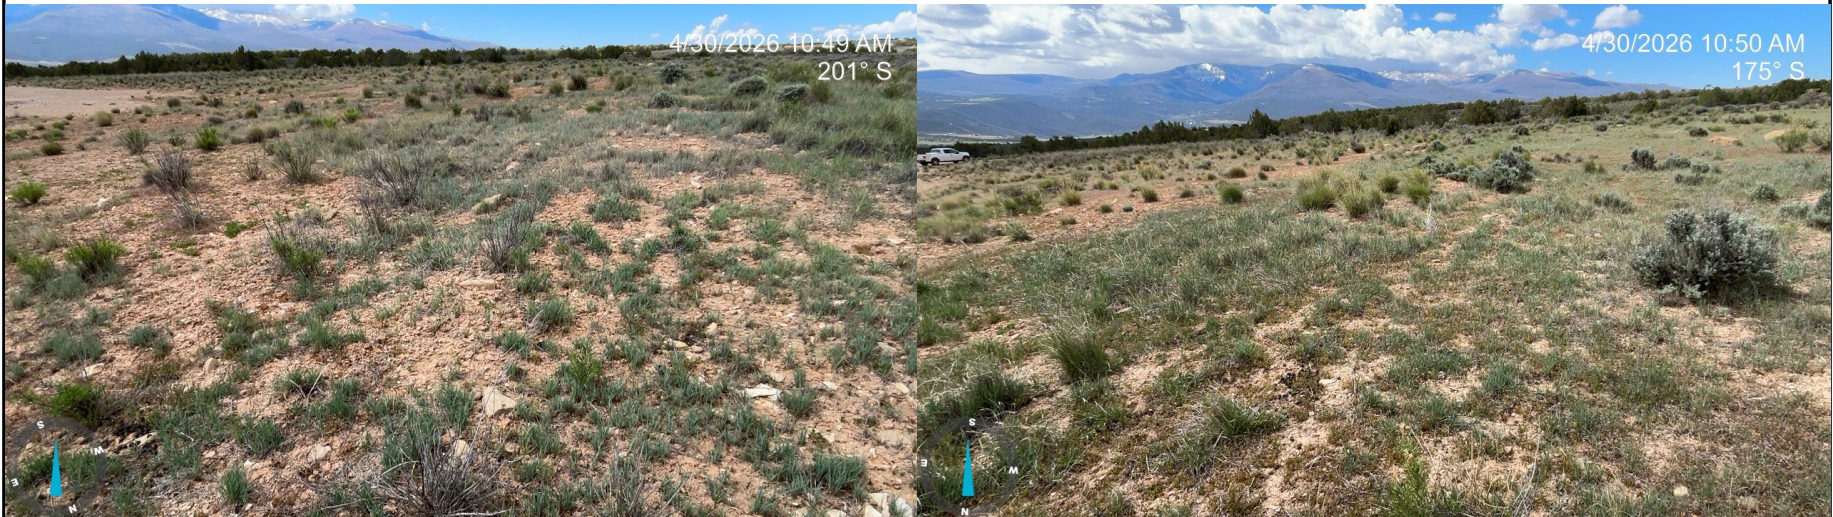
Photo 6: Photos showing the western and southwestern interrim areas. Overall, interrim areas are progressing towards 1003 reclamation requirements.

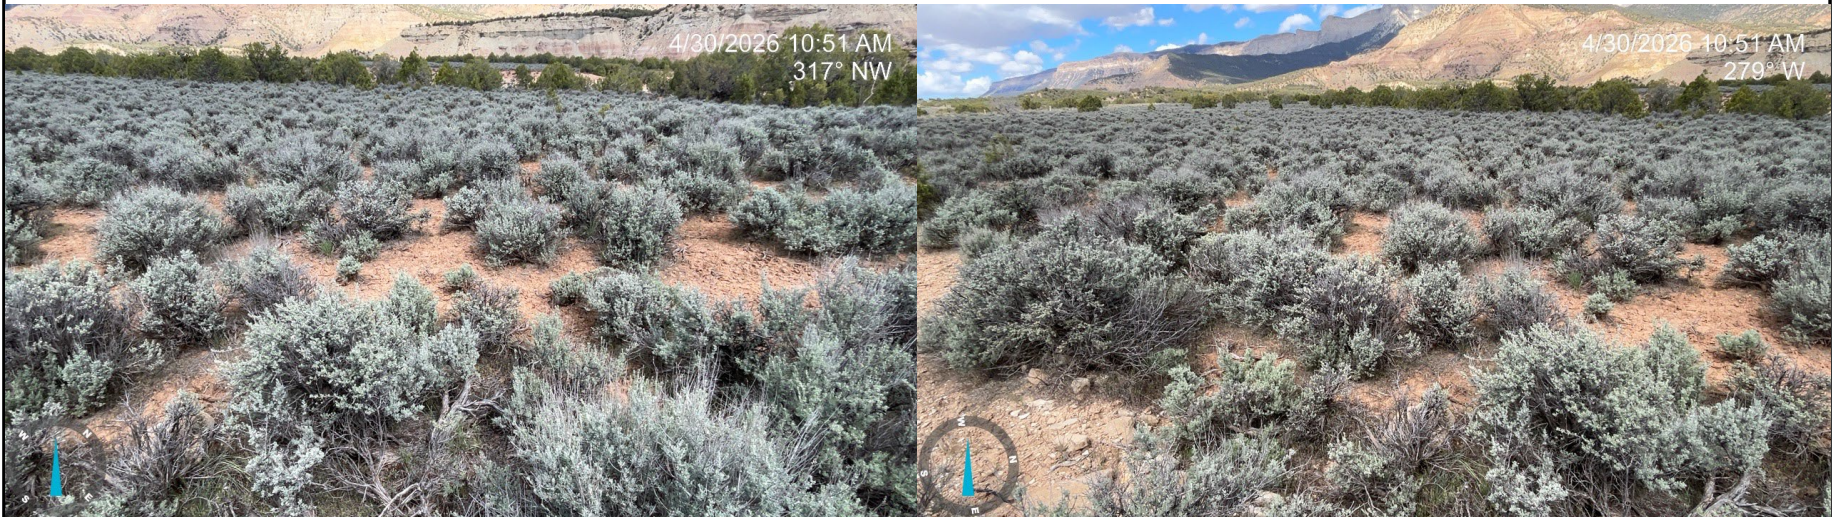
Photo 7: Photos showing the nearby reference area, directly west of the location. The reference area is characterized as a big sagebrush flat.
