Inspection Photos

Operator: TEP Rocky Mountain LLC #96850

Location ID: 418465

Inspection Doc: 719201124

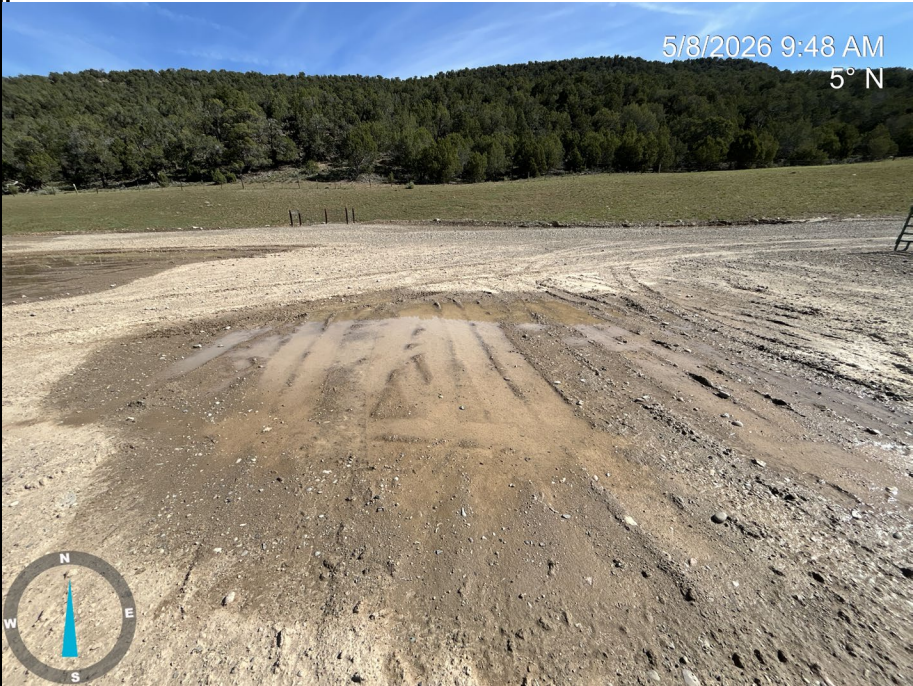
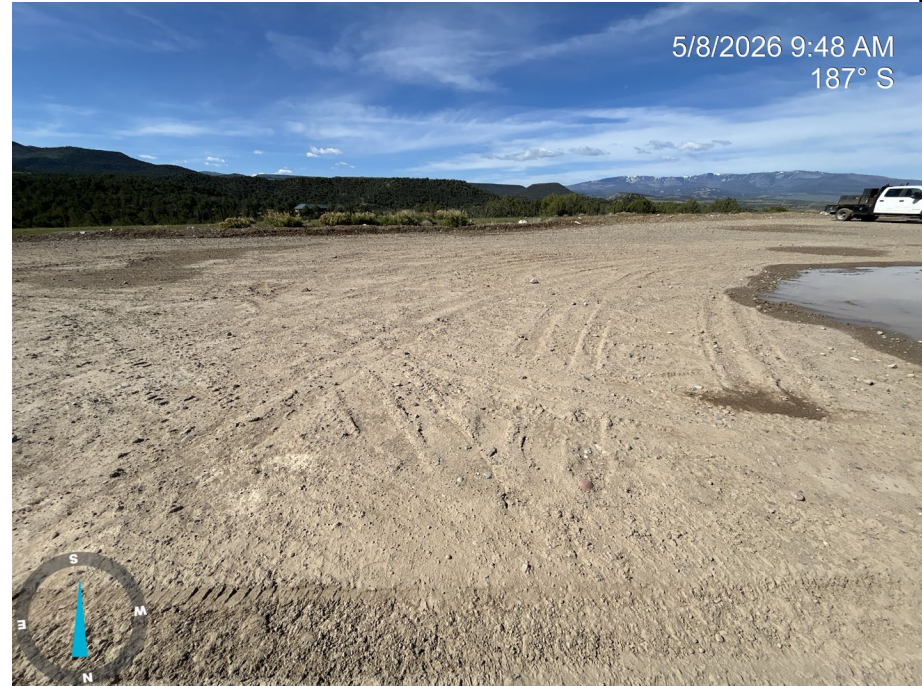
Photo 1: Photos showing an overview of the location looking north and south, respectively.

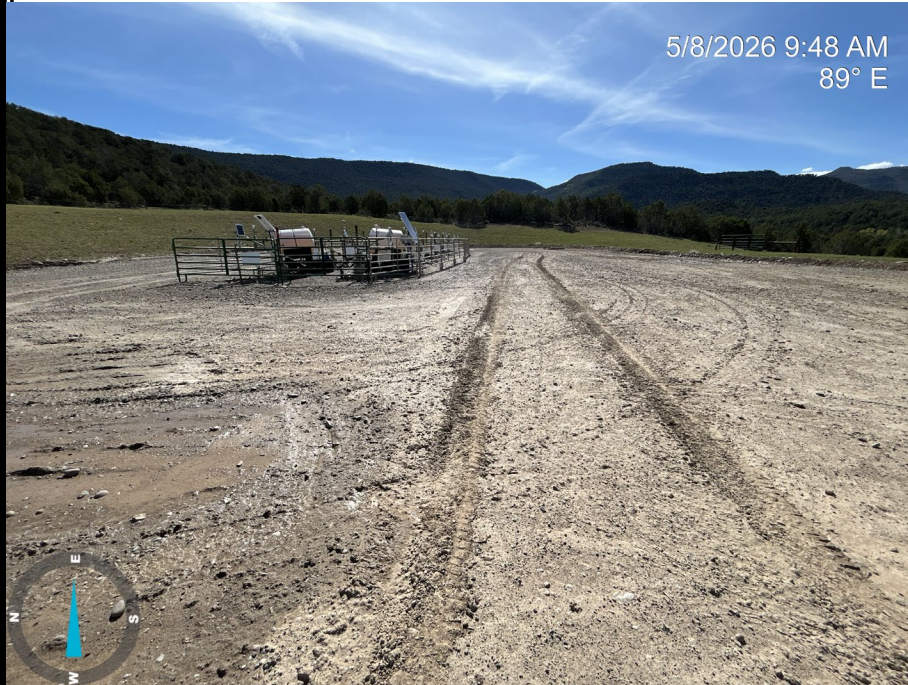
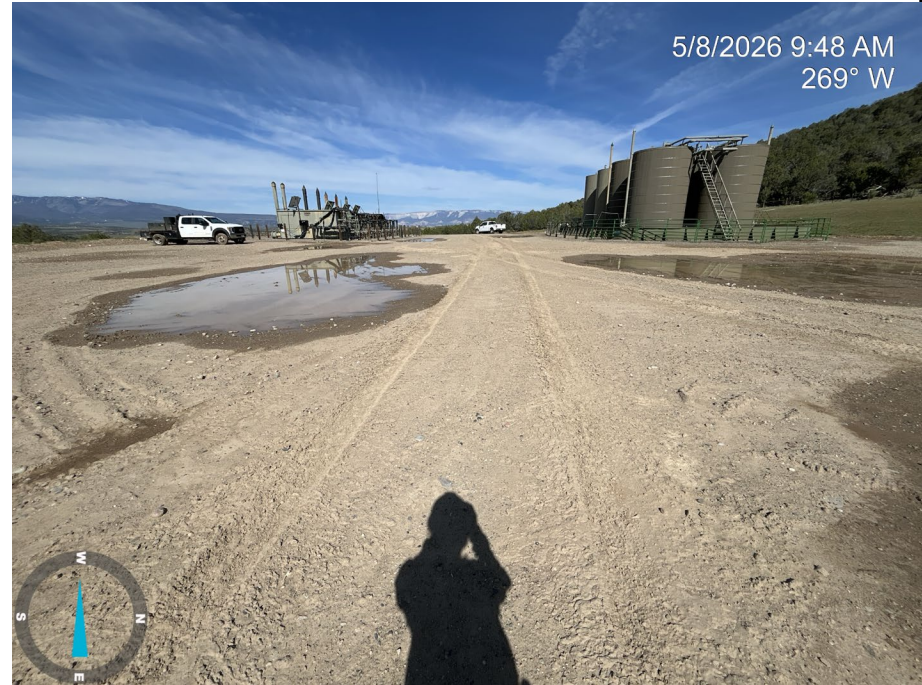
Photo 2: Photos showing an overview of the location looking east and west, respectively.

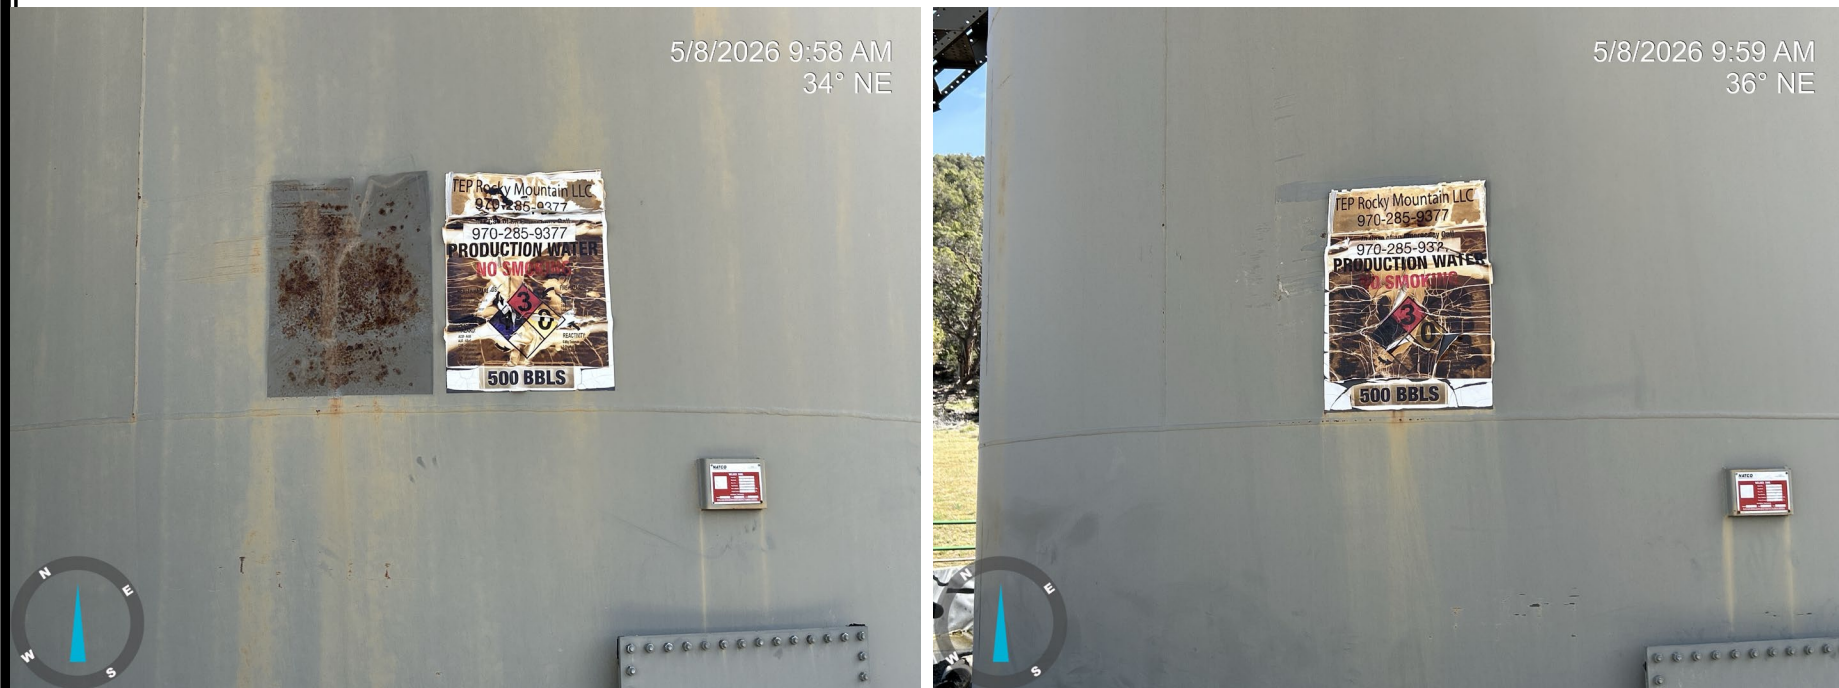
Photo 3: Photos showing examples of tank labels that are discolored and peeling; maintenance is required. Comply with 605.h.

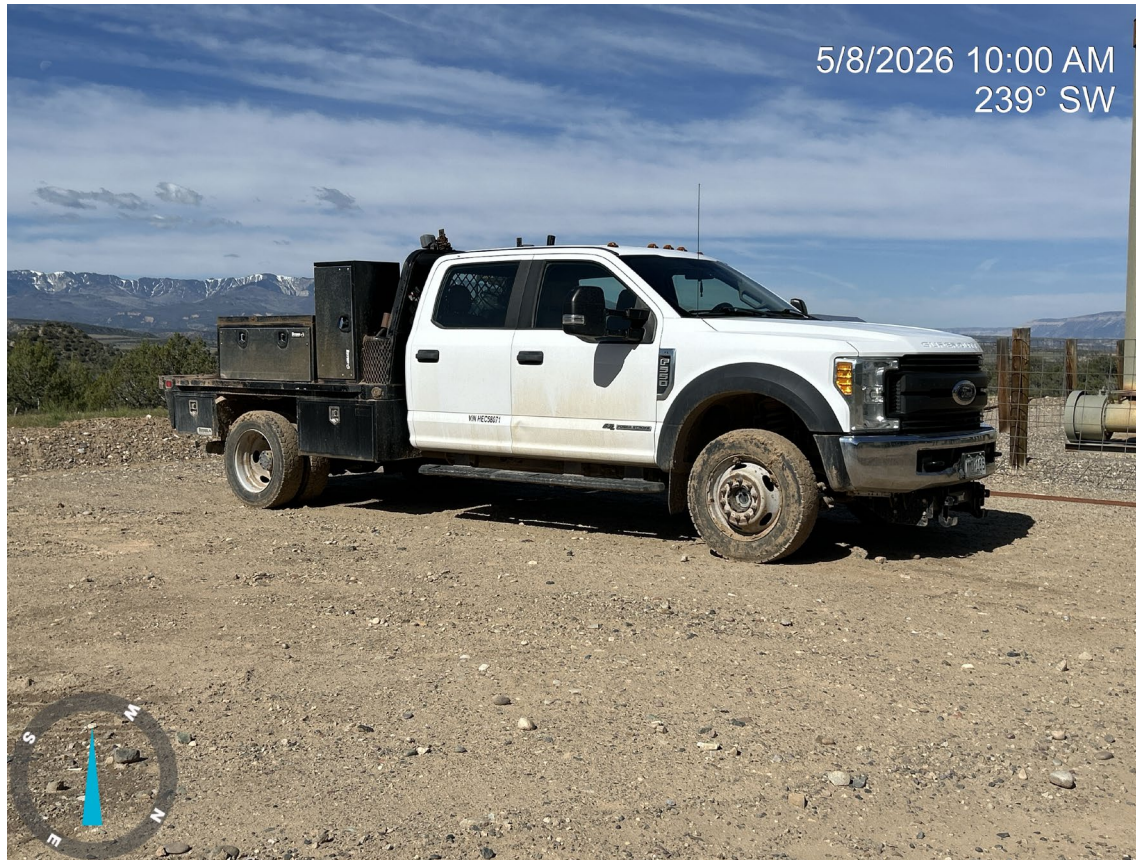
Photo 4: An unused/unoccupied vehicle is parked at the location; removal is required pursuant to Rule 606.a.

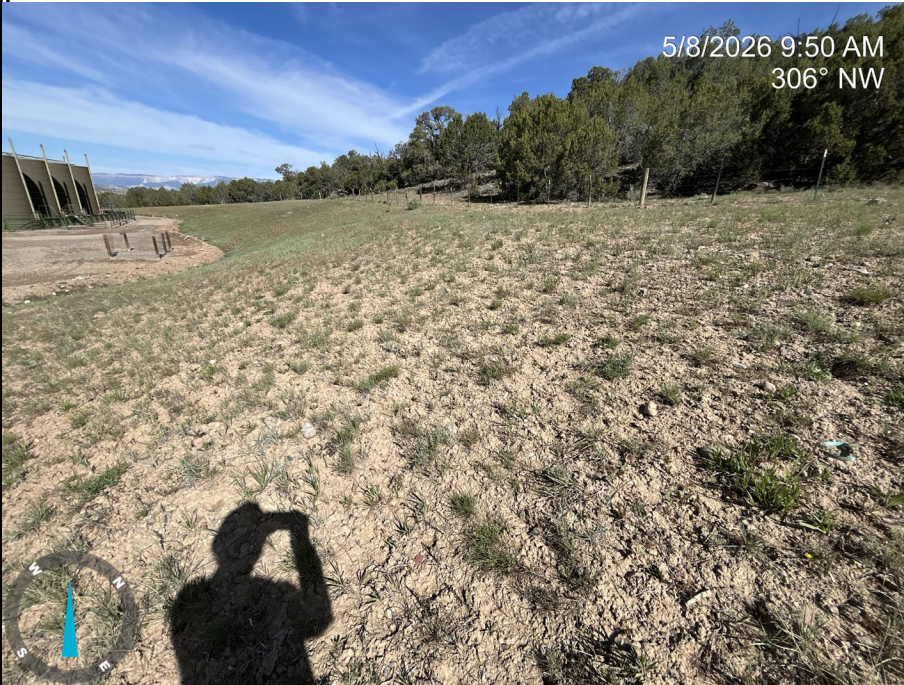
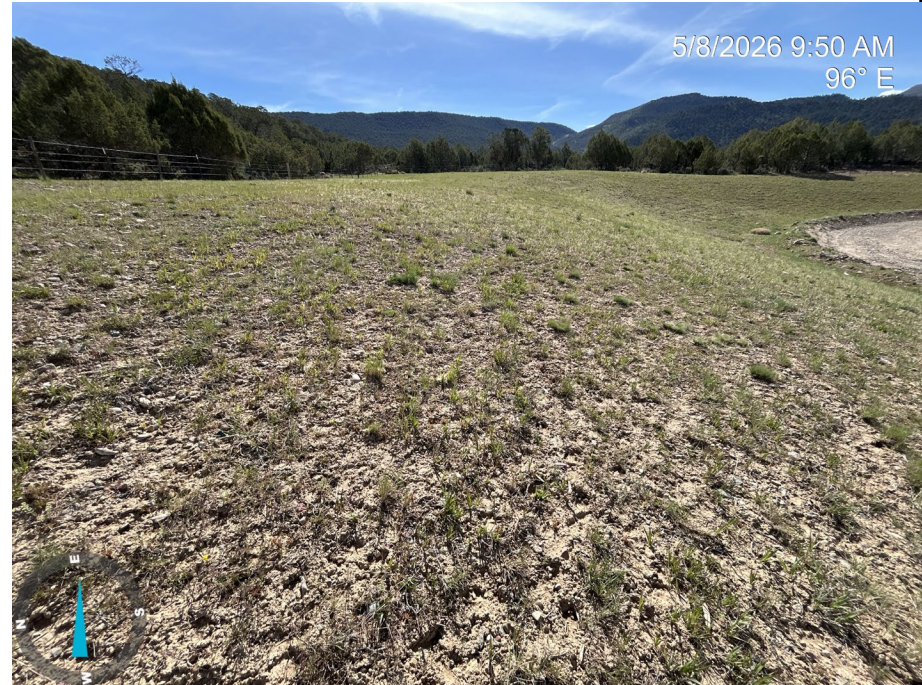
Photo 5: Photos showing the northern interim area. Interim areas progressing towards 1003 reclamation requirements; noxious weeds are present throughout.

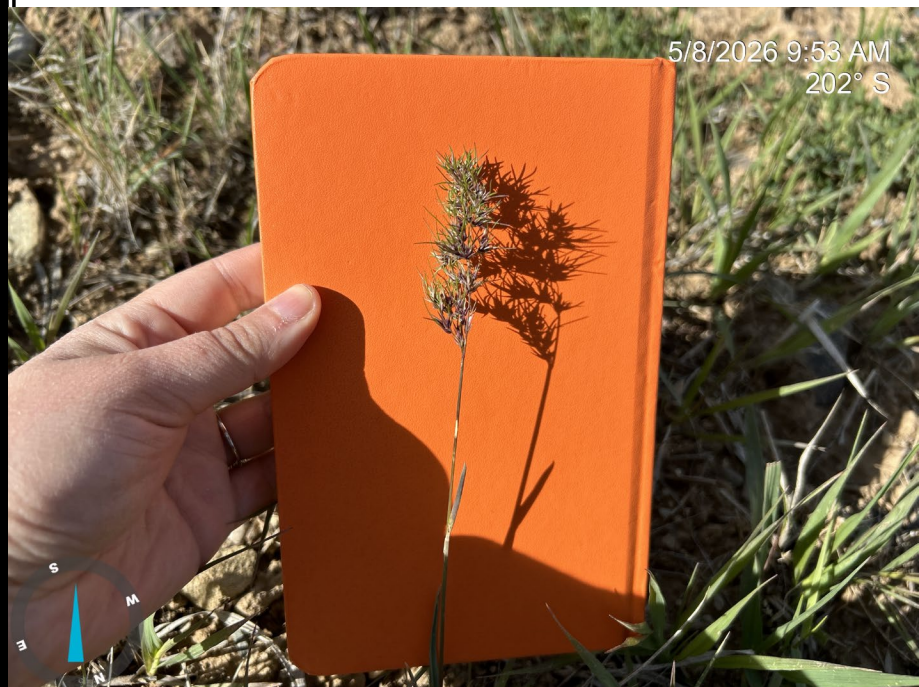
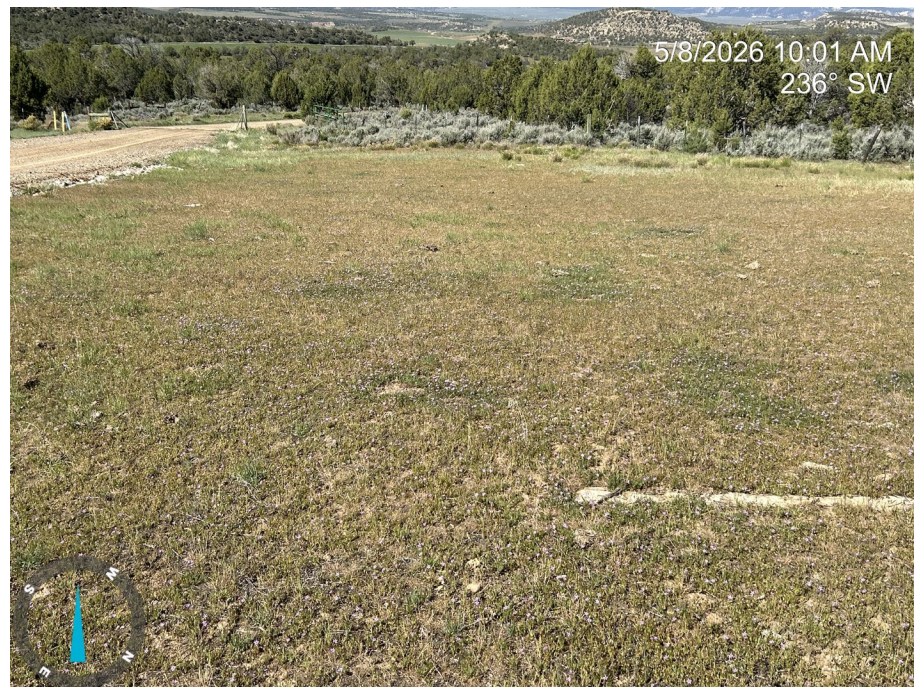
Photo 6: Photos showing bulbous bluegrass (left) and redstem fillaree, both List C noxious weeds that is present throughout the interim area. Redstem fillaree is dominant in the northwestern portion of the interim. Weed maintenance is required.

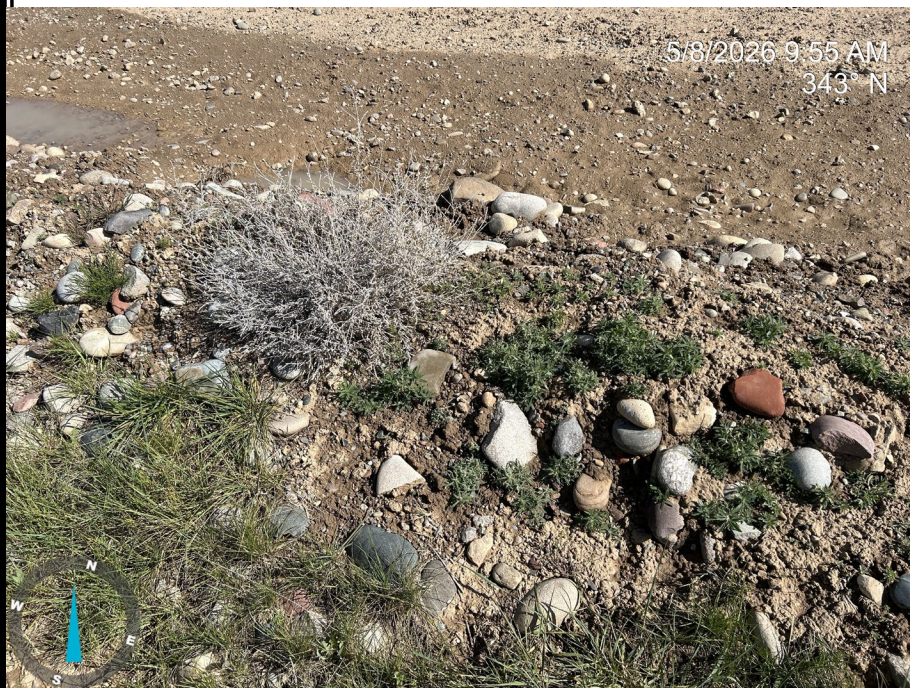
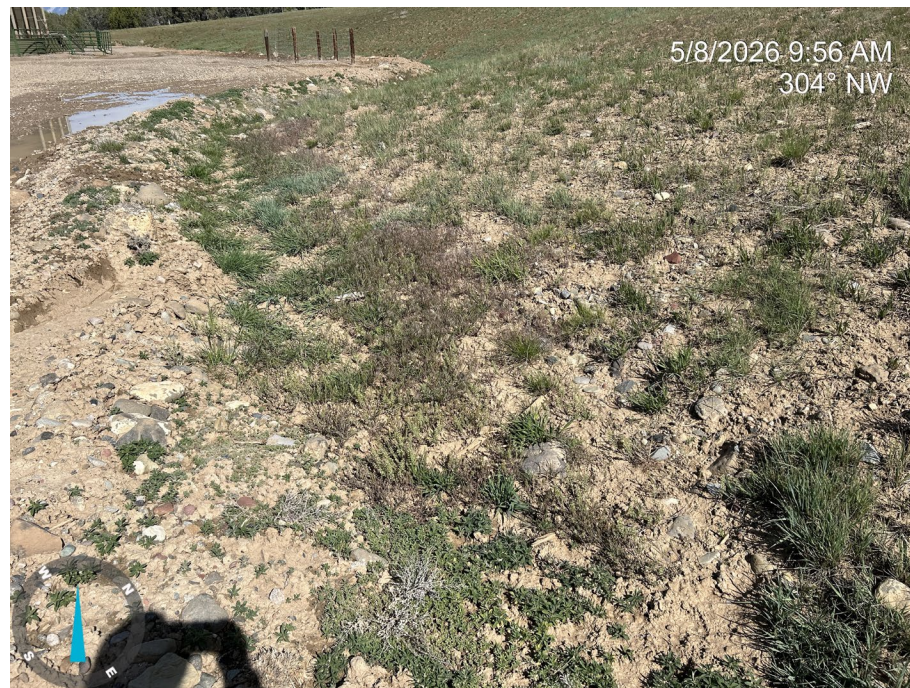
Photo 7: Photos showing an example of prickly Russian thistle, cheatgrass, kochia and weedy annual species that are present along the edges of the working pad surface. Weed maintenance is required.

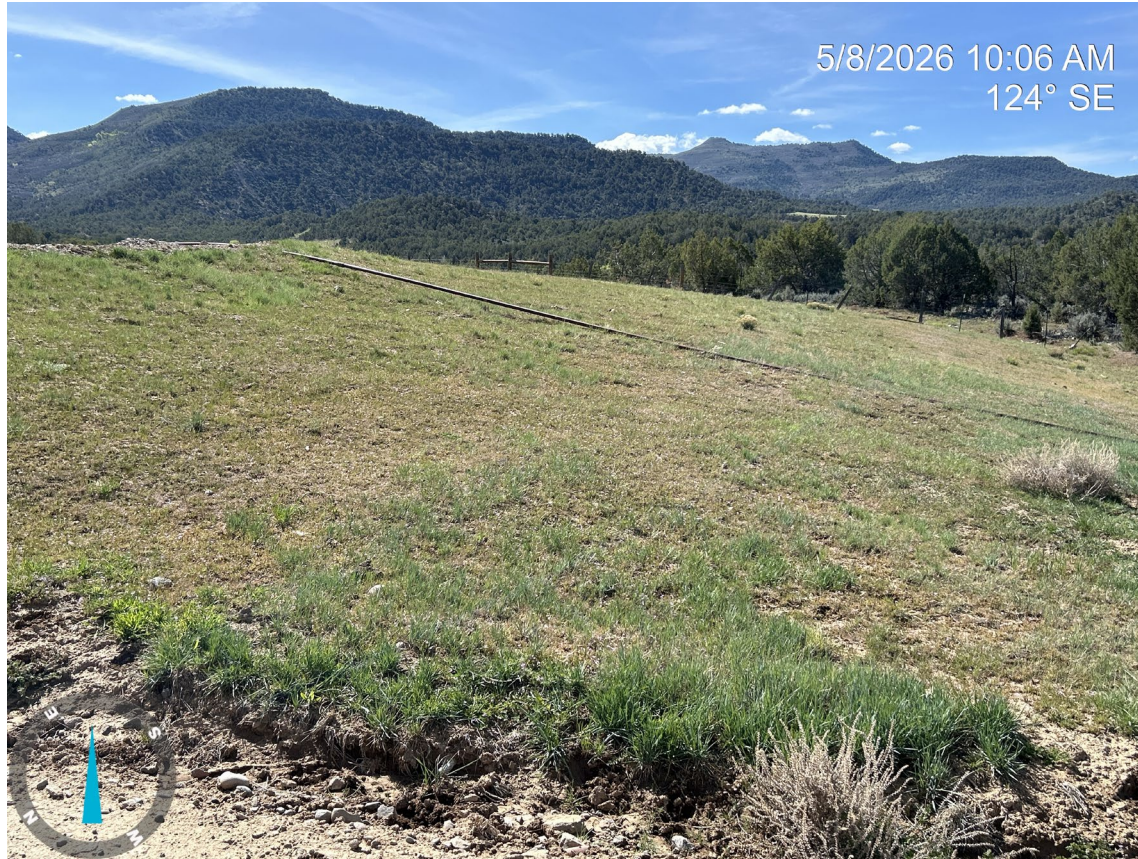
Photo 8: Photo showing the southwestern interim area with primary to secondary amounts of cheatgrass present.

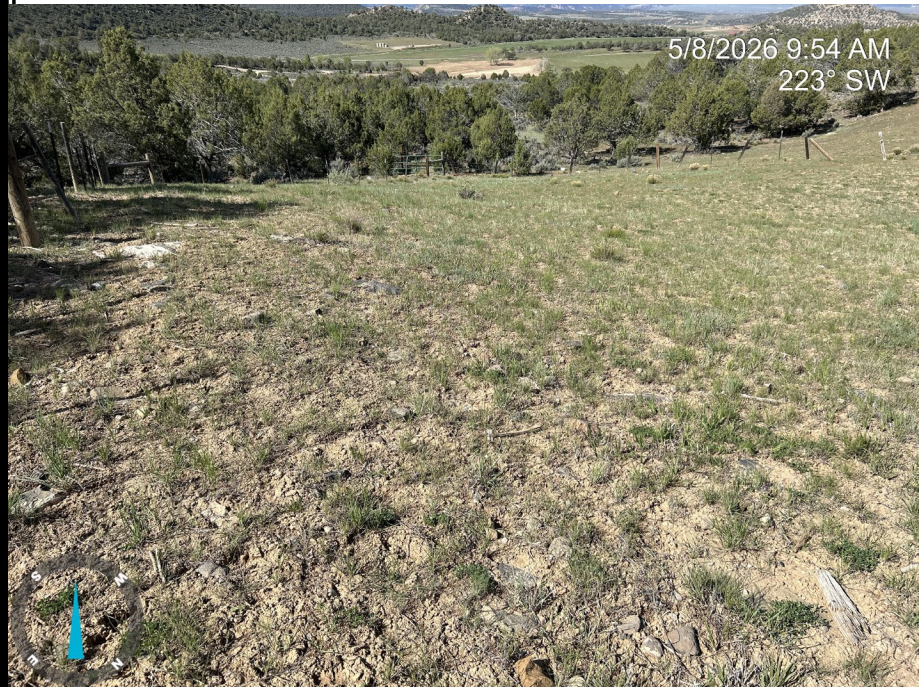
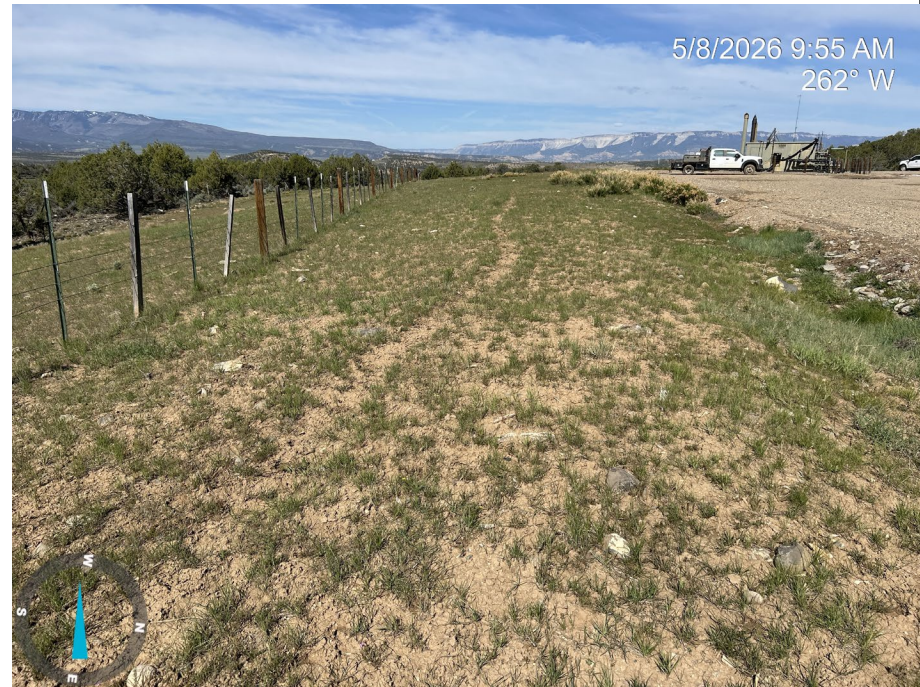
Photo 9: Photos showing the eastern and southern interim areas, respectively. Overall, interim areas are progressing towards 1003 reclamation requirements.
