Inspection Photos

Operator: TEP Rocky Mountain LLC #96850

Location ID: 417787

Inspection Doc: 719201129

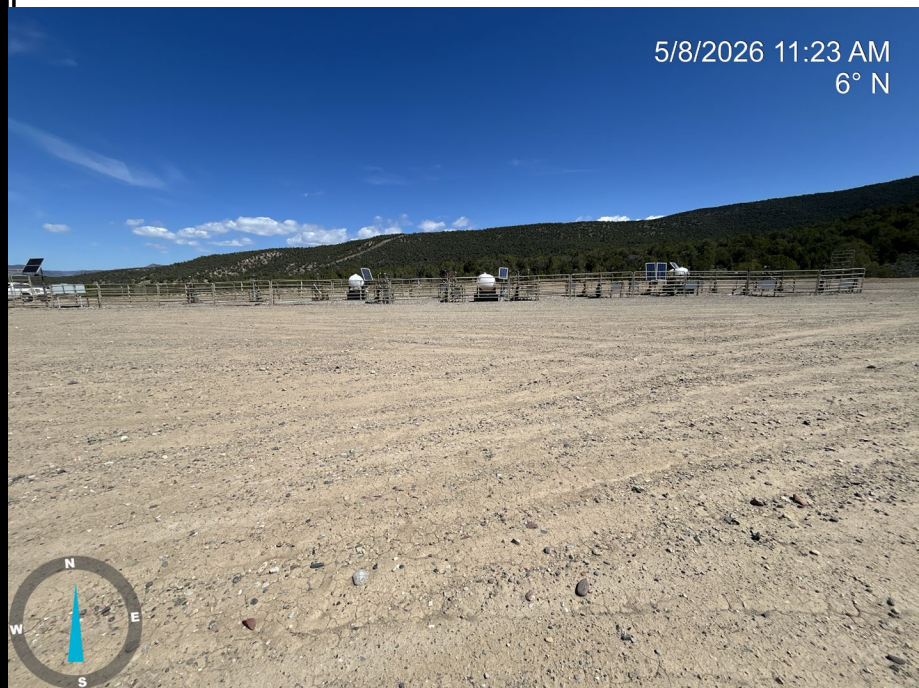
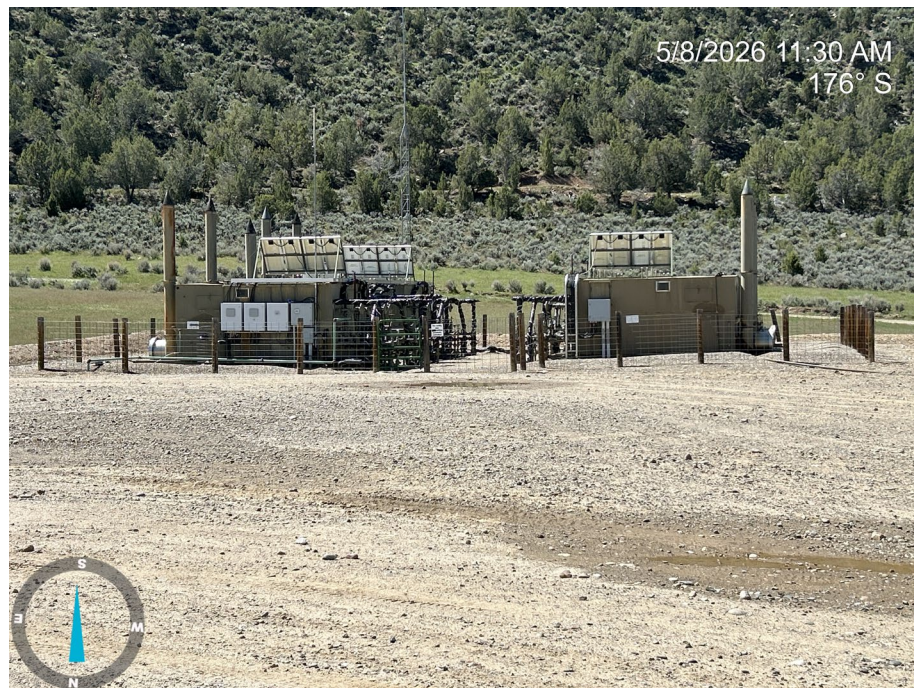
Photo 1: Photos showing an overview of the location looking north and south, respectively.

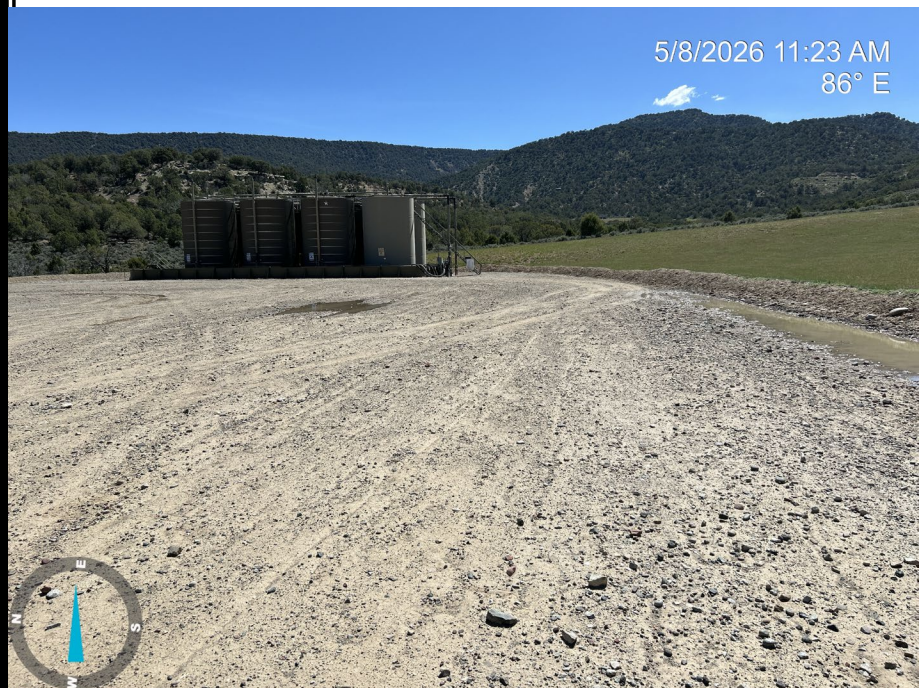
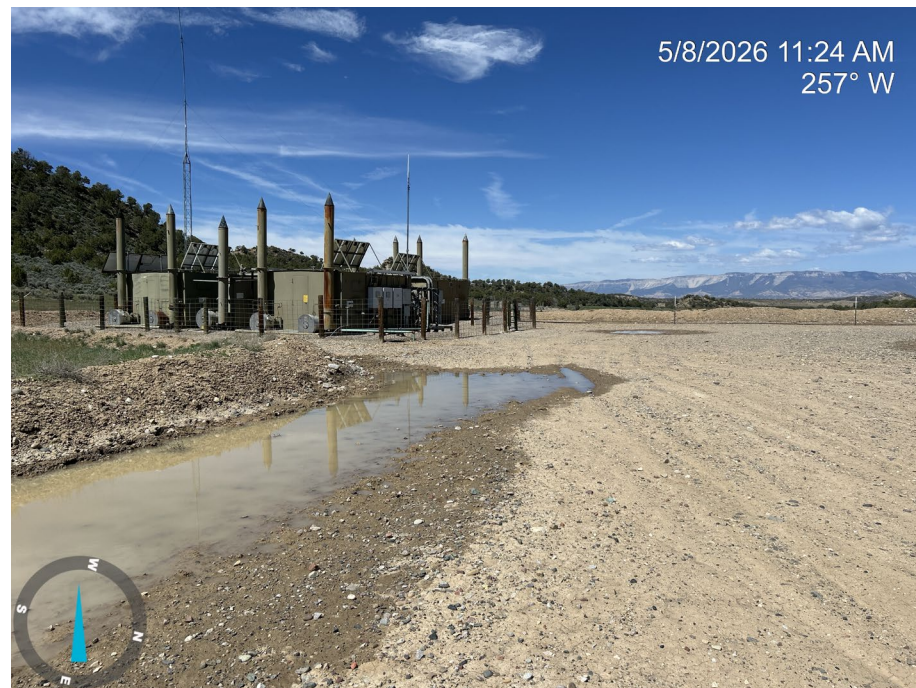
Photo 2: Photos showing an overview of the location looking east and west, respectively.

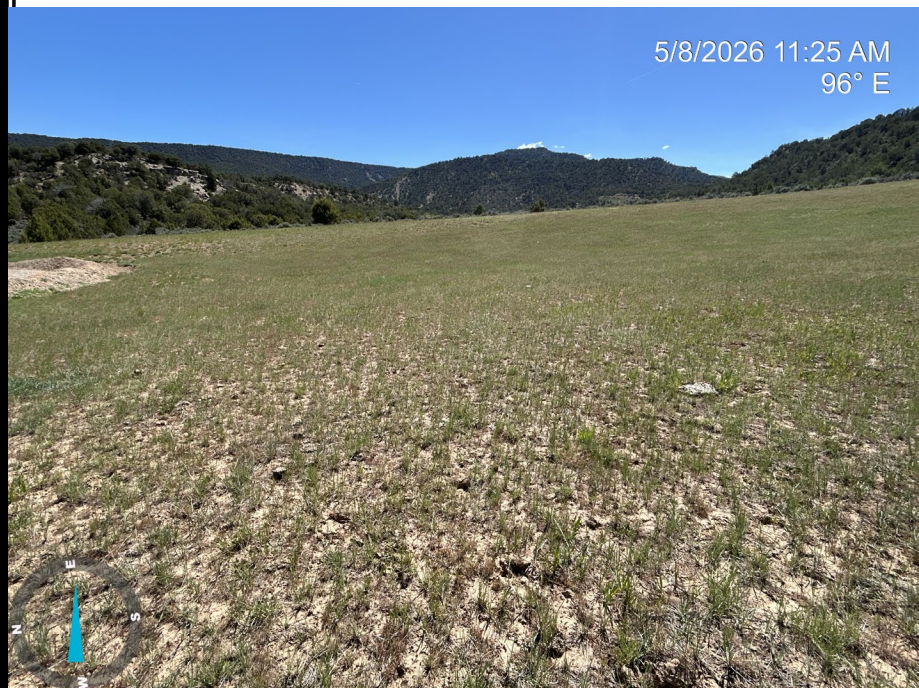
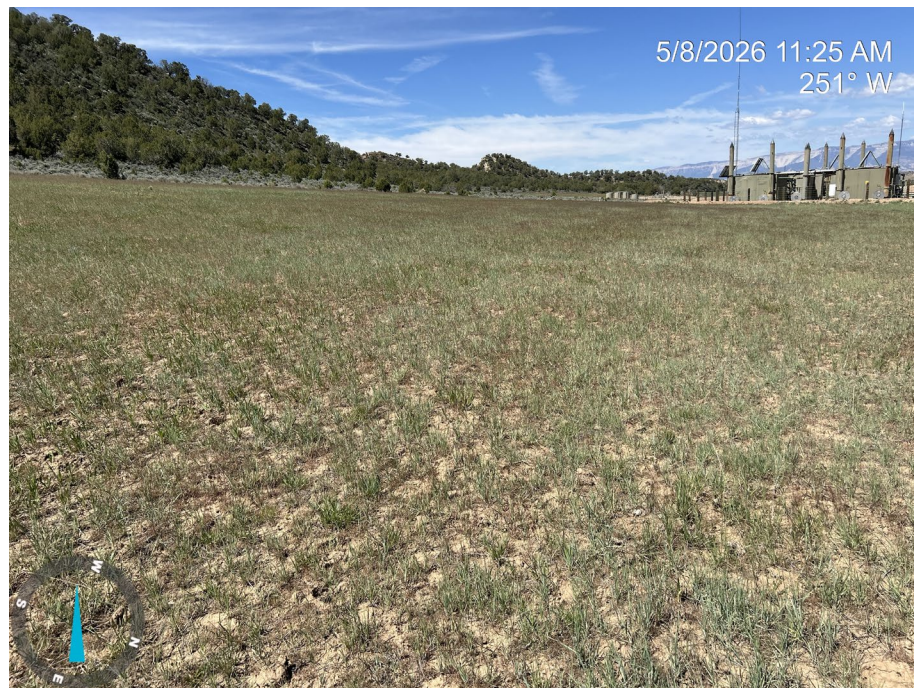
Photo 3: Photos showing an overview of the southern interim area. Interim areas are dominated by bulbous bluegrass, a List C noxious weed. Secondary amounts of smooth brome are present; weed management is required.

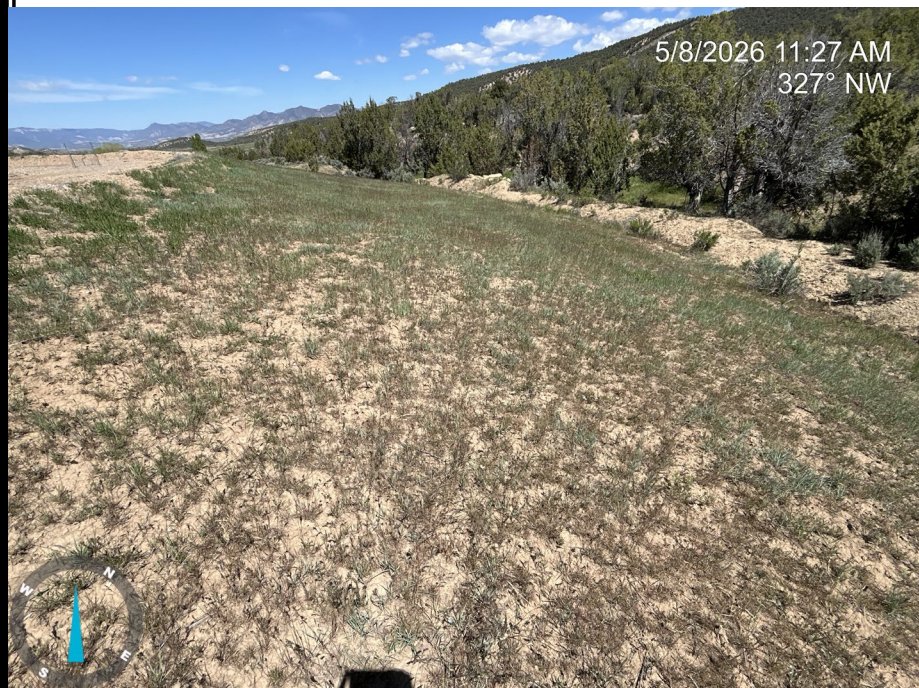
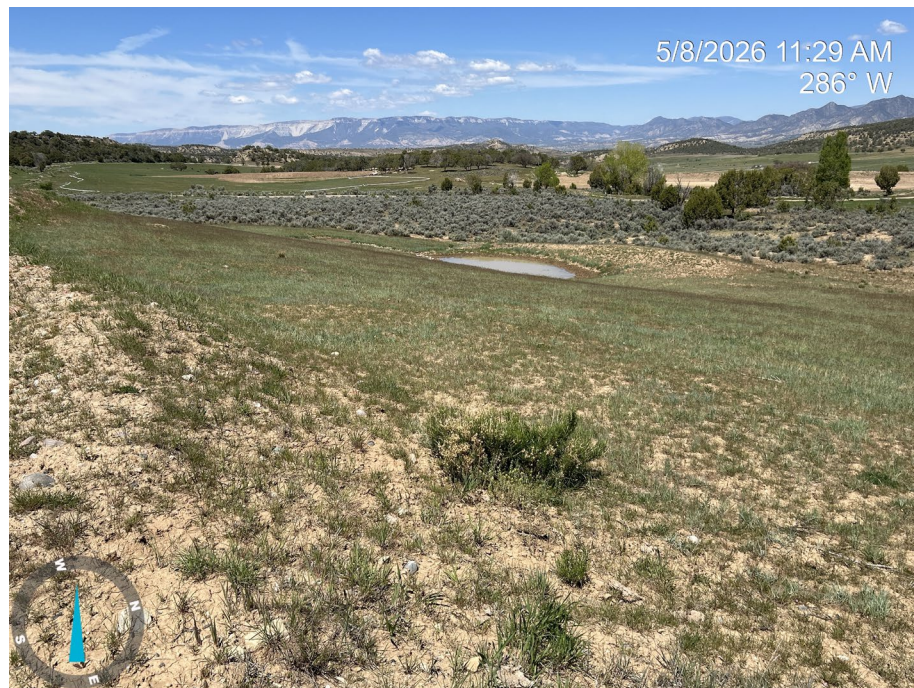
Photo 4: Photos showing an overview of the eastern and northern interim areas, respectively. Interim areas are dominated by bulbous bluegrass, a List C noxious weed. Secondary amounts of smooth brome are present; weed management is required.

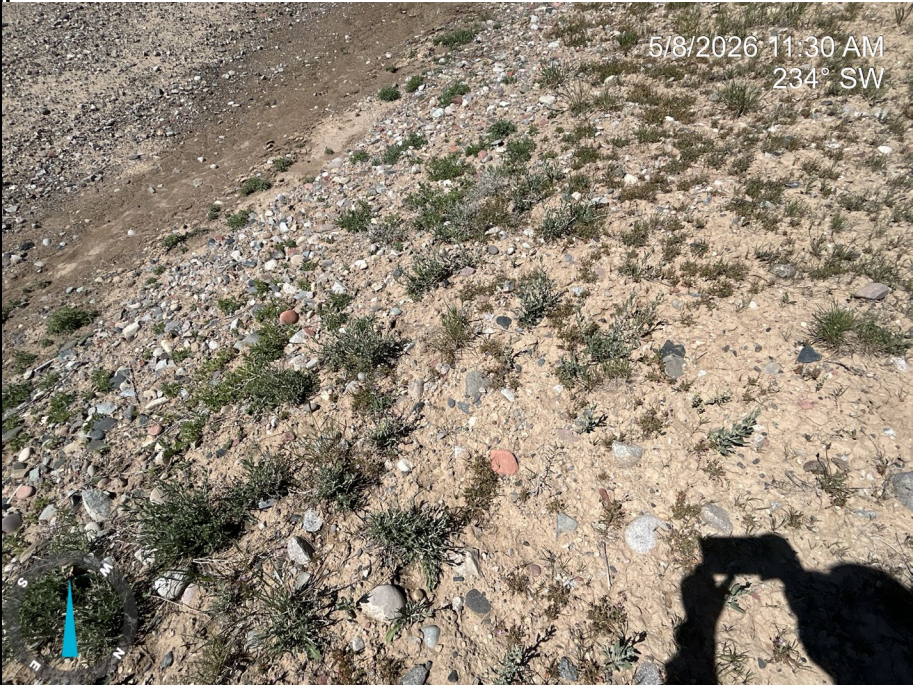
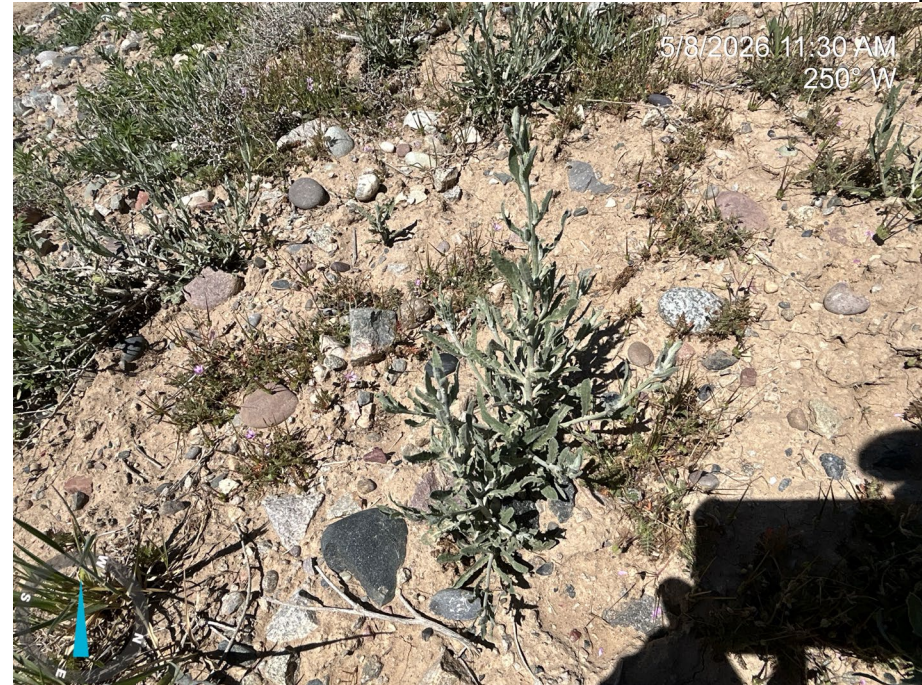
Photo 5: Photos showing a patch of Russian knapweed, a List B noxious weed, is present on the northern earthen berm along the edge of the working pad surface. Weed management is required.

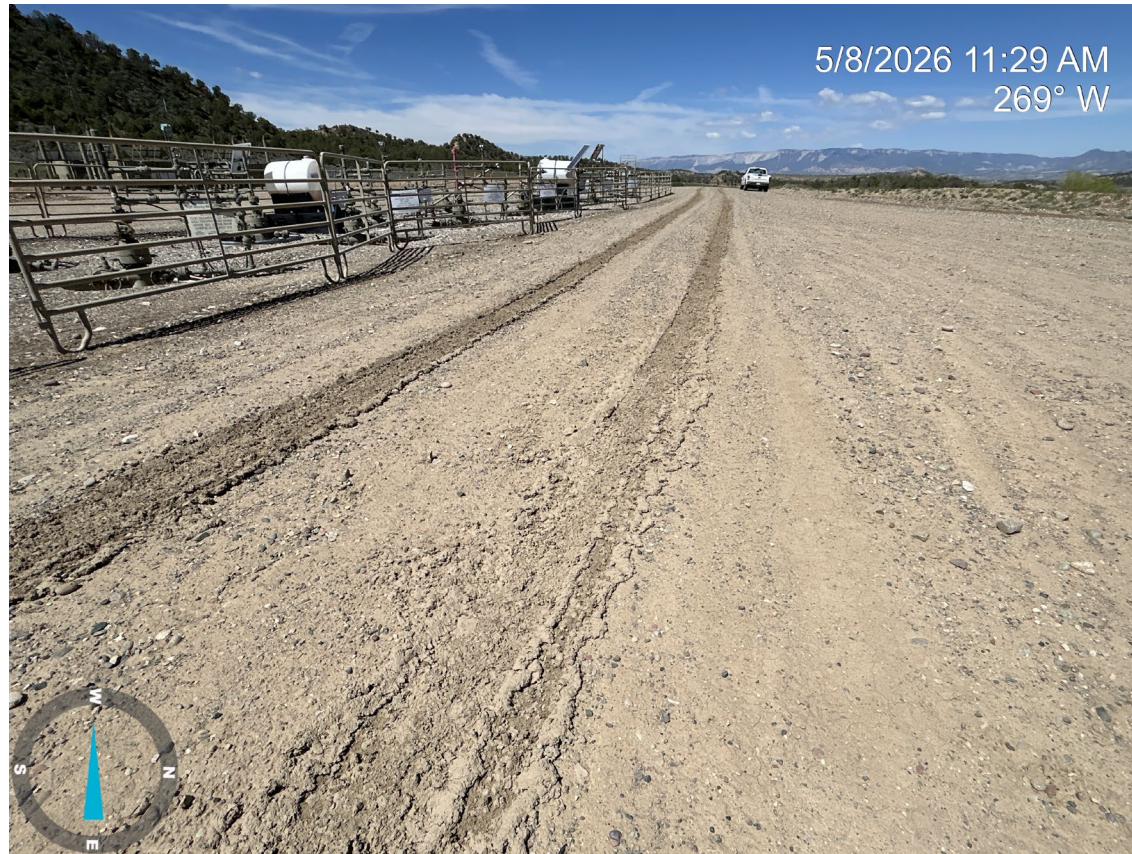
Photo 6: Vehicle rutting is present and gravel appears sparse on the working pad surface; maintenance is recommended.

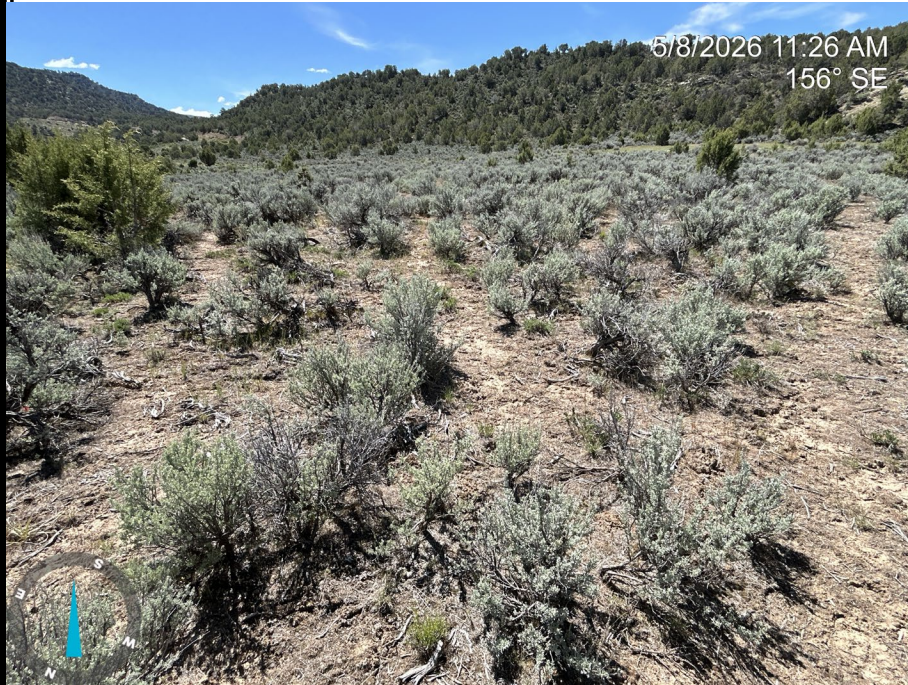
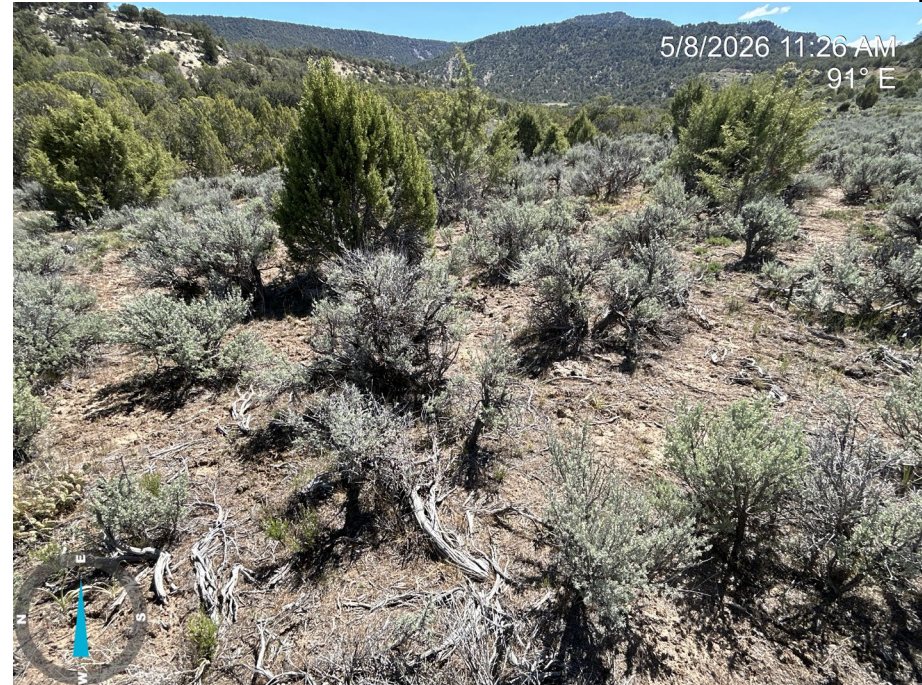
Photo 7: Photos showing the nearby reference area, directly east of the location. Bulbous bluegrass is present in the understory; however, big sagebrush is dominant throughout.
