INSPECTION PHOTOS

Well: AZTEC FEDERAL 41-15

INSPECTION DOC #: 716302334

Operator: EVERGREEN NATURAL RESOURCES LLC

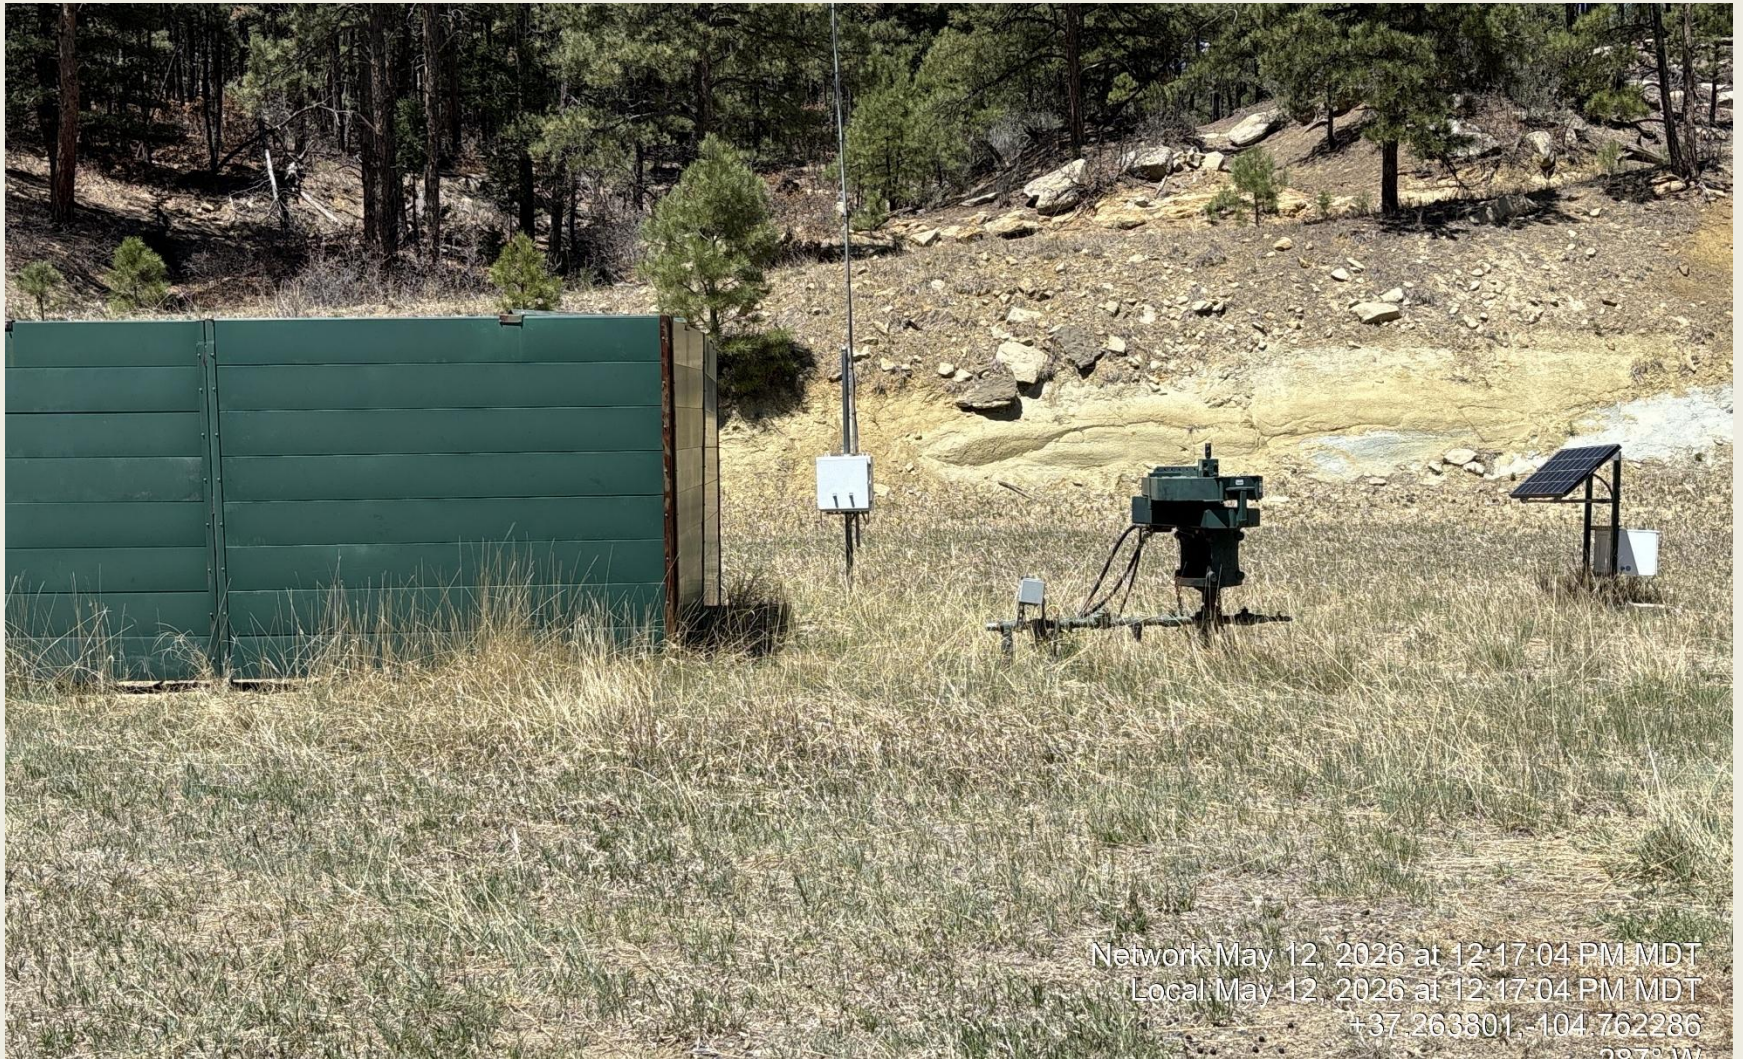
**PHOTO 4: WELLHEAD AND EQUIPMENT. GRASS AROUND WELLHEAD, EQUIPMENT AND METERHOUSE IS NOT MAINTAINED.
MAINTAIN GRASS/WEEDS AROUND ALL EQUIPMENT INCLUDING INSIDE SOUNDWALLS PER RULE 606. CA DATE 6/12/2026.**

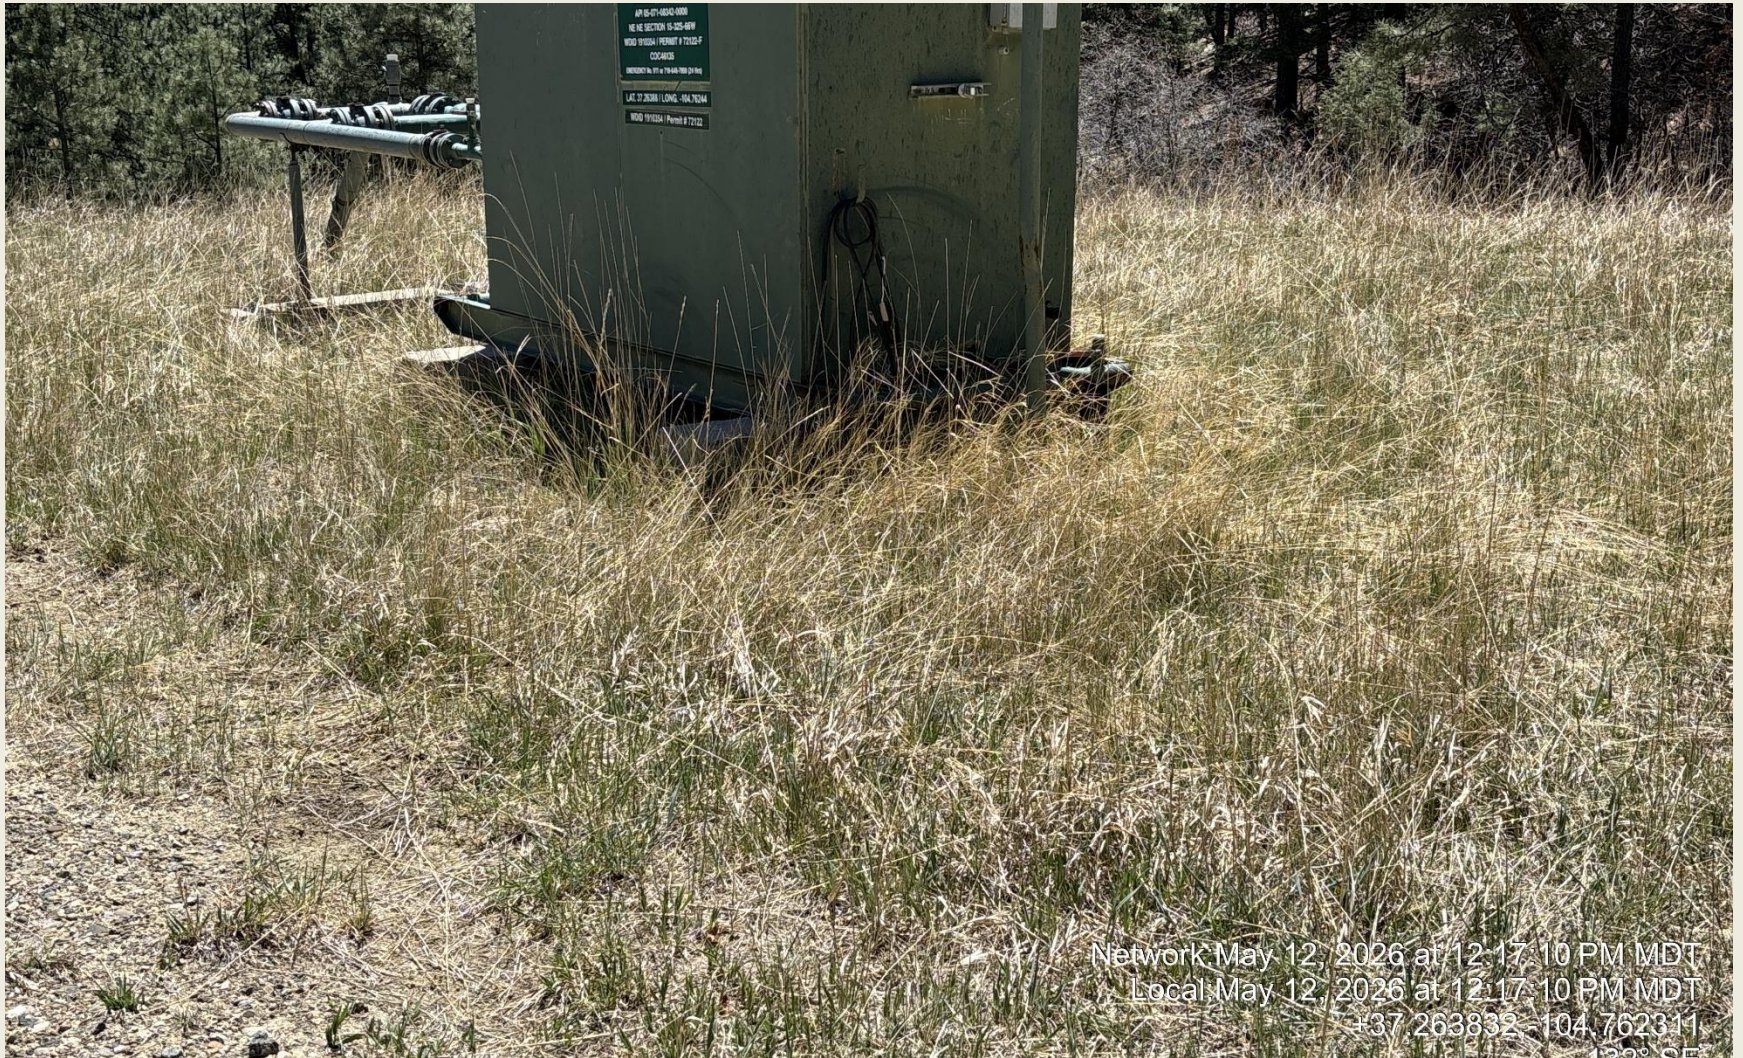
PHOTO 5: GRASS AROUND WELLHEAD, EQUIPMENT AND METERHOUSE IS NOT MAINTAINED. MAINTAIN GRASS/WEEDS AROUND ALL EQUIPMENT INCLUDING INSIDE SOUNDWALLS PER RULE 606. CA DATE 6/12/2026.
