# INSPECTION PHOTOS

**Well: VISION 31-11 & TR**

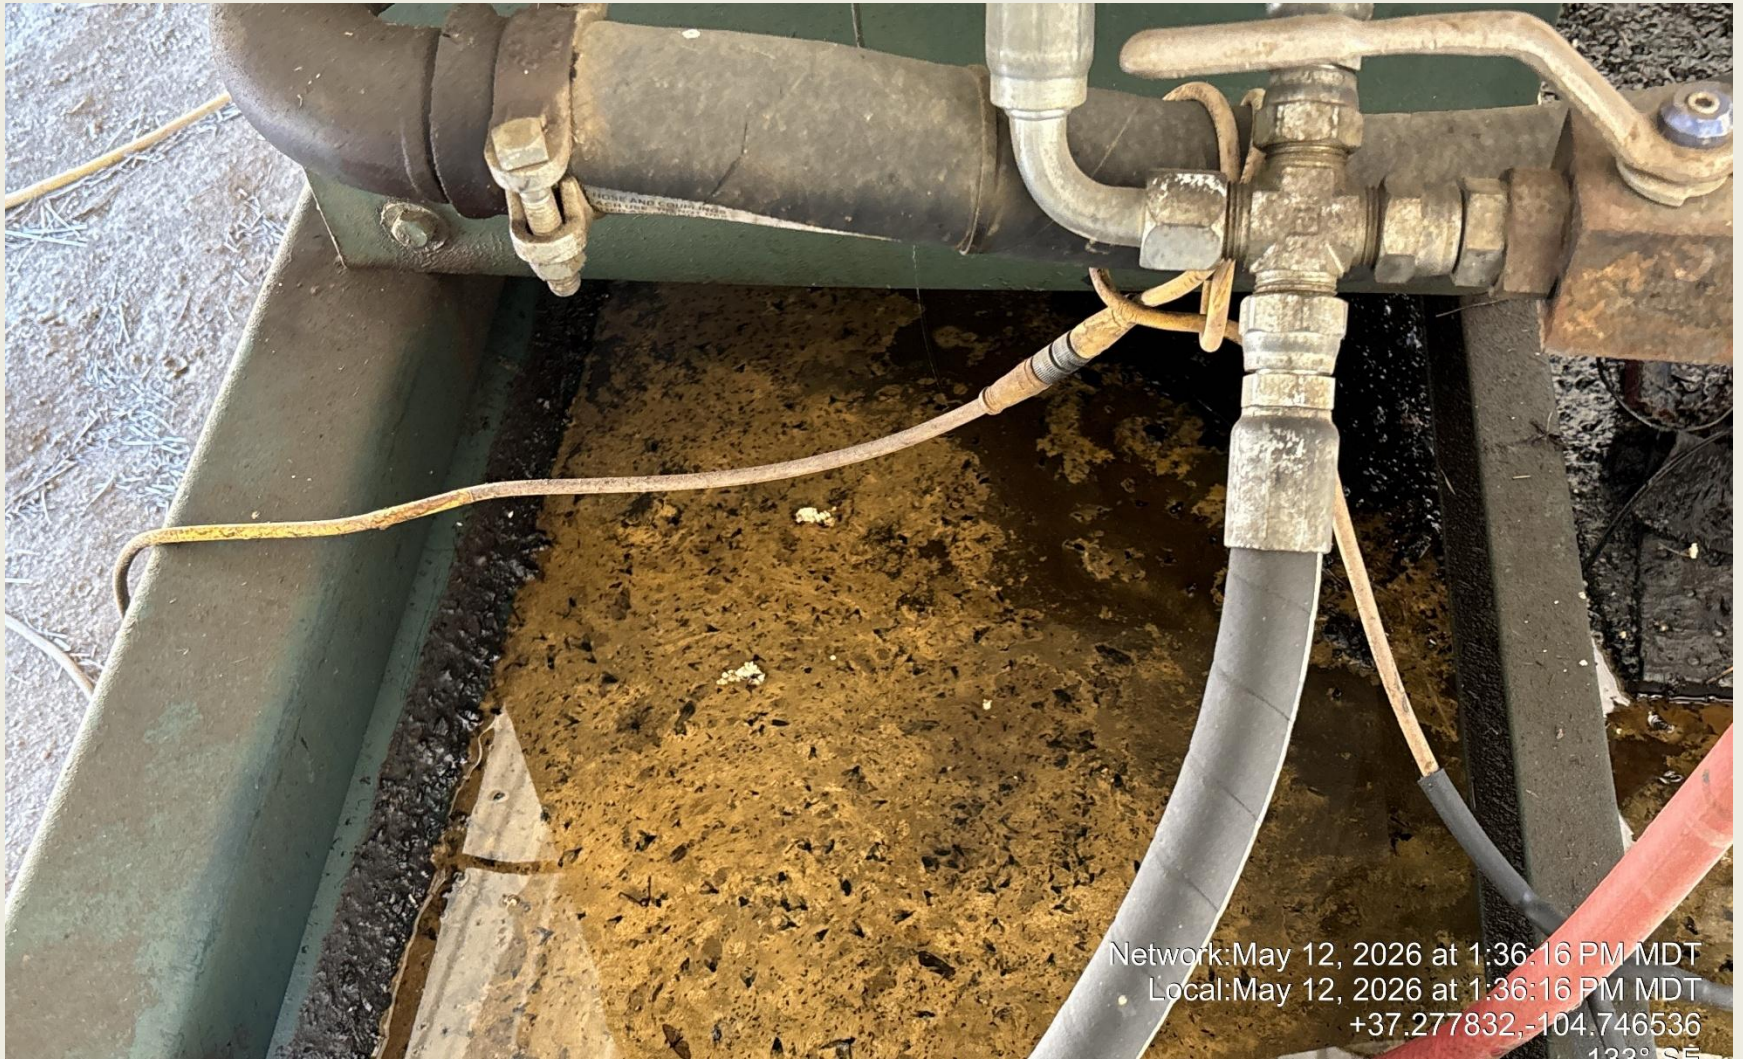
Network: May 12, 2026 at 1:36:16 PM MDT  
Local: May 12, 2026 at 1:36:16 PM MDT  
+37.277832, -104.746536  
122° SE
