Inspection Photos

Operator: TEP Rocky Mountain LLC #96850

Location ID: 415116

Inspection Doc: 719201135

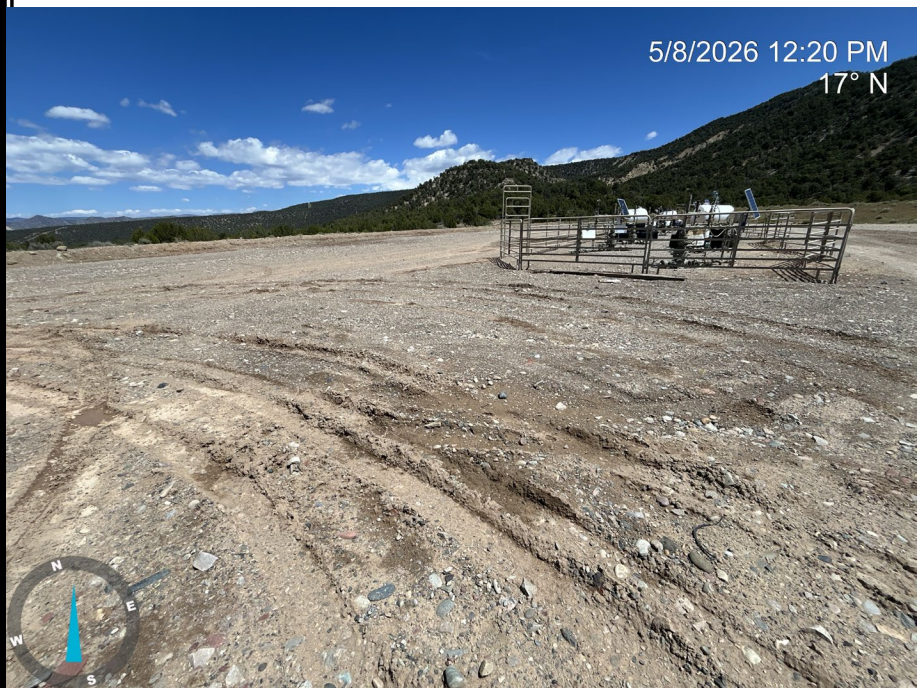
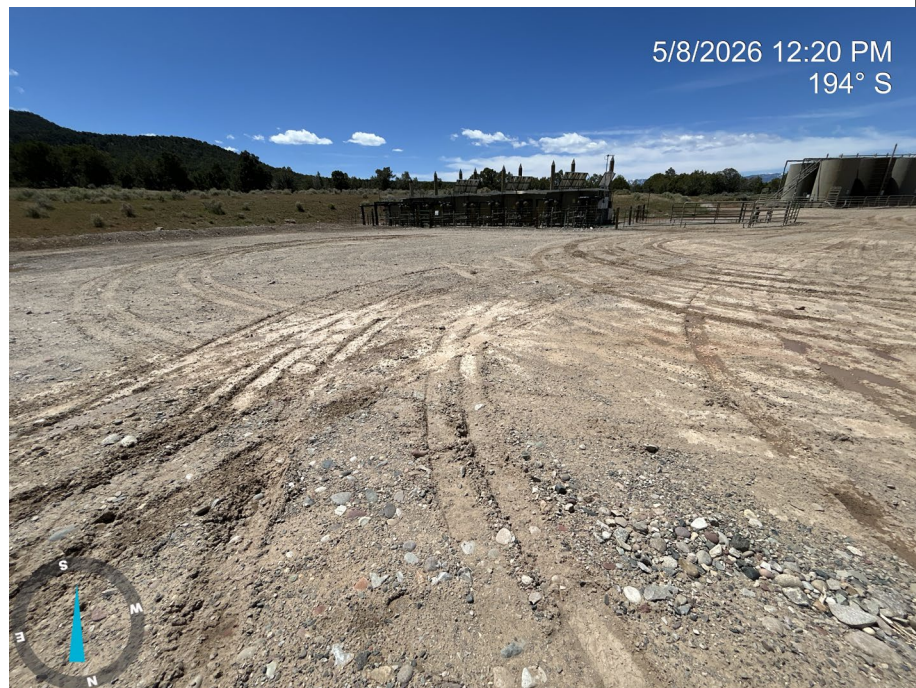
Photo 1: Photos showing an overview of the location looking north and south, respectively.

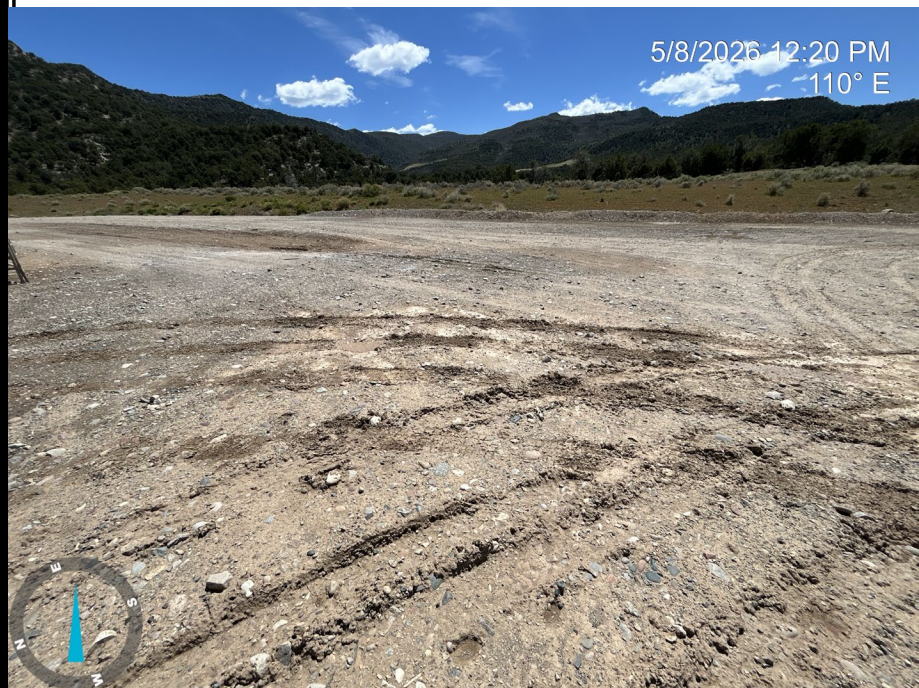
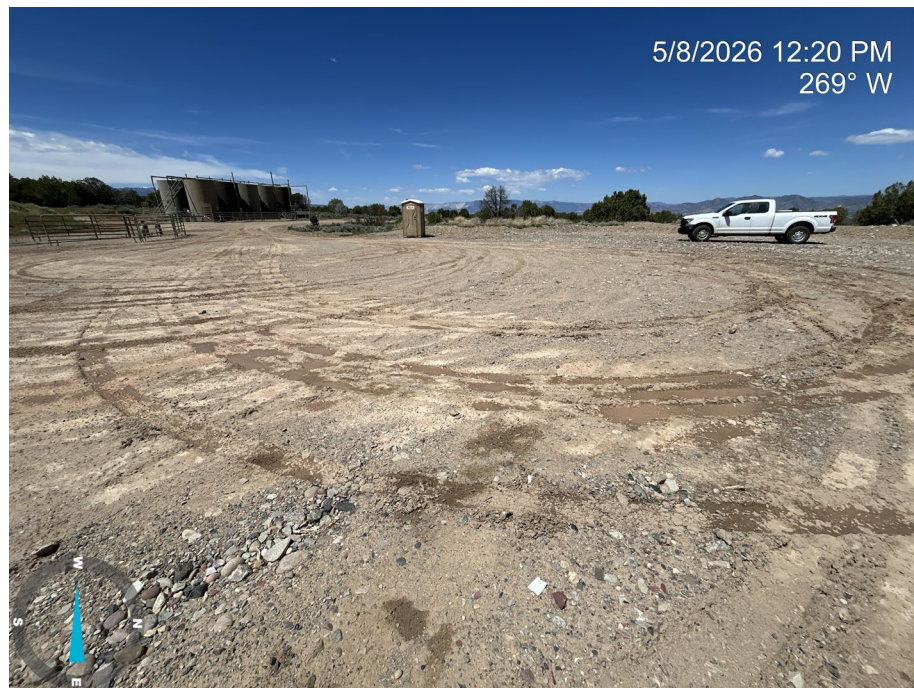
Photo 2: Photos showing an overview of the location looking east and west, respectively. Vehicle tracking is present throughout the working pad surface and requires maintenance pursuant to Rule 1002.f.

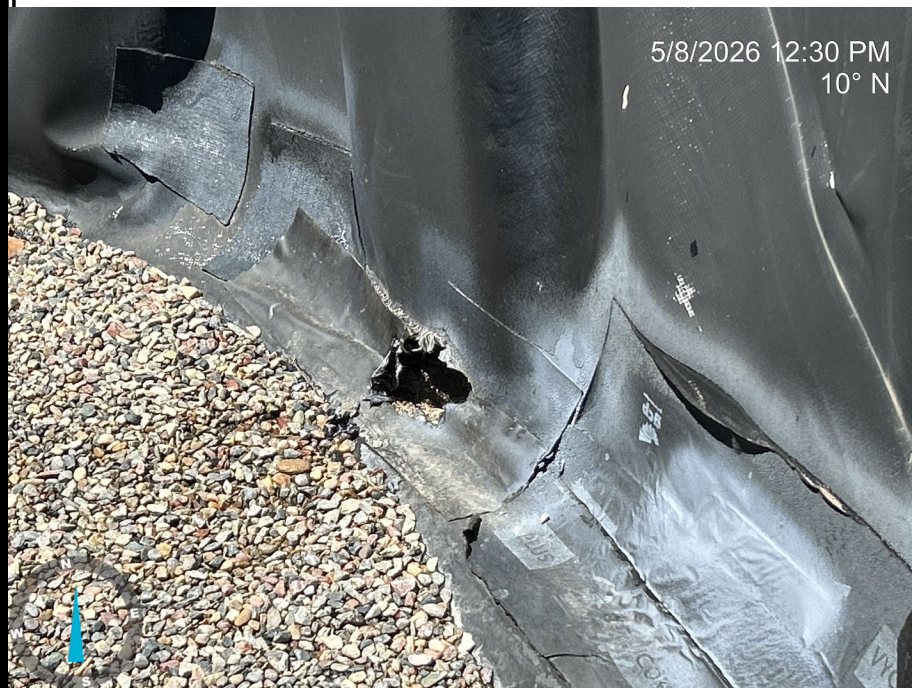
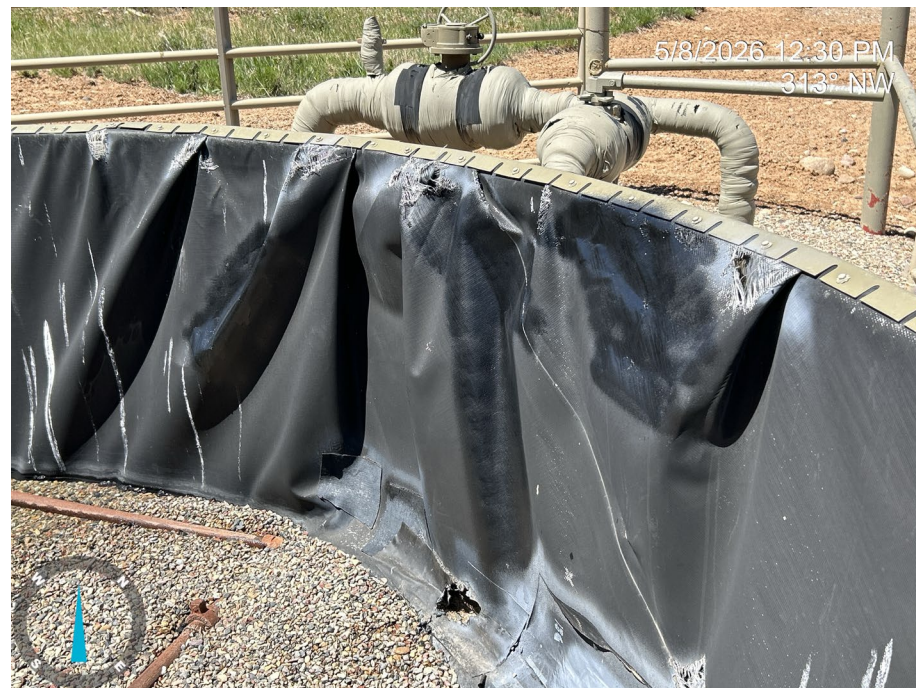
Photo 3: Photos showing examples of holes and tears that are present in the tank's secondary containment black geotextile liner. Maintenance/repair is required.

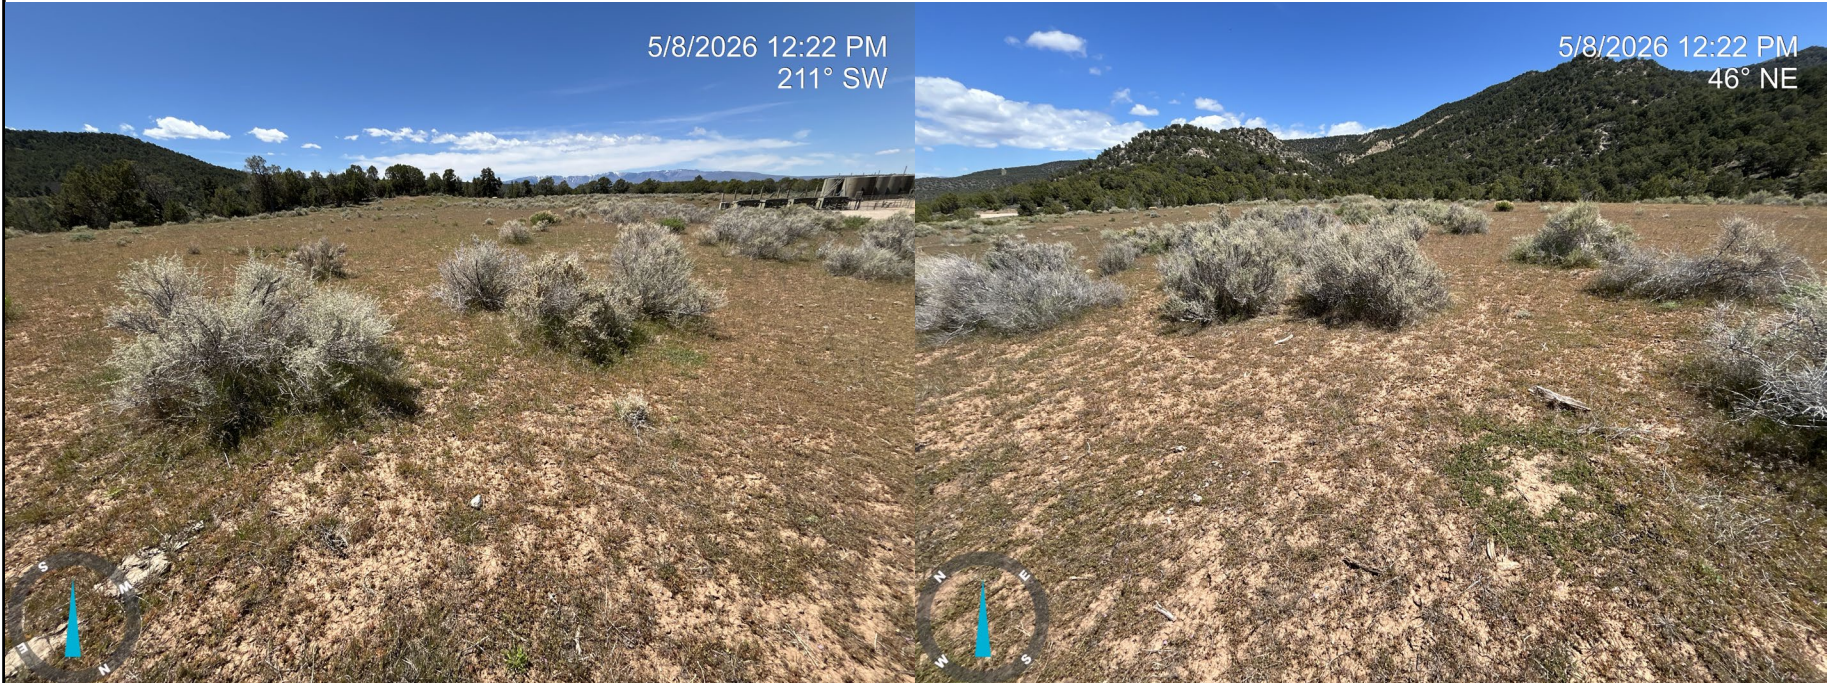
Photo 4: Photos showing an overview of the southern interim area; fourwing saltbush is present in secondary amounts; bulbous bluegrass and redstem fillaree, both List C noxious weeds, are dominant in the understory. Weed management is required.

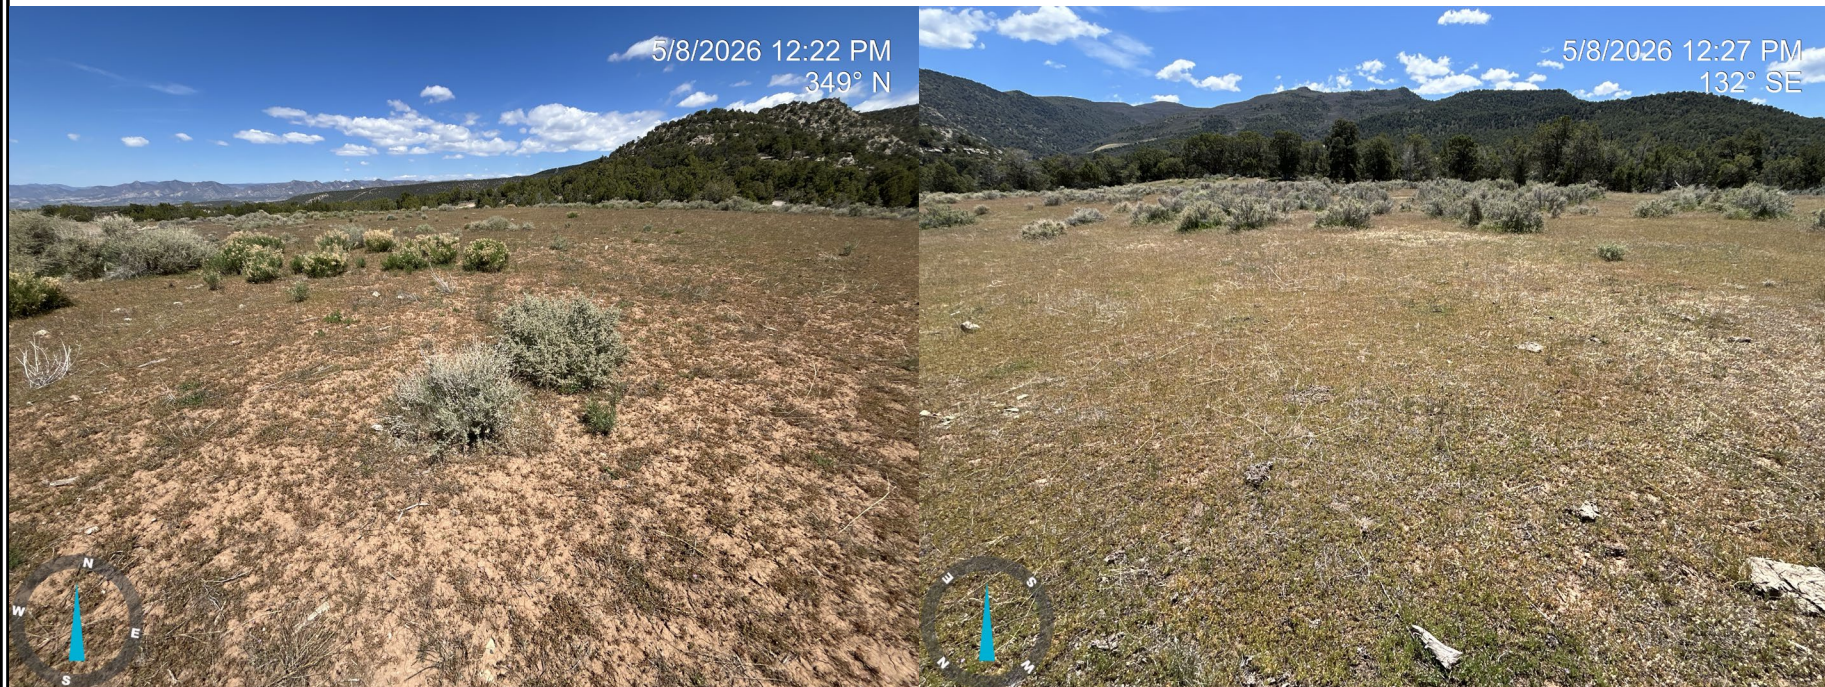
Photo 5: Photos showing an overview of the eastern interim area; fourwing saltbush is present in secondary amounts; bulbous bluegrass and redstem fillaree, both List C noxious weeds, are dominant in the understory. Weed management is required.

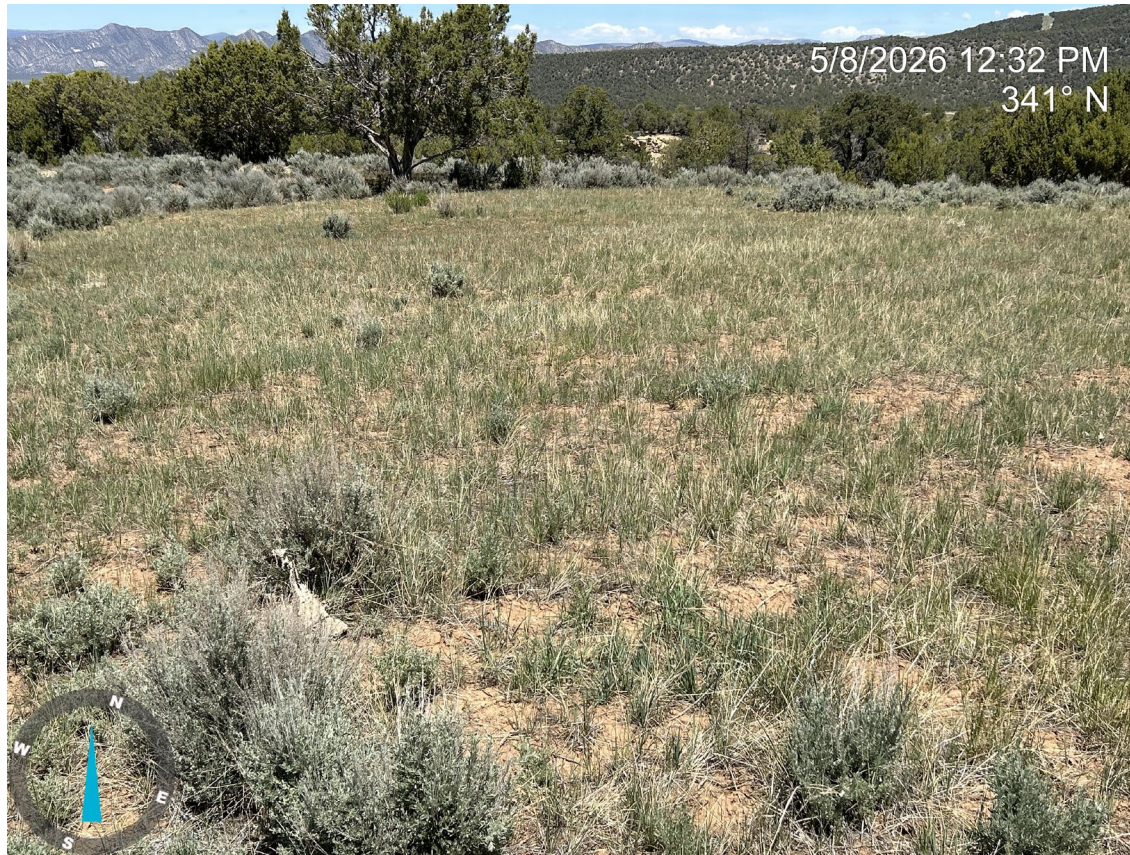
Photo 6: Photos showing the northern interim area. This portion of the interim area is composed of desirable, perennial and uniform vegetation and is progressing towards 1003 reclamation requirements.

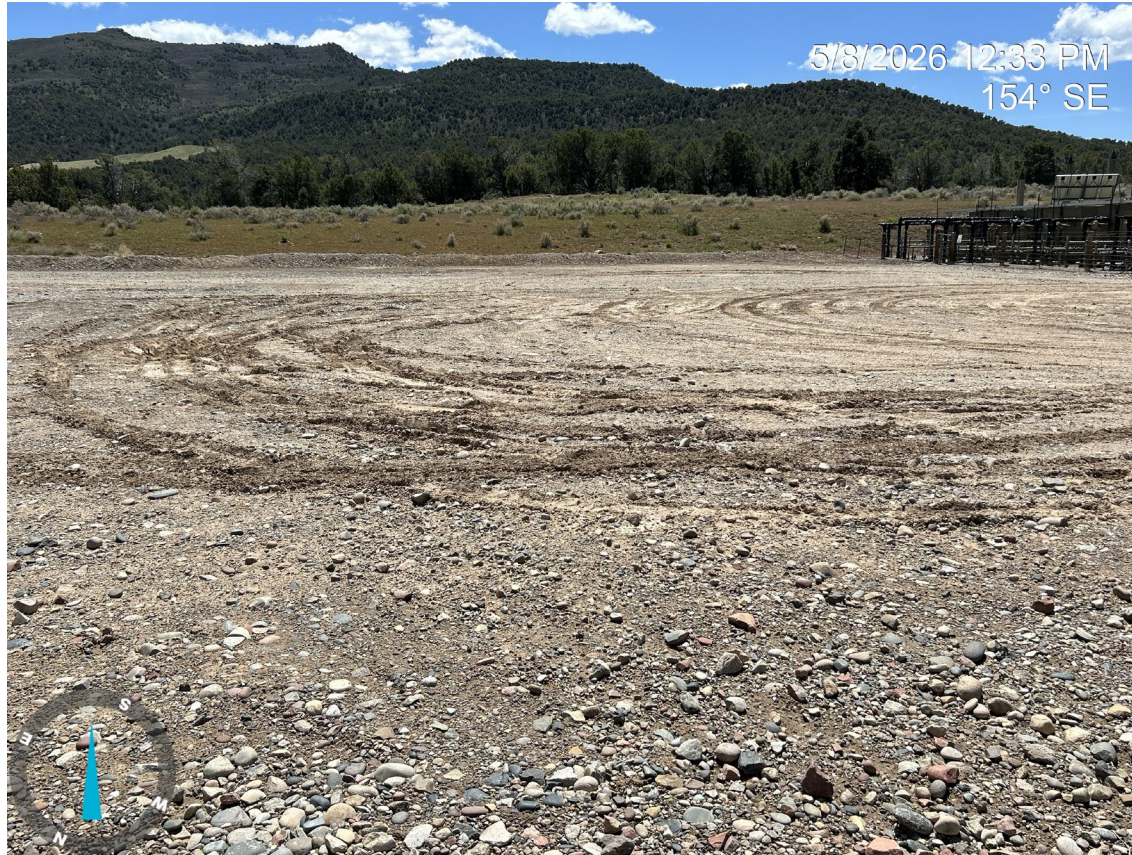
Photo 7: Vehicle rutting/tracking is present throughout the working pad surface and gravel appears sparse in some areas. Maintenance is required.
