Inspection Photos

Operator: TEP Rocky Mountain LLC #96850

Location ID: 335266

Inspection Doc: 719201139

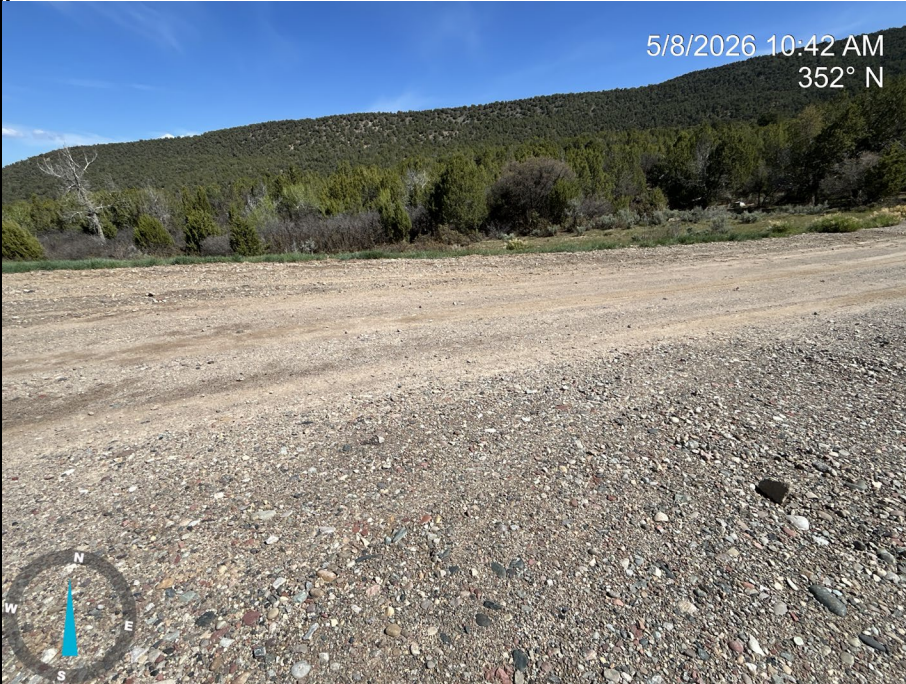
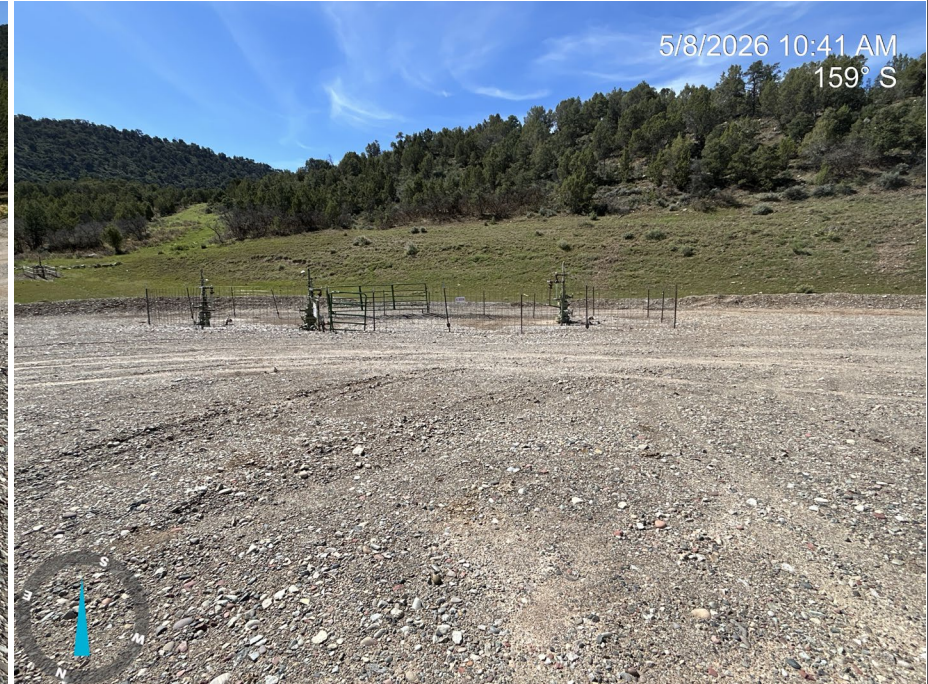
Photo 1: Photos showing an overview of the location looking north and south, respectively.

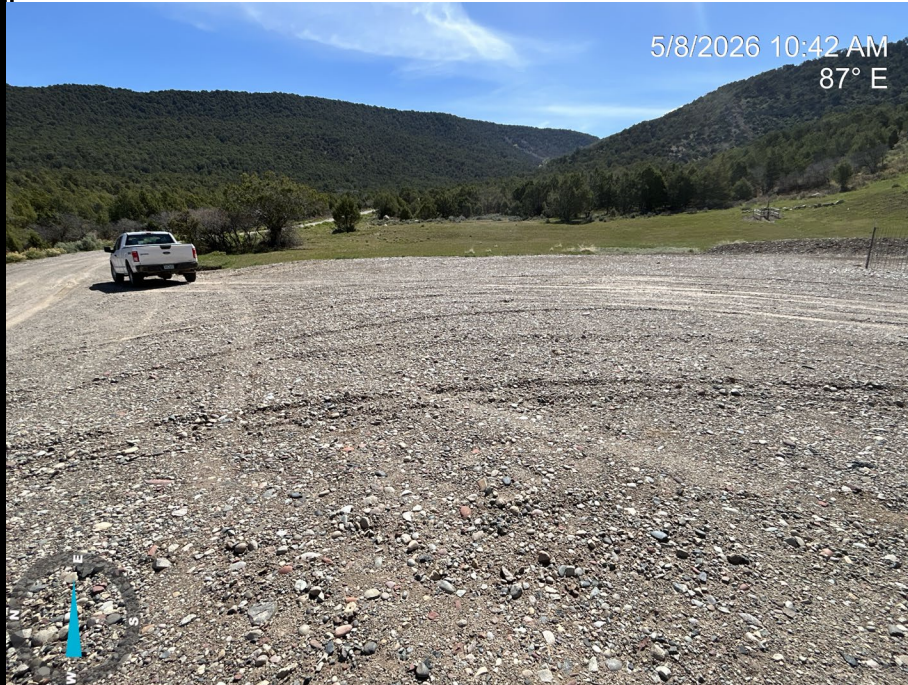
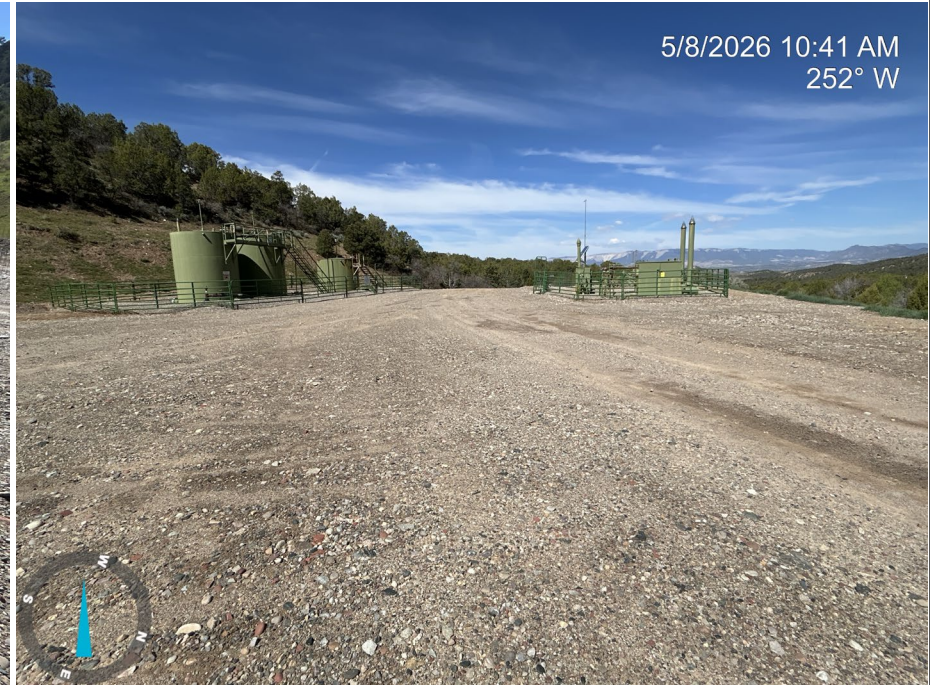
Photo 2: Photos showing an overview of the location looking east and west, respectively.

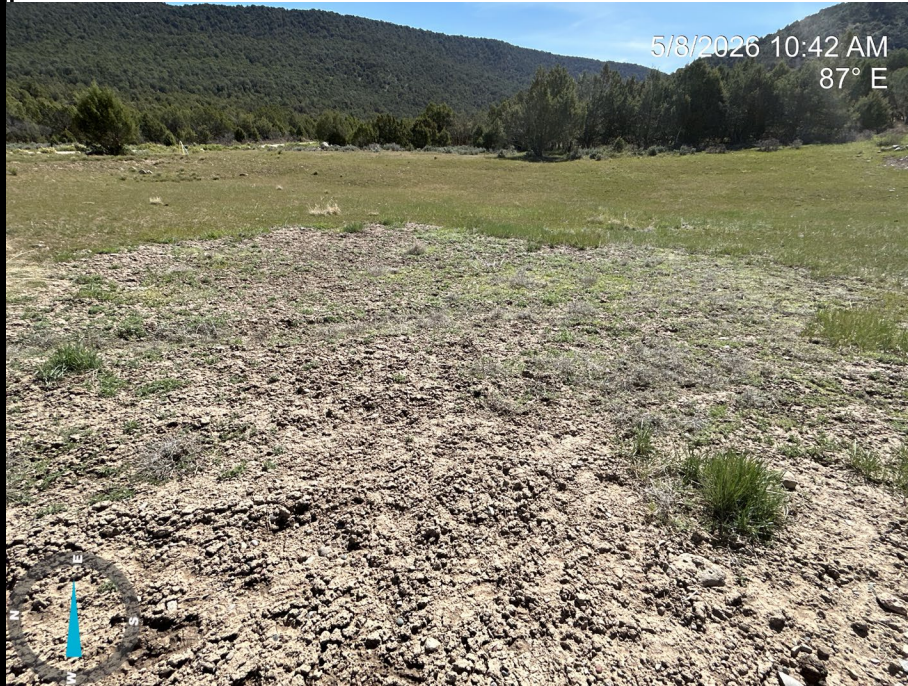
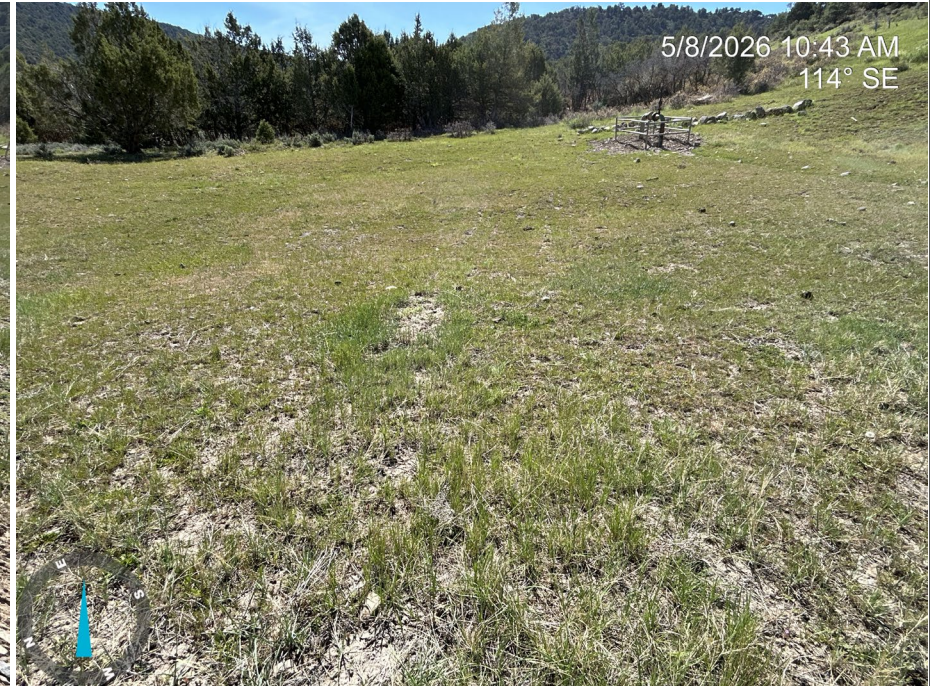
Photo 3: Photos showing the eastern interim area. The area is composed of perennial grasses and kochia (light green) as well as bulbous bluegrass, a List C noxious weed.

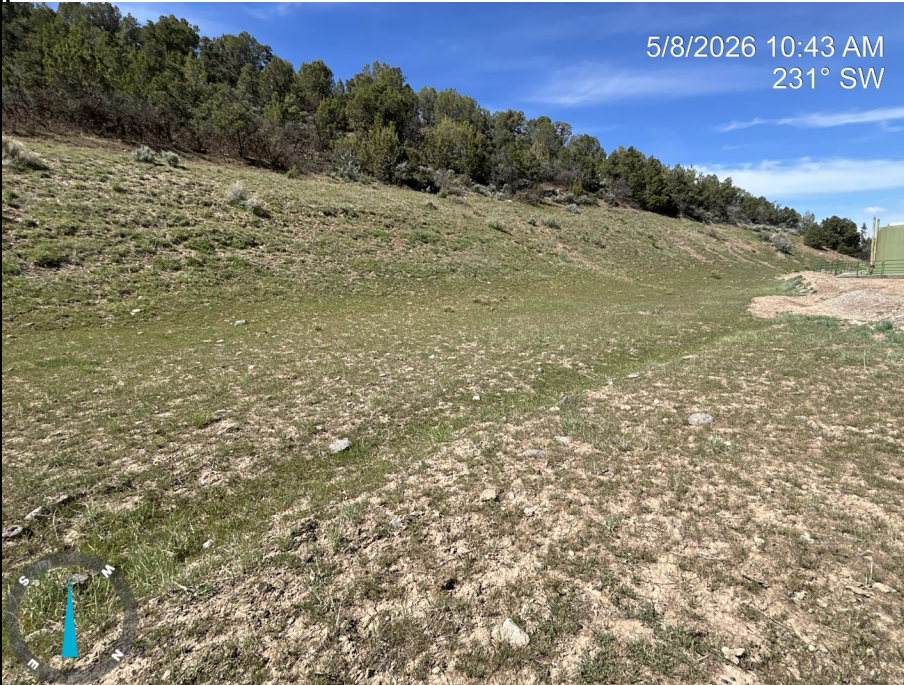
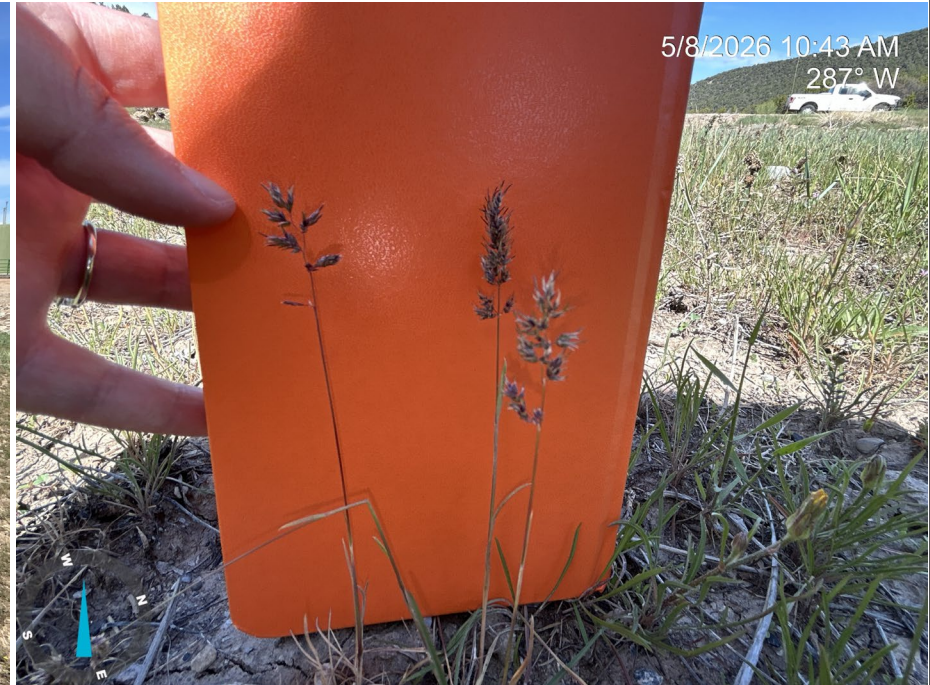
Photo 4: Photos showing the southern interim area. Cut slopes are well vegetated. Bulbous bluegrass is present in primary amounts throughout the interim area.

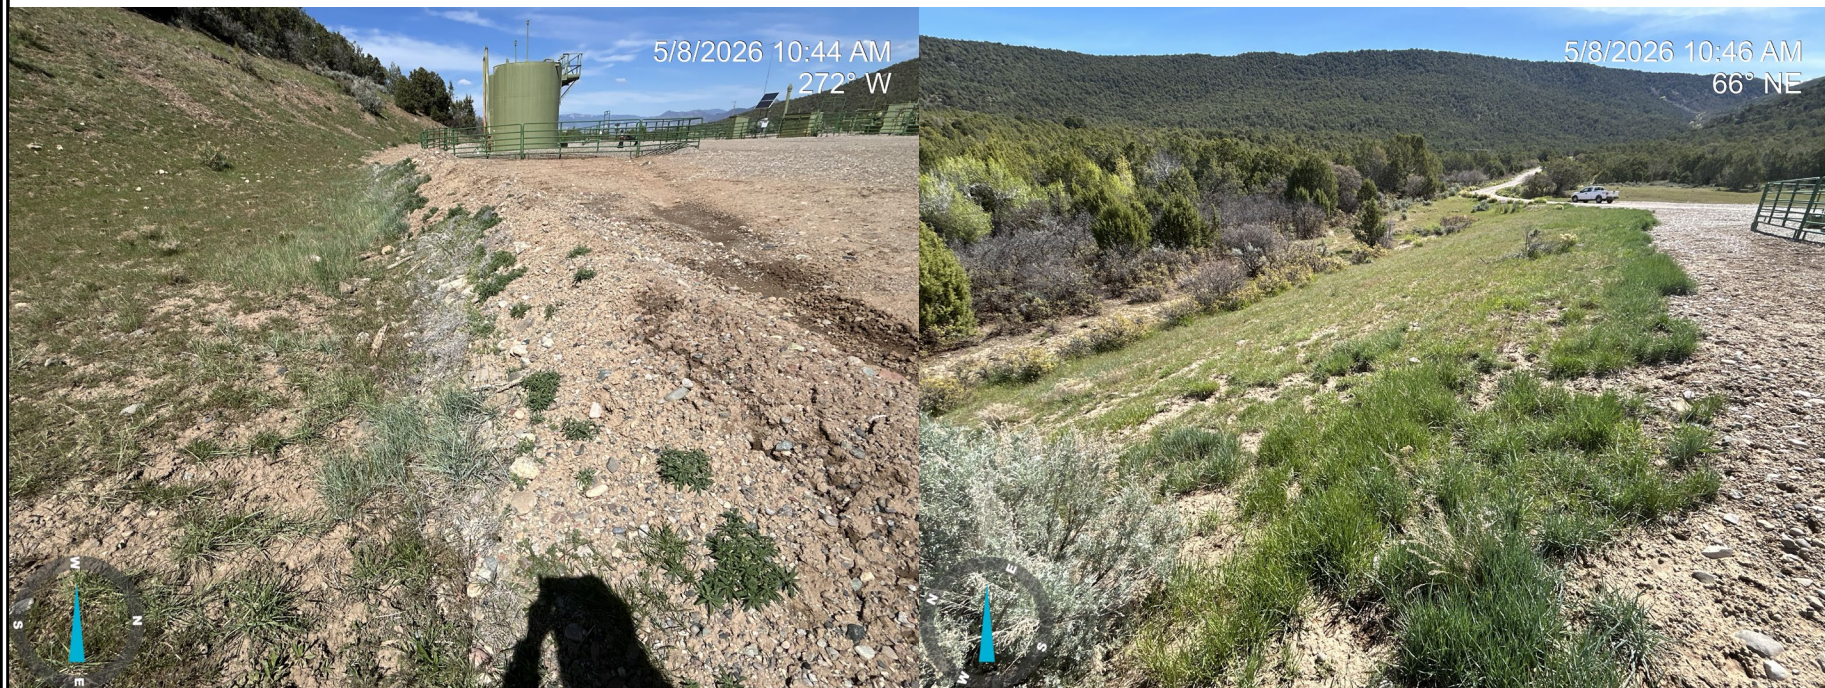
Photo 5: Photos showing kochia is beginning to establish along the edges of the working pad surface (left), and the northern interim area is well established with perennial grasses. Overall, interim areas are progressing towards 1003 reclamation requirements.
