# INSPECTION PHOTOS

Well: BUSHMASTER 32-35

API #: 05-071-08155

Operator: EVERGREEN NATURAL RESOURCES LLC

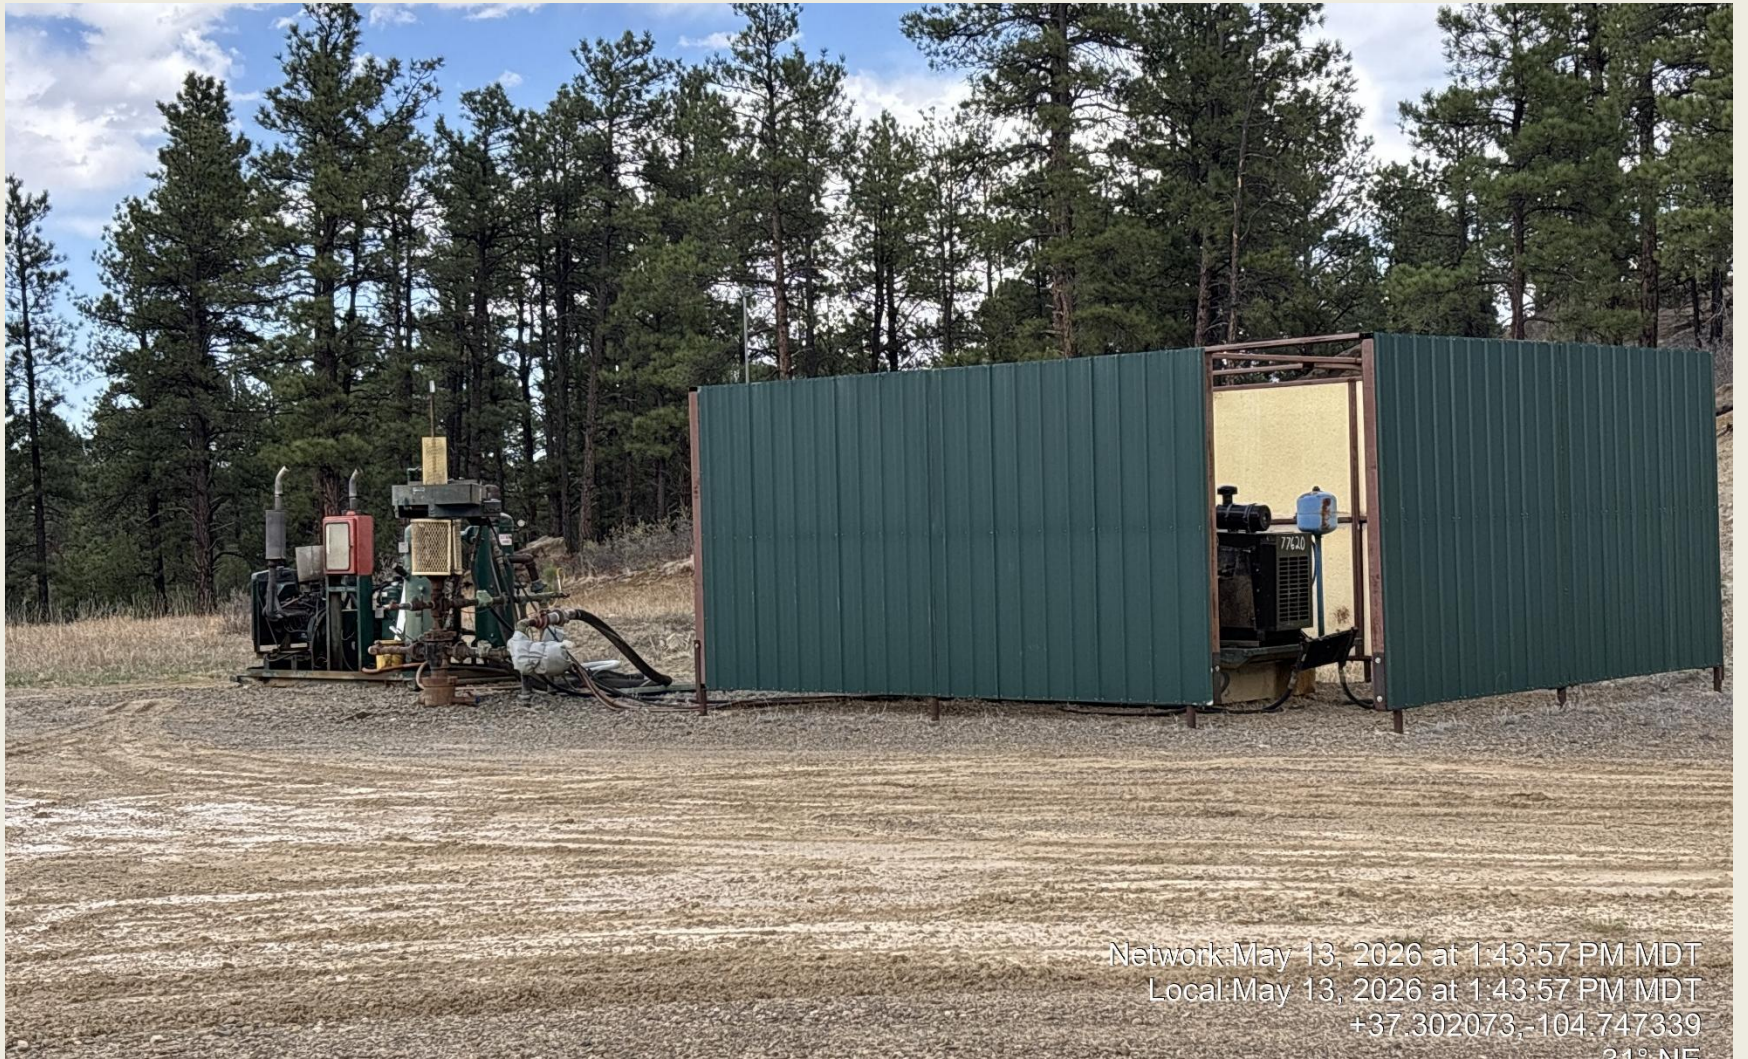
Network: May 13, 2026 at 1:43:57 PM MDT  
Local: May 13, 2026 at 1:43:57 PM MDT  
+37.302073, -104.747339  
21° NE

PHOTO 4: WELLHEAD AND EQUIPMENT.

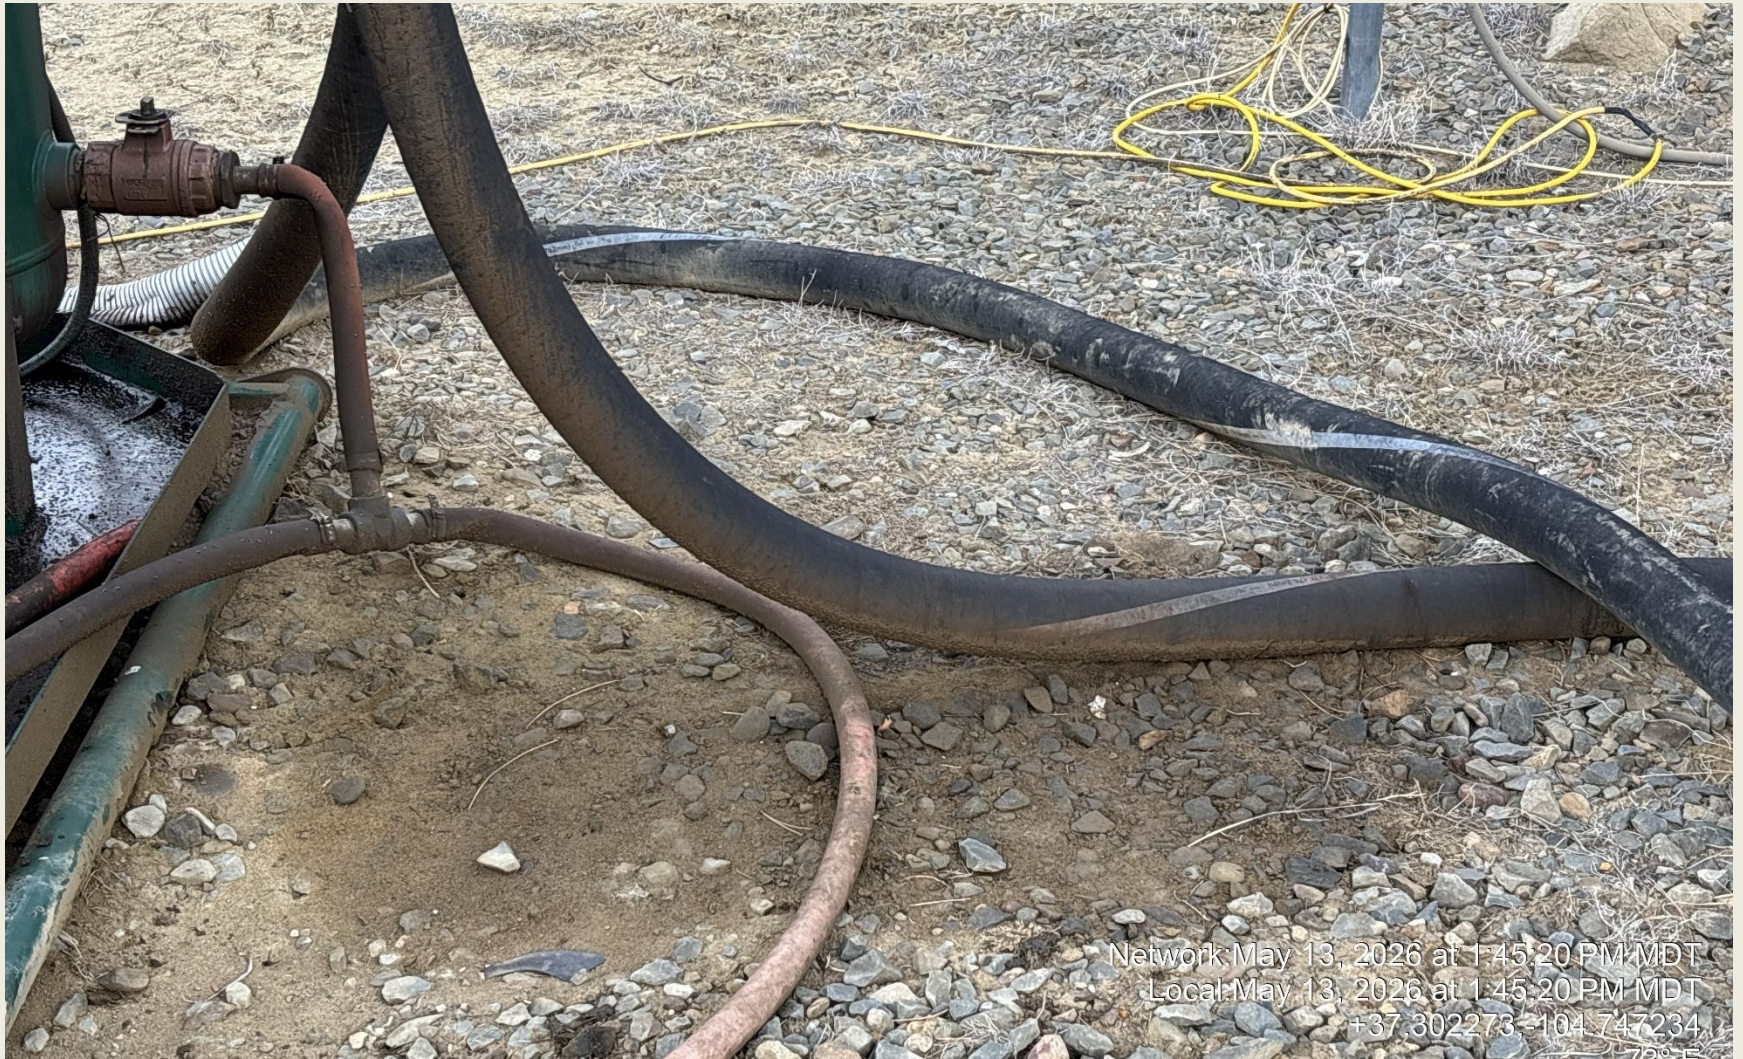
**PHOTO 5: AREA OF IMPACTED SOIL NEAR COMPRESSOR SKID. Conduct maintenance on equipment, cleanup stained material and review self inspection processes. COMPLY WITH RULE 1002,(2).D. CA DATE 6/13/2026.**

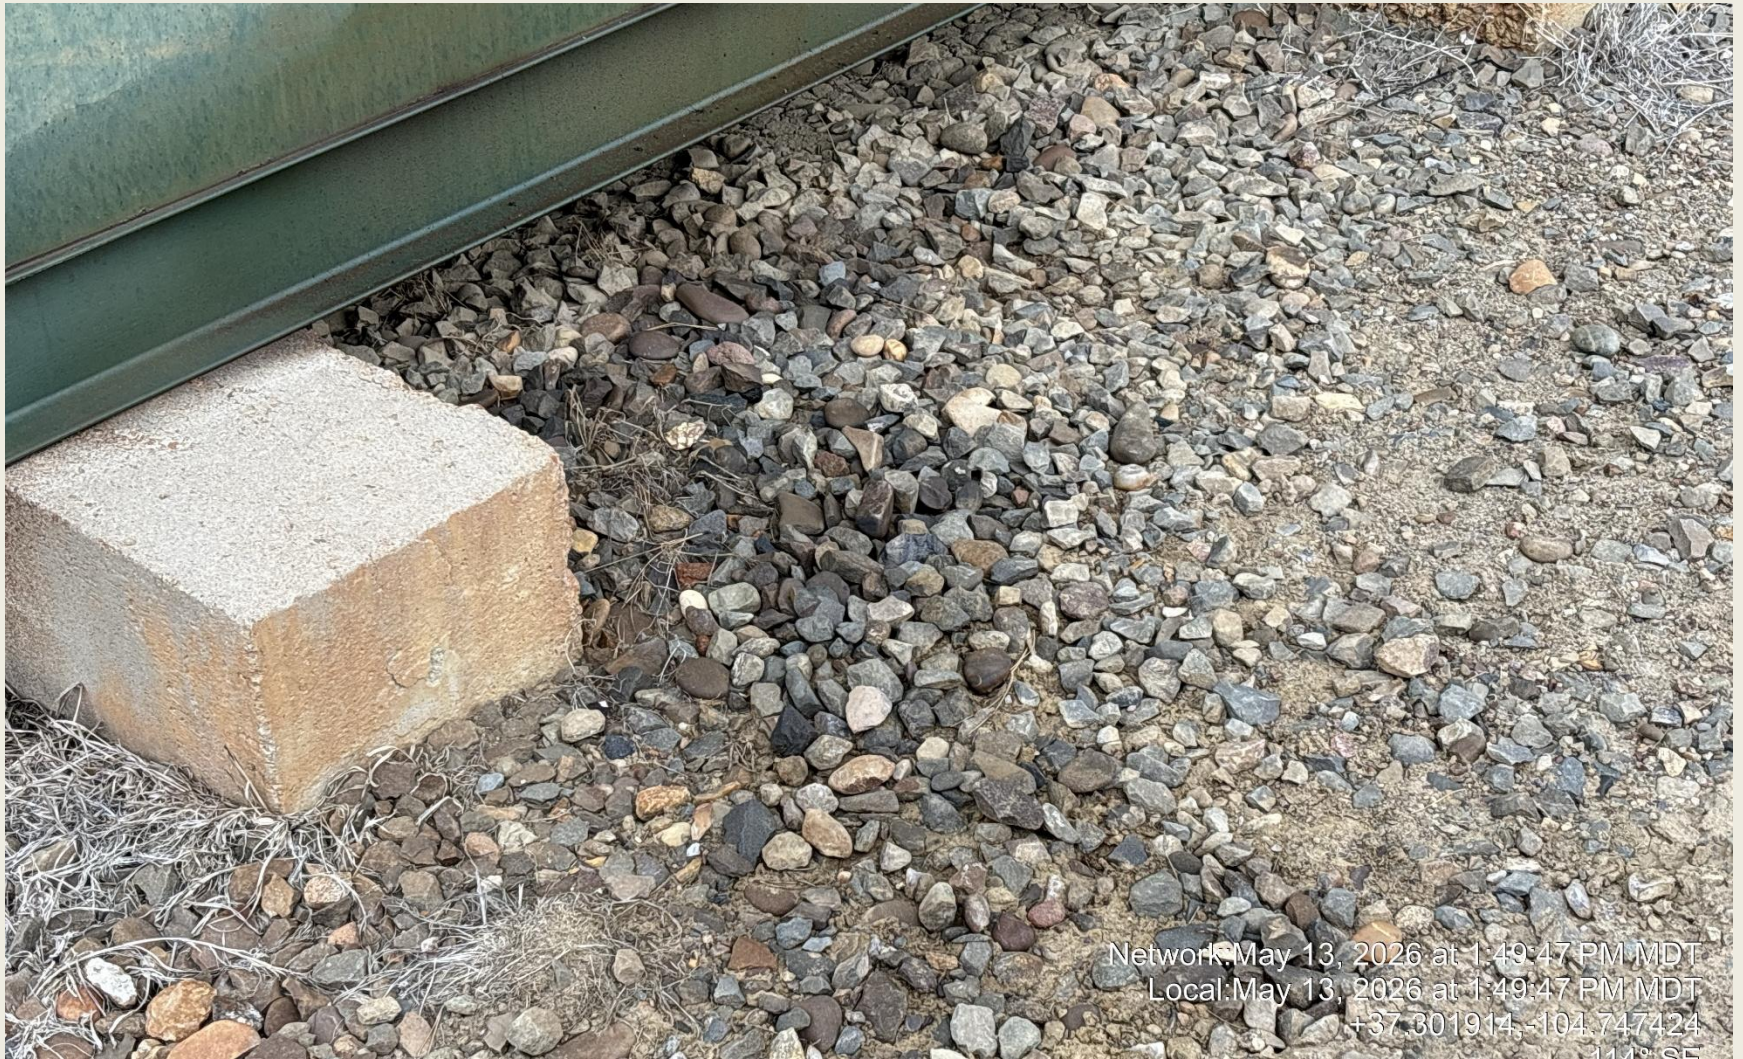
Network: May 13, 2026 at 1:49:47 PM MDT  
Local: May 13, 2026 at 1:49:47 PM MDT  
+37.301914, -104.747424  
31.1° SE

**PHOTO 6: AREA OF IMPACTED SOIL NEAR METER HOUSE. Conduct maintenance on equipment, cleanup stained material and review self inspection processes. COMPLY WITH RULE 1002,.(2).D. CA DATE 6/13/2026.**
